MONITORING YEAR 3 ANNUAL REPORT Final

FOUST CREEK MITIGATION SITE

Alamance County, NC

DMS Project Number 95715

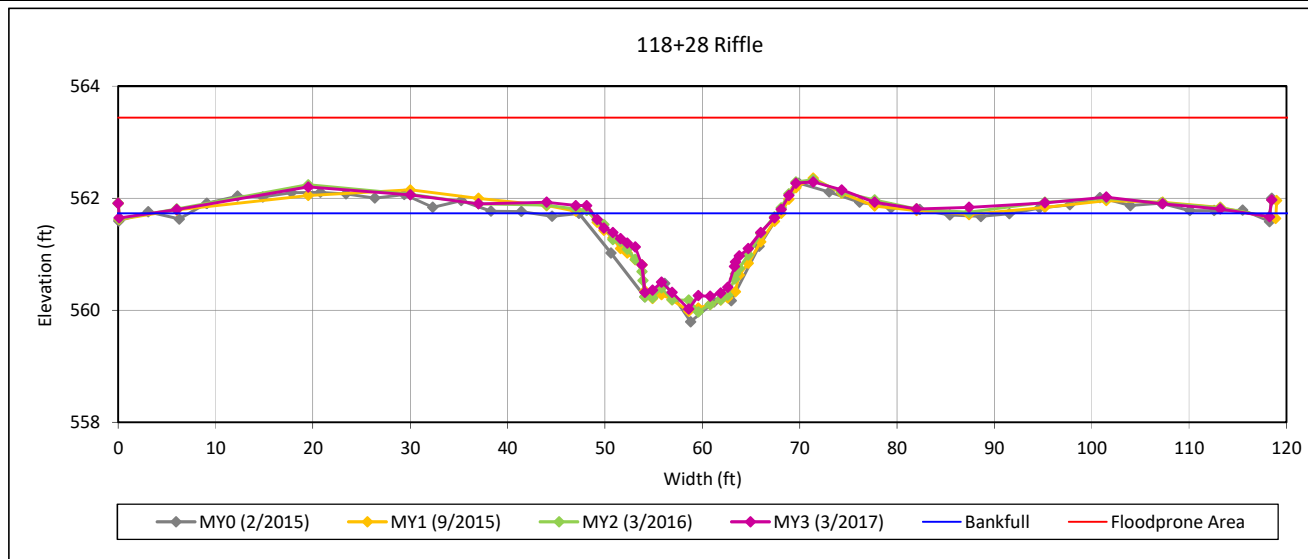
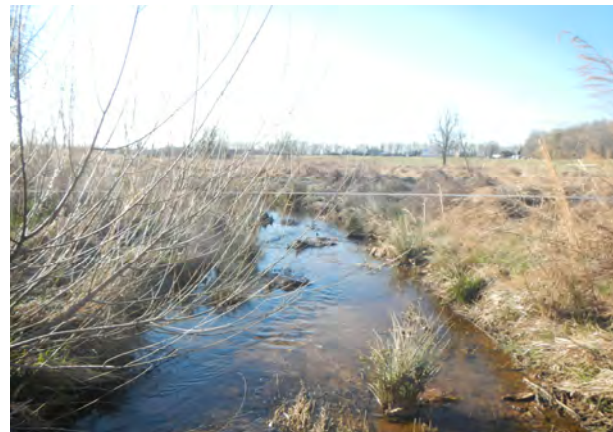
Cross Section 1- Foust Creek Reach 2

17.5	x-section area (ft.sq.)
19.1	width (ft)
0.9	mean depth (ft)
1.7	max depth (ft)
19.7	wetted perimeter (ft)
0.9	hyd radi (ft)
20.8	width-depth ratio
150.0	W flood prone area (ft)
7.9	entrenchment ratio
1.0	low bank height ratio

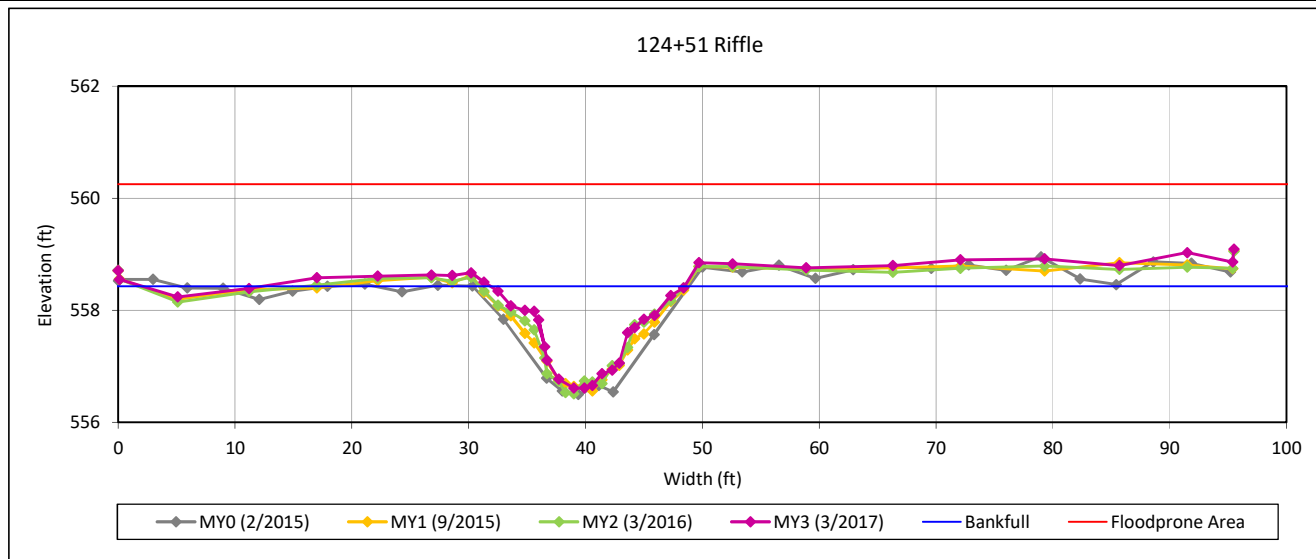
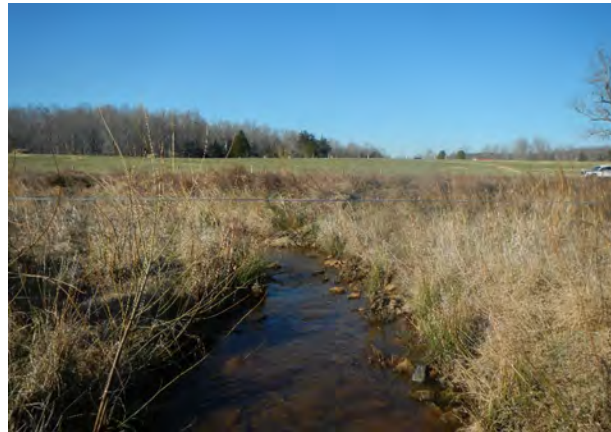
Cross Section 3- Foust Creek Reach 2

15.1	x-section area (ft.sq.)
16.7	width (ft)
0.9	mean depth (ft)
1.8	max depth (ft)
18.8	wetted parimeter (ft)
0.8	hyd radi (ft)
18.4	width-depth ratio
150.0	W flood prone area (ft)
9.0	entrenchment ratio
1.0	low bank height ratio

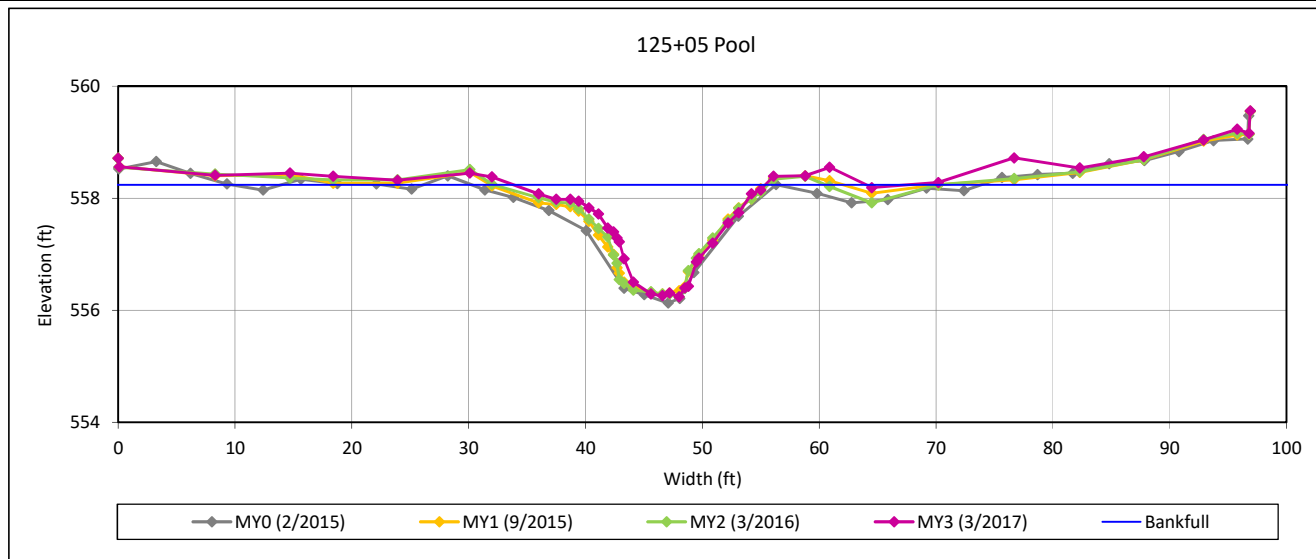
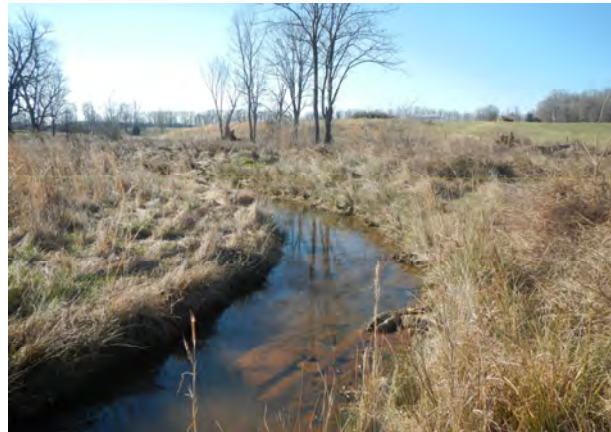
Cross Section 4- Foust Creek Reach 2

18.7	x-section area (ft.sq.)
21.5	width (ft)
0.9	mean depth (ft)
2.0	max depth (ft)
22.2	wetted parimeter (ft)
0.8	hyd radi (ft)
24.9	width-depth ratio

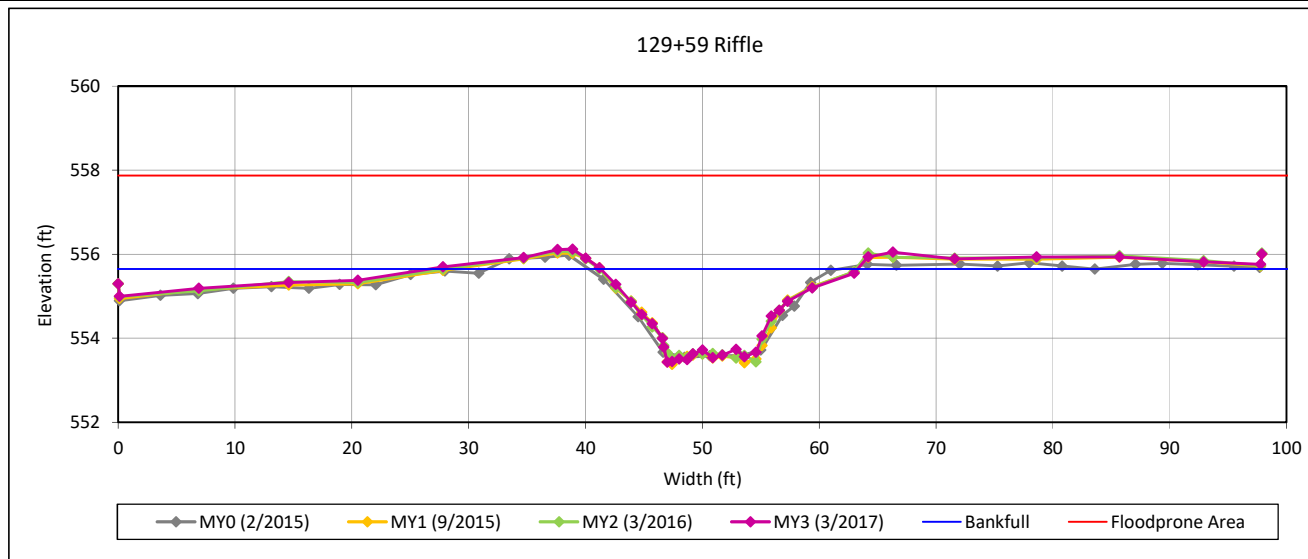
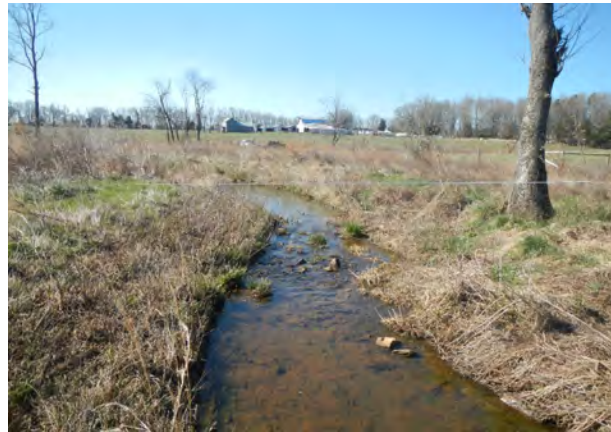
Cross Section 5- Foust Creek Reach 2

26.2	x-section area (ft.sq.)
22.0	width (ft)
1.2	mean depth (ft)
2.2	max depth (ft)
23.0	wetted parimeter (ft)
1.1	hyd radi (ft)
18.4	width-depth ratio
150.0	W flood prone area (ft)
6.8	entrenchment ratio
1.0	low bank height ratio

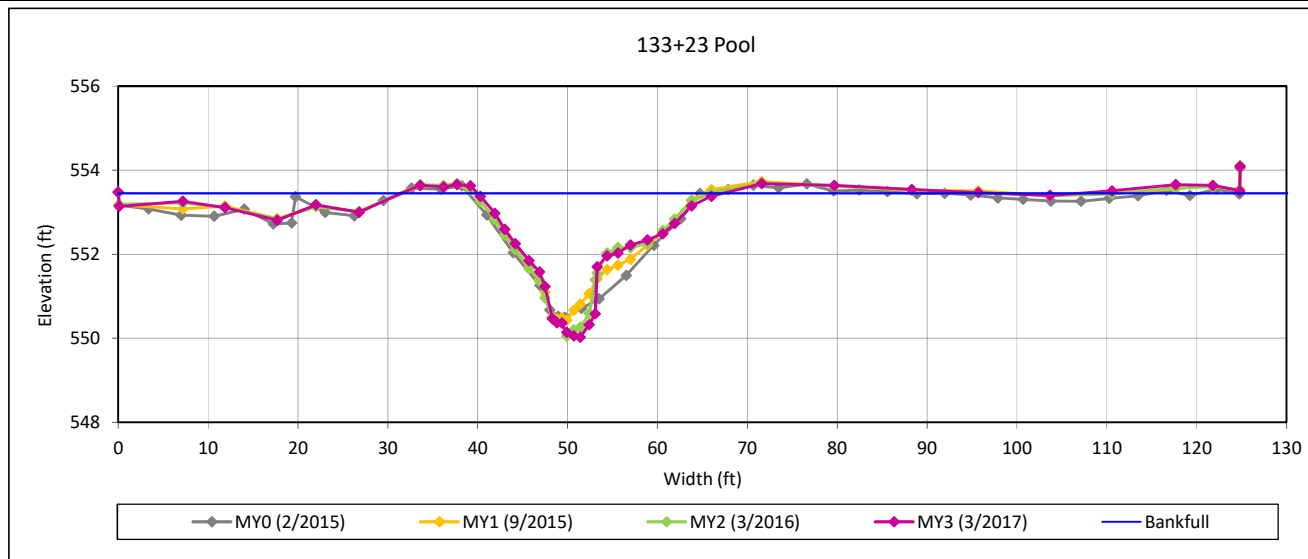
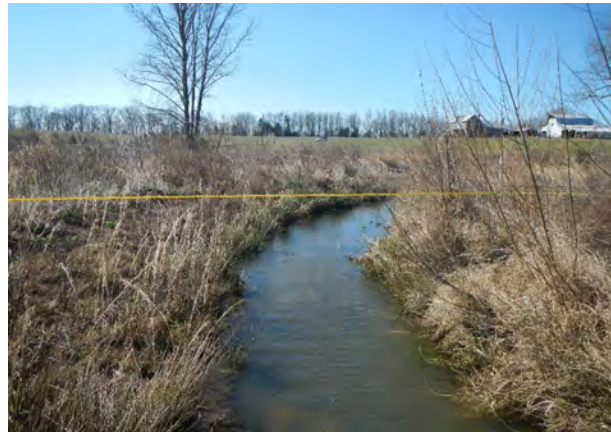
Cross Section 6- Foust Creek Reach 2

37.6	x-section area (ft.sq.)
26.0	width (ft)
1.4	mean depth (ft)
3.4	max depth (ft)
27.9	wetted parimeter (ft)
1.3	hyd radi (ft)
18.0	width-depth ratio

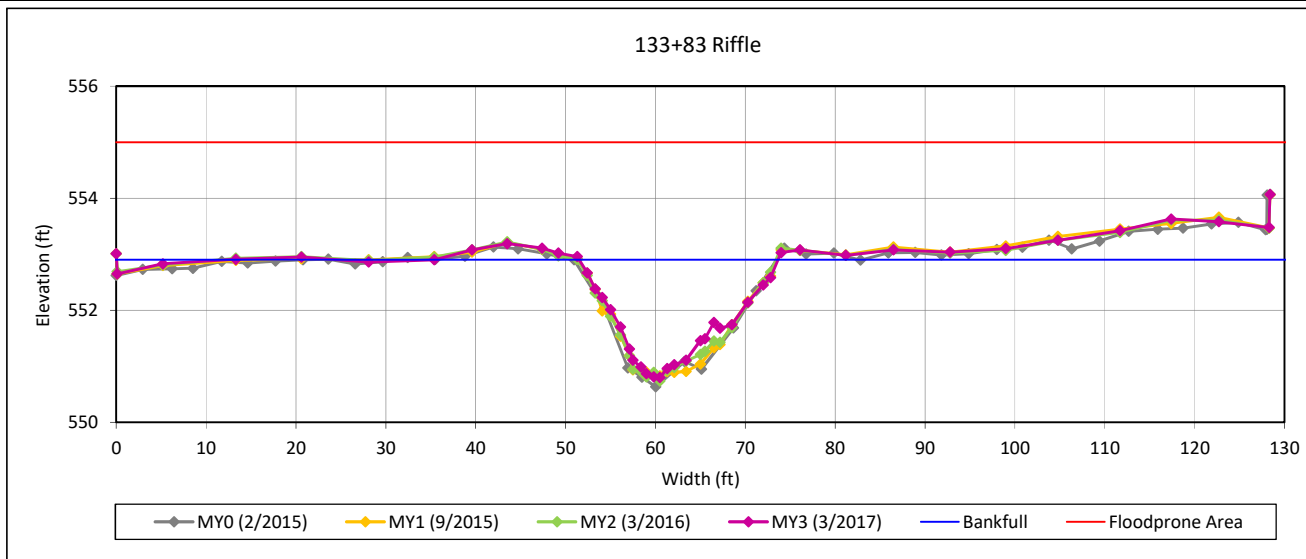
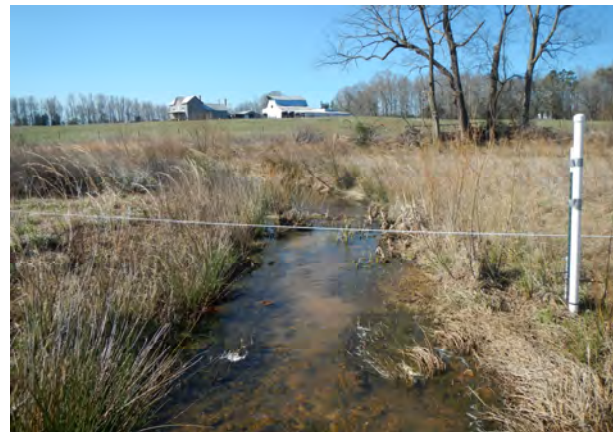
Cross Section 7- Foust Creek Reach 2

26.4	x-section area (ft.sq.)
22.1	width (ft)
1.2	mean depth (ft)
2.1	max depth (ft)
22.7	wetted parimeter (ft)
1.2	hyd radi (ft)
18.5	width-depth ratio
150.0	W flood prone area (ft)
6.8	entrenchment ratio
1.0	low bank height ratio

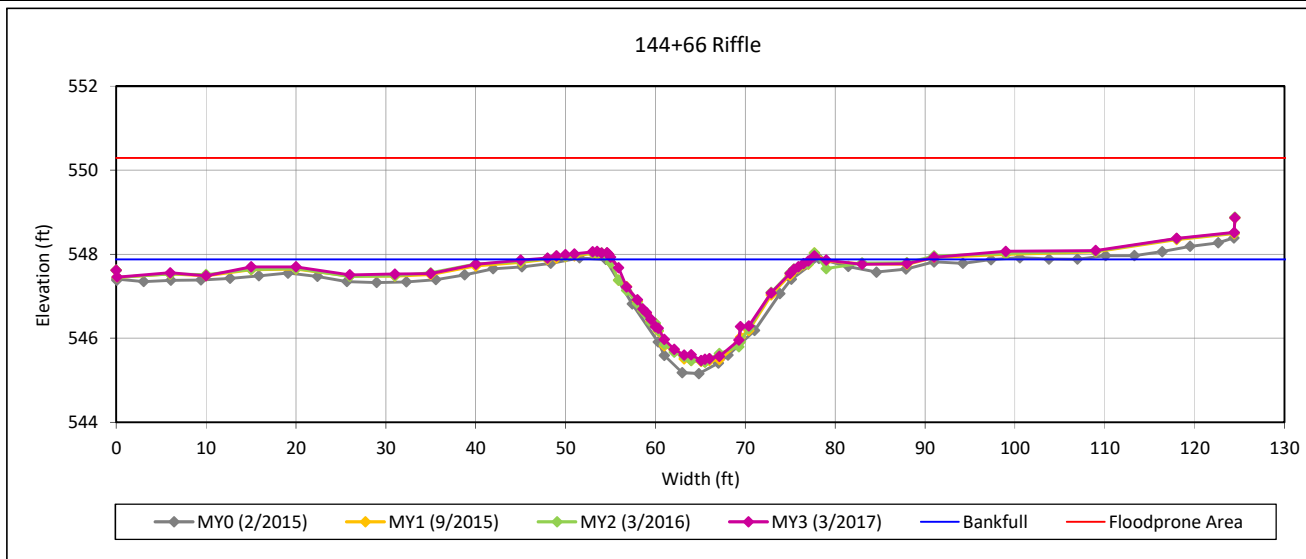
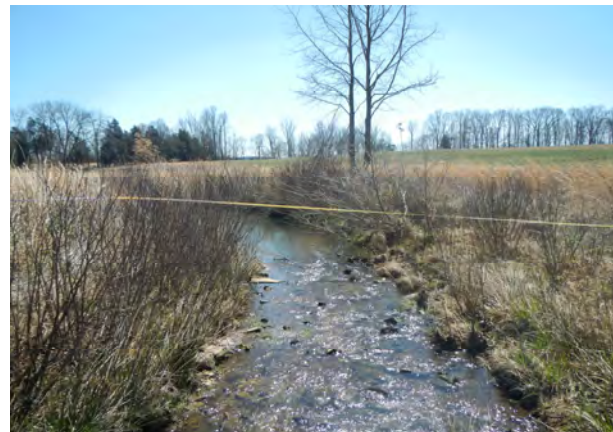
Cross Section 8- Foust Creek Reach 3B

30.5	x-section area (ft.sq.)
22.3	width (ft)
1.4	mean depth (ft)
2.4	max depth (ft)
23.1	wetted parimeter (ft)
1.3	hyd radi (ft)
16.3	width-depth ratio
150.0	W flood prone area (ft)
6.7	entrenchment ratio
1.0	low bank height ratio

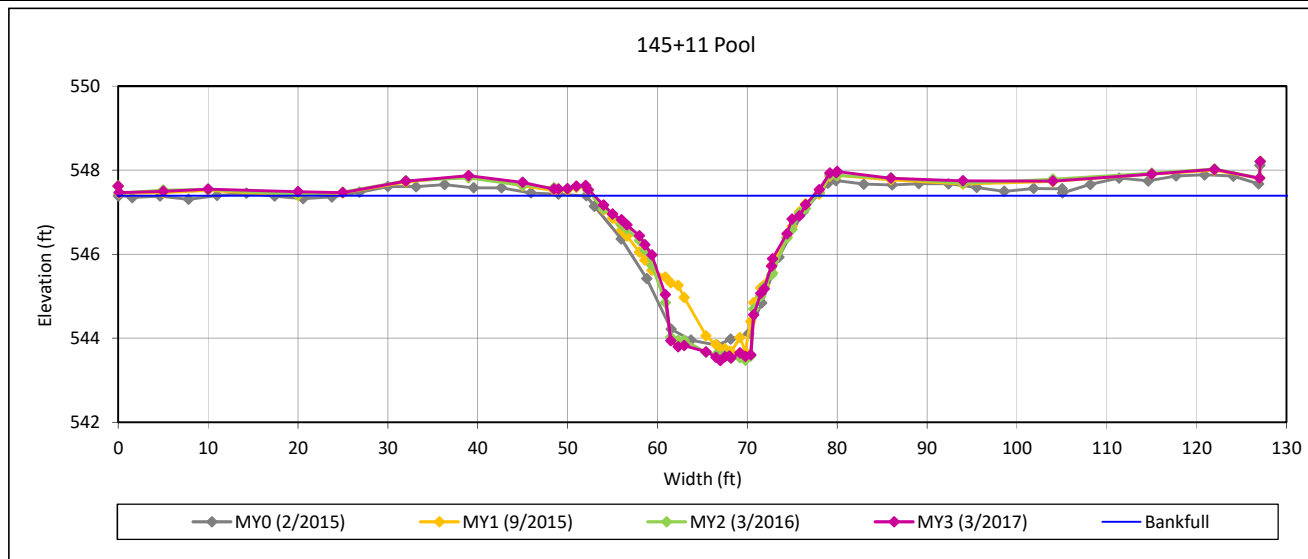
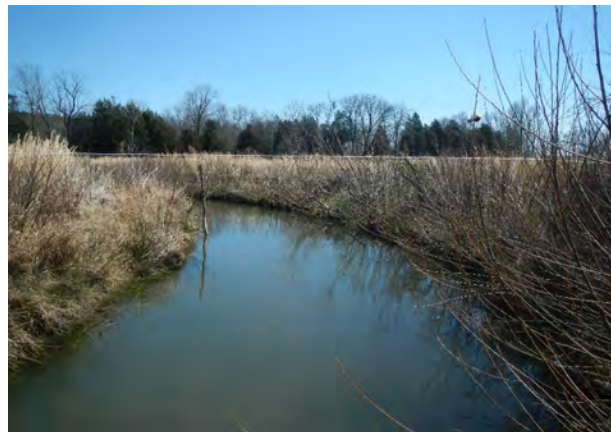
Cross Section 9- Foust Creek Reach 3B

50.5	x-section area (ft.sq.)
24.4	width (ft)
2.1	mean depth (ft)
3.9	max depth (ft)
26.9	wetted parimeter (ft)
1.9	hyd radi (ft)
11.8	width-depth ratio

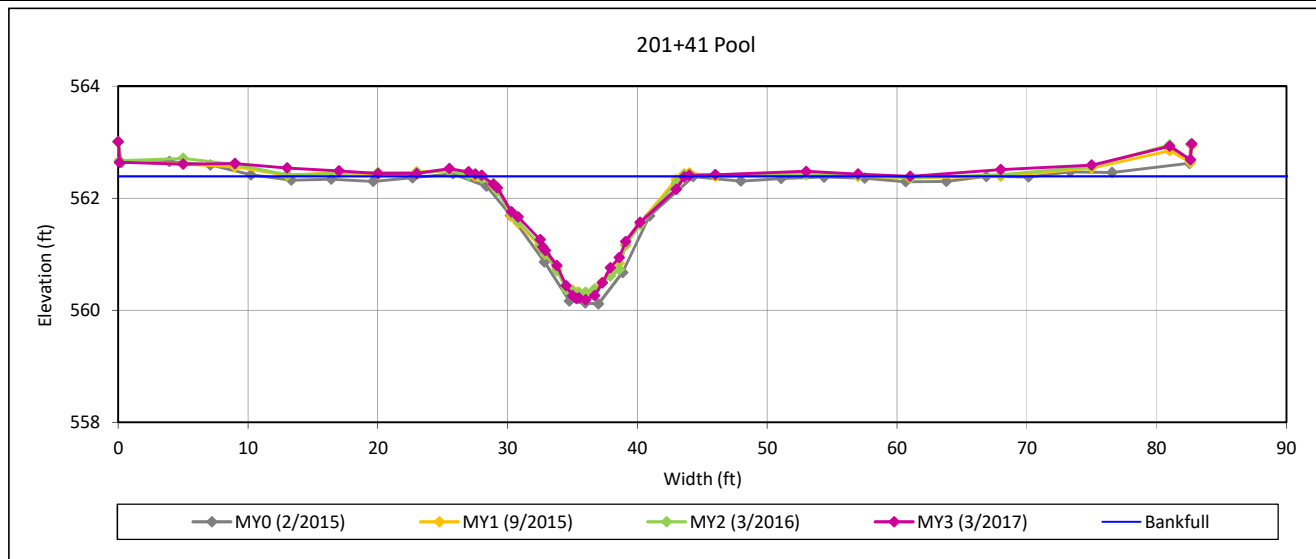
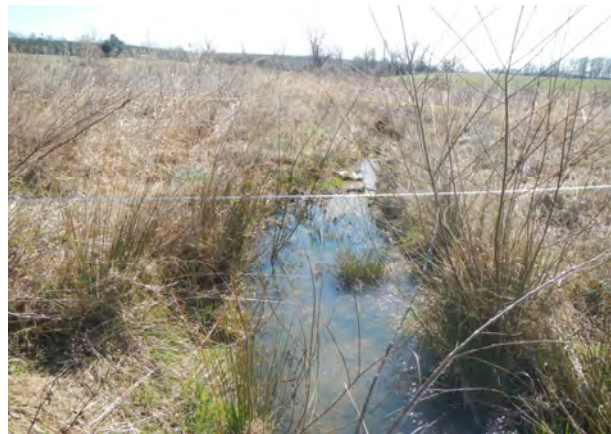
Cross Section 10-UT1

16.9	x-section area (ft.sq.)
15.6	width (ft)
1.1	mean depth (ft)
2.2	max depth (ft)
16.3	wetted parimeter (ft)
1.0	hyd radi (ft)
14.5	width-depth ratio

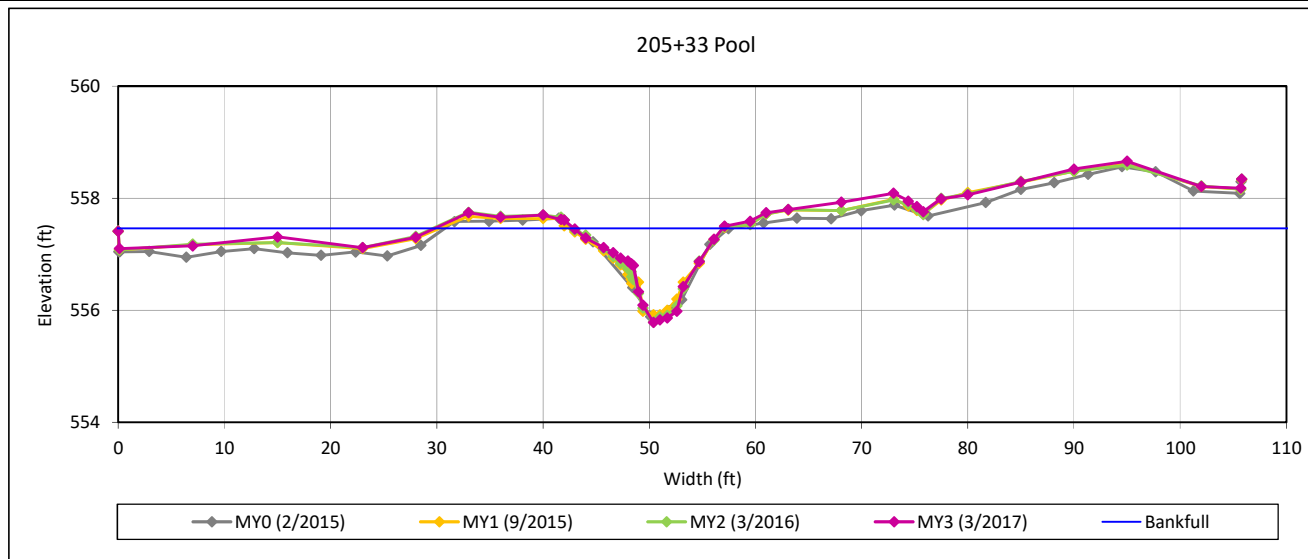
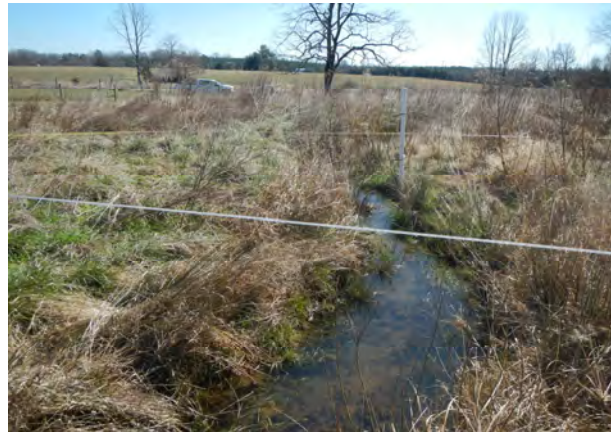
Cross Section 12-UT1

10.5	x-section area (ft.sq.)
14.0	width (ft)
0.7	mean depth (ft)
1.7	max depth (ft)
14.6	wetted parimeter (ft)
0.7	hyd radi (ft)
18.7	width-depth ratio

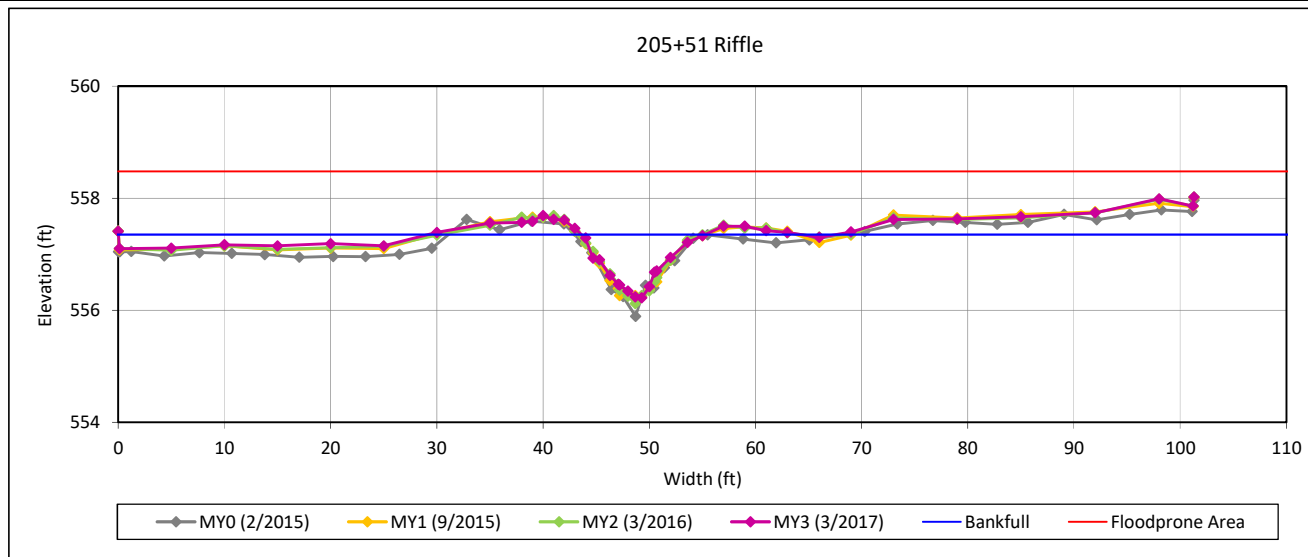
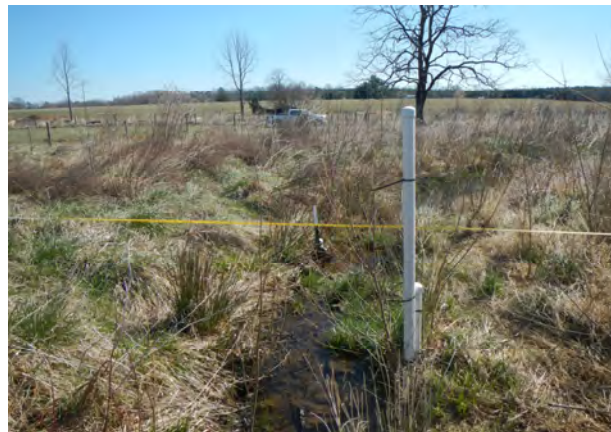
Cross Section 13-UT1

6.4	x-section area (ft.sq.)
11.6	width (ft)
0.6	mean depth (ft)
1.1	max depth (ft)
11.9	wetted parimeter (ft)
0.5	hyd radi (ft)
20.8	width-depth ratio
150.0	W flood prone area (ft)
12.9	entrenchment ratio
1.0	low bank height ratio
