MONITORING YEAR 4 ANNUAL REPORT FINAL

FOUST CREEK MITIGATION SITE

Alamance County, NC

DMS Project Number 95715

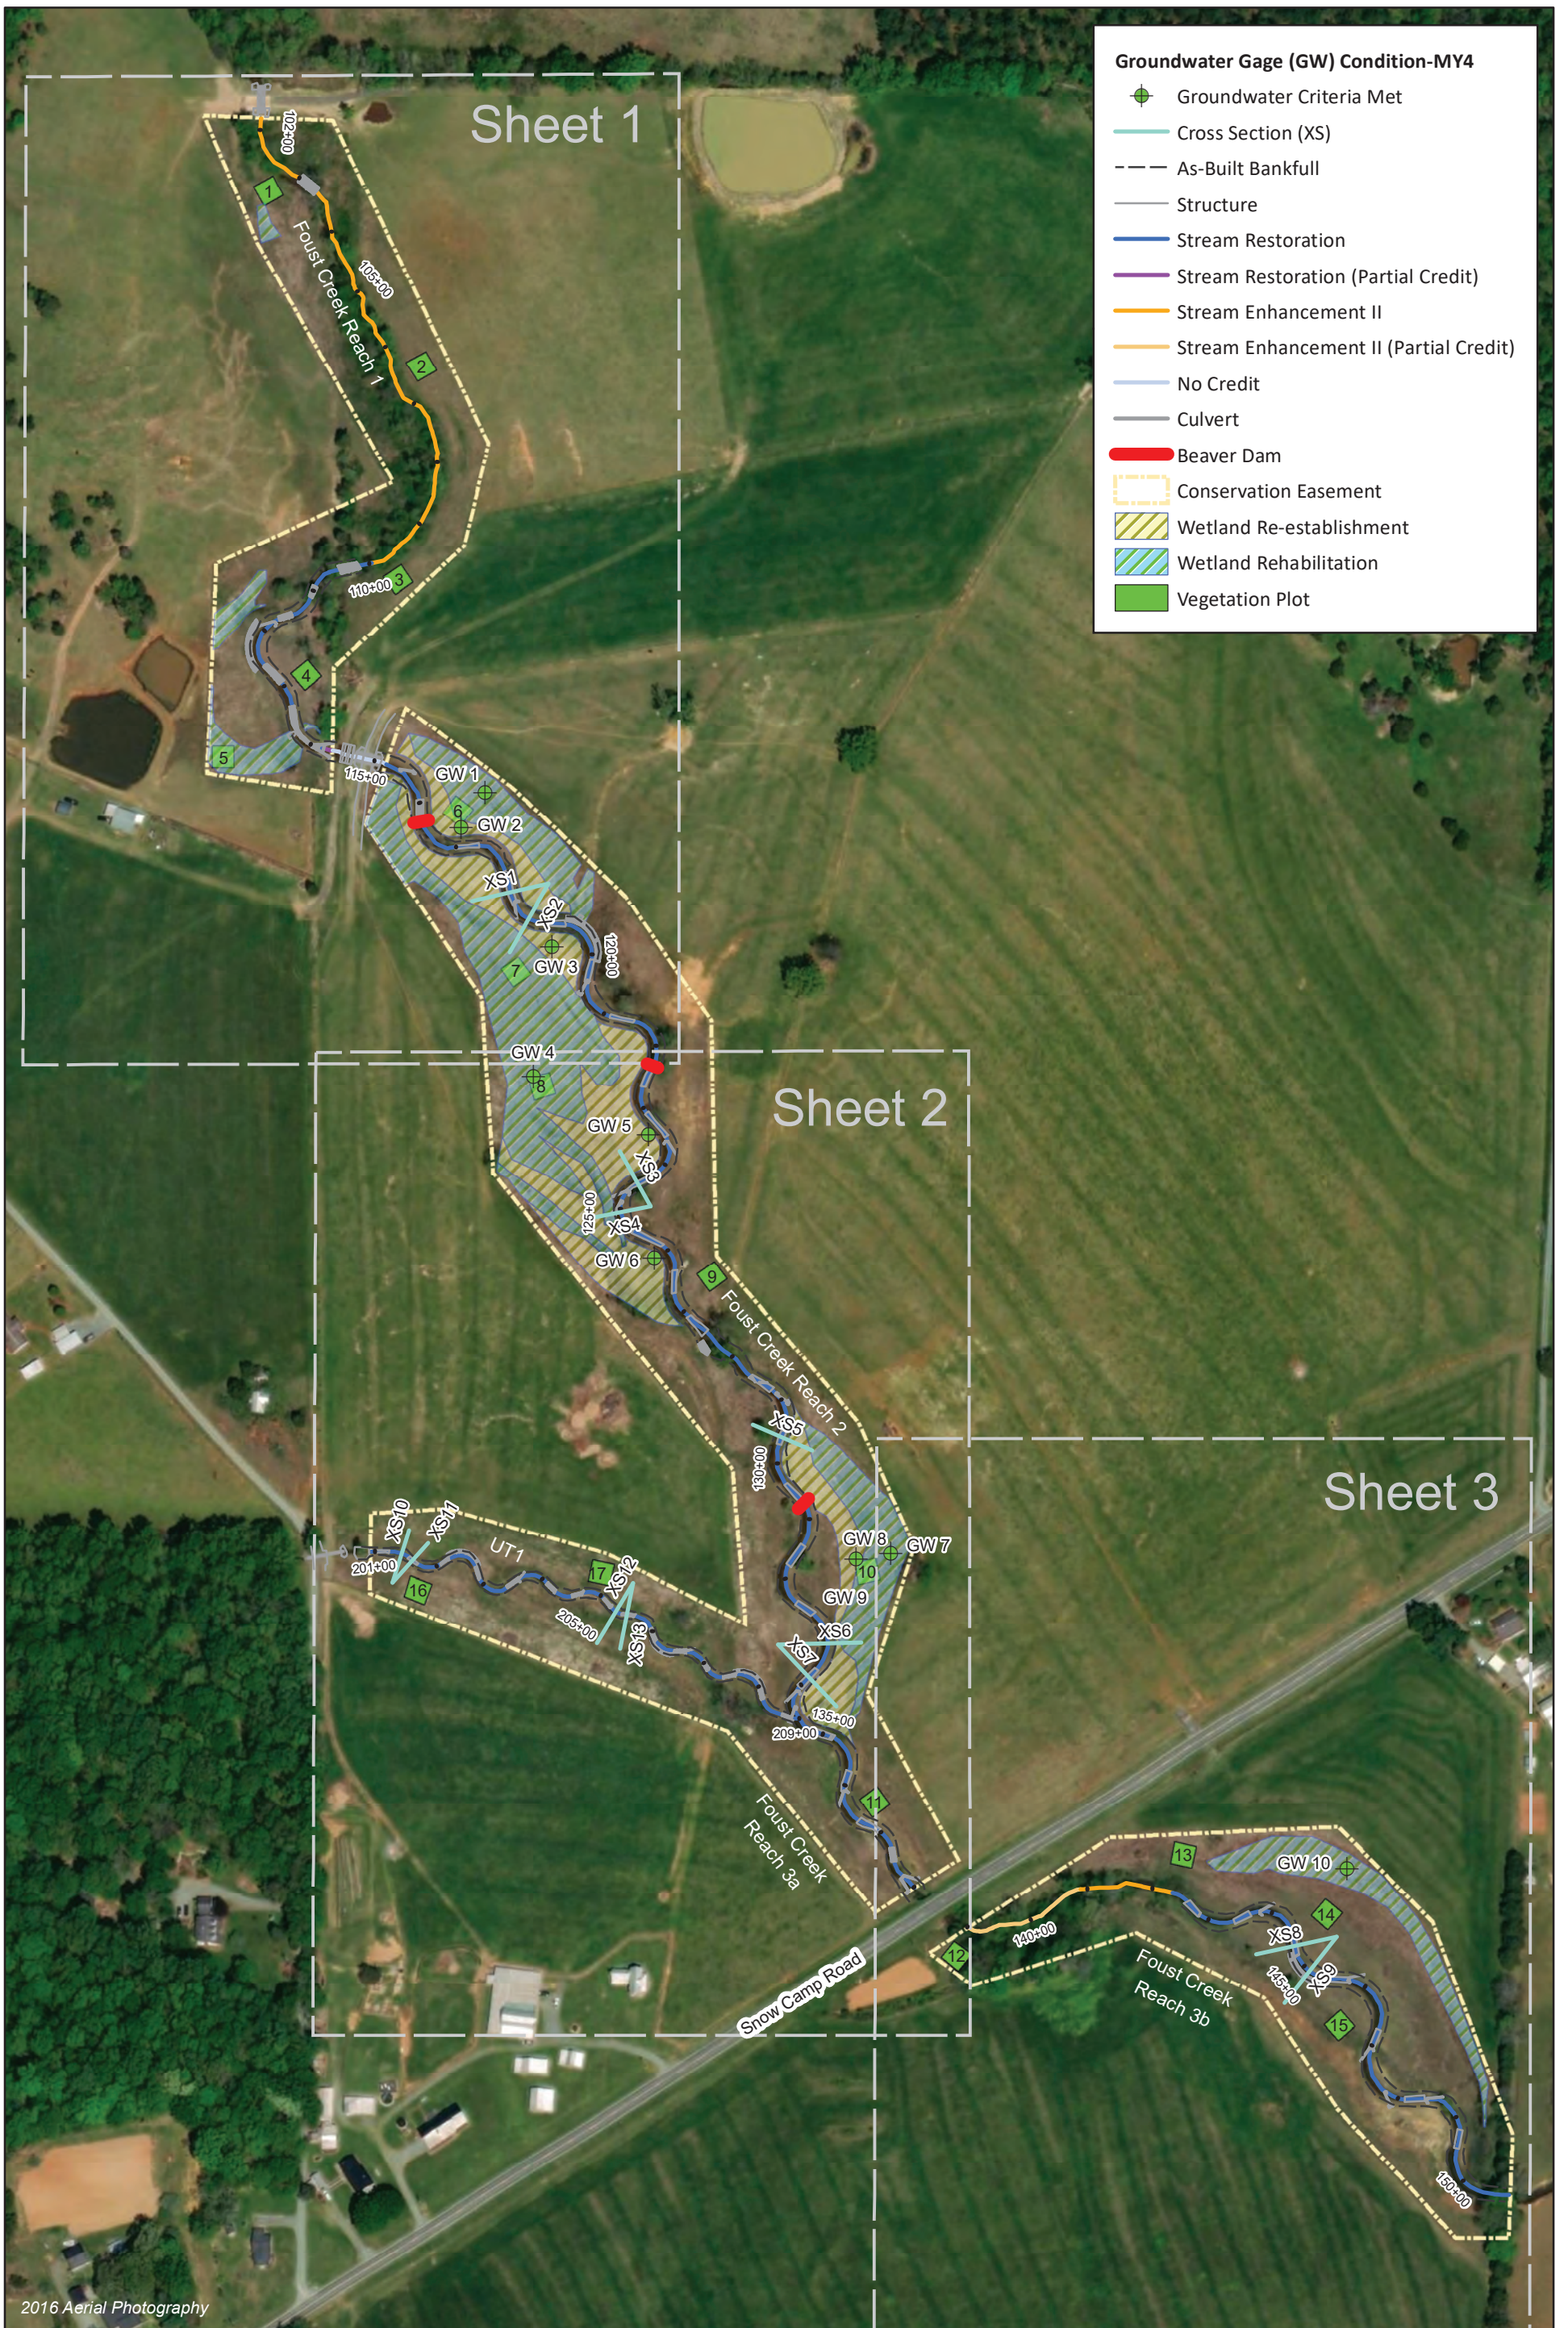
Figure 3.0 Integrated Current Condition Plan View (Key)

Concentrated populations of Chinese privet (*Ligustrum sinense*), tree of heaven (*Ailanthus altissima*), and autumn olive (*Eleagnus umbellata*) were observed during MY4 (Figure 3.1, Figure 3.3). The autumn olive and tree of heaven populations were located adjacent to Foust Creek Reach 1. The Chinese privet population consisted of re-sprouts from a previous treatment located in the northwestern portion of the easement adjacent to Foust Creek Reach 3b. Stems of autumn olive and Chinese privet larger than one inch in diameter were treated with triclopyr or glyphosate, respectively, using the cut stump method. Stems smaller than one inch in diameter were treated via foliar application of the same respective herbicides. Tree of heaven was treated with triclopyr using the hack and squirt method. All treatment occurred during September 2018.

During October of MY4, beaver dams were observed in Foust Creek Reach 2 (Figure 3.1, Figure 3.2). The USDA has been contracted to remove the beaver and clear the dams from the stream.
