**MONITORING YEAR 5  
ANNUAL REPORT**  
Final

**FOUST CREEK MITIGATION SITE**

Alamance County, NC

DMS Project Number 95715

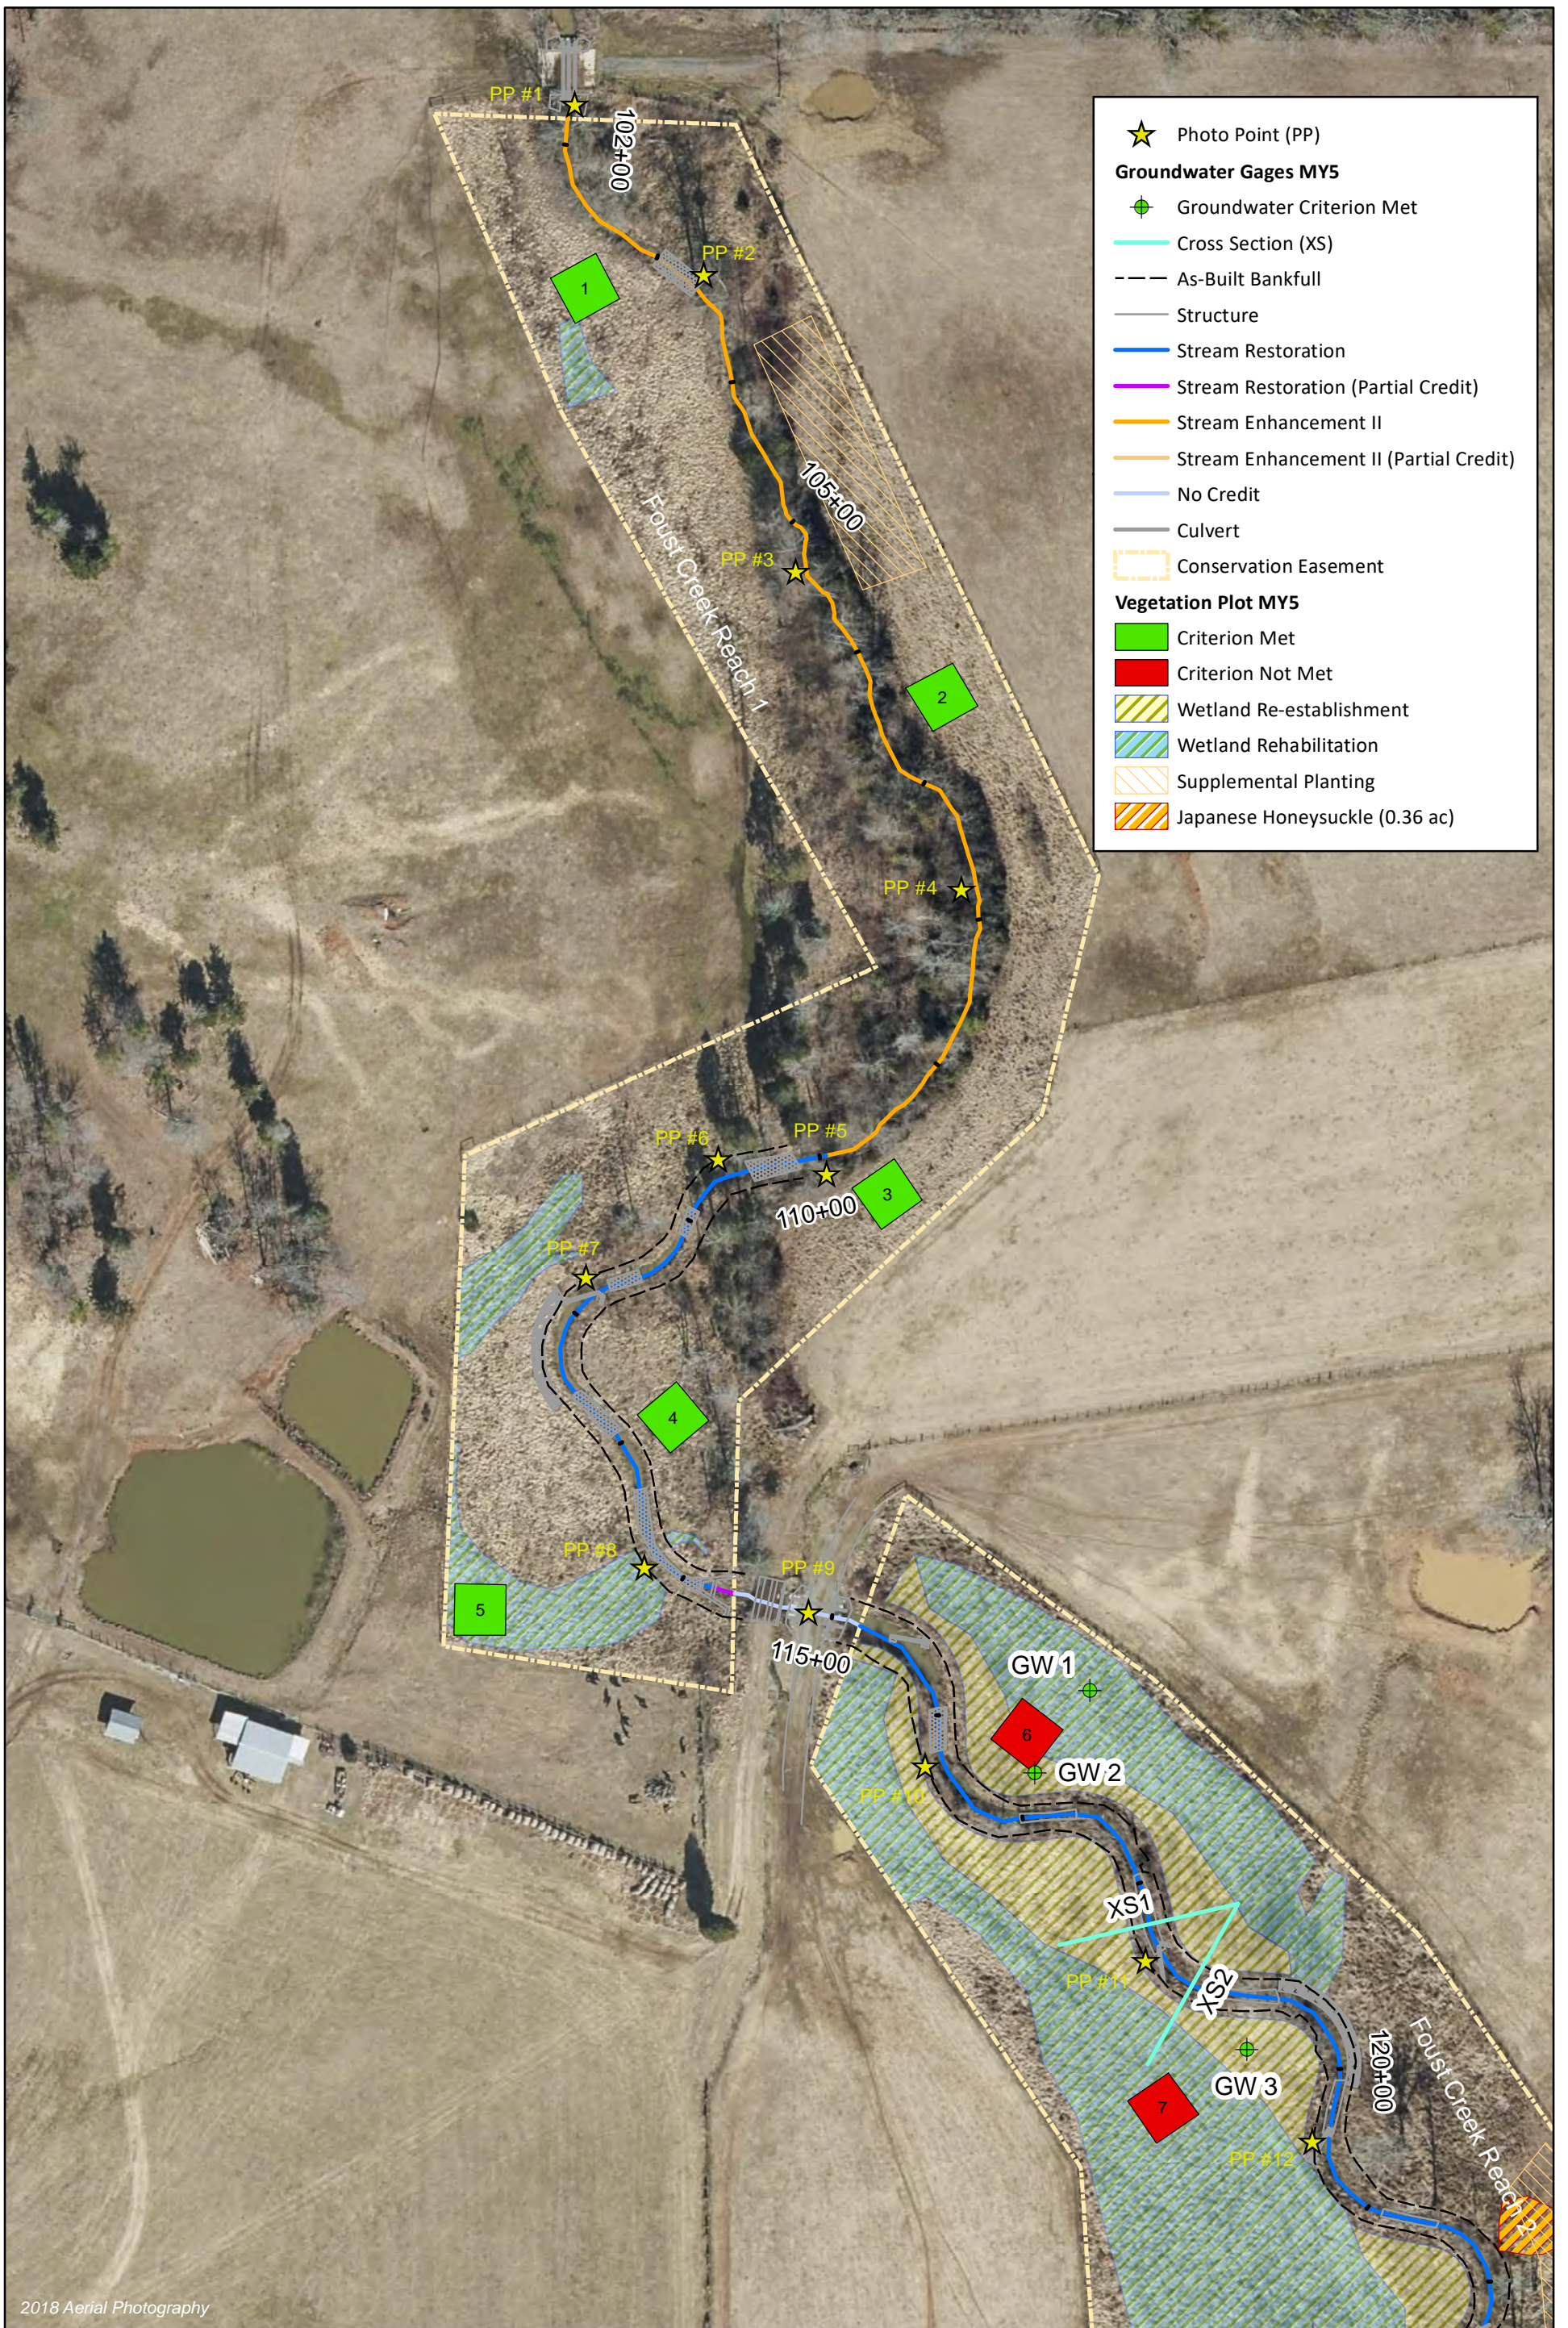
Figure 3.1 Integrated Current Condition Plan View (Sheet 1 of 3)

During MY5, defined populations of Japanese honeysuckle (*Lonicera japonica*) and Chinese privet (*Ligustrum sinense*) were identified within the project area (Figures 3.1-3.3). The populations of Chinese privet were treated during May and October of 2019. During the October invasive vegetation treatment, the entire site was also spot treated for invading invasive individuals to prevent spreading. Japanese honeysuckle was not treated because treatment for this species can be conducted with greater effectiveness during winter and without adverse impact to non-target species. The autumn olive (*Elaeagnus umbellata*) stem inventoried in plot 3 and the Chinese privet stems inventoried in plot 14 were not located within the defined population treatment zones identified on Figures 3.1-3.3 but were removed during the spot treatment.

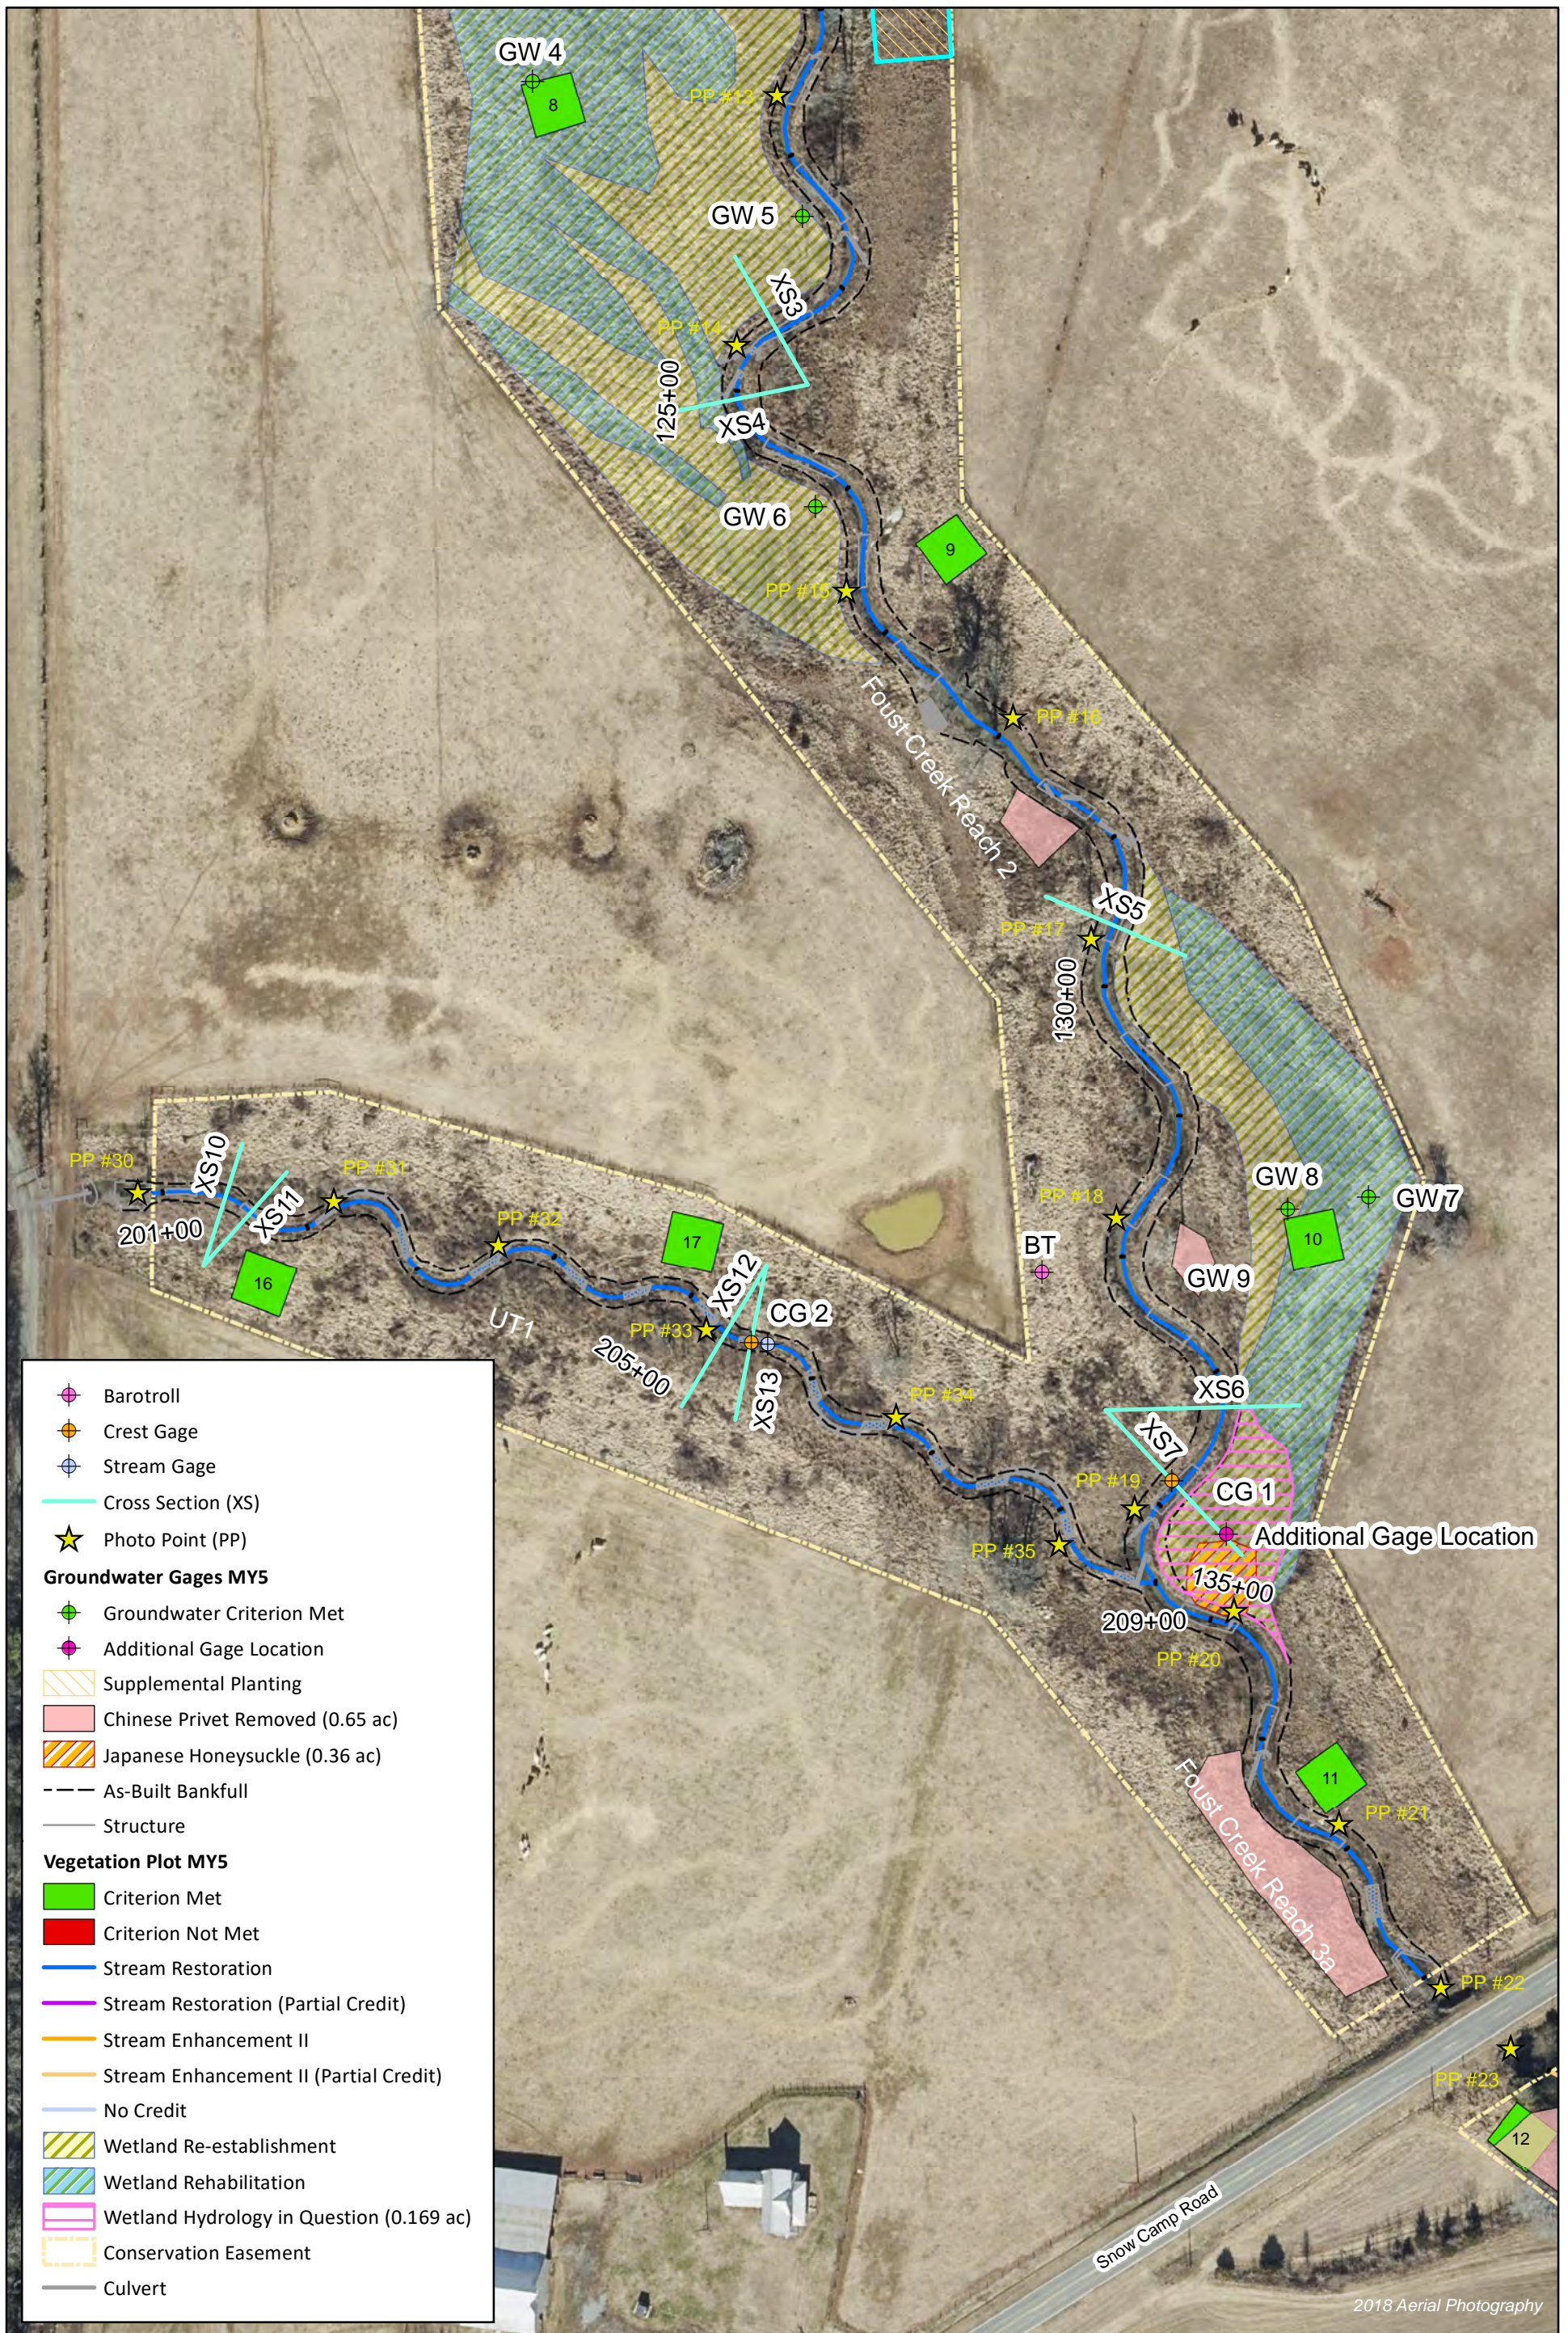
Figure 3.2 Integrated Current Condition Plan View (Sheet 2 of 3)

All groundwater wells attained the hydrology criterion during MY5. The measured hydroperiod ranged from 24.0% to 73.6% of the growing season consecutively. During an IRT site visit on November 18, 2019, limited hydric soil development was observed in a wetland re-establishment area near cross

section seven. Concern was expressed over whether this area would attain the wetland hydroperiod criterion for the Site. An additional groundwater gage will be installed within this area and data will be discussed in future reports (Figure 3.2).
