# **Year 1 Monitoring Report**

## **Freedom Park Stream Restoration**

**February 2006**

**S&EC Project No. 9443.D1**  
**EEP Project No. 00032**

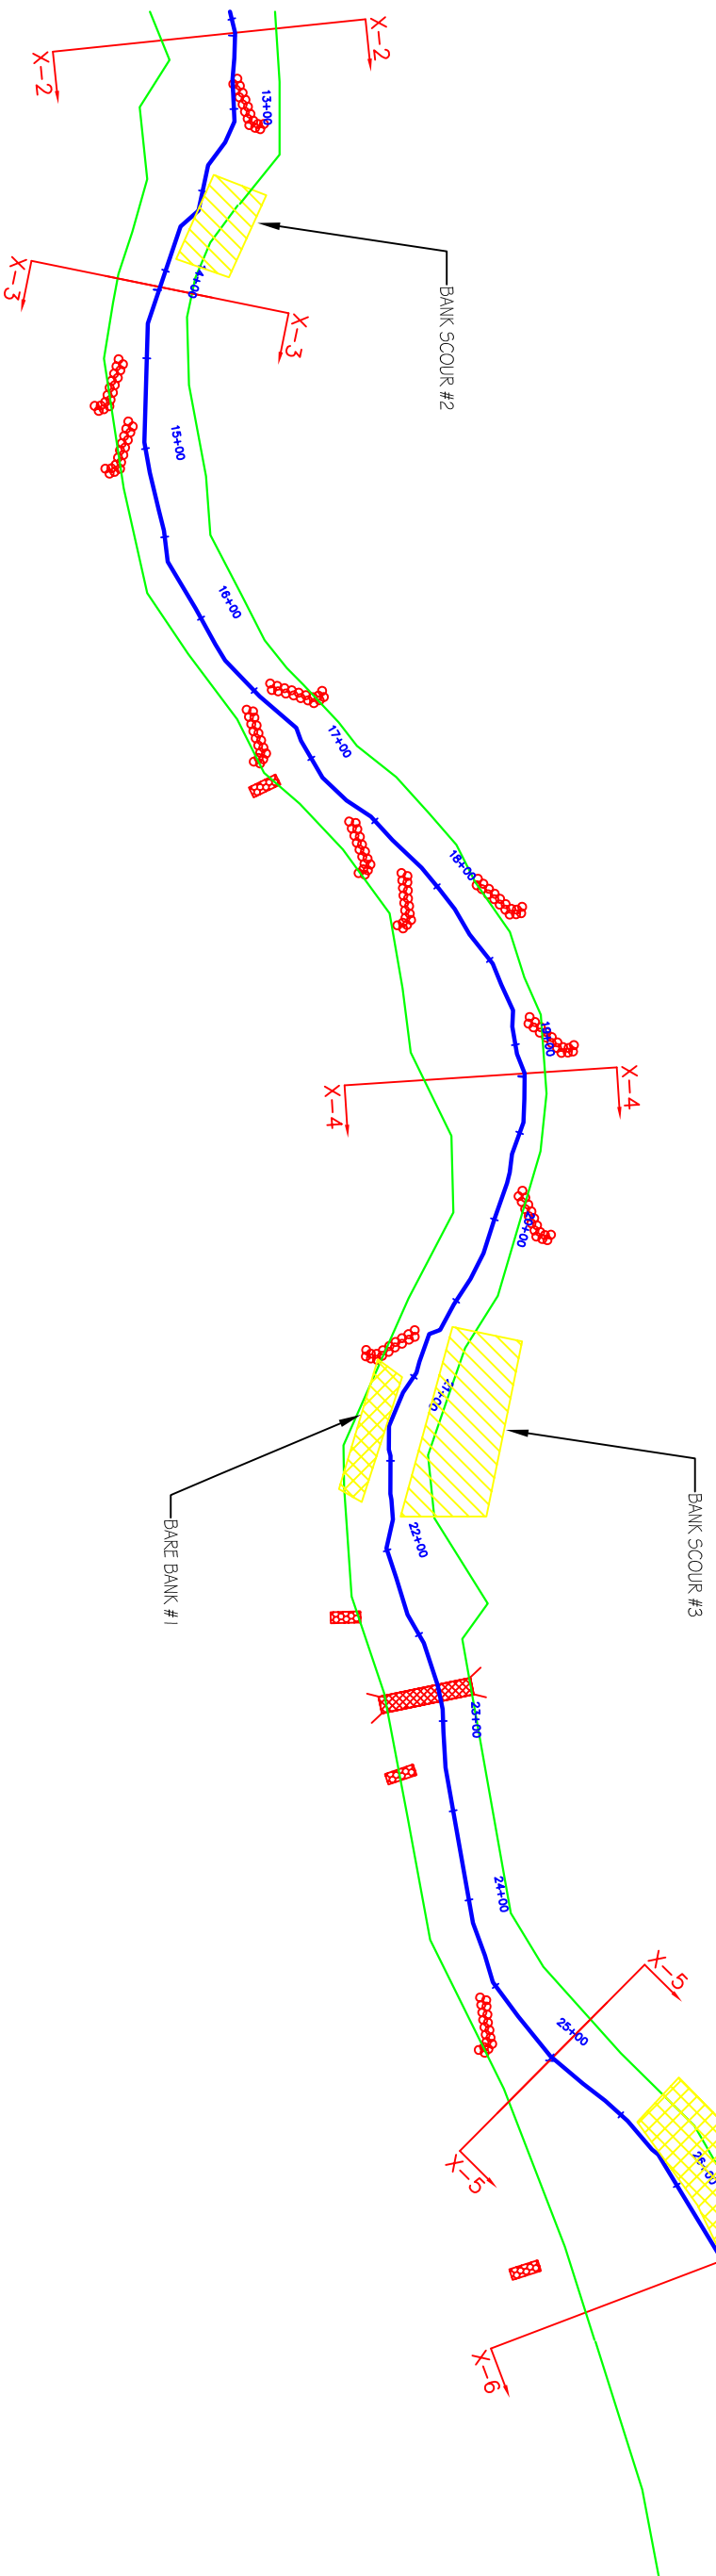
Project: FREEDOM PARK STREAM RESTORATION		Project No.: 9443.D1
Location: MECKLENBURG CO., NC	Client: NCEEP	Proj. Mgr.: PK5 Drawn: JER
Sheet Title: PAPV - SEGMENT 2		Scale: 1" = 100' Sheet No.: 2 OF 3

An assessment of the stability of the channel was performed on September 12, 2005, by S&EC. Several areas of concern were observed and documented including localized bank scour, overbank scour, and several areas of bare banks. These problem areas are shown on Sheets 4 through 6 (Problem Area Plan View).

<b>Feature Issues</b>	<b>Station numbers</b>	<b>Suspected Cause</b>	<b>Photo number</b>
Bank Scour	10+47 to 11+17	Excessive bank shear stress	Stream Problem Areas 1-3
	13+39 to 13+94	Resultant from floodplain drainage	
	20+66 to 21+82	Excessive bank shear stress
