Freedom Park (Little Sugar Creek) Final Monitoring Report Year 2 of 5 (2006)

Mecklenburg County, North Carolina

Project ID No. 141

January 2007

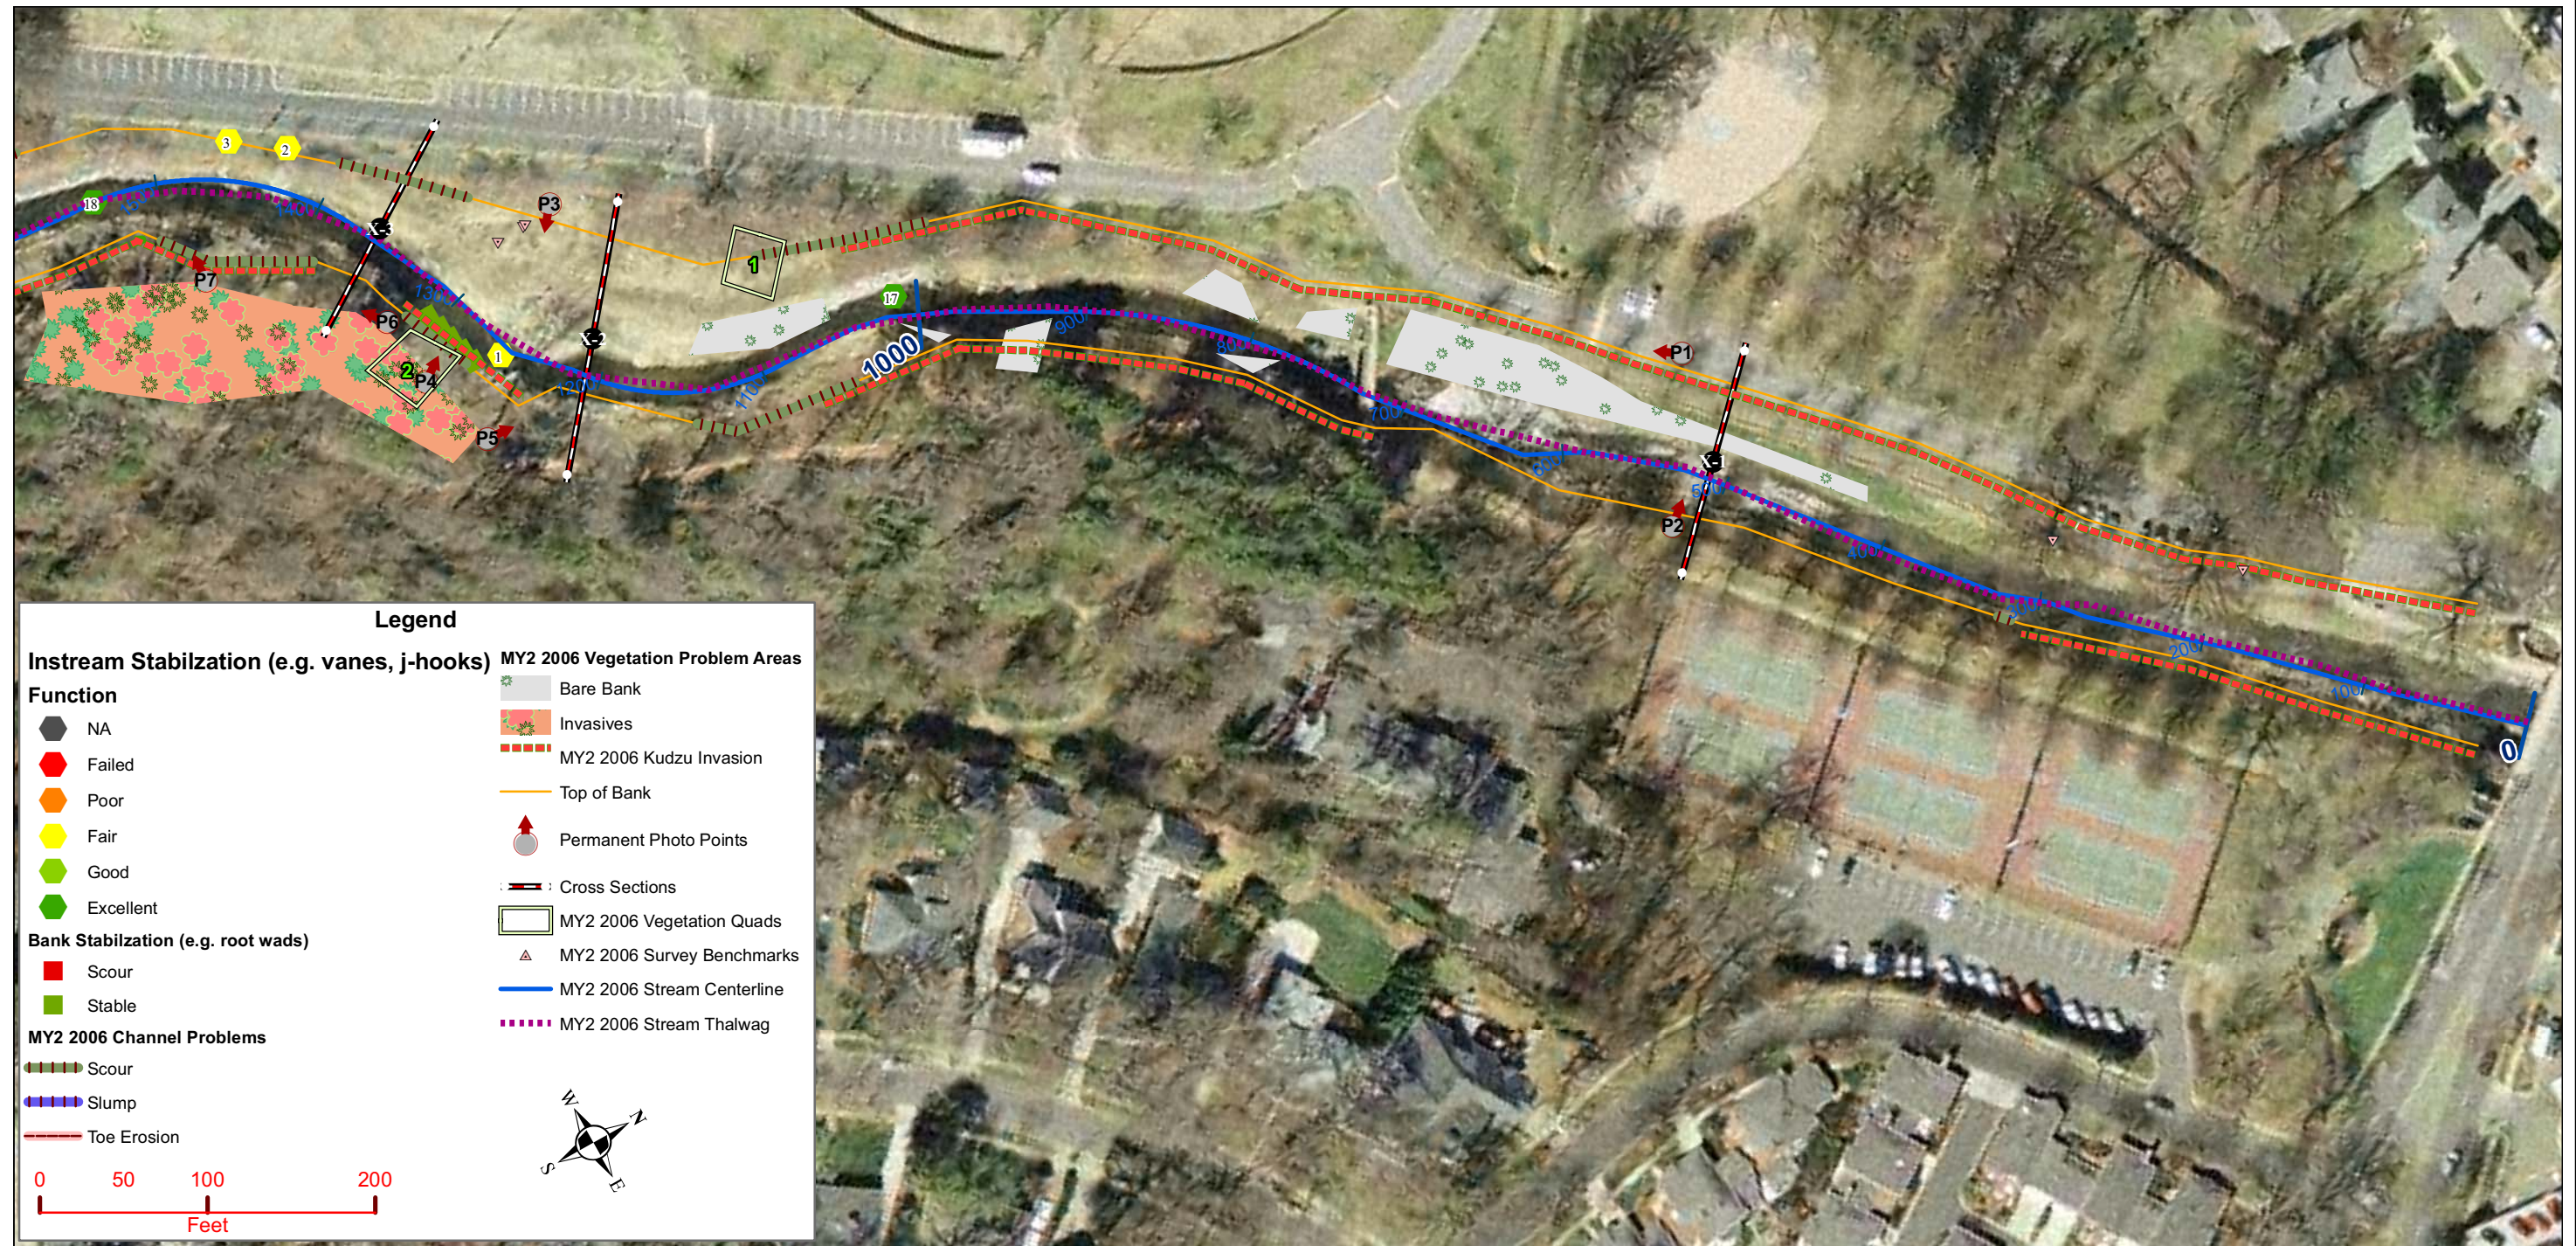
Figure 2: Monitoring Plan View Sheet 1

KHA assessed site vegetation in September and October, 2006. Kudzu has invaded much of the site. An interview with a park user suggests that a local community group within Charlotte has a program to combat invasives. Many sections of the reach exhibit bare banks. As noted in previous monitoring reports, the cause of the bare banks may be due to a lack of root development capable of withstanding stresses to during flood flows and/or compacted soils inhibiting vegetation growth. One section of floodplain appears to have been cleared and now exhibits early successional growth including invasives from areas surrounding the riparian buffer. Appendix A provides a summary of vegetative problem areas. Figures 2-4 show the problem areas.

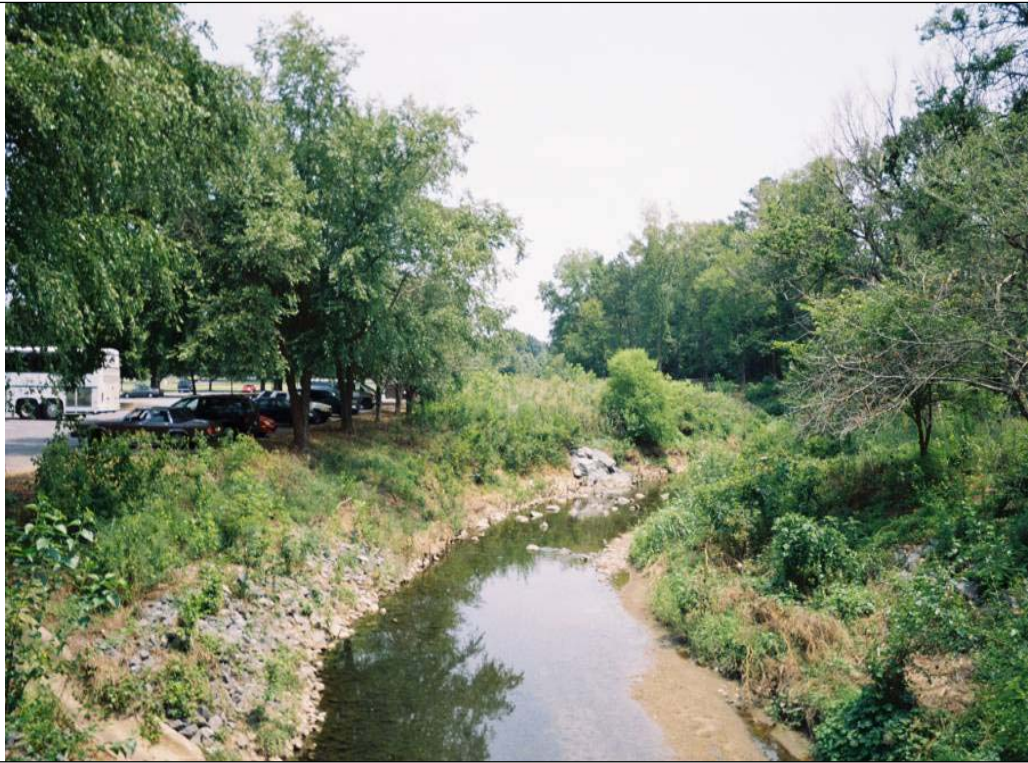
Feature/Issue	Station # / Range	Probable Cause	Photo #
Bare Bank	410 - 1,140 (Both Banks)	Excessive bank stresses during yearly flooding events	VP 2
	1,690 - 1,750 (Left Bank)		
	2,065 - 2,350 (Both Banks)		
Bare Bench	--	--	--
Bare Flood Plain	1,250 - 1,580 (Left Floodplain)	Cleared area exhibiting successional growth including invasives from Local source colonization after bank scour	VP 4
	35 - 1,030 (Both Banks)		
Invasive/Exotic Populations	1,240 - 1,860 (Left Bank)		
	1,250 - 1,580 (Left Floodplain)	Cleared area exhibiting successional growth including invasives from local sources	VP 4
	1,950 - 2,190 (Left Bank)		VP 3
	2,210 - 2,380 (Right Bank)		VP 1
	2,680 - 3,065 (Left Bank)		
	2,690 - 3,555 (Right Bank)		
	3,555 - 3,790 (Left Bank)

VP 1: Kudzu

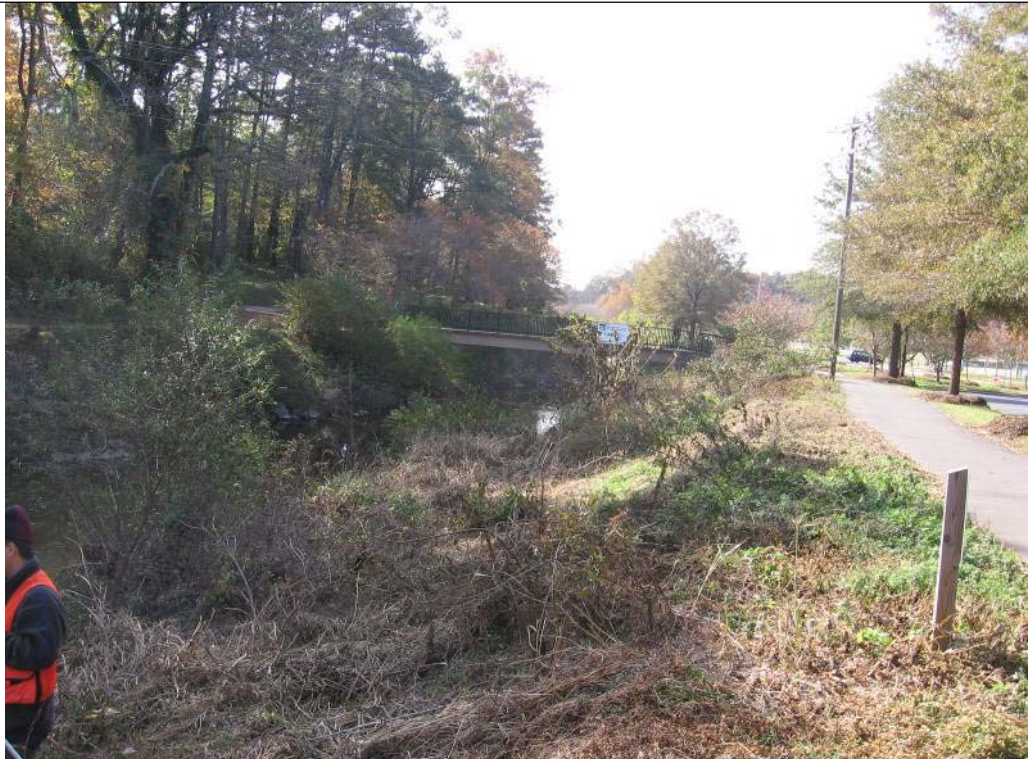
VP 2: Bare Bank

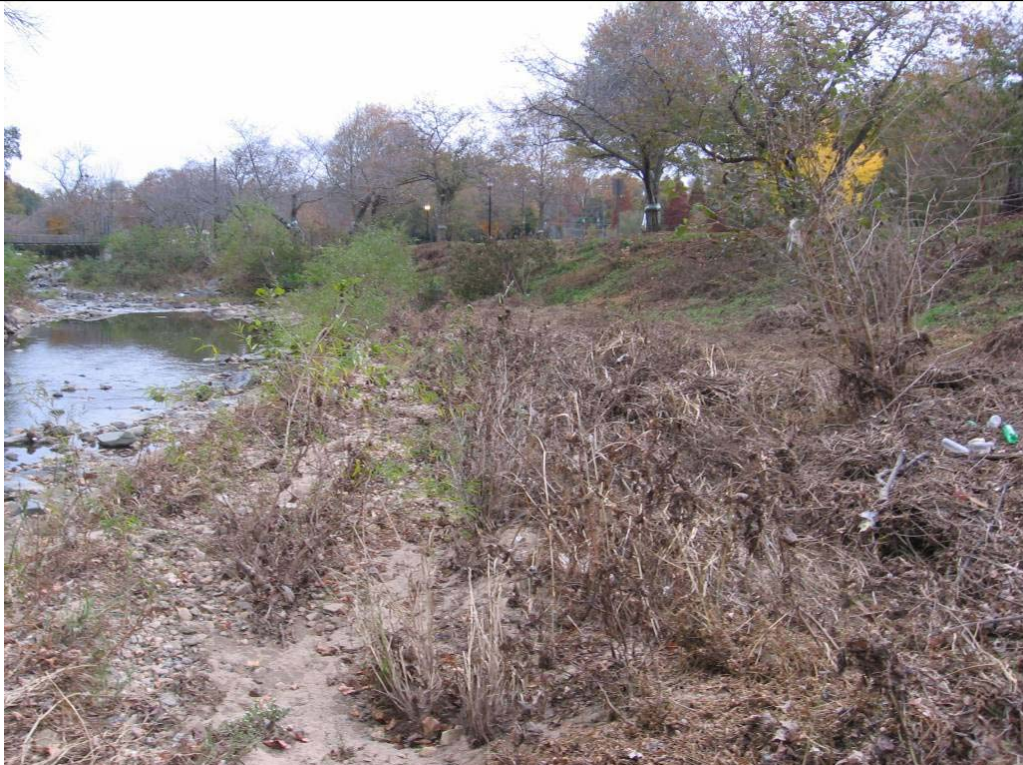
BE 1: Indication of high flows – possibly bankfull
