Freedom Park (Little Sugar Creek) Final Monitoring Report Year 3 of 5 (2007)

Mecklenburg County, North Carolina

Project ID No. 141

February 2008

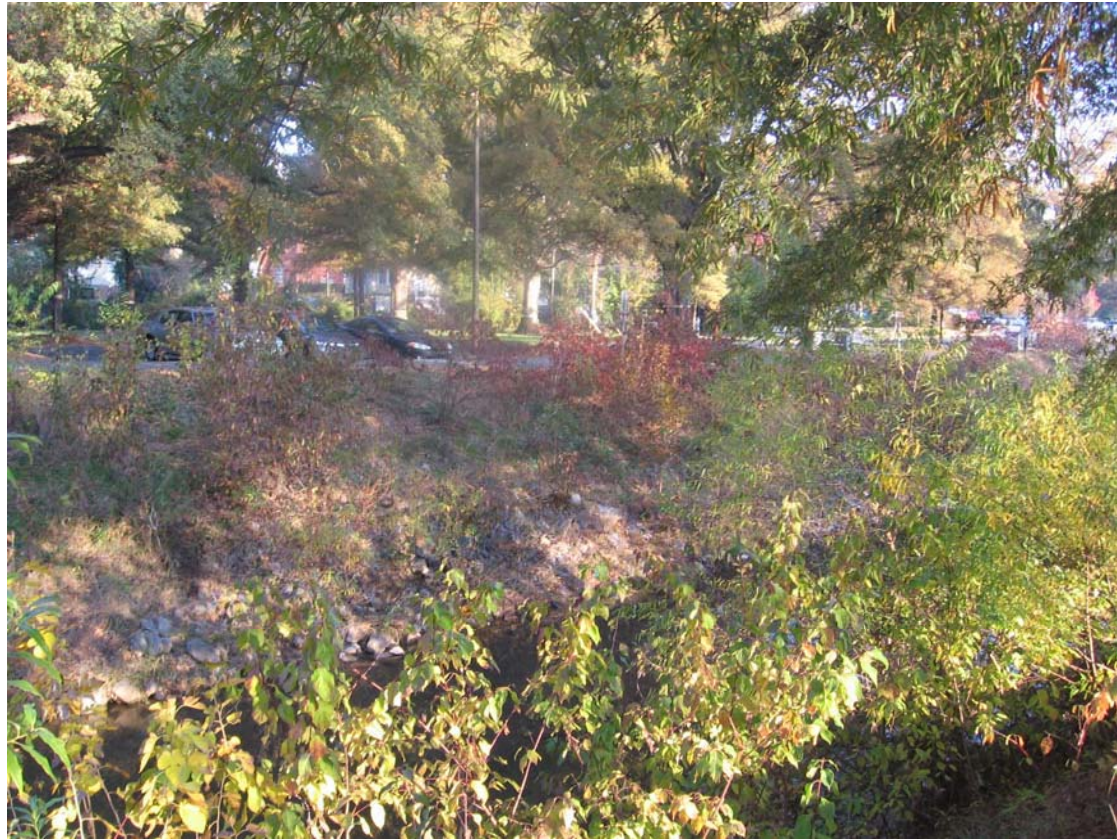
VP 1: Looking at right bank, bare bank

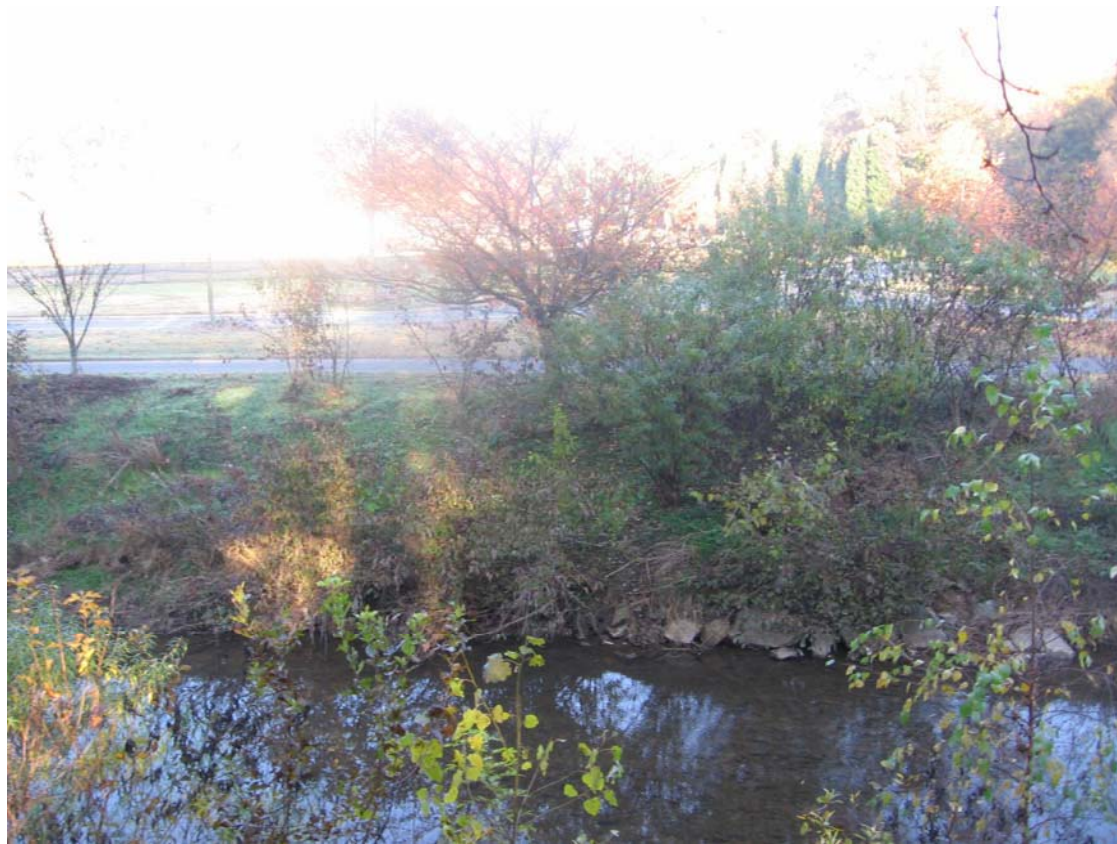
VP 3: Looking at right bank, bare bank

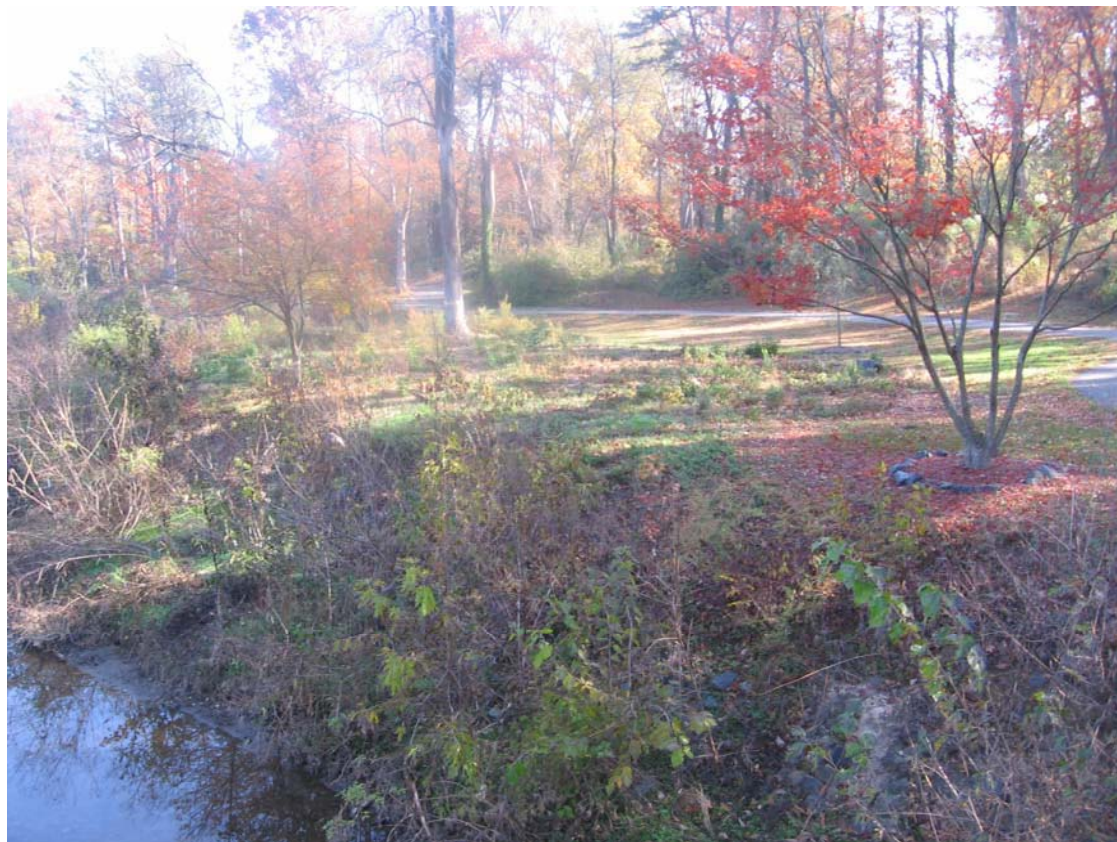
VP 7: Looking upstream at left floodplain, maintained area

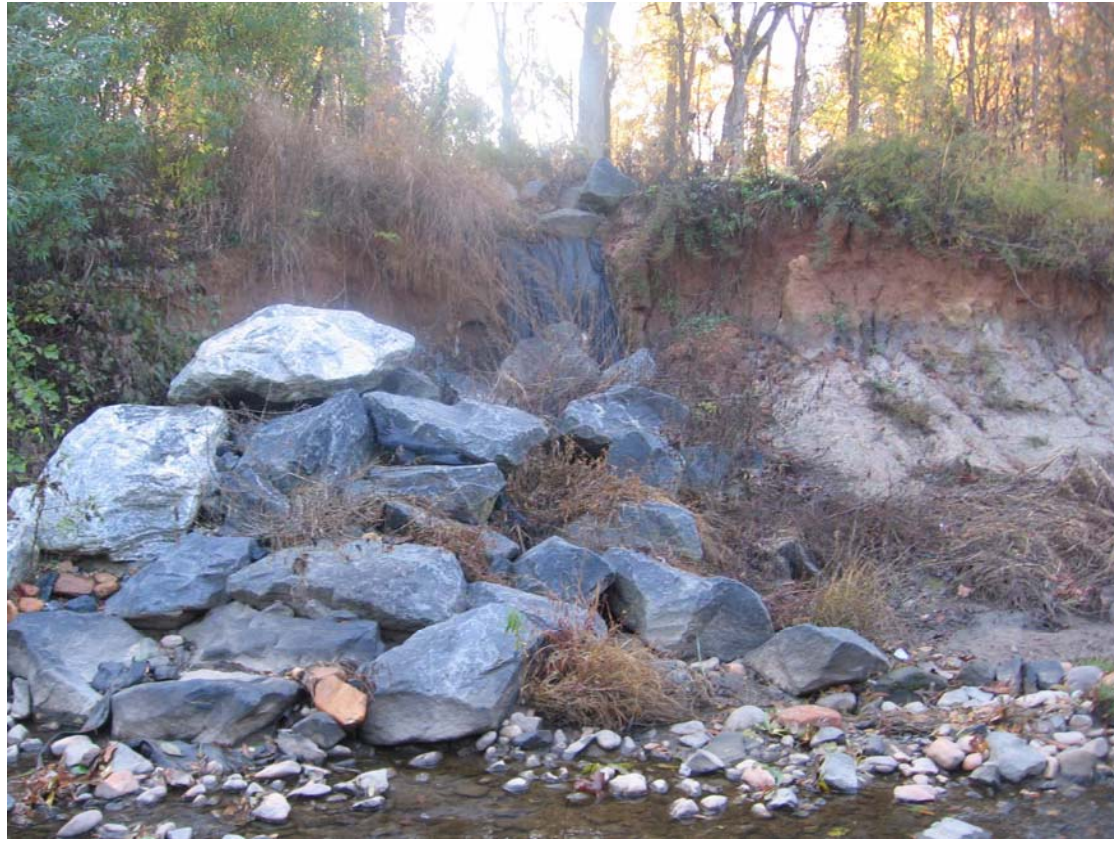
Feature Issue	Reach	Station numbers	Description	Suspected Cause	Photo number
2007					
Aggradation/Bar Formation					
Bank scour		315 - 320	Bank Scour (Left Bank)	Stormwater Drain	
		1,300 - 1,360	Bank Scour (Left Bank)	Excessive shear stresses	SP1
		2,015 - 2,060	Bank Scour (Right Bank)	Excessive shear stresses	SP2
		2,040 - 2,140	Bank Scour (Left Bank)	Excessive shear stresses	SP3
		2,630 - 2,700	Bank Scour (Left Bank)	Excessive shear stresses	SP4
		2,625 - 2,740	Scour behind toe protect (Right Bank)	Excessive shear stresses	SP5
Engineered structures – back or arm scour Etc.		4,030 - 4,070	Scour (Left Bank) - Possibly displaced root wads	Excessive shear stresses	SP6
		1,260	Missing header rock	Excessive shear stresses	
		2,020 - 2,060	Scour behind coir log. Stressed rip-rap clusters (both sides of channel)	Excessive shear stresses	SP3
		2,660	Arm boulder collapse	Excessive shear stresses	SP4
	3,950 - 4,140	Scour behind root wads	Excessive shear stresses	SP7

SP 1: Looking at left bank, collapsed structure

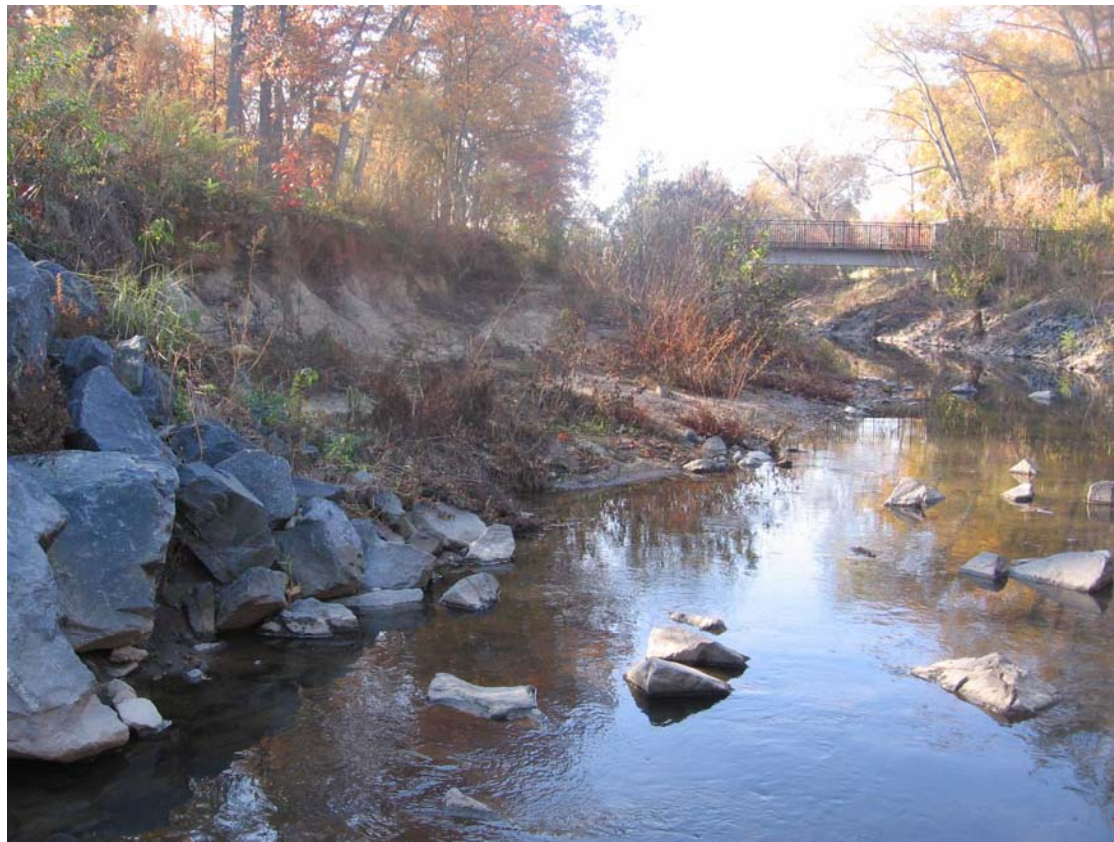
SP 3: Looking downstream at left bank, scour

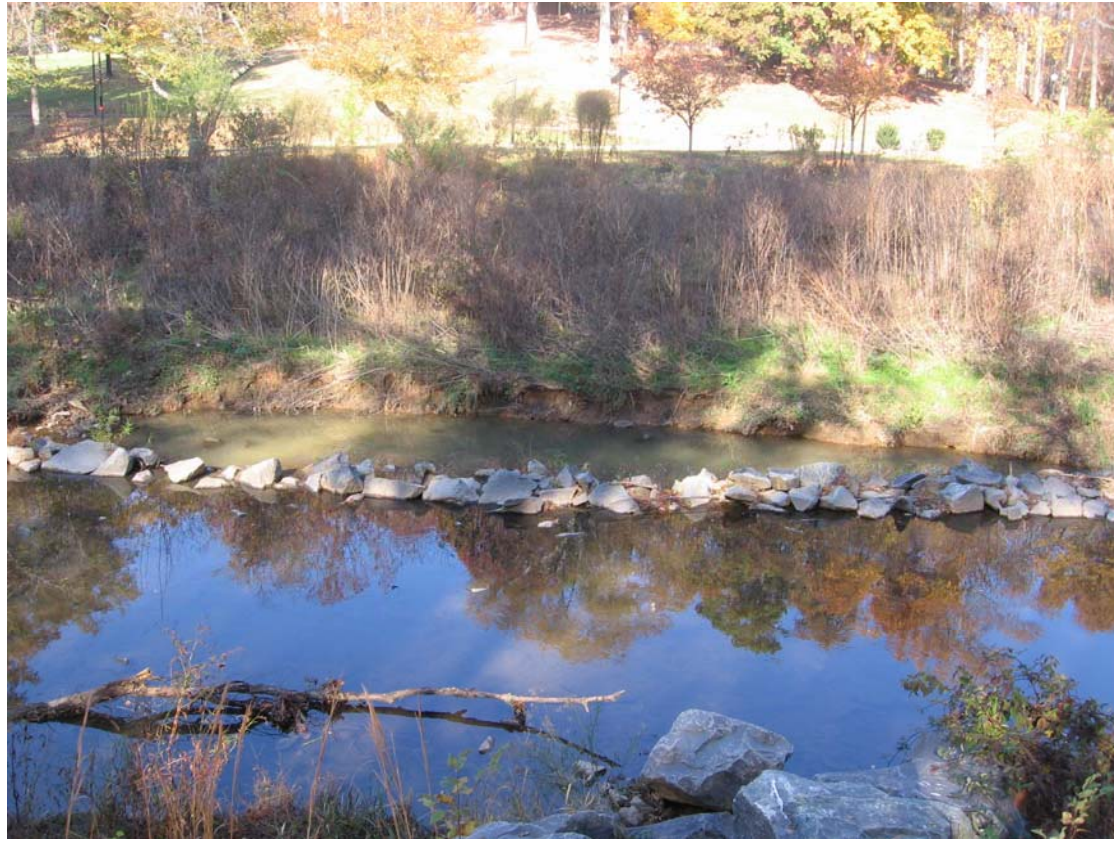
SP 5: Looking at right bank, scour behind boulder toe protection

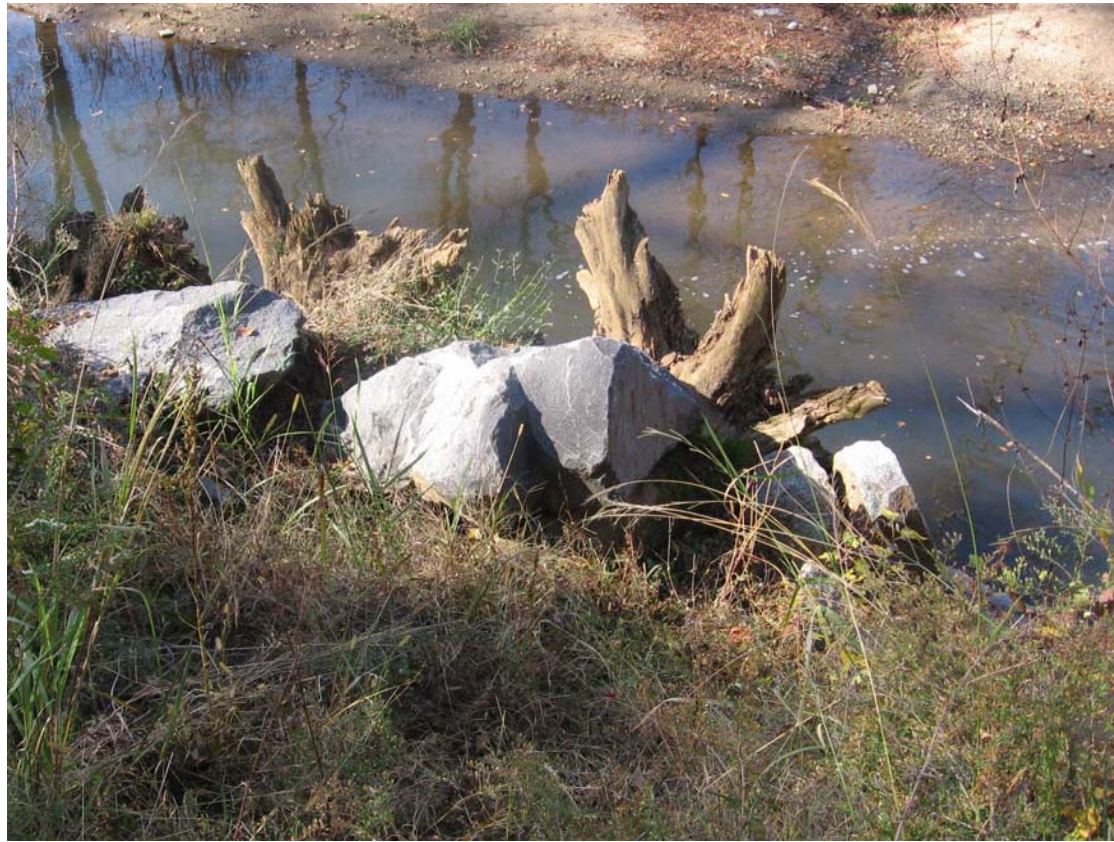
Engineered structures – back or arm scour Etc.		1,260	Missing header rock	Excessive shear stresses	
		1,960	Missing structure	Excessive shear stresses	
		2,660	Arm boulder collapse	Excessive shear stresses	
		3,950 - 4,140	Scour behind root wads	Excessive shear stresses	
2005					
Bank Scour		1,047 - 1,117		Excessive bank shear stress	
		1,339 - 1,394		Resultant from floodplain drainage	
		2,066 - 2,182		Excessive bank shear stress

SP 7: Looking at left bank, root wads stabilized by boulders
