# Freedom Park (Little Sugar Creek) Monitoring Report Year 4 of 5 (2008)

Mecklenburg County, North Carolina

Project ID No. 141

May 2009

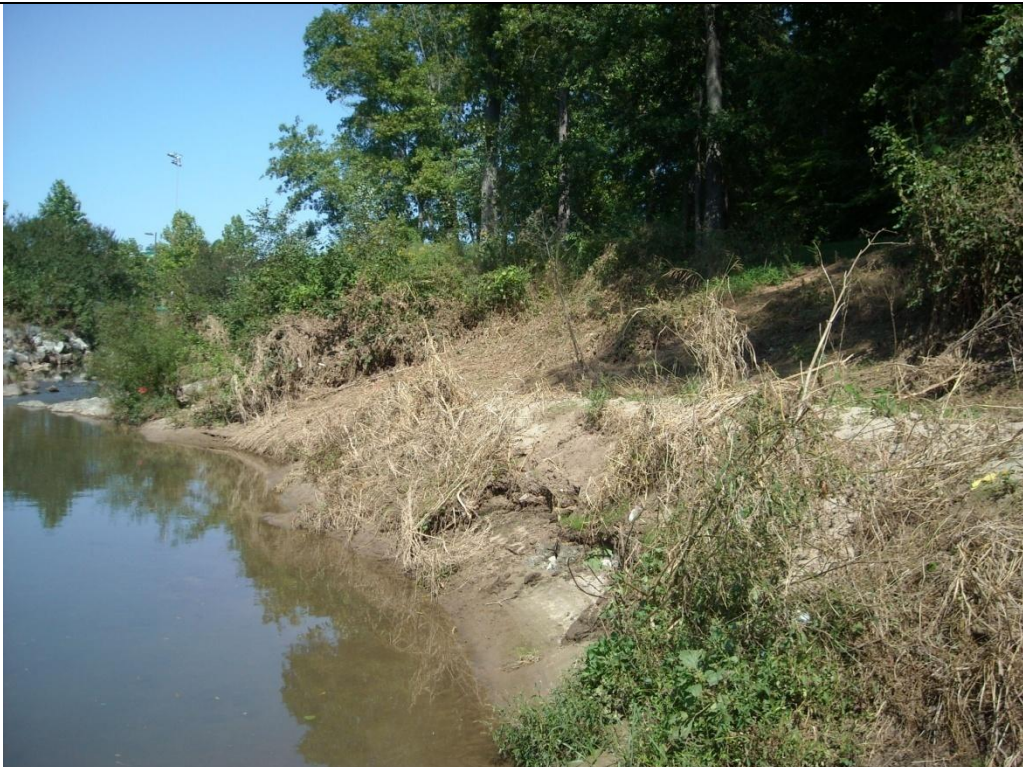
KHA assessed the stream channel during the spring and fall of 2008. A few isolated sections exhibited bank scour (3%). Causes of scour may include lack of vegetative establishments; frequent flooding flows; unstable soils; and failed short-term protection such as coir fiber matting.

SP1: Bank erosion in area of limited woody vegetation  
Taken 9/24/2008
