# Buffalo Creek Watershed Phase I Stream Mitigation Plan Greensboro, North Carolina

North Carolina Department of Environment and Natural Resources  
Ecosystem Enhancement Program

February 2005

Mitigation Plan Prepared By Buck Engineering PC

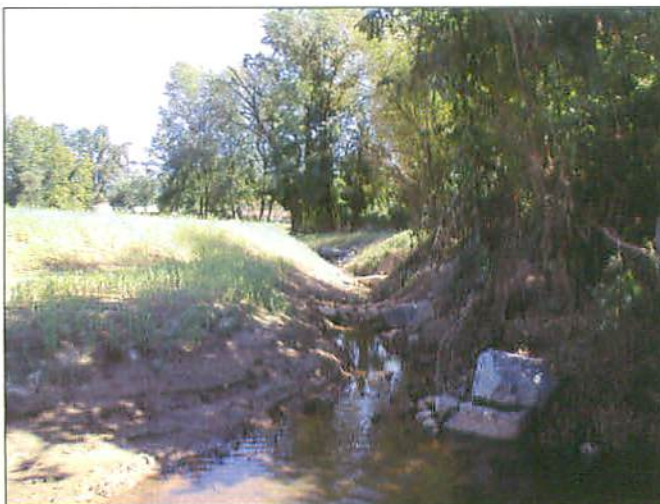
PP45A Reach 2 End (Upstream View)

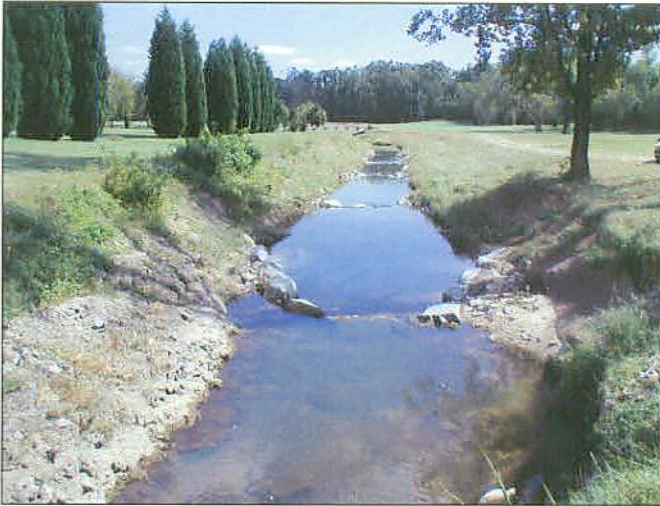
PP1 Reach 1A Project Start

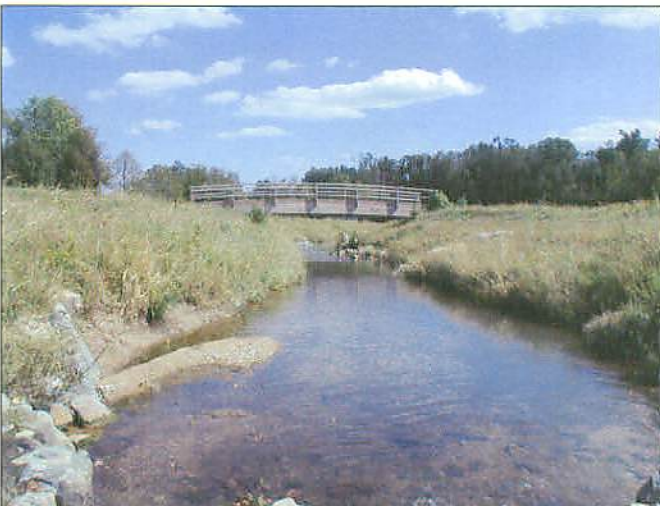
PP3A Reach 1A Towards Bridge 1

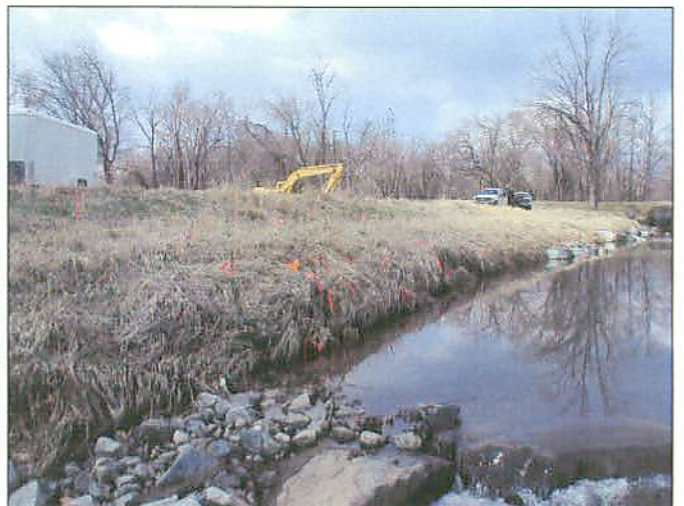
PP3B Reach 1A Forrested Buffer  
Bareroot/Livestake Plot Looking Upstream

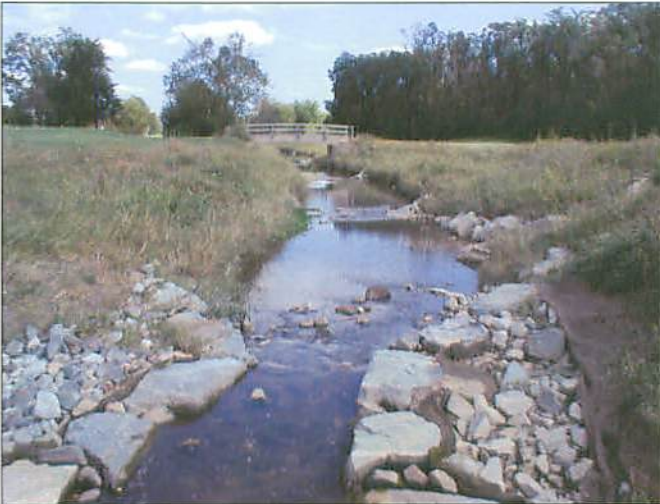
PP7 Reach 1B Towards Bridge 2

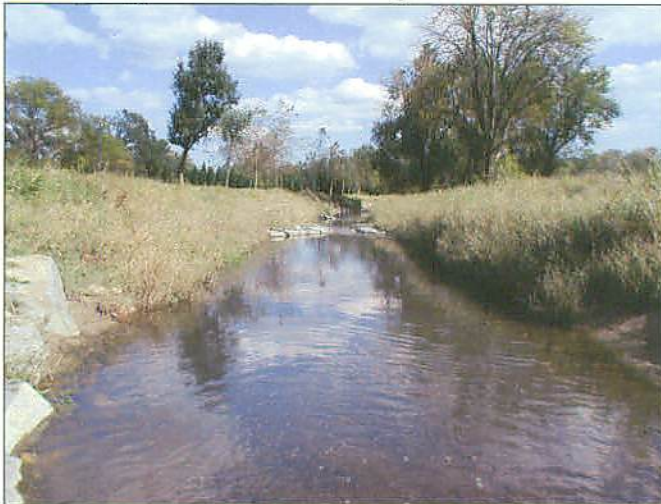
PP11 Reach 1D Double Wing Deflector #1
