**Glade Creek
Stream Restoration
NCDMS Project Number: 854
Monitoring Contract Number: D08033S
Monitoring Year 5
2015 Final Report**

**Submitted to
North Carolina Division of Mitigation Services
North Carolina Department of Environmental Quality
December 2015**

Glade Creek Stream Restoration 2015 Monitoring Report (MY 5)

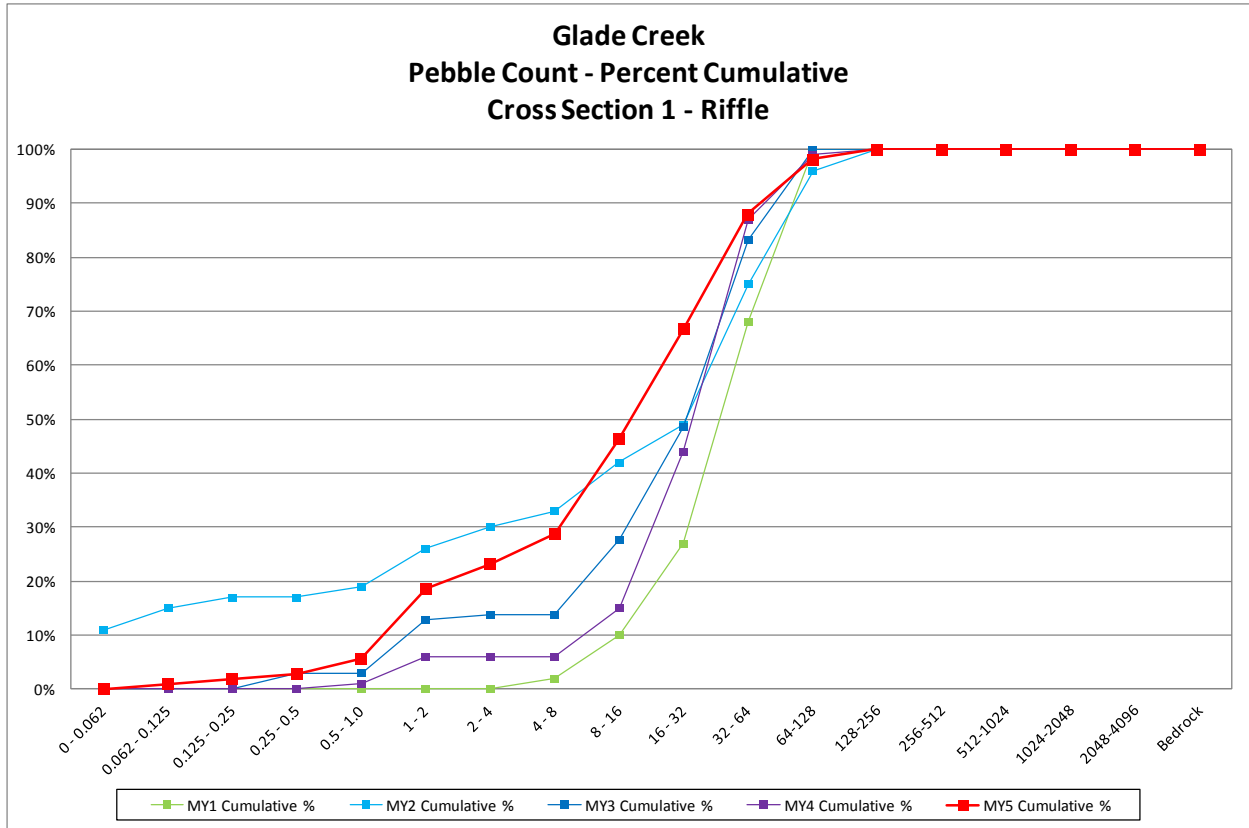
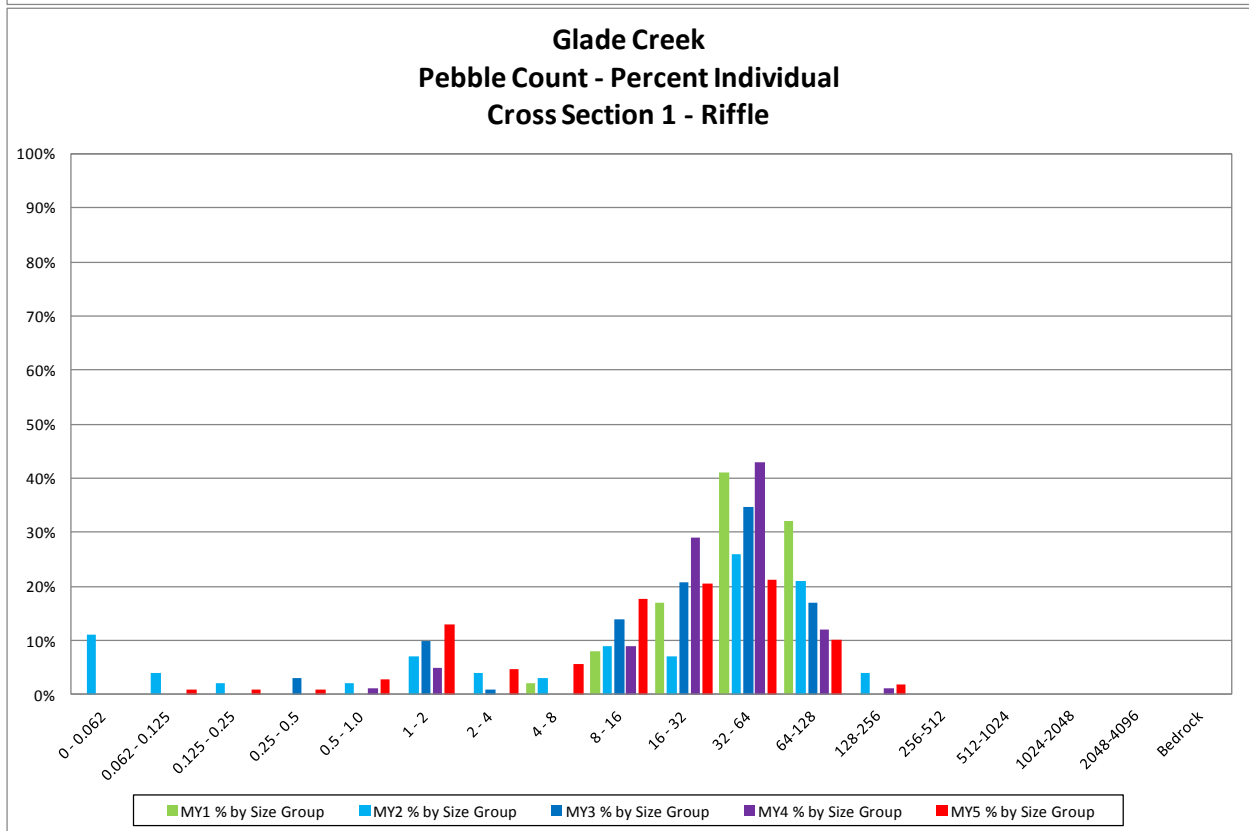
Glade Creek			
Cross Section 1 - Riffle			
Monitoring Year - 2015; MY5			
Bed Surface Material Particle Size Class (mm)	Number	% Individual	% Cumulative
0 - 0.062	0	0.0%	0%
0.062 - 0.125	1	0.9%	1%
0.125 - 0.25	1	0.9%	2%
0.25 - 0.5	1	0.9%	3%
0.5 - 1.0	3	2.8%	6%
1 - 2	14	13.0%	19%
2 - 4	5	4.6%	23%
4 - 8	6	5.6%	29%
8 - 16	19	17.6%	46%
16 - 32	22	20.4%	67%
32 - 64	23	21.3%	88%
64-128	11	10.2%	98%
128-256	2	1.9%	100%
256-512	0	0.0%	100%
512-1024	0	0.0%	100%
1024-2048	0	0.0%	100%
2048-4096	0	0.0%	100%
Bedrock	0	0.0%	100%
Total	108	100%	100%
		Summary Data	
		D50	17
		D84	57
		D95	110

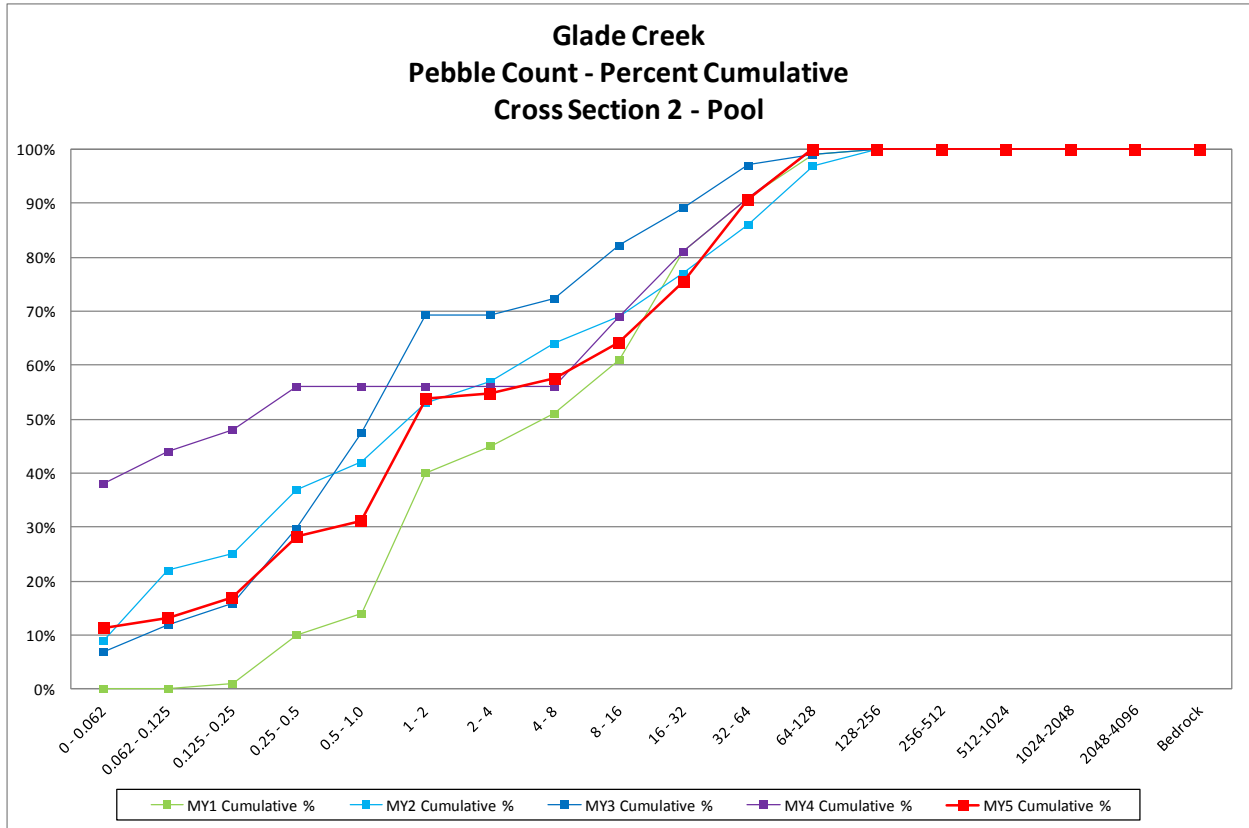
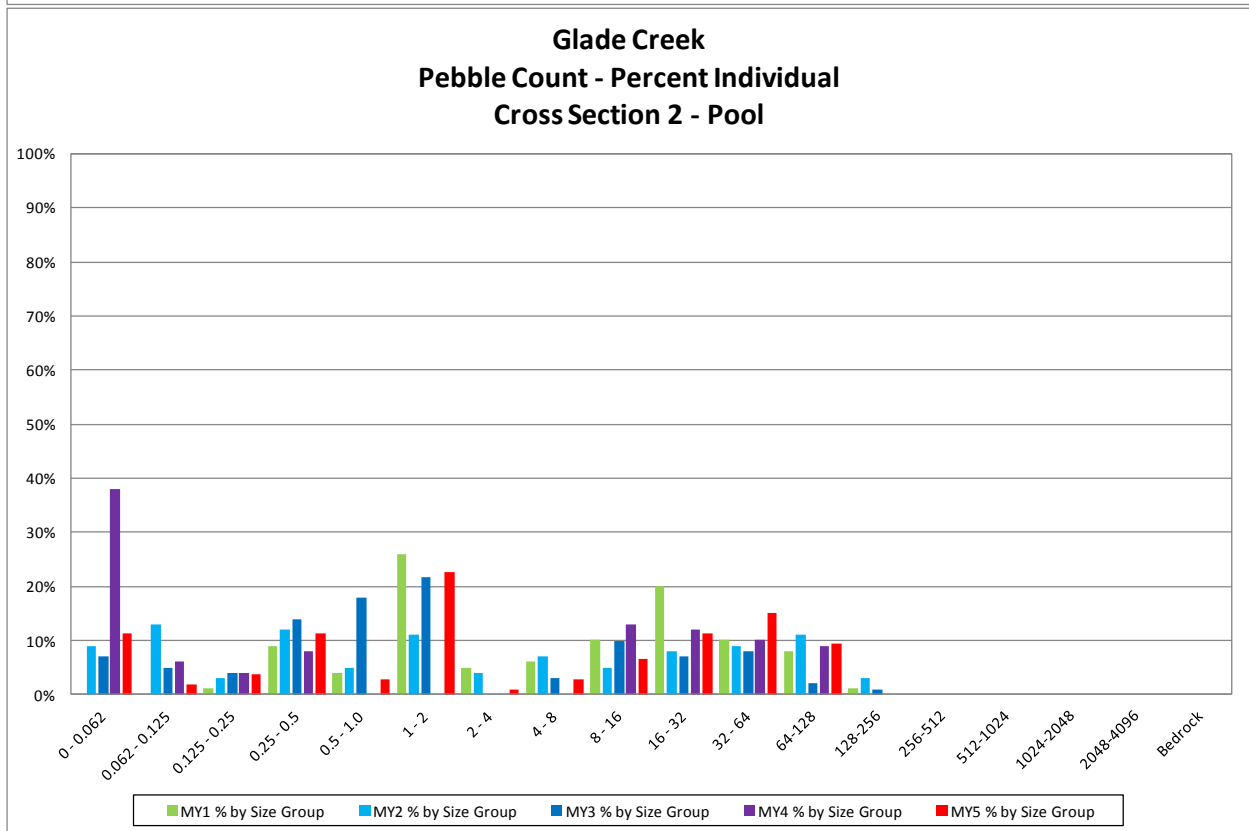
Glade Creek			
Cross Section 2 - Pool			
Monitoring Year - 2015; MY5			
Bed Surface Material Particle Size Class (mm)	Number	% Individual	% Cumulative
0 - 0.062	12	11.3%	11%
0.062 - 0.125	2	1.9%	13%
0.125 - 0.25	4	3.8%	17%
0.25 - 0.5	12	11.3%	28%
0.5 - 1.0	3	2.8%	31%
1 - 2	24	22.6%	54%
2 - 4	1	0.9%	55%
4 - 8	3	2.8%	58%
8 - 16	7	6.6%	64%
16 - 32	12	11.3%	75%
32 - 64	16	15.1%	91%
64-128	10	9.4%	100%
128-256	0	0.0%	100%
256-512	0	0.0%	100%
512-1024	0	0.0%	100%
1024-2048	0	0.0%	100%
2048-4096	0	0.0%	100%
Bedrock	0	0.0%	100%
Total	106	100%	100%
		Summary Data	
		D50	1.8
		D84	47
		D95	88

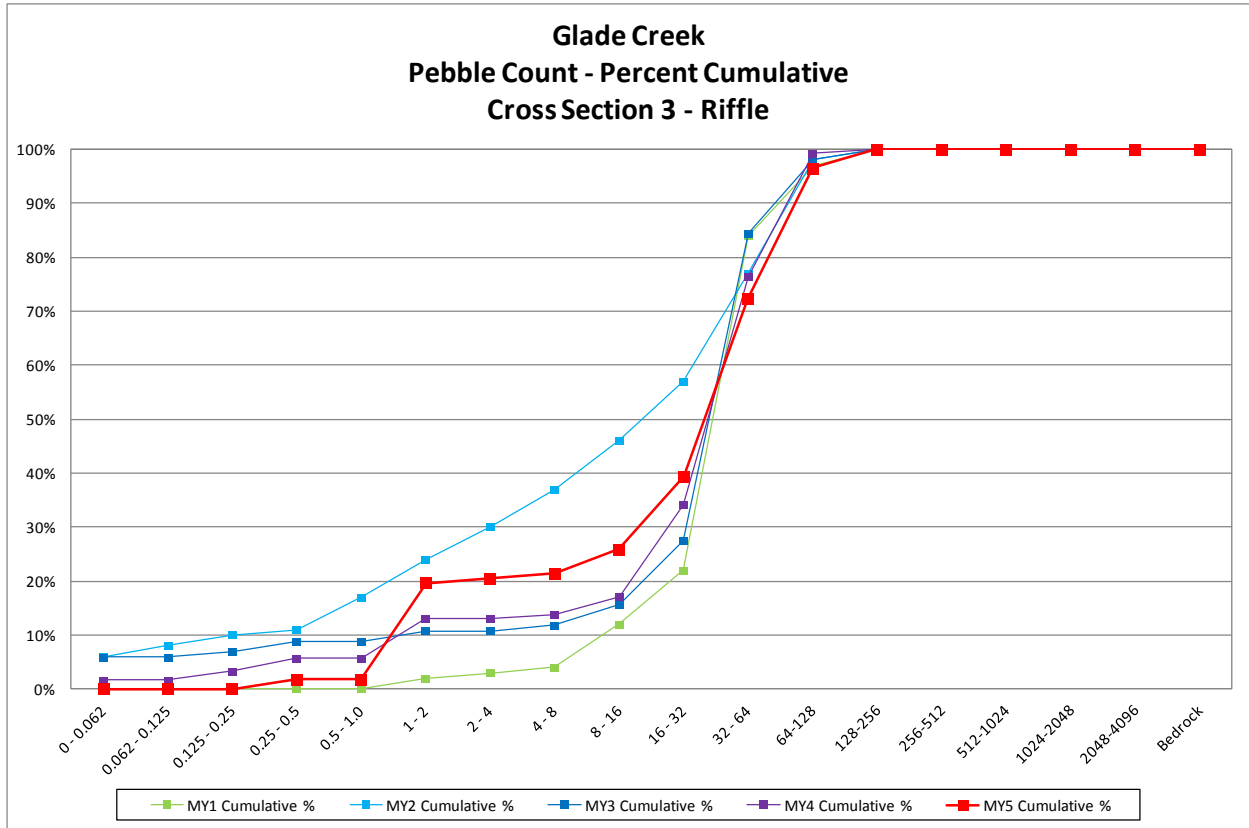
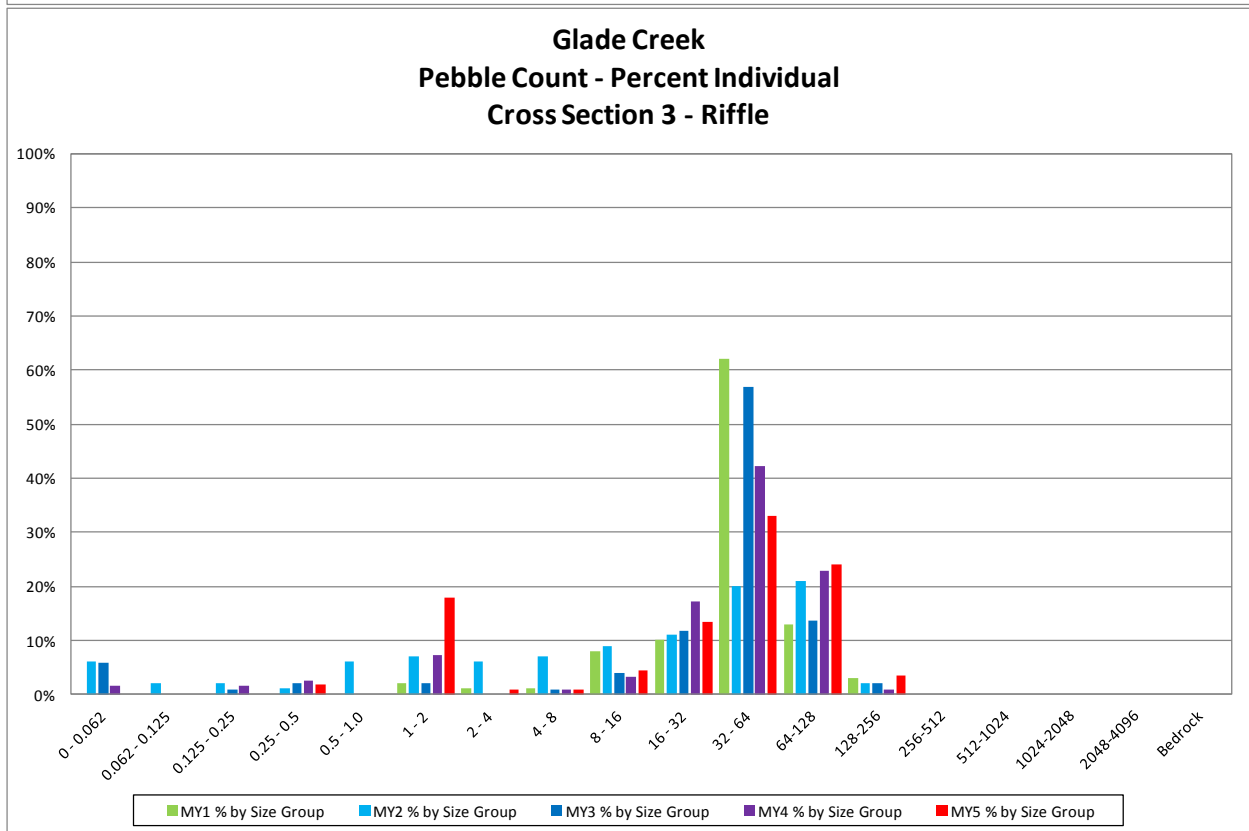
Glade Creek			
Cross Section 3 - Riffle			
Monitoring Year - 2015; MY5			
Bed Surface Material Particle Size Class (mm)	Number	% Individual	% Cumulative
0 - 0.062	0	0.0%	0%
0.062 - 0.125	0	0.0%	0%
0.125 - 0.25	0	0.0%	0%
0.25 - 0.5	2	1.8%	2%
0.5 - 1.0	0	0.0%	2%
1 - 2	20	17.9%	20%
2 - 4	1	0.9%	21%
4 - 8	1	0.9%	21%
8 - 16	5	4.5%	26%
16 - 32	15	13.4%	39%
32 - 64	37	33.0%	72%
64-128	27	24.1%	96%
128-256	4	3.6%	100%
256-512	0	0.0%	100%
512-1024	0	0.0%	100%
1024-2048	0	0.0%	100%
2048-4096	0	0.0%	100%
Bedrock	0	0.0%	100%
Total	112	100%	100%
		Summary Data	
		D50	42
		D84	82
		D95	120

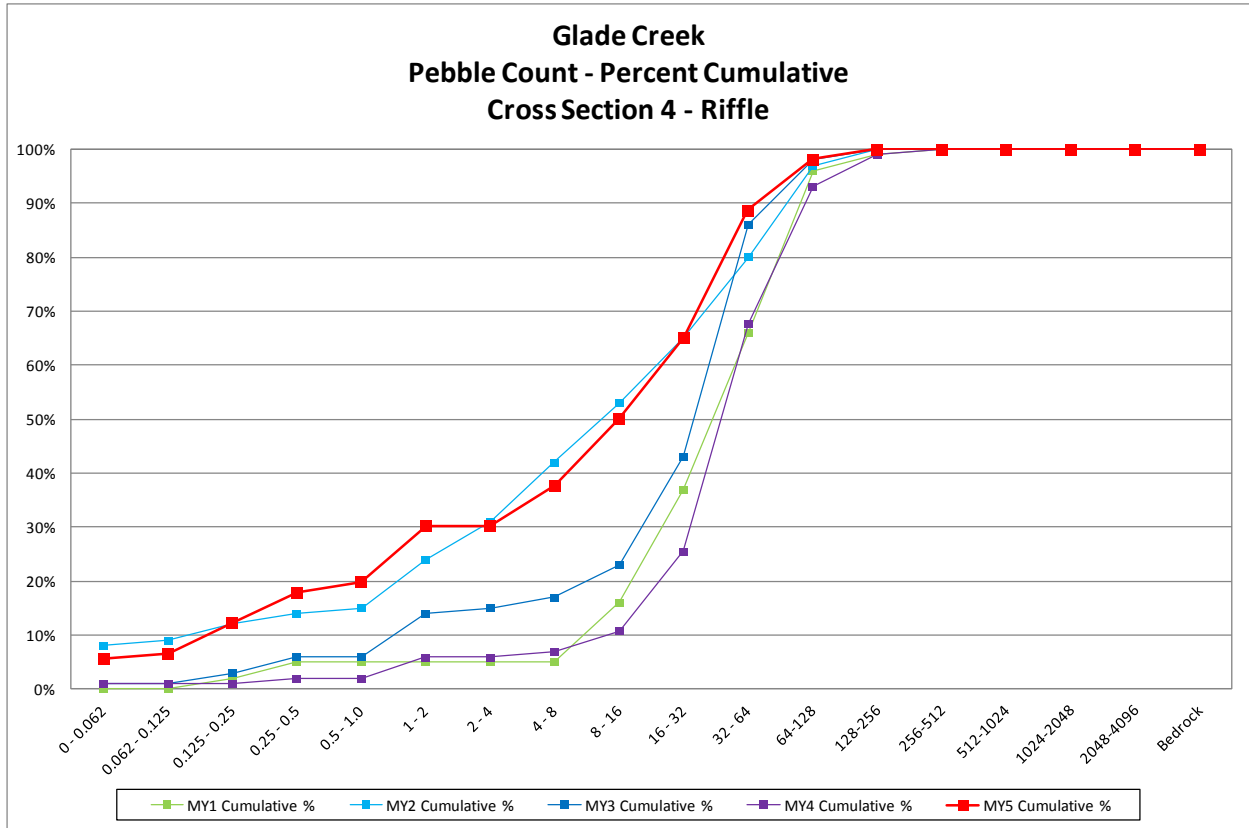
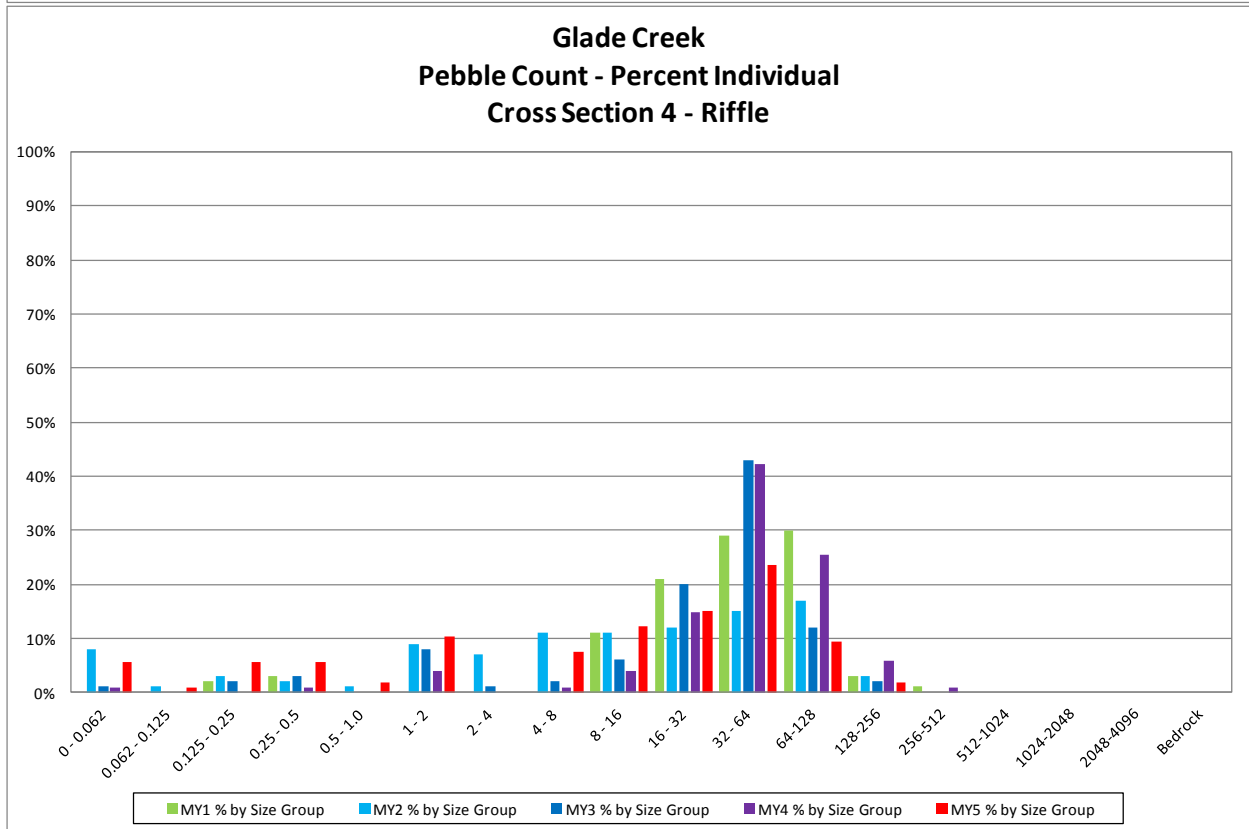
Glade Creek			
Cross Section 4 - Riffle			
Monitoring Year - 2015; MY5			
Bed Surface Material Particle Size Class (mm)	Number	% Individual	% Cumulative
0 - 0.062	6	5.7%	6%
0.062 - 0.125	1	0.9%	7%
0.125 - 0.25	6	5.7%	12%
0.25 - 0.5	6	5.7%	18%
0.5 - 1.0	2	1.9%	20%
1 - 2	11	10.4%	30%
2 - 4	0	0.0%	30%
4 - 8	8	7.5%	38%
8 - 16	13	12.3%	50%
16 - 32	16	15.1%	65%
32 - 64	25	23.6%	89%
64-128	10	9.4%	98%
128-256	2	1.9%	100%
256-512	0	0.0%	100%
512-1024	0	0.0%	100%
1024-2048	0	0.0%	100%
2048-4096	0	0.0%	100%
Bedrock	0	0.0%	100%
Total	106	100%	100%
		Summary Data	
		D50	16
		D84	57
		D95	96

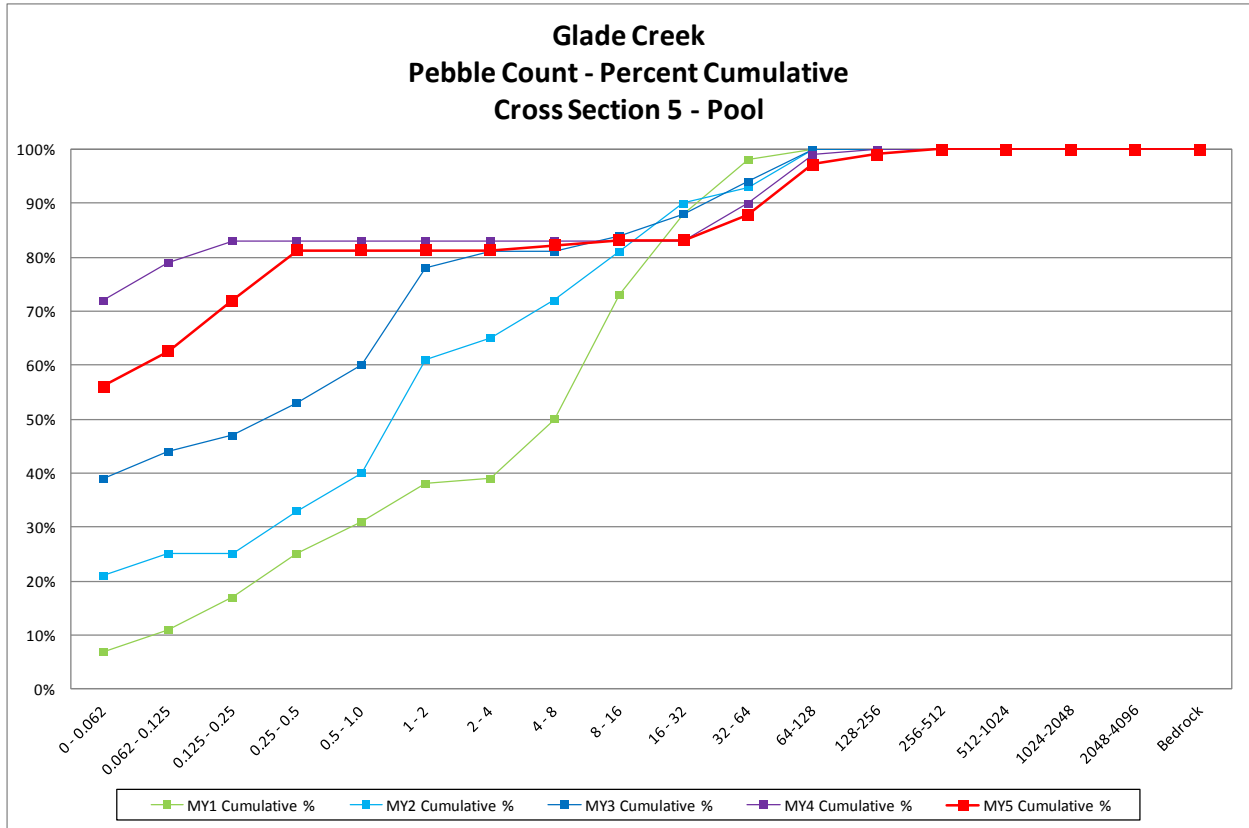
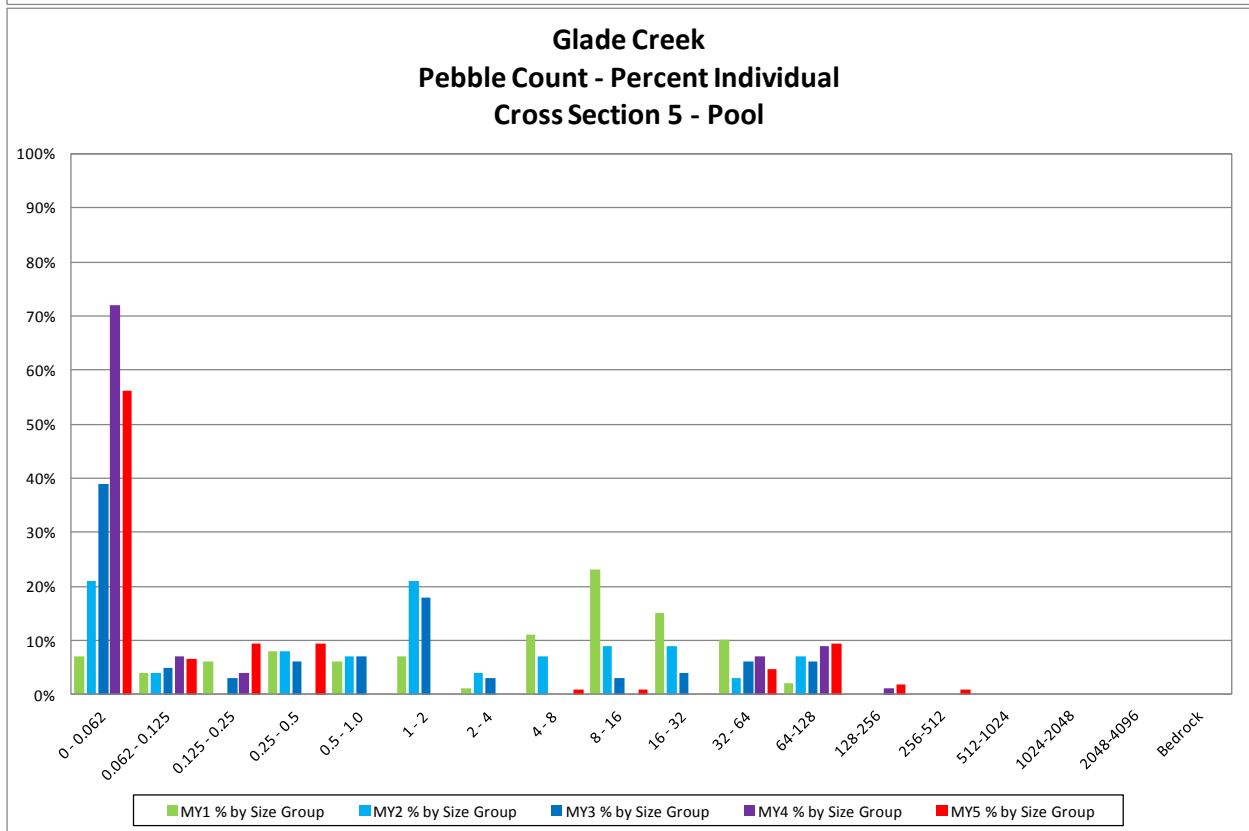
Glade Creek			
Cross Section 5 - Pool			
Monitoring Year - 2015; MY5			
Bed Surface Material Particle Size Class (mm)	Number	% Individual	% Cumulative
0 - 0.062	60	56.1%	56%
0.062 - 0.125	7	6.5%	63%
0.125 - 0.25	10	9.3%	72%
0.25 - 0.5	10	9.3%	81%
0.5 - 1.0	0	0.0%	81%
1 - 2	0	0.0%	81%
2 - 4	0	0.0%	81%
4 - 8	1	0.9%	82%
8 - 16	1	0.9%	83%
16 - 32	0	0.0%	83%
32 - 64	5	4.7%	88%
64-128	10	9.3%	97%
128-256	2	1.9%	99%
256-512	1	0.9%	100%
512-1024	0	0.0%	100%
1024-2048	0	0.0%	100%
2048-4096	0	0.0%	100%
Bedrock	0	0.0%	100%
Total	107	100%	100%
		Summary Data	
		D50	0.062
		D84	37
		D95	110

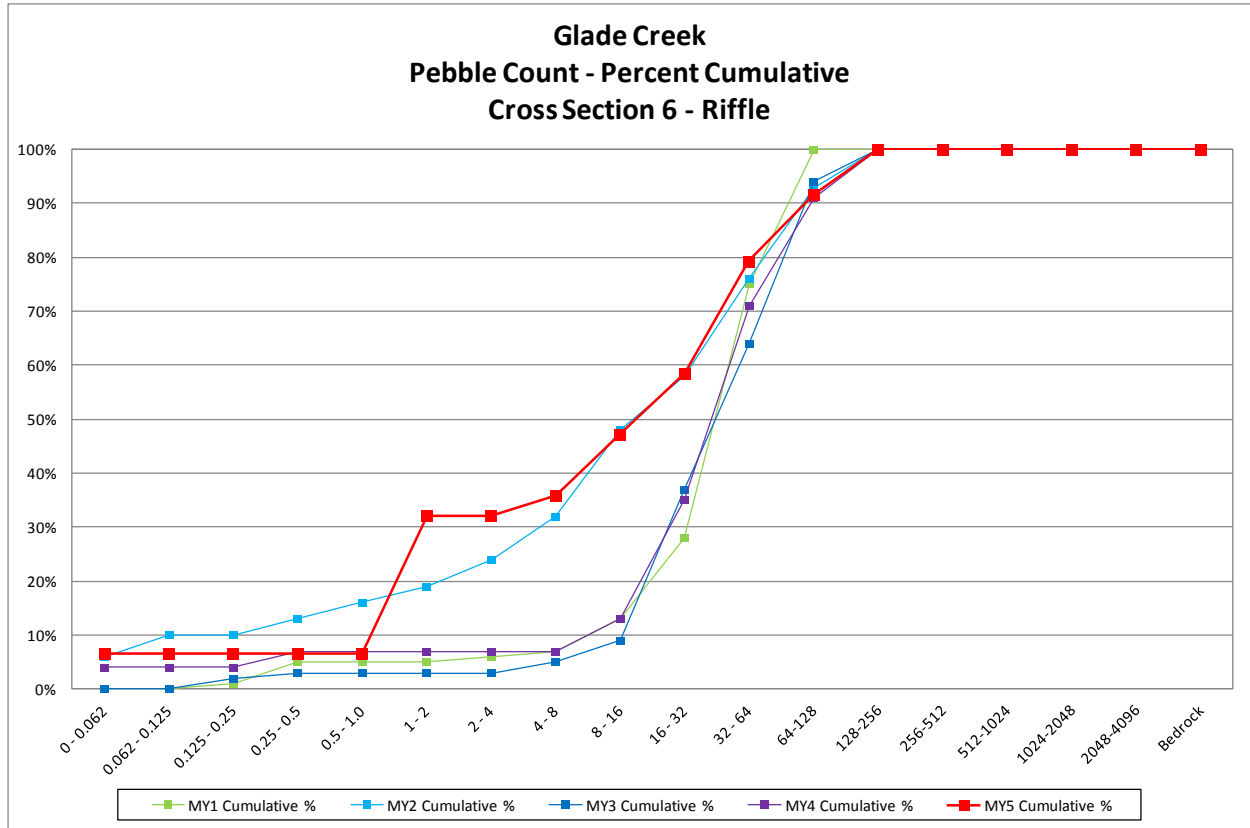
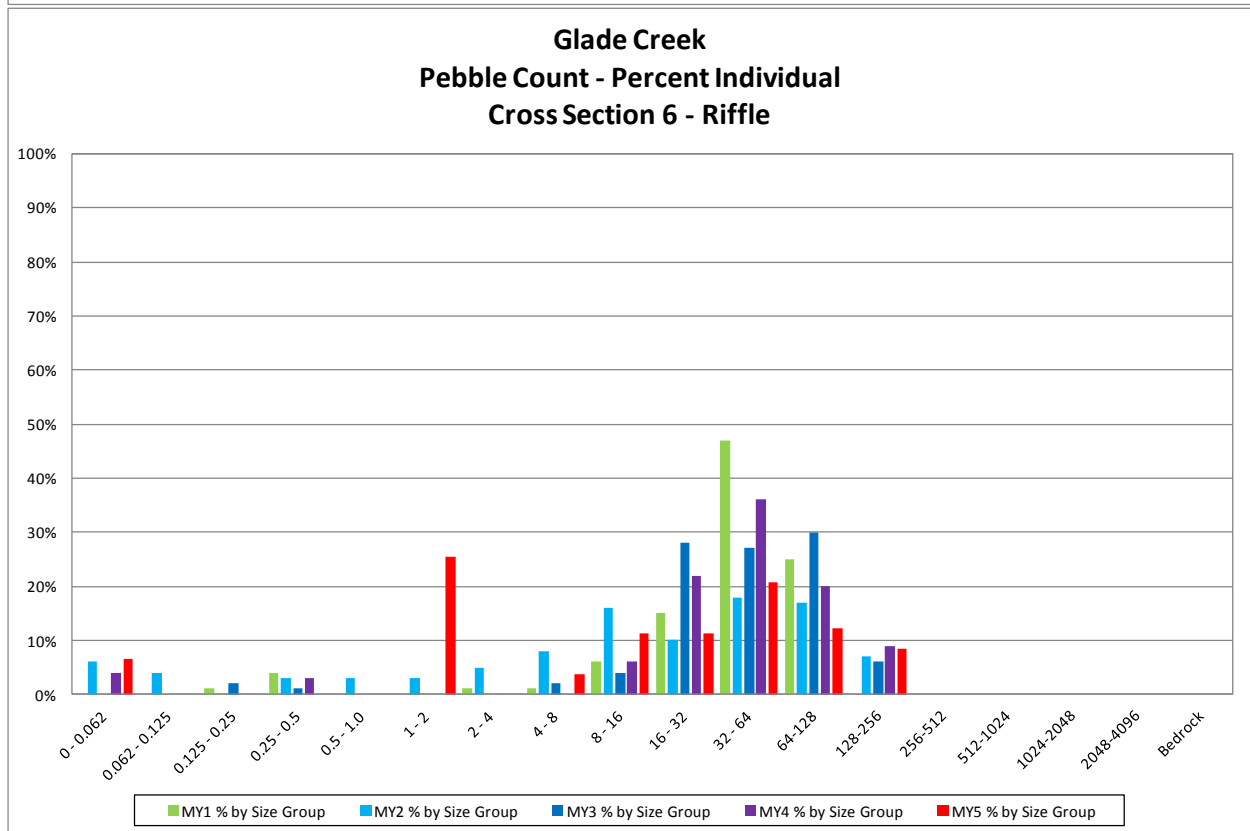
Glade Creek			
Cross Section 6 - Riffle			
Monitoring Year - 2015; MY5			
Bed Surface Material Particle Size Class (mm)	Number	% Individual	% Cumulative
0 - 0.062	7	6.6%	7%
0.062 - 0.125	0	0.0%	7%
0.125 - 0.25	0	0.0%	7%
0.25 - 0.5	0	0.0%	7%
0.5 - 1.0	0	0.0%	7%
1 - 2	27	25.5%	32%
2 - 4	0	0.0%	32%
4 - 8	4	3.8%	36%
8 - 16	12	11.3%	47%
16 - 32	12	11.3%	58%
32 - 64	22	20.8%	79%
64-128	13	12.3%	92%
128-256	9	8.5%	100%
256-512	0	0.0%	100%
512-1024	0	0.0%	100%
1024-2048	0	0.0%	100%
2048-4096	0	0.0%	100%
Bedrock	0	0.0%	100%
Total	106	100%	100%
		Summary Data	
		D50	23
		D84	75
		D95	150

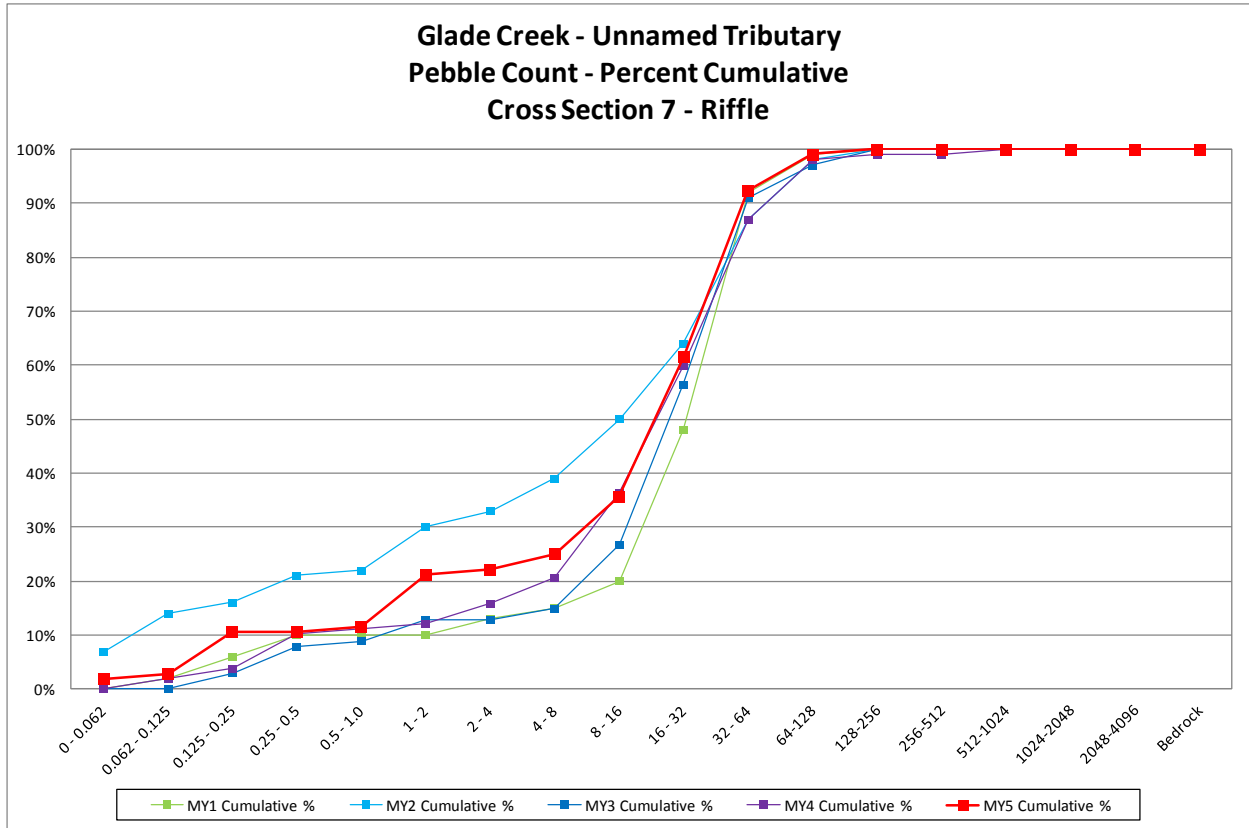
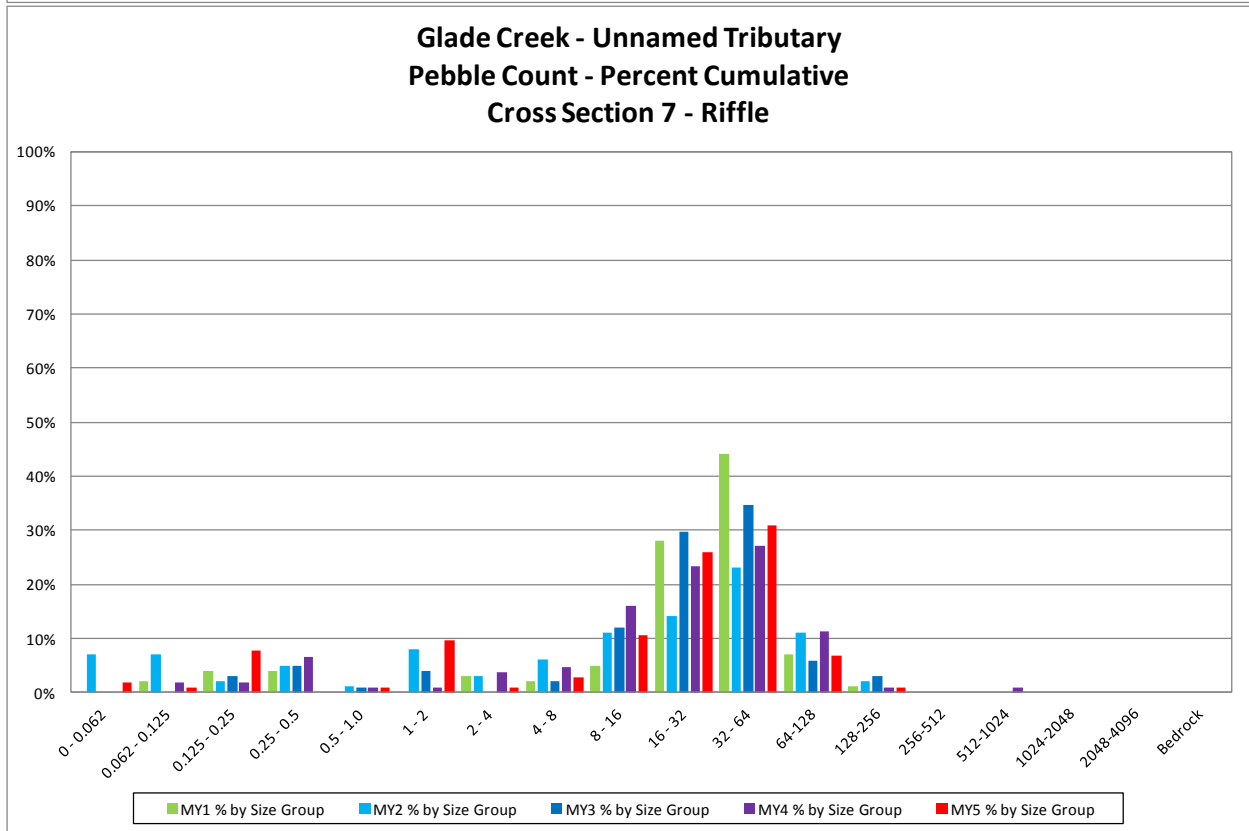
Glade Creek			
Cross Section 7 - Riffle			
Monitoring Year - 2015; MY5			
Bed Surface Material Particle Size Class (mm)	Number	% Individual	% Cumulative
0 - 0.062	2	1.9%	2%
0.062 - 0.125	1	1.0%	3%
0.125 - 0.25	8	7.7%	11%
0.25 - 0.5	0	0.0%	11%
0.5 - 1.0	1	1.0%	12%
1 - 2	10	9.6%	21%
2 - 4	1	1.0%	22%
4 - 8	3	2.9%	25%
8 - 16	11	10.6%	36%
16 - 32	27	26.0%	62%
32 - 64	32	30.8%	92%
64-128	7	6.7%	99%
128-256	1	1.0%	100%
256-512	0	0.0%	100%
512-1024	0	0.0%	100%
1024-2048	0	0.0%	100%
2048-4096	0	0.0%	100%
Bedrock	0	0.0%	100%
Total	104	100%	100%
		Summary Data	
		D50	23
		D84	53
		D95	75

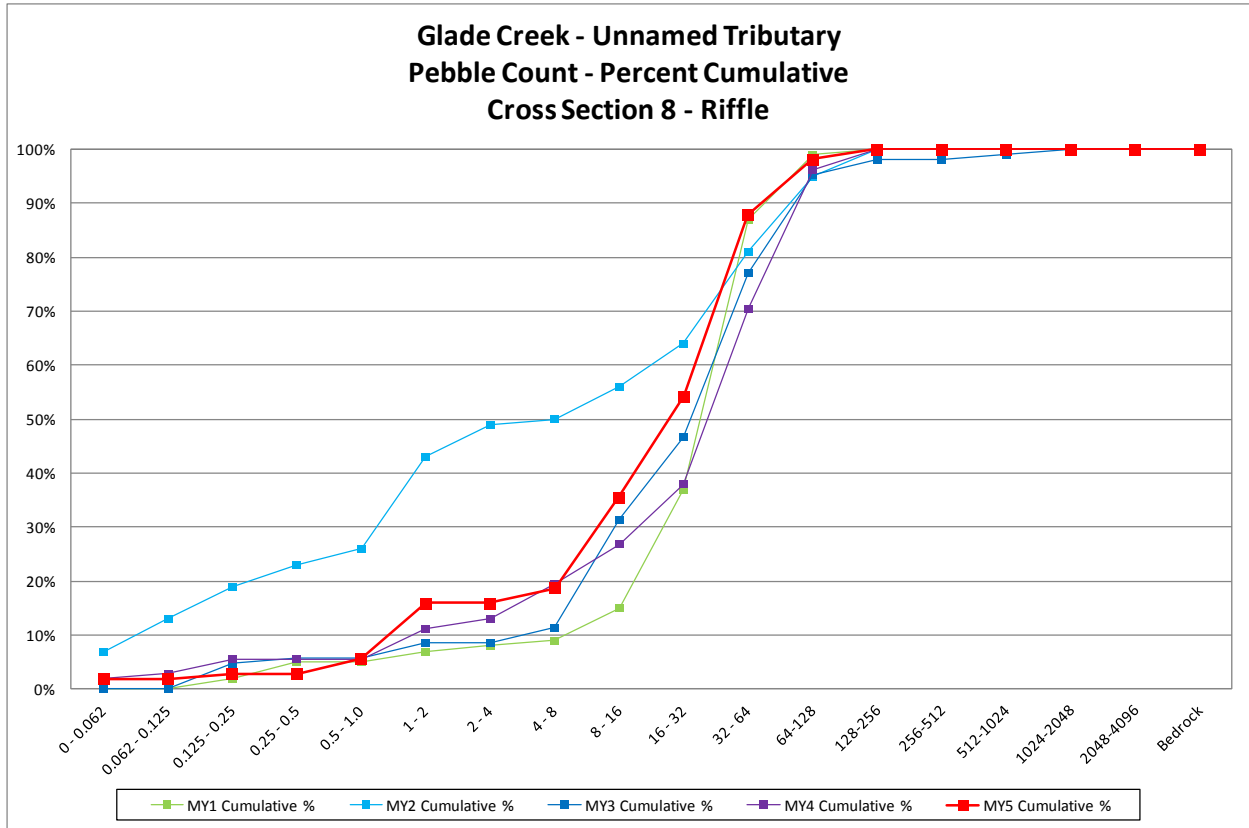
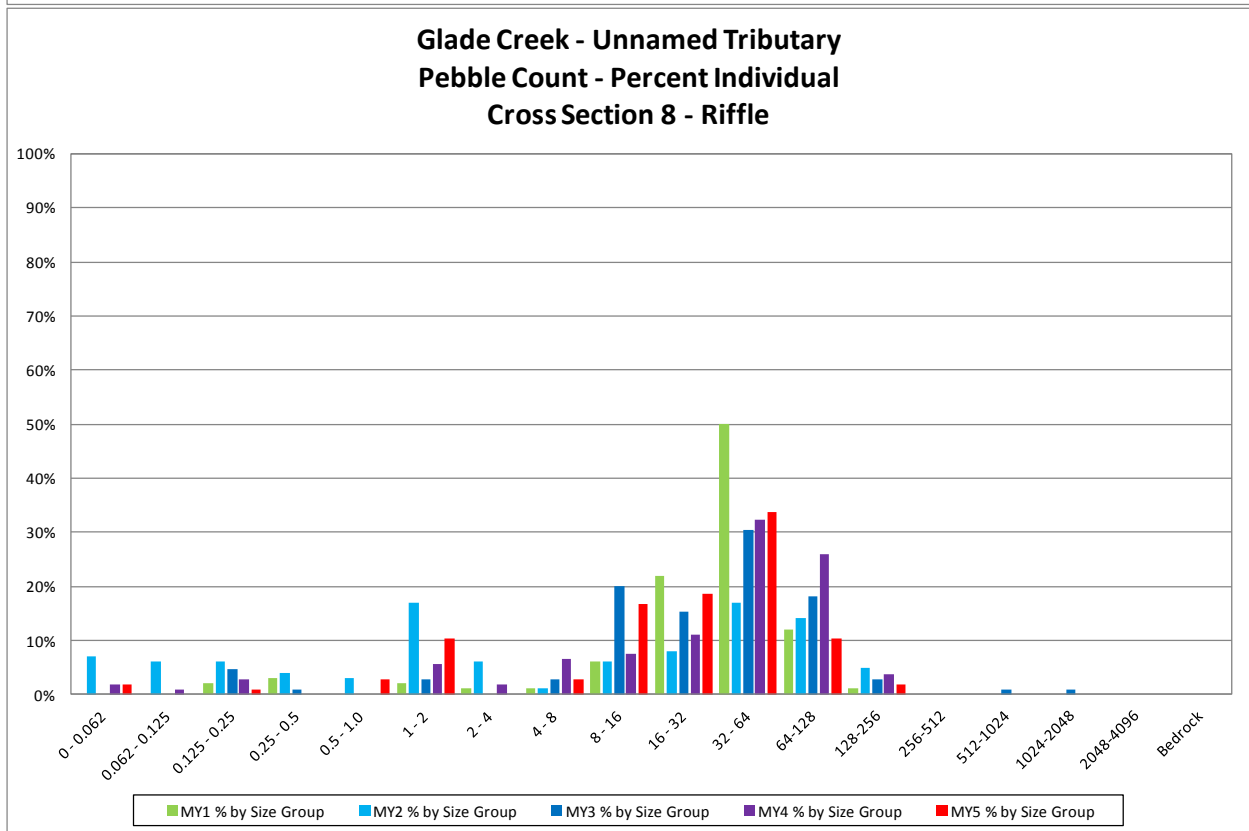
Glade Creek			
Cross Section 8 - Riffle			
Monitoring Year - 2015; MY5			
Bed Surface Material Particle Size Class (mm)	Number	% Individual	% Cumulative
0 - 0.062	2	1.9%	2%
0.062 - 0.125	0	0.0%	2%
0.125 - 0.25	1	0.9%	3%
0.25 - 0.5	0	0.0%	3%
0.5 - 1.0	3	2.8%	6%
1 - 2	11	10.3%	16%
2 - 4	0	0.0%	16%
4 - 8	3	2.8%	19%
8 - 16	18	16.8%	36%
16 - 32	20	18.7%	54%
32 - 64	36	33.6%	88%
64-128	11	10.3%	98%
128-256	2	1.9%	100%
256-512	0	0.0%	100%
512-1024	0	0.0%	100%
1024-2048	0	0.0%	100%
2048-4096	0	0.0%	100%
Bedrock	0	0.0%	100%
Total	107	100%	100%
		Summary Data	
		D50	28
		D84	60
		D95	86
