**MONITORING YEAR 1
ANNUAL REPORT**
Final

GLADE CREEK II RESTORATION PROJECT

Alleghany County, NC

NCDMS Project Number 92343

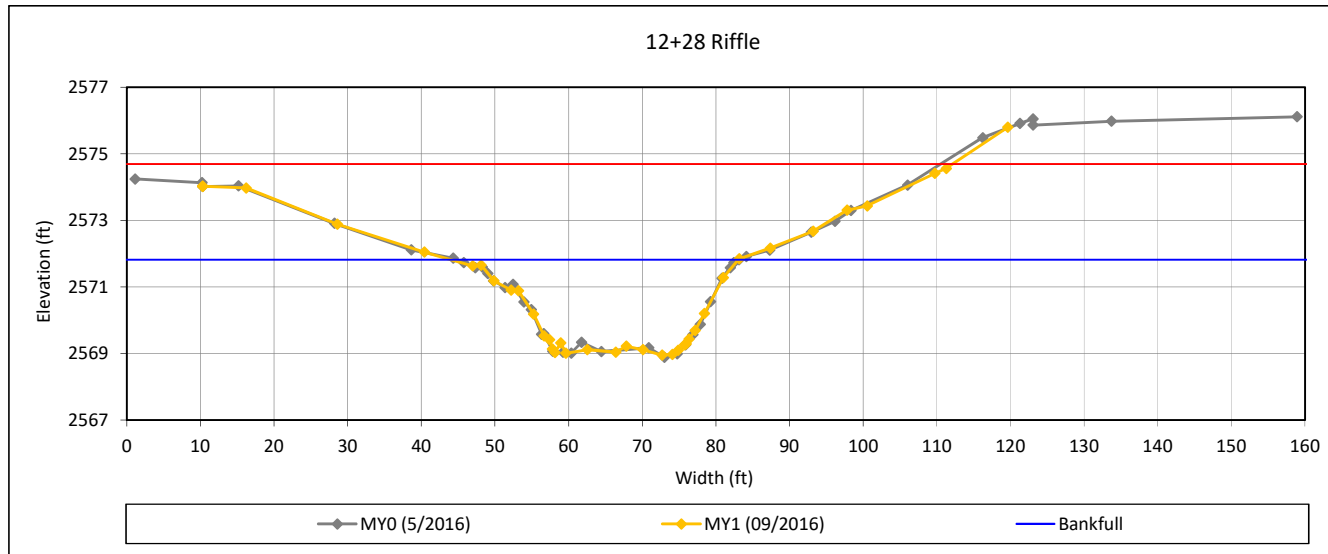
Cross Section 1 - Glade Creek

66.9	x-section area (ft.sq.)
34.4	width (ft)
1.9	mean depth (ft)
2.9	max depth (ft)
35.2	wetted perimeter (ft)
1.9	hydraulic radius (ft)
17.7	width-depth ratio
106	W flood prone area (ft)
3.1	entrenchment ratio
1.0	low bank height ratio

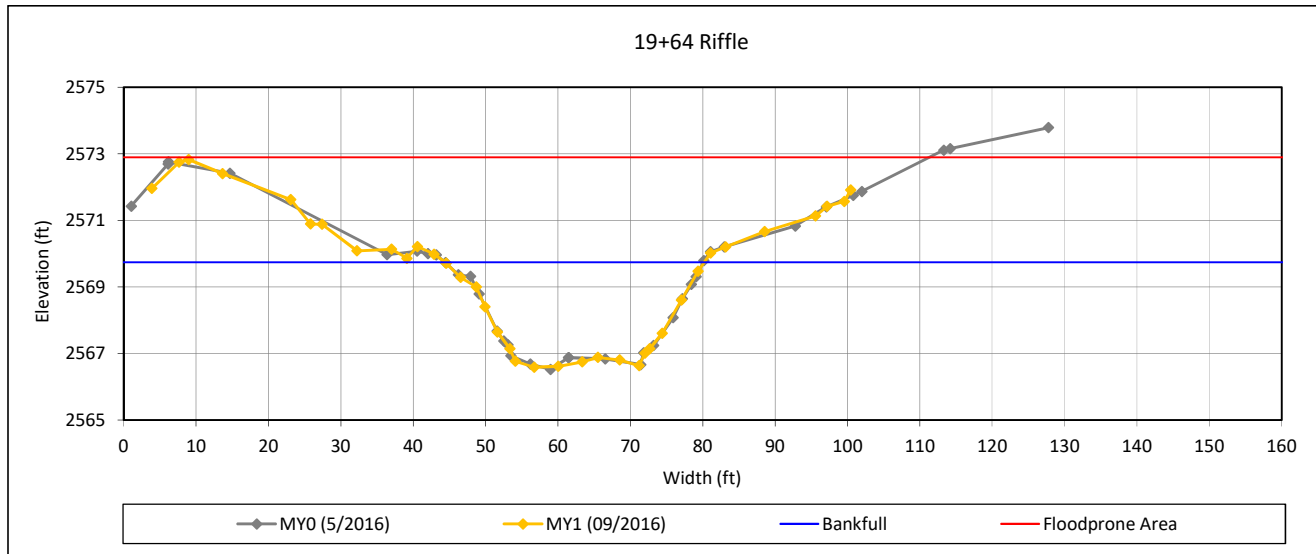
Cross Section 2 - Glade Creek

78.0	x-section area (ft.sq.)
35.0	width (ft)
2.2	mean depth (ft)
3.2	max depth (ft)
36.0	wetted perimeter (ft)
2.2	hydraulic radius (ft)
15.7	width-depth ratio
110	W flood prone area (ft)
3.2	entrenchment ratio
1.0	low bank height ratio

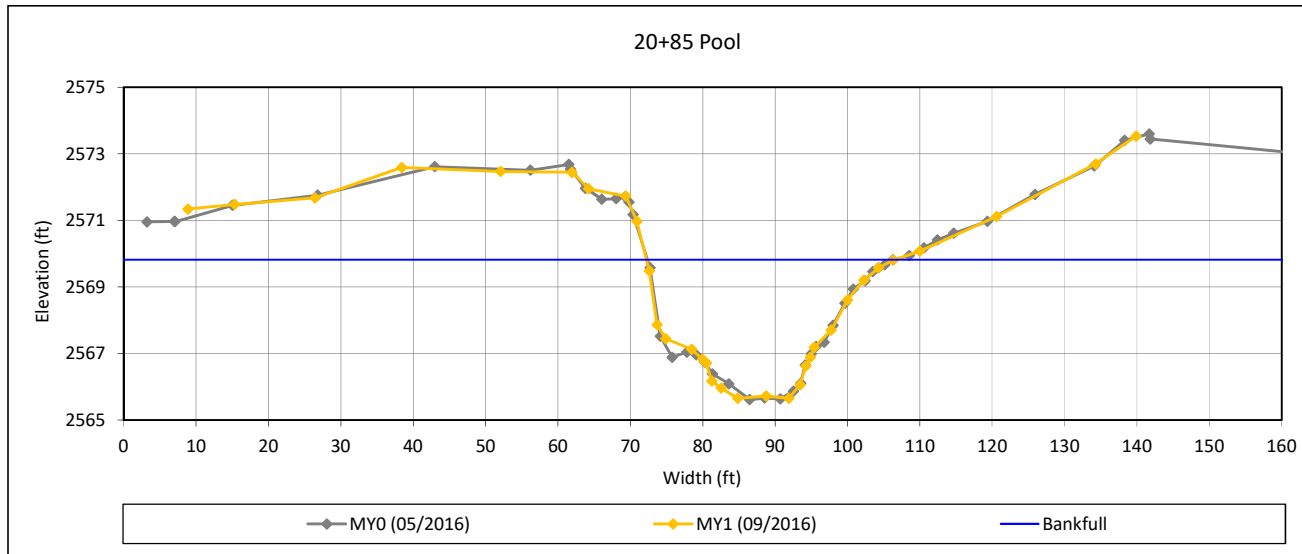
Cross Section 3 - Glade Creek

88.4	x-section area (ft.sq.)
30.0	width (ft)
2.9	mean depth (ft)
4.2	max depth (ft)
32.0	wetted perimeter (ft)
2.8	hydraulic radius (ft)
10.2	width-depth ratio

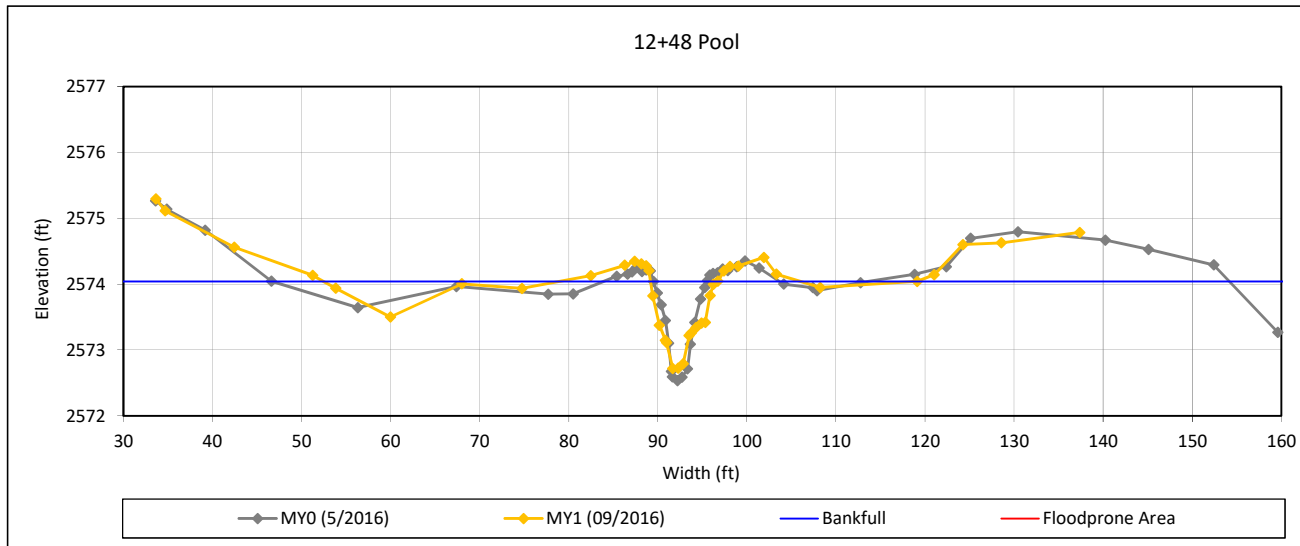
Cross Section 4 -UT Glade Creek

5.5	x-section area (ft.sq.)
7.1	width (ft)
0.8	mean depth (ft)
1.3	max depth (ft)
7.7	wetted perimeter (ft)
0.7	hydraulic radius (ft)
9.0	width-depth ratio

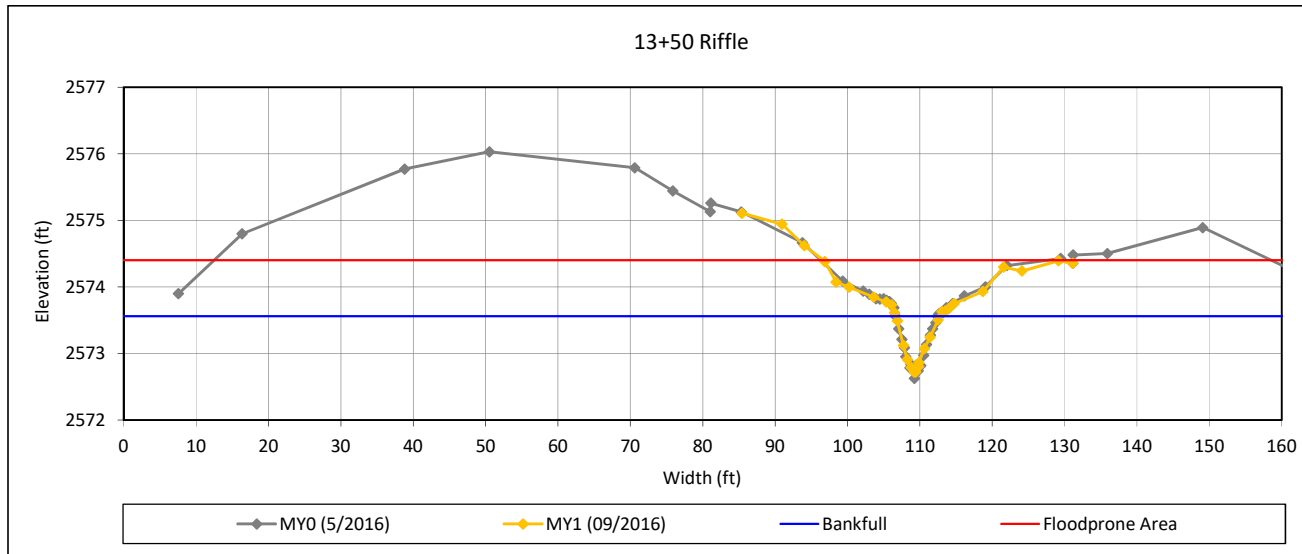
Cross Section 5 - UT Glade Creek

2.7	x-section area (ft.sq.)
6.1	width (ft)
0.4	mean depth (ft)
0.8	max depth (ft)
6.3	wetted perimeter (ft)
0.4	hydraulic radius (ft)
13.5	width-depth ratio
61	W flood prone area (ft)
10.0	entrenchment ratio
1.0	low bank height ratio
