MONITORING YEAR 3 ANNUAL REPORT

GLADE CREEK II RESTORATION PROJECT

Alleghany County, NC
DEQ Contract 6843
DMS Project Number 92343
USACE Action ID 2009-00589

Data Collection Period: March 2018 – November 2018
Submission Date: December 12, 2018

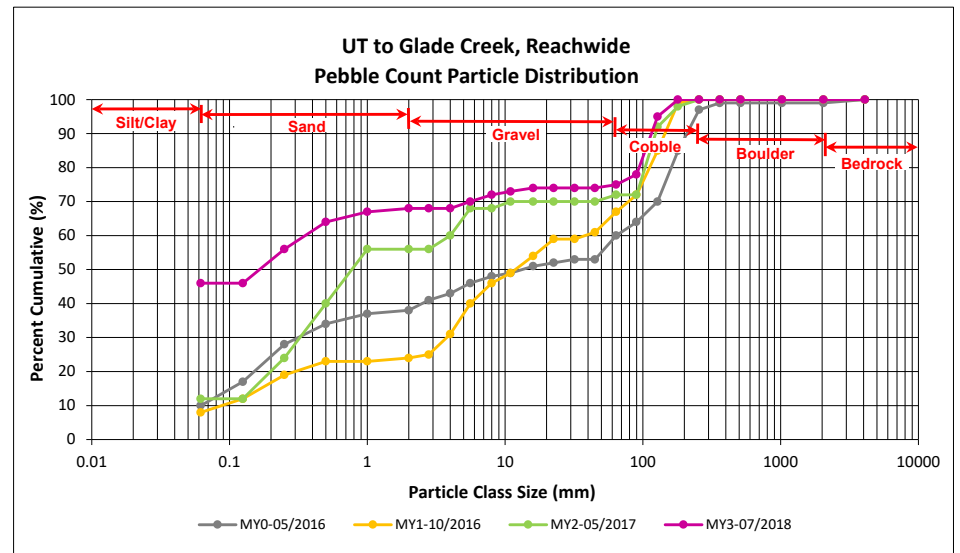
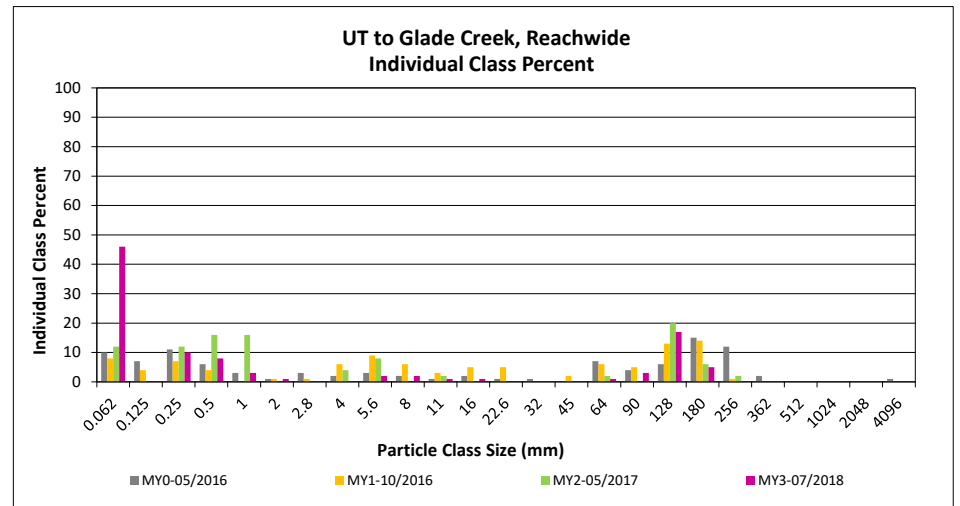
UT to Glade Creek has continued to experience an increase in fine sediment throughout MY3. Sedimentation has continued despite the adaptive management was performed in March 2018 on UT to Glade Creek to improve stream function and reduce active braiding. At the start of UT to Glade Creek Reach 2, sediment deposition has directed flow through Wetland D on the left floodplain of the channel. This was observed after two large storm events that occurred in September and October 2018. Land management activities and cattle pasture upstream of the project are most likely contributing excessive sediment on UT to Glade Creek.

Reachwide Channel materials (mm)	
D ₁₆ =	Silt/Clay
D ₃₅ =	Silt/Clay
D ₅₀ =	0.2
D ₈₄ =	101.9
D ₉₅ =	128.0
D ₁₀₀ =	180.0

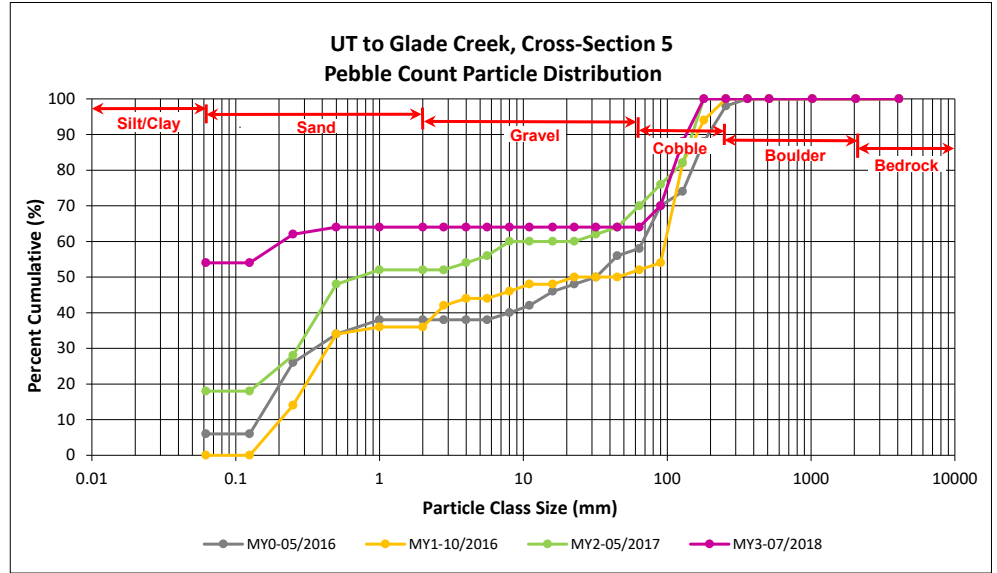
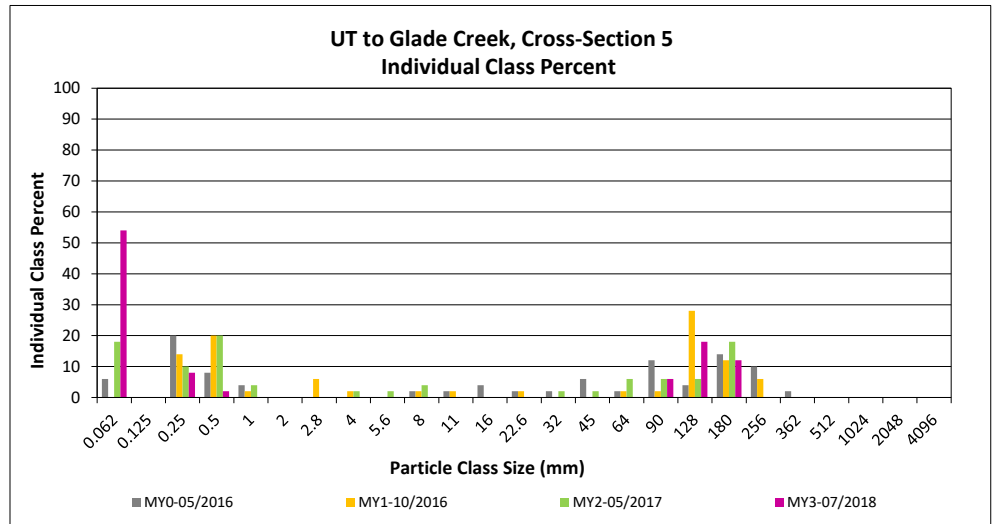
Cross Section 5 Channel materials (mm)	
D ₁₆ =	Silt/Clay
D ₃₅ =	Silt/Clay
D ₅₀ =	Silt/Clay
D ₈₄ =	118.4
D ₉₅ =	156.2
D ₁₀₀ =	180.0

Morphological surveys for MY3 were conducted in May 2018. Results indicate that the channel dimensions are stable and functioning as designed on Glade Creek. However, UT to Glade Creek cross-section 4 and cross-section 5 plots show significant sediment deposition that has increased the width-to-depth ratios. In general, the reachwide pebble counts on Glade Creek show coarser materials in the riffles and fines in the pools. The UT to Glade Creek reachwide channel materials resulted in a D_{50} of 0.2 mm (sand) during MY3. This fining of sediment materials was observed in MY2 and continues in MY3 for UT to Glade Creek.
