# MONITORING YEAR 4 ANNUAL REPORT

## GLADE CREEK II RESTORATION PROJECT

Alleghany County, NC  
DEQ Contract 6843  
DMS Project Number 92343  
USACE Action ID 2009-00589

Data Collection Period: March – October 2019  
Submission Date: December 13, 2019

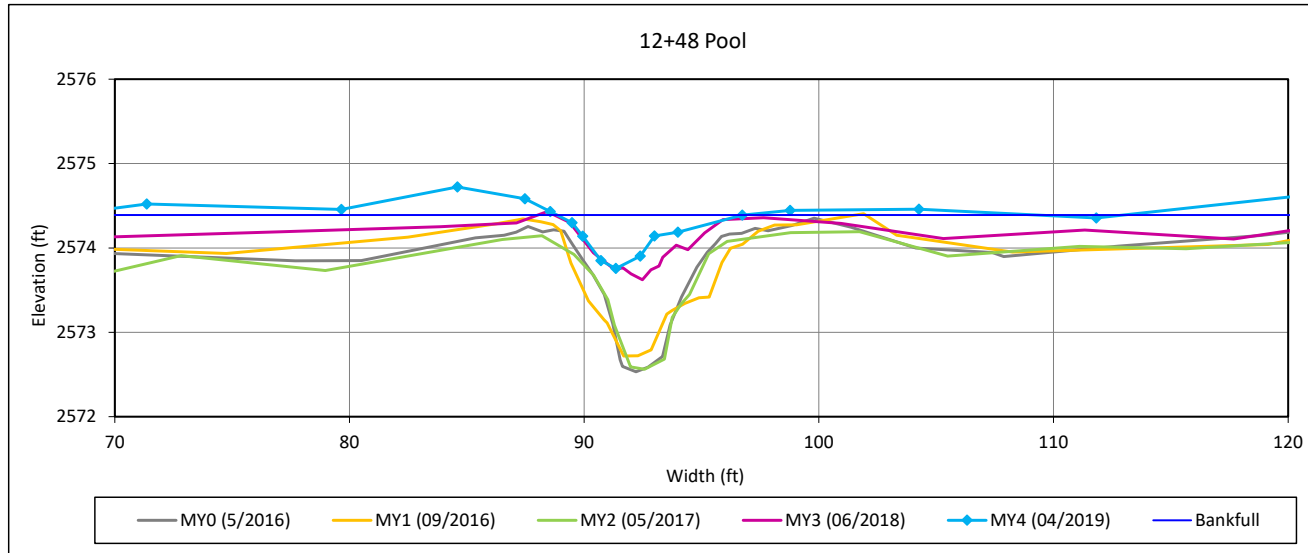
#### Cross-Section 4 - UT to Glade Creek

2.1	x-section area (ft.sq.)
7.9	width (ft)
0.3	mean depth (ft)
0.6	max depth (ft)
8.1	wetted perimeter (ft)
0.3	hydraulic radius (ft)
29.8	width-depth ratio

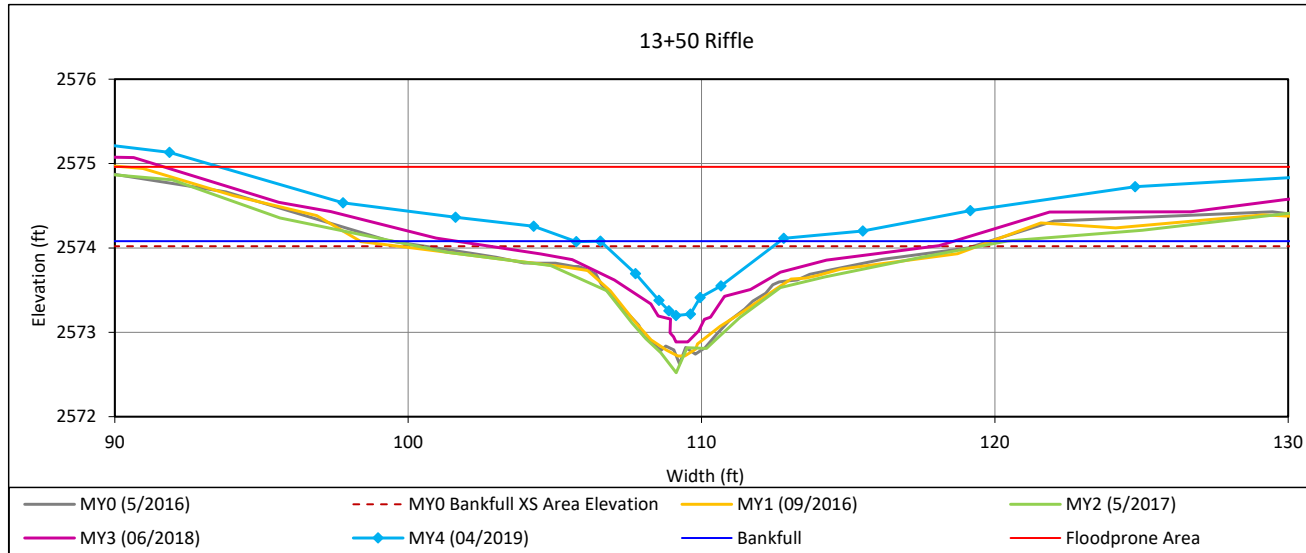
**Cross-Section 5 - UT to Glade Creek**

2.8	x-section area (ft.sq.)
6.1	width (ft)
0.5	mean depth (ft)
0.9	max depth (ft)
6.4	wetted perimeter (ft)
0.4	hydraulic radius (ft)
13.5	width-depth ratio
37.0	W flood prone area (ft)
6.0	entrenchment ratio
1.1	low bank height ratio

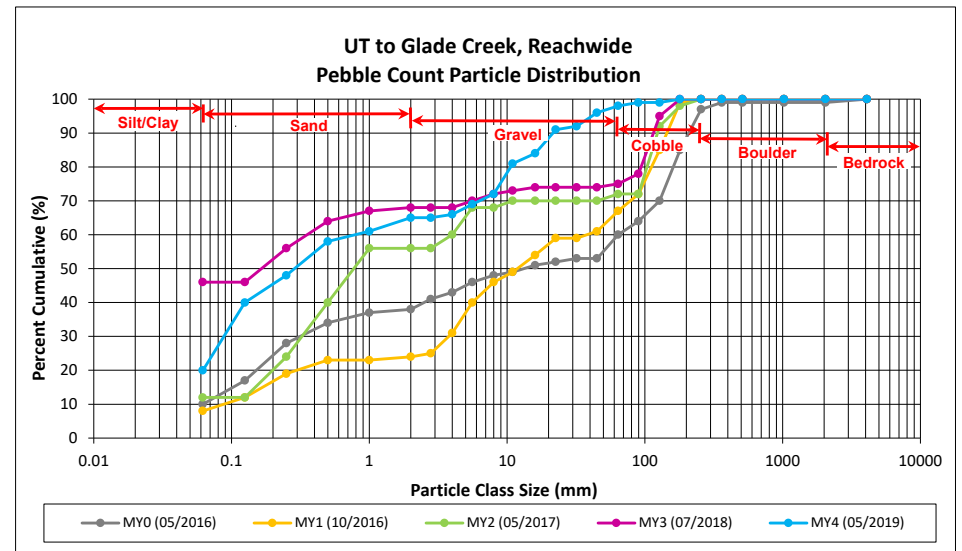
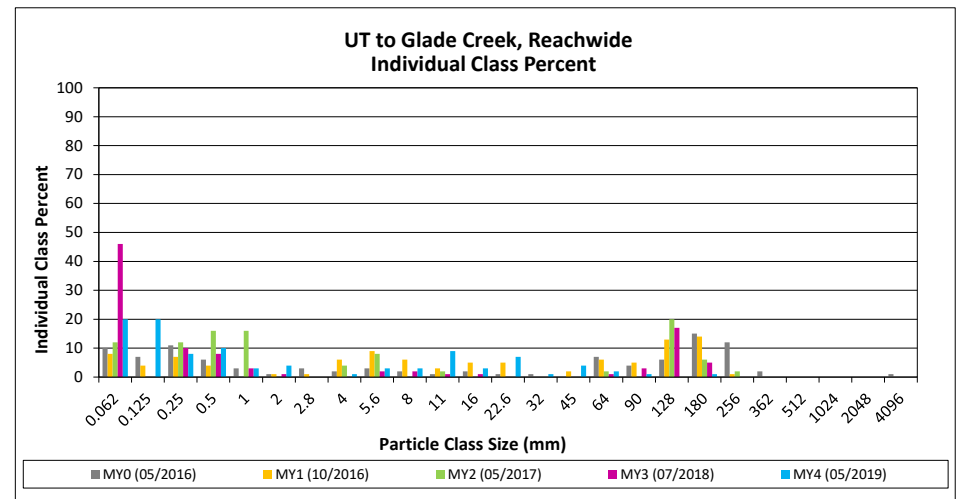
In general, the reachwide pebble counts on Glade Creek show coarser materials in the riffles and fines in the pools. The UT to Glade Creek reachwide channel materials resulted in a  $D_{50}$  of 0.3 mm (sand) during MY4. This fining of sediment materials observed in MY3 has continued in MY4 for UT to Glade Creek. Please refer to Appendix 4 for pebble count plots with annual overlays.

Reachwide Channel materials (mm)	
D <sub>16</sub> =	Silt/Clay
D <sub>35</sub> =	0.1
D <sub>50</sub> =	0.3
D <sub>84</sub> =	16.0
D <sub>95</sub> =	41.3
D <sub>100</sub> =	180.0
