MONITORING YEAR 5 ANNUAL REPORT

GLADE CREEK II RESTORATION PROJECT

Alleghany County, NC
DEQ Contract 6843
DMS Project Number 92343
USACE Action ID 2009-00589

GLADE CREEK II RESTORATION PROJECT
Monitoring Year 5 Annual Report

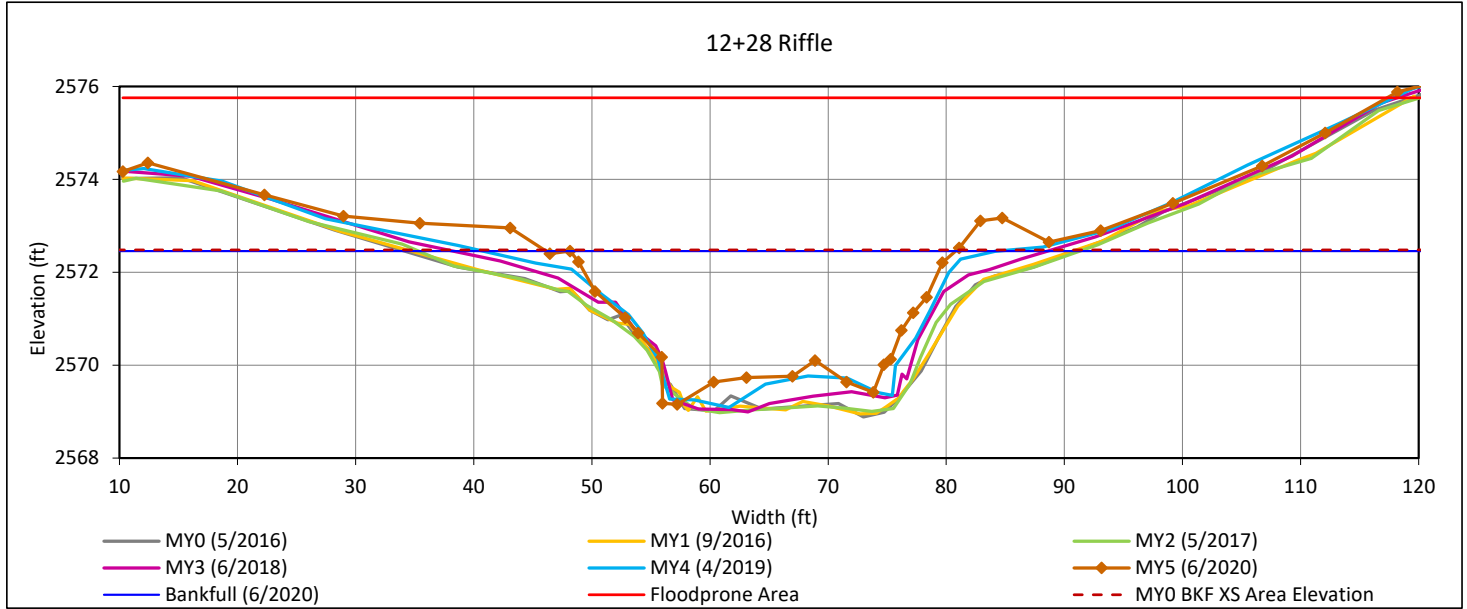
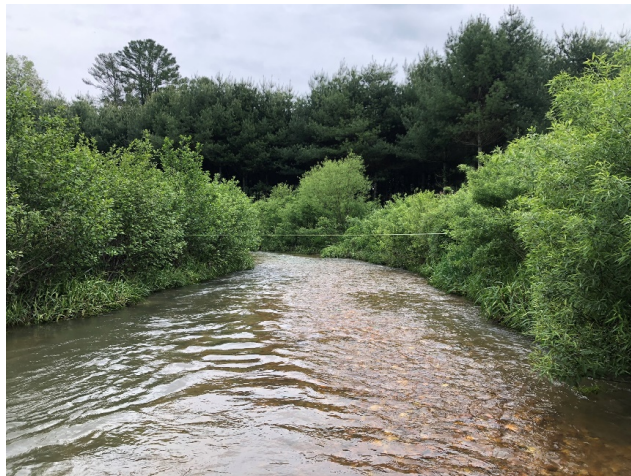
Cross-Section 1 - Glade Creek

69.4	x-section area (ft.sq.)
32.6	width (ft)
2.1	mean depth (ft)
3.3	max depth (ft)
34.8	wetted perimeter (ft)
2.0	hydraulic radius (ft)
15.4	width-depth ratio
107	W flood prone area (ft)
3.3	entrenchment ratio
1.0	low bank height ratio

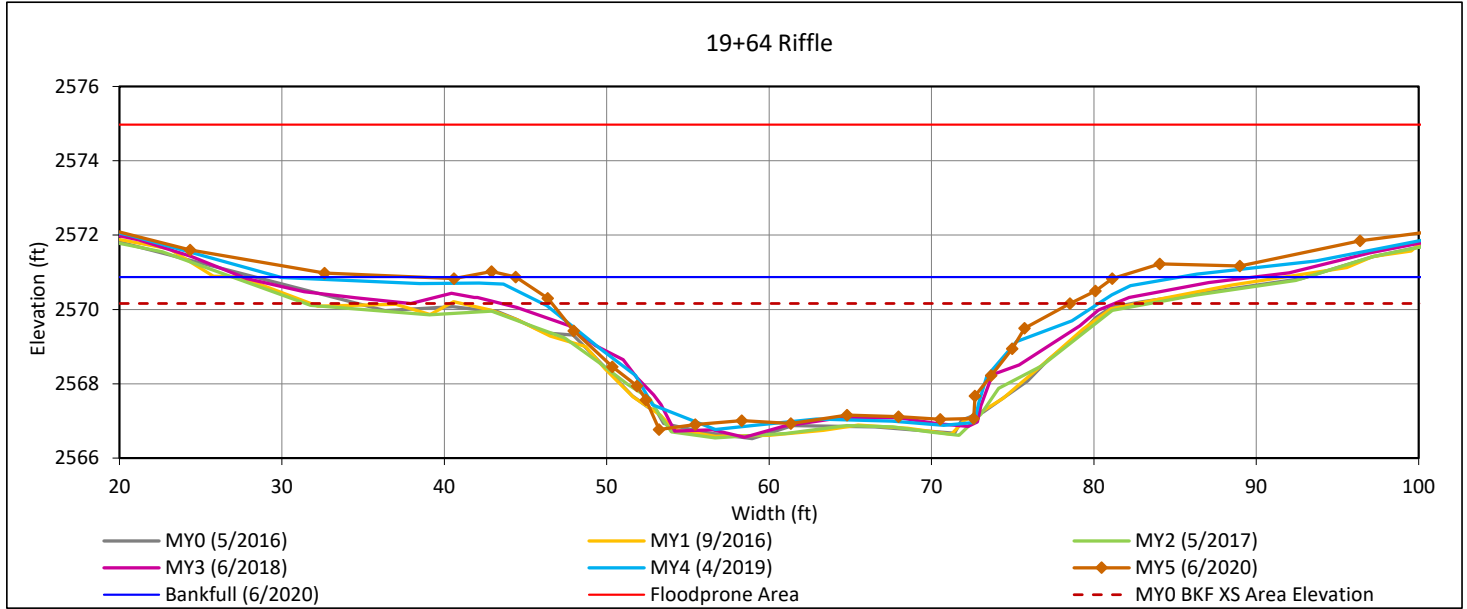
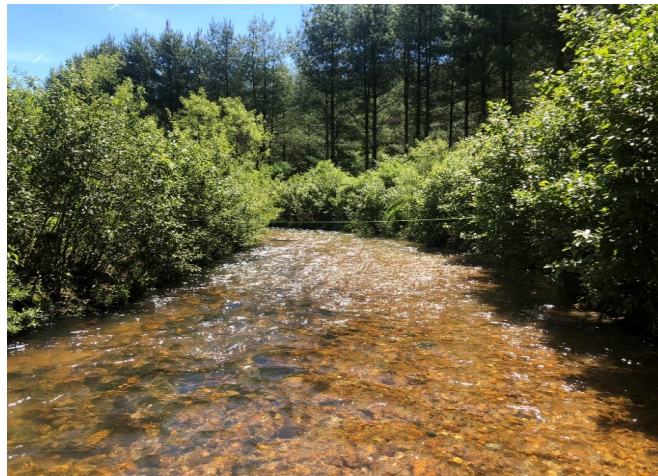
Cross-Section 2 - Glade Creek

101.6	x-section area (ft.sq.)
37.0	width (ft)
2.7	mean depth (ft)
4.1	max depth (ft)
39.3	wetted perimeter (ft)
2.6	hydraulic radius (ft)
13.5	width-depth ratio
95.9	W flood prone area (ft)
2.6	entrenchment ratio
1.2	low bank height ratio

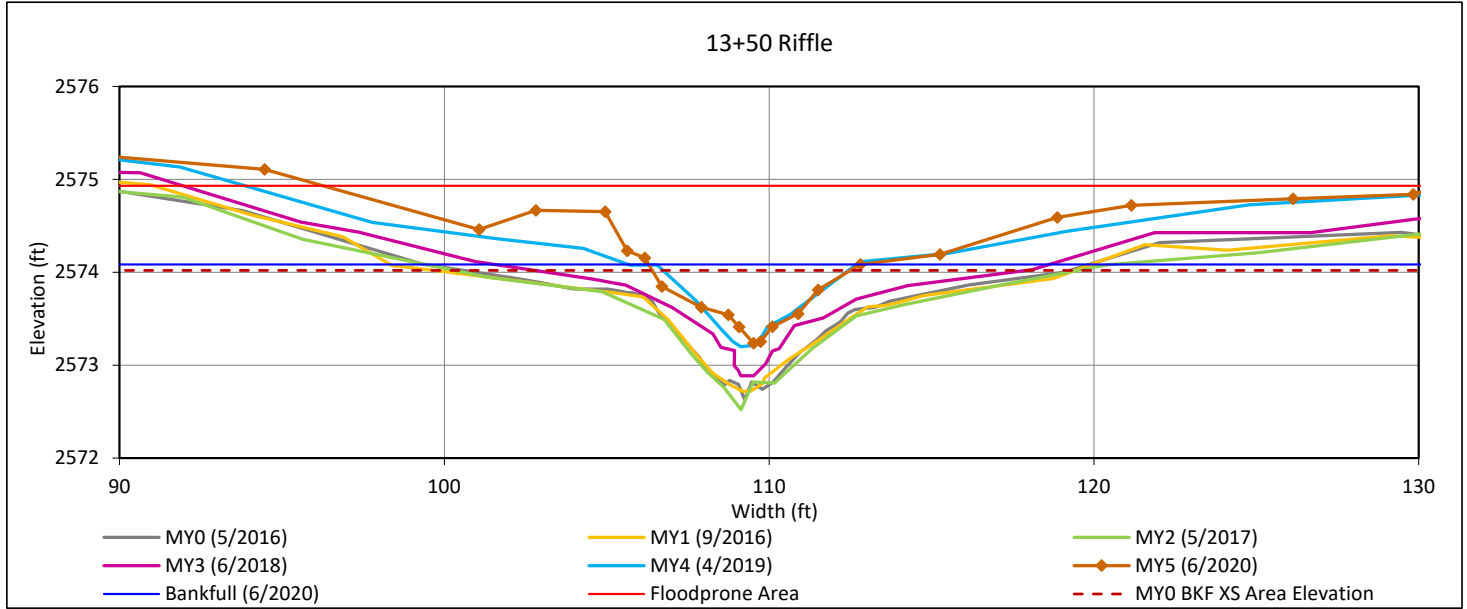
Cross-Section 5 - UT to Glade Creek

2.8	x-section area (ft.sq.)
6.5	width (ft)
0.4	mean depth (ft)
0.8	max depth (ft)
6.8	wetted perimeter (ft)
0.4	hydraulic radius (ft)
15.3	width-depth ratio
34.8	W flood prone area (ft)
5.3	entrenchment ratio
1.1	low bank height ratio

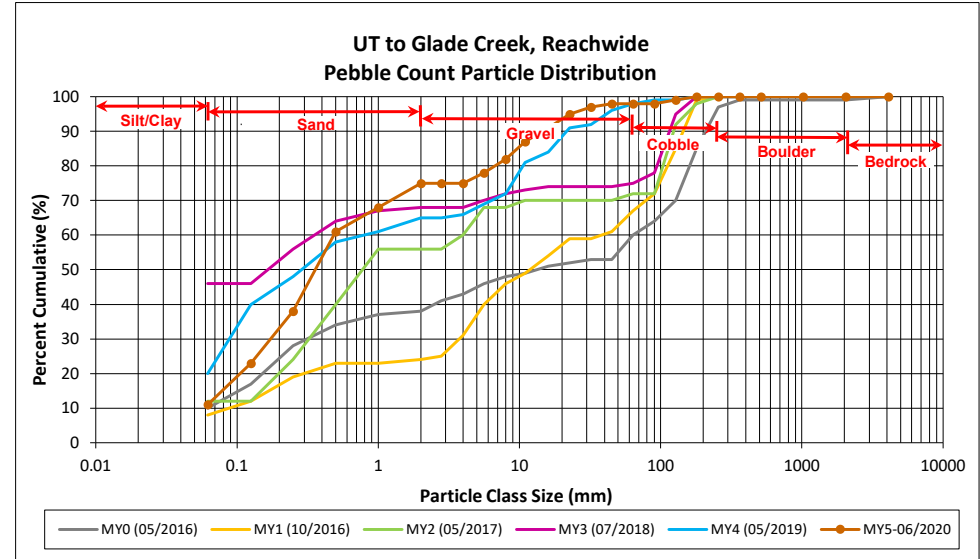
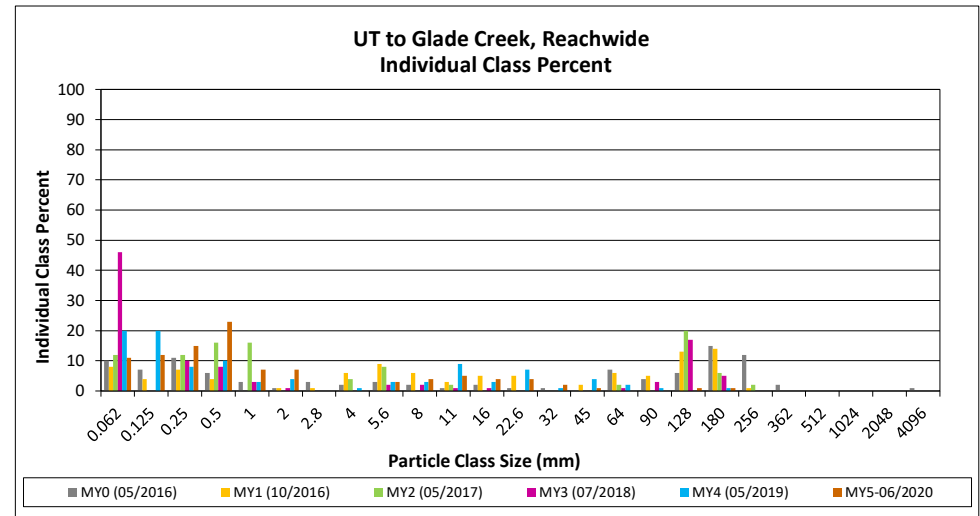
Along Glade Creek, the reachwide pebble counts show coarser materials in the riffles and fines in the pools. The UT to Glade Creek reachwide channel materials resulted in a D_{50} of 0.4 mm (sand) during MY5. This fining of sediment materials observed in MY3 has continued through MY5 for UT to Glade Creek. Please refer to Appendix 4 for pebble count plots with annual overlays.

Reachwide Channel materials (mm)	
D ₁₆ =	0.1
D ₃₅ =	0.2
D ₅₀ =	0.4
D ₈₄ =	9.1
D ₉₅ =	22.6
D ₁₀₀ =	180.0

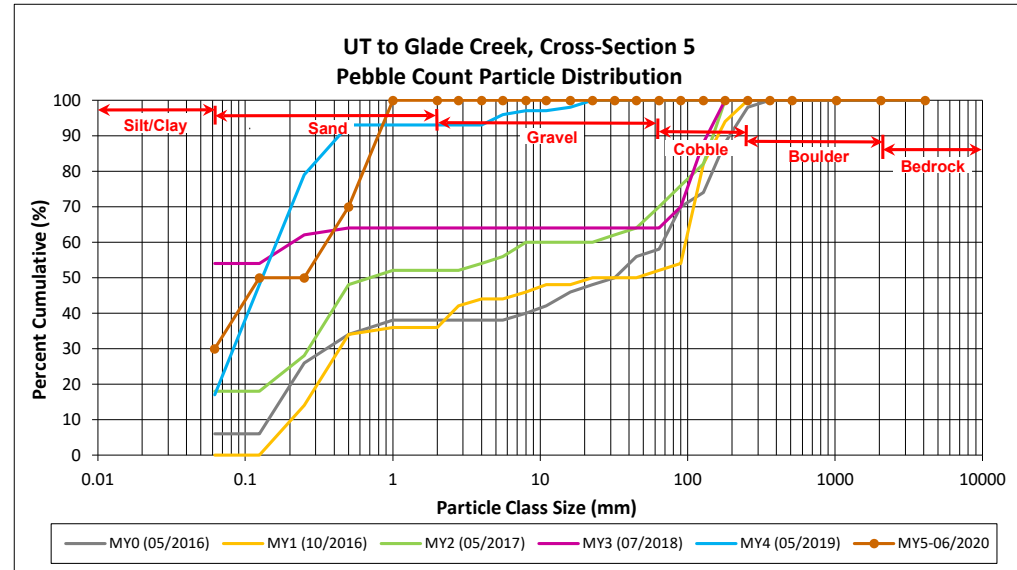
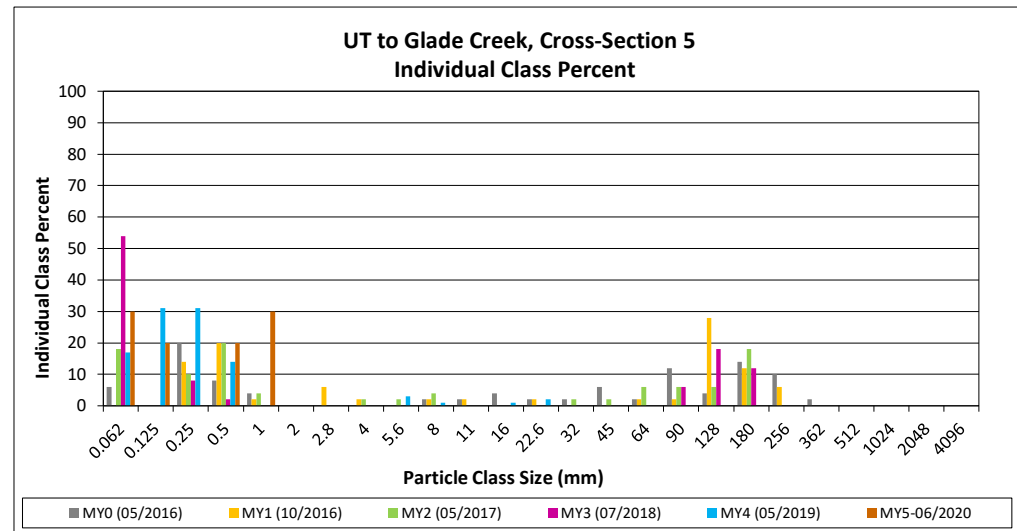
Cross Section 5	
Channel materials (mm)	
D ₁₆ =	Silt/Clay
D ₃₅ =	0.1
D ₅₀ =	0.1
D ₈₄ =	0.7
D ₉₅ =	0.9
D ₁₀₀ =	1.0

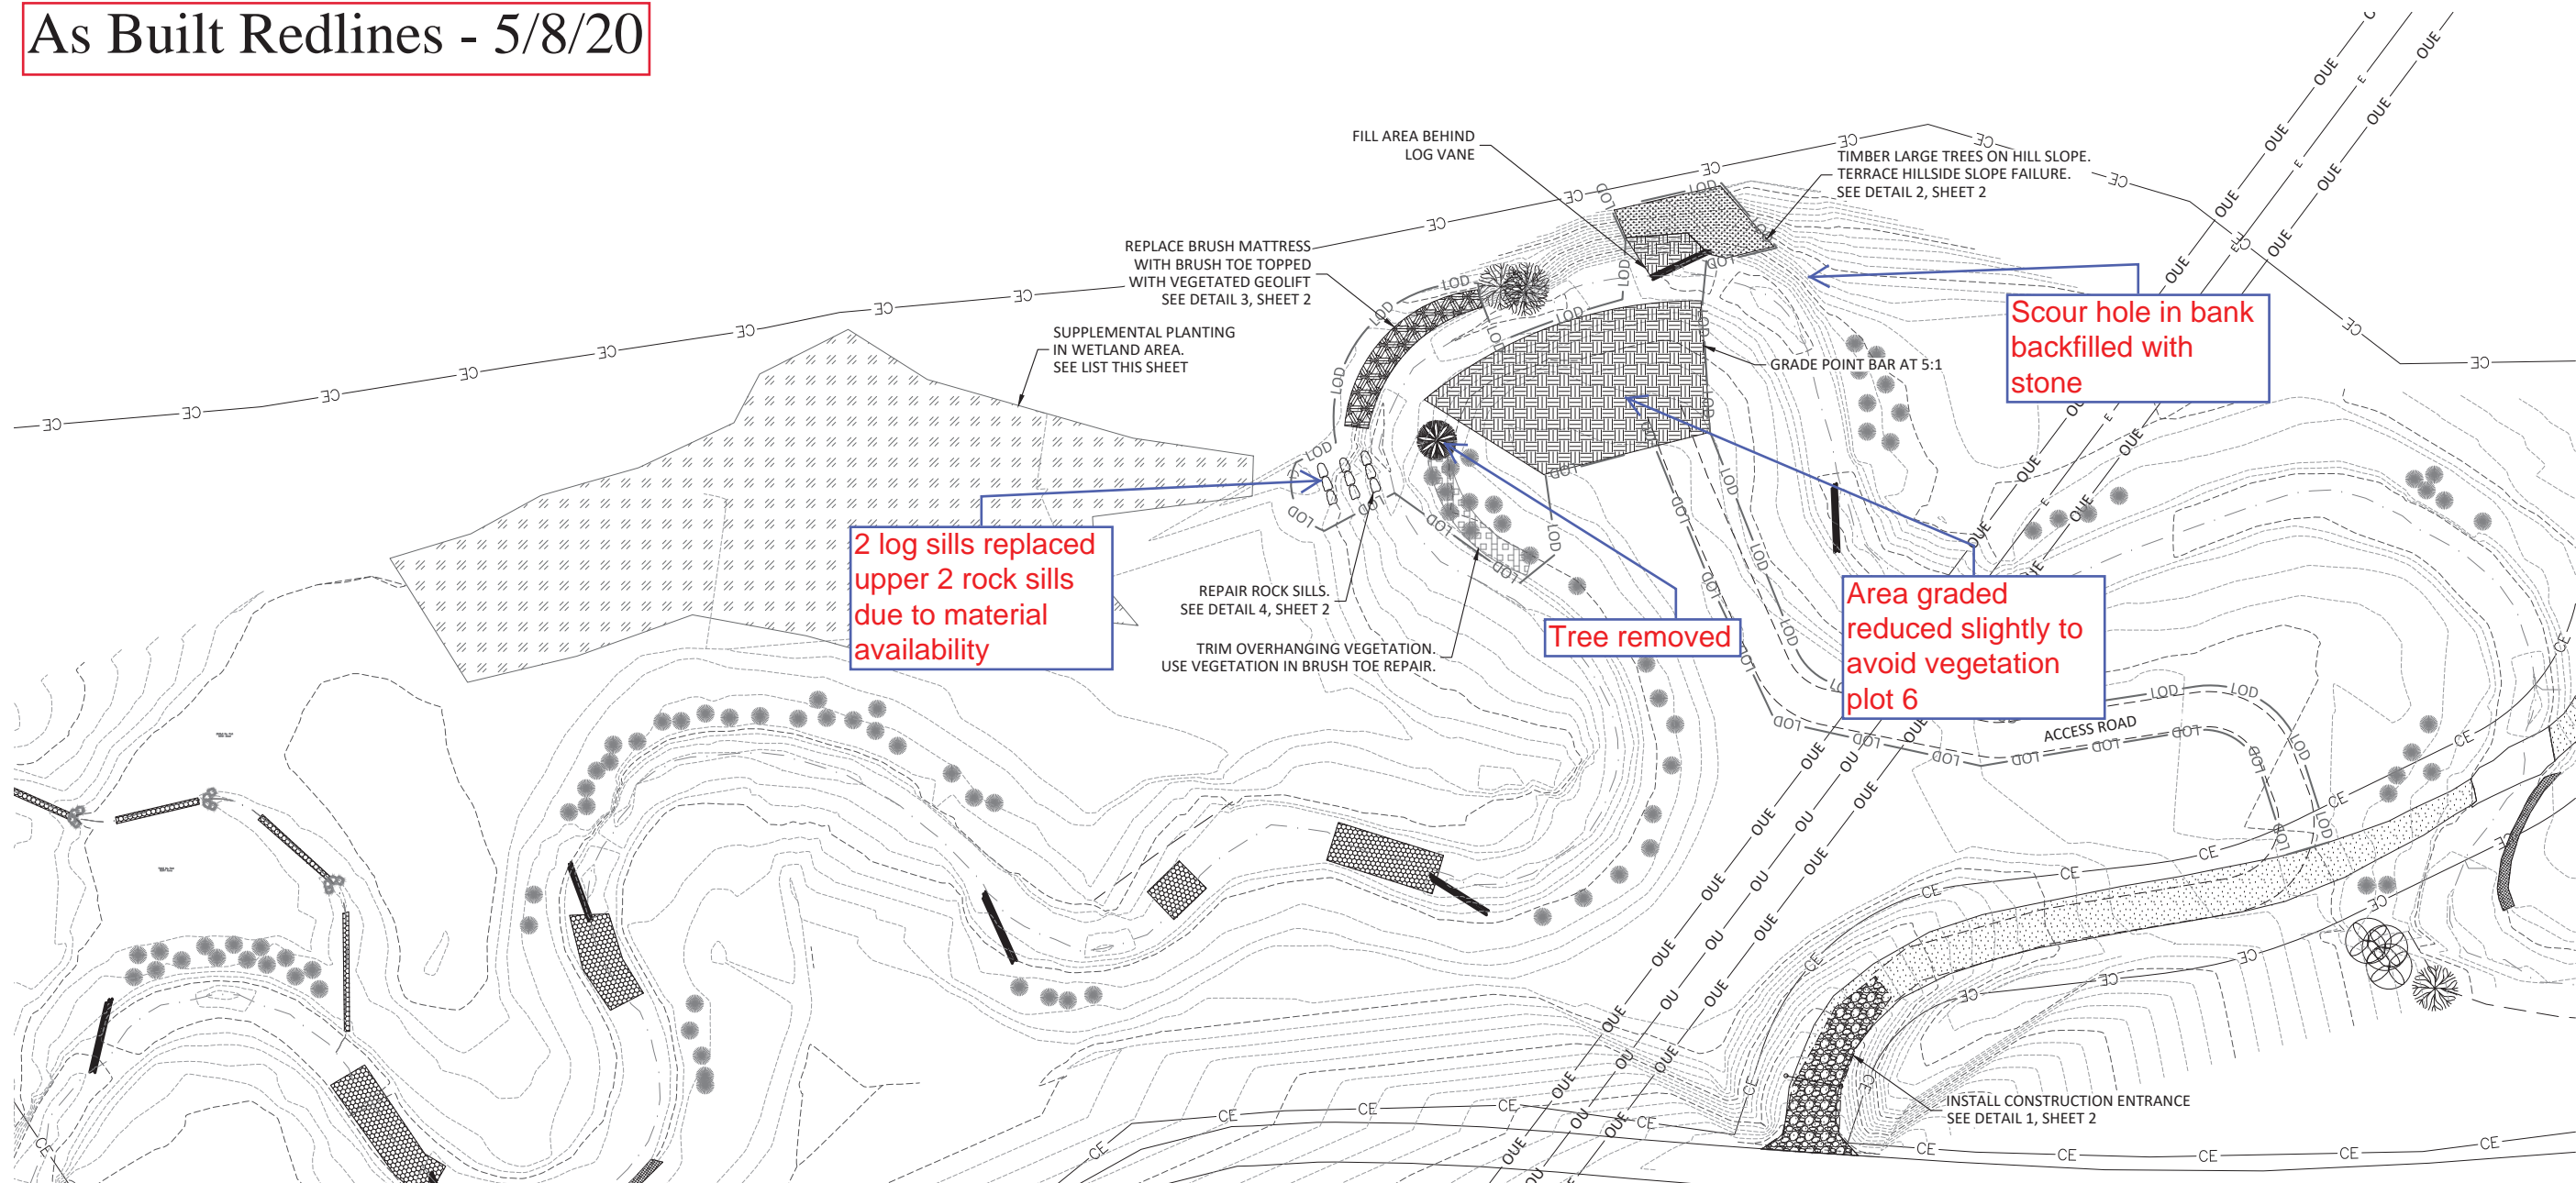
As Built Redlines - 5/8/20

Along Glade Creek, areas of concern previously noted included an undercut brush mattress (station 22+95 to 23+50) and left bank hillslope erosion (station 24+25 to 24+75). DMS contracted with a provider to complete repairs which included brush toe geolift, point bar regrading, and stabilization of the hillslope. The repairs were completed in April 2020 and appear to be stable. Other small areas of scour that were not addressed by the repair remain along Glade Creek. However, woody vegetation has become well established in these areas causing them to be of minor concern to the ecological integrity of the project. The remaining areas of concern are depicted on the CCPV Figure 3 in Appendix 2 and the stream repair as-built plans are included in Appendix 6.

One headcut was previously noted beginning in MY3 at the outflow of Wetland B where it meets Glade Creek Reach 2 (near station 22+75). DMS contracted with a provider to complete repairs in April 2020 which included the installation of log sills for grade control at the wetland outflow. As discussed in section 1.2.2, Wetland B had previously been noted to have poor woody stem growth and therefore supplemental planting occurred in April 2020 with appropriate wetland tree and shrub species. Please refer to the repair as-built plan in Appendix 6.

Wildlands Engineering, Inc. (Wildlands) submitted a repair plan for the above areas to NC DMS on April 7, 2020 and received plan approval on April 14, 2020. Wildlands Construction mobilized to the site on April 15, 2020 and demobilized on April 17, 2020. Wildlands installed live stakes on April 22, 2020 and Bruton Natural Systems, Inc. planted tublings, containers, and bare root species on April 25, 2020.
