**Glen Raven Stream Restoration
Monitoring Report – MY01
Alamance County, NC
Basin 03030002 - Contract # D05011-1**

November 2007

**Project Manager: Joseph J. Pfeiffer, P.W.S.
Email: jpfeiffer@kci.com**

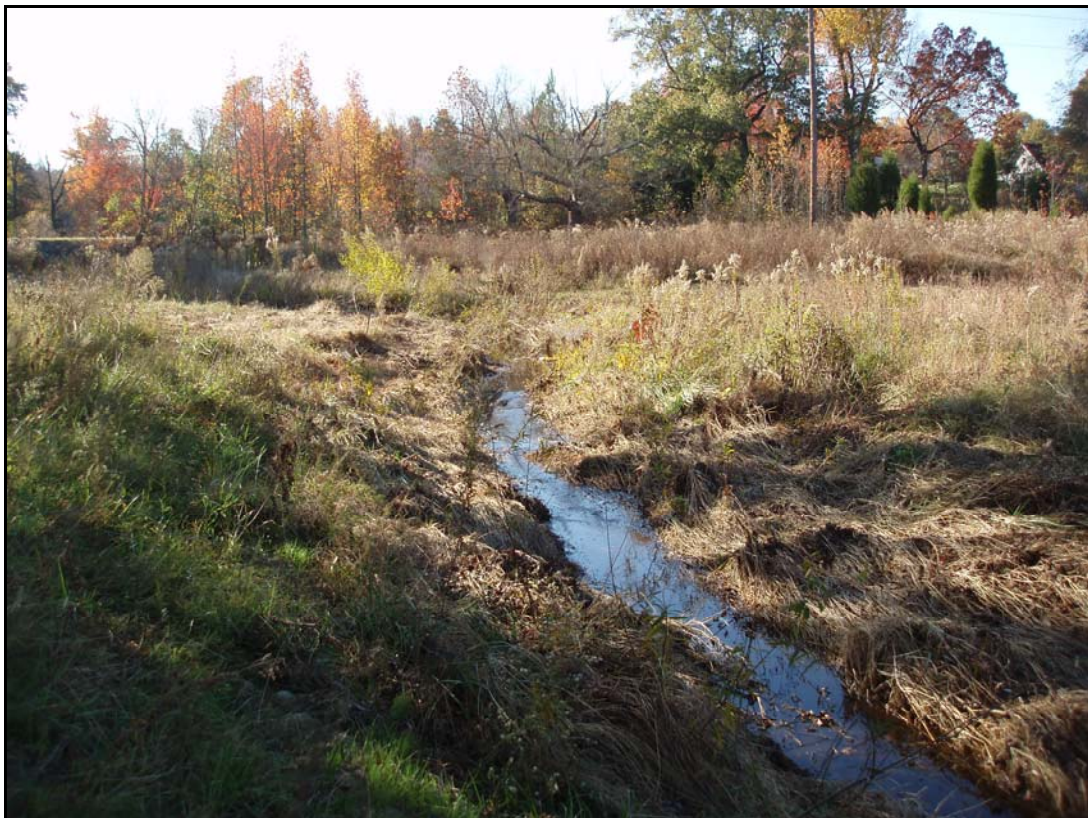
Photo Point 2a: View looking south near Station 13+25. 11/16/07 – MY-01

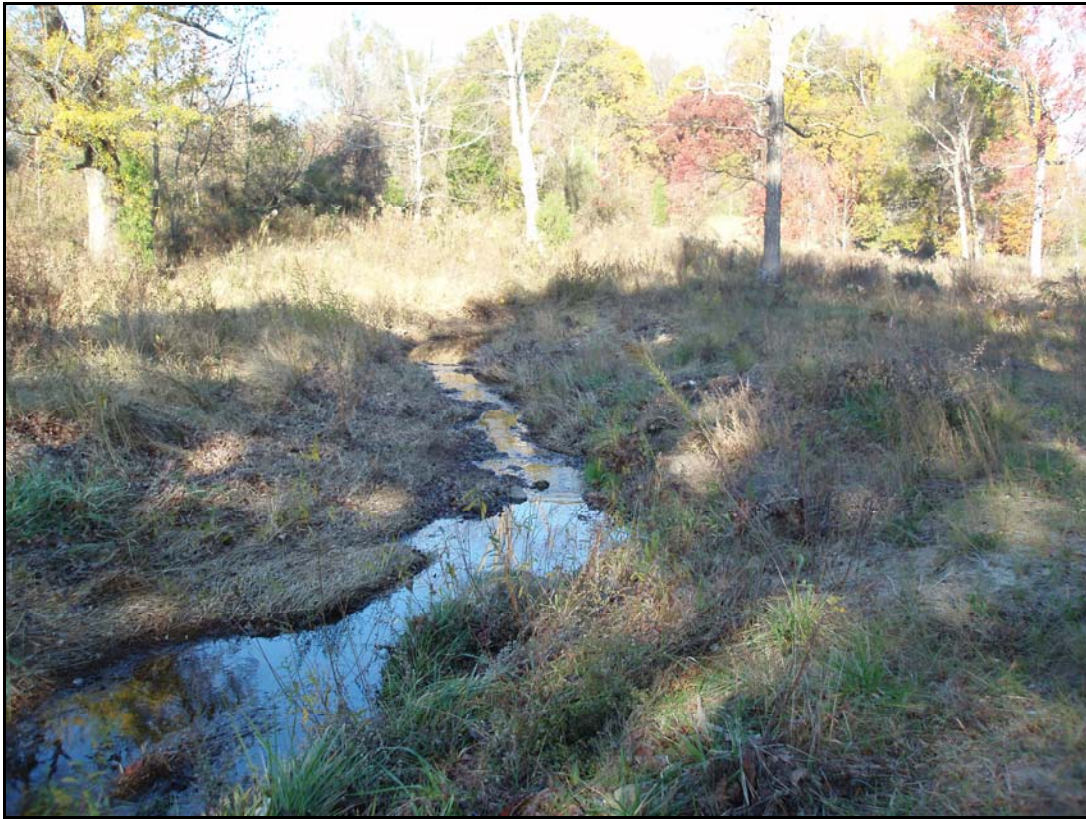
Photo Point 2b: View looking north near Station 13+25. 11/16/07 – MY-01

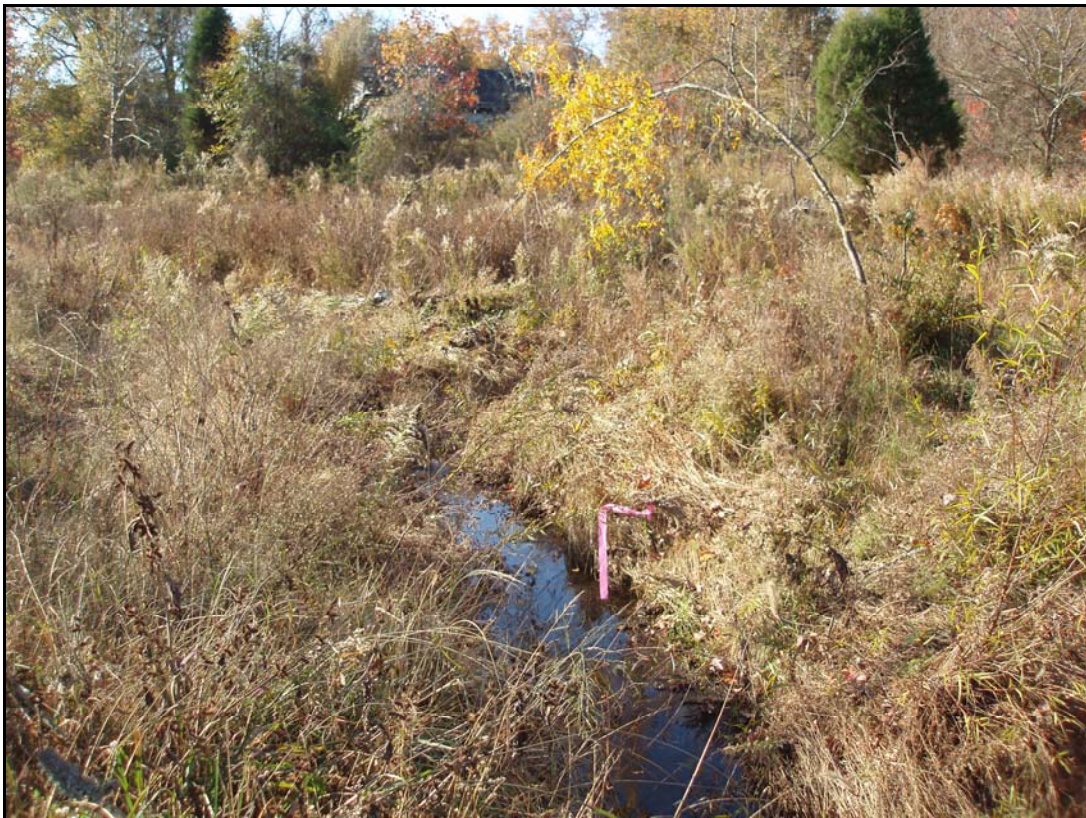
Photo Point 3a: View looking south near Station 16+75. 11/16/07 – MY-01

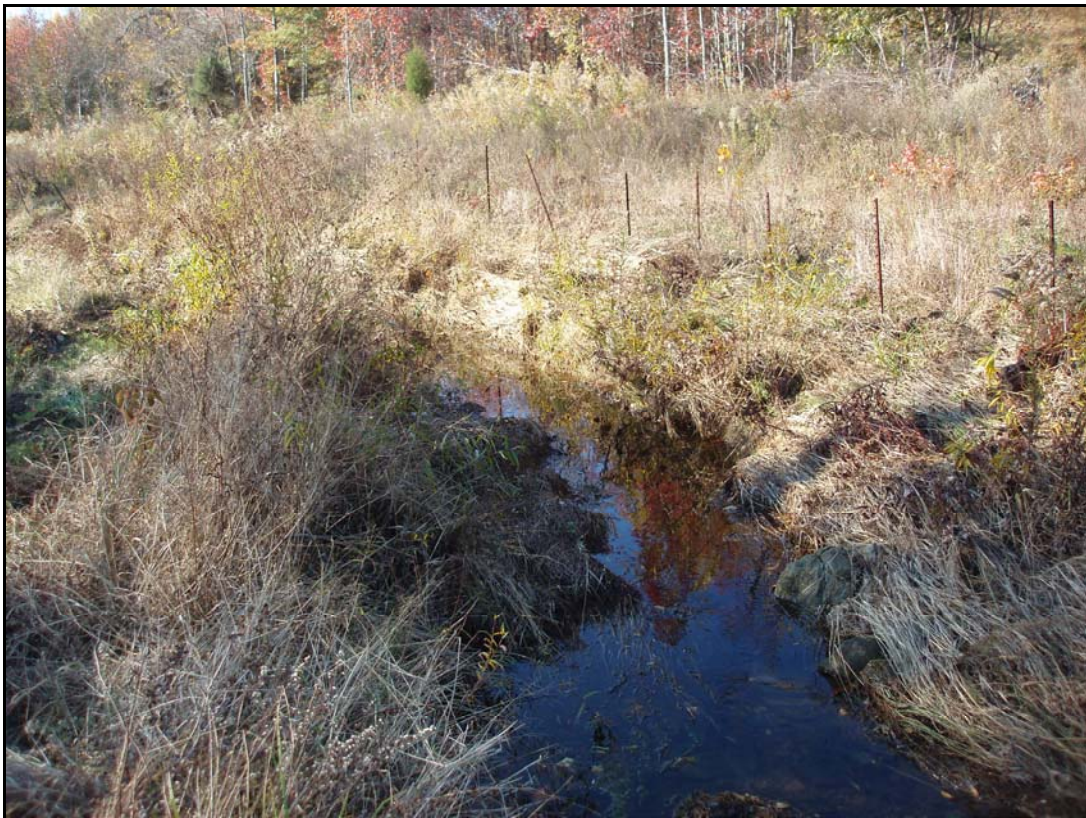
Photo Point 4a: View looking south near Station 22+75. 11/16/07 – MY-01

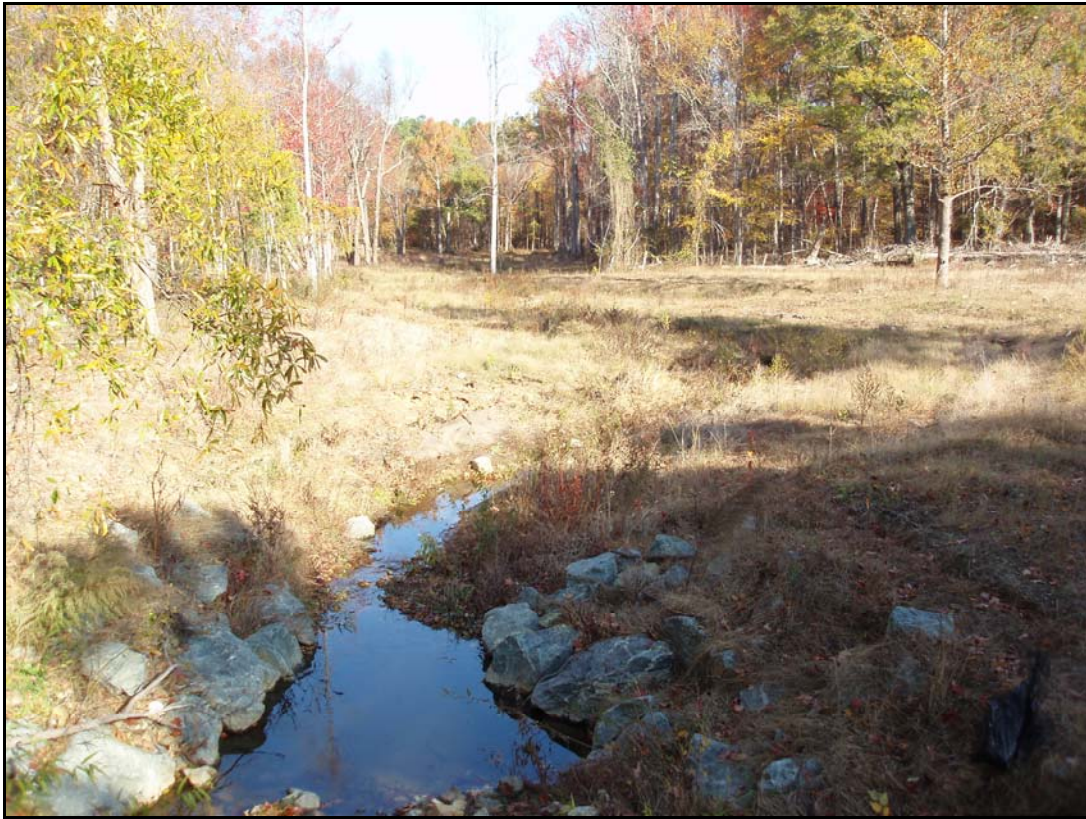
Photo Point 6: View looking north from Gerring Road culvert. 11/16/07 – MY-01

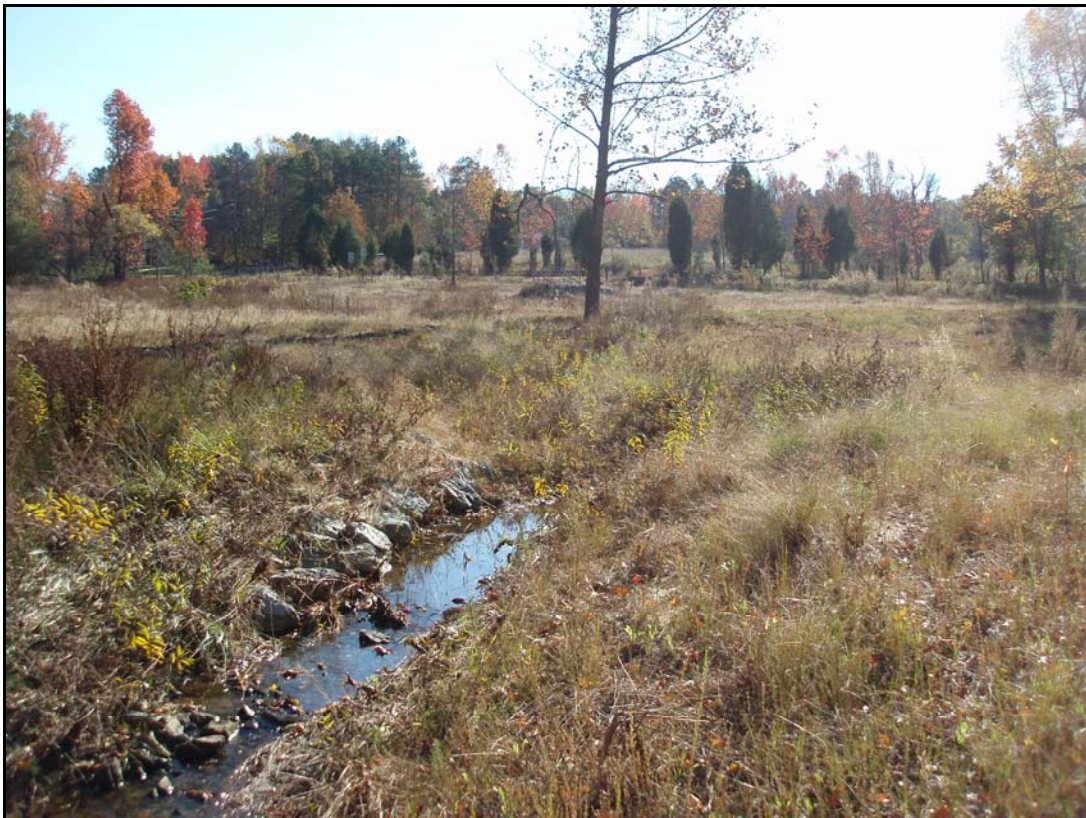
Photo Point 7a: View looking south at confluence of UT2 and UTHR. 11/16/07 – MY-01

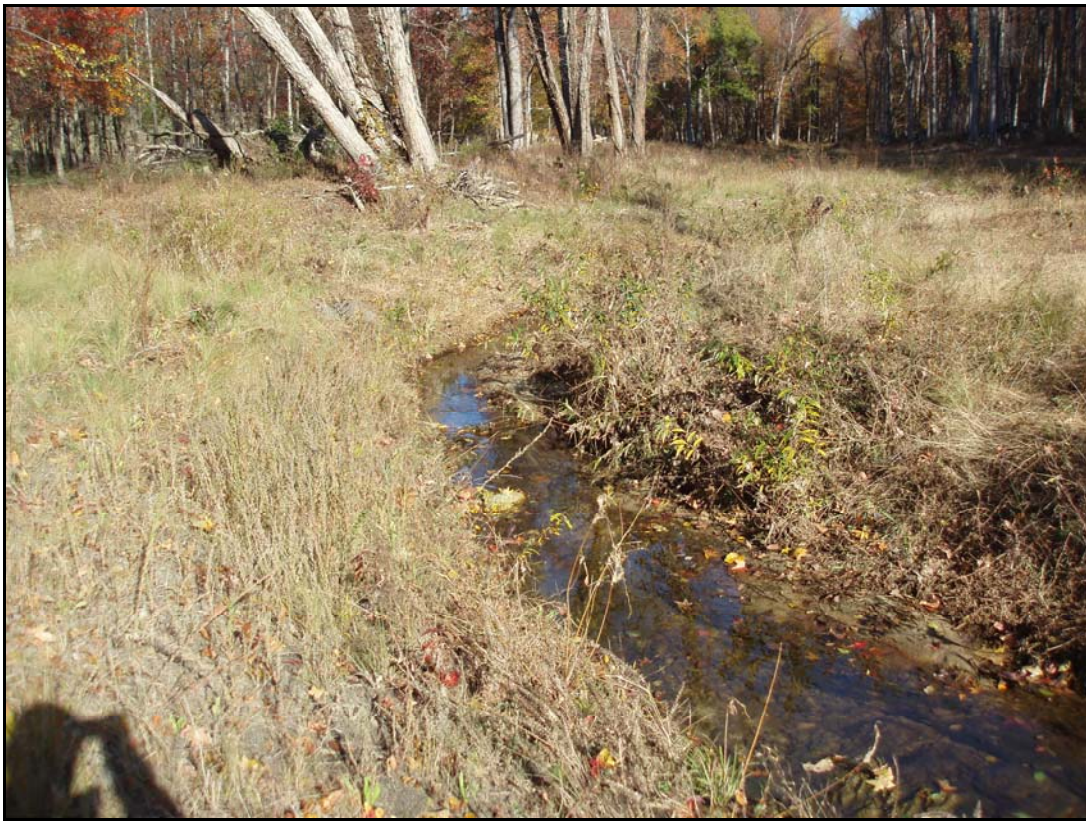
Photo Point 7b: View looking north near Station 31+15. 11/16/07 – MY-01

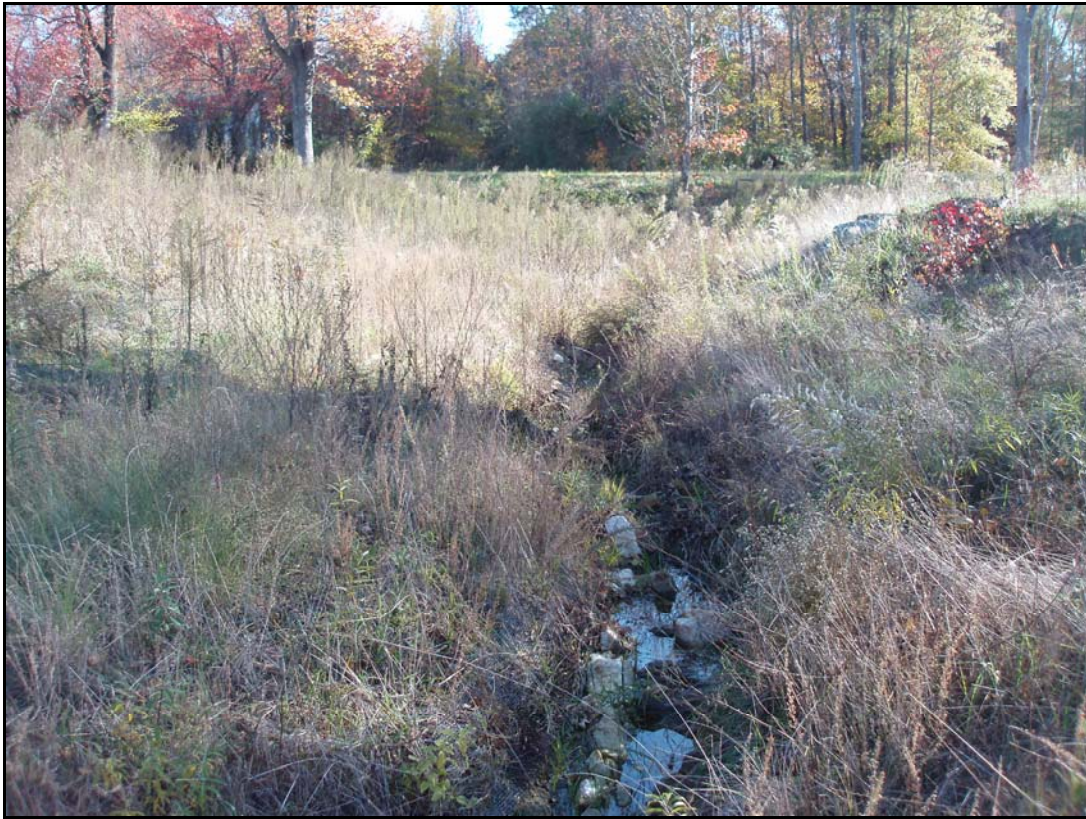
Photo Point 10a: View looking upstream on UT1 near Station 41+25. 11/16/07 – MY-01

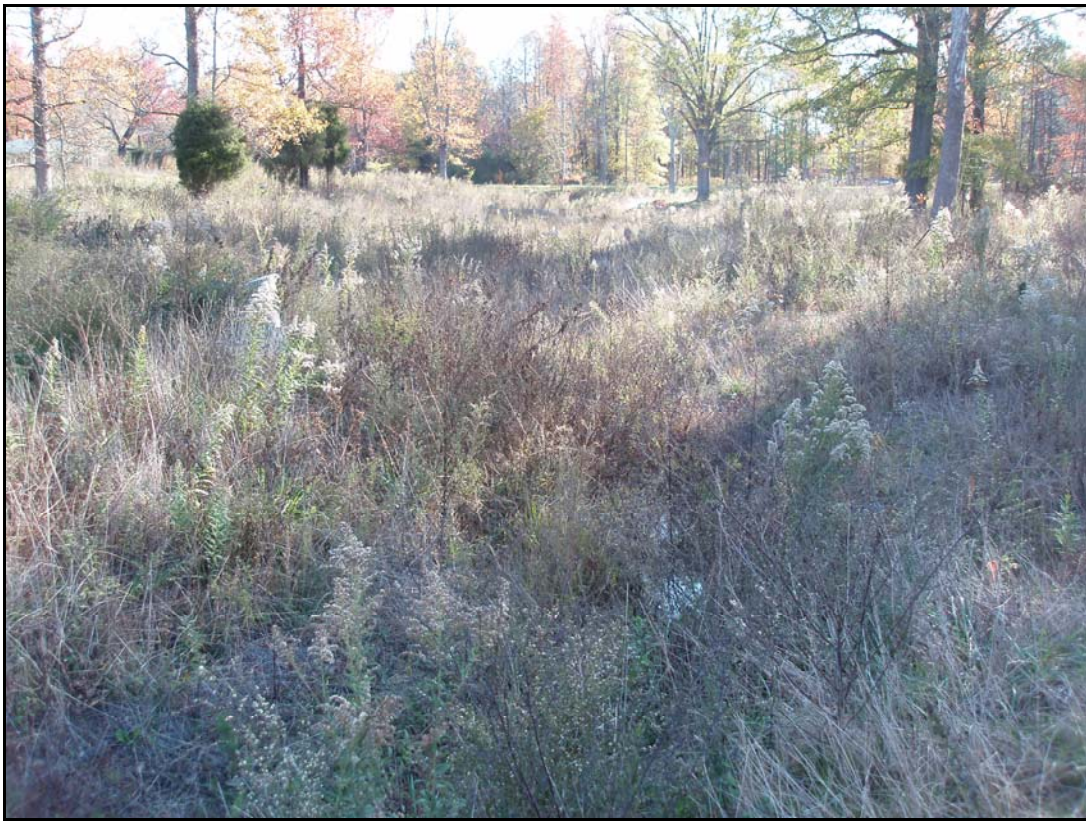
Photo Point 11a: View looking east on UT1 with vegetation plot #4 on right. 11/16/07 – MY-01

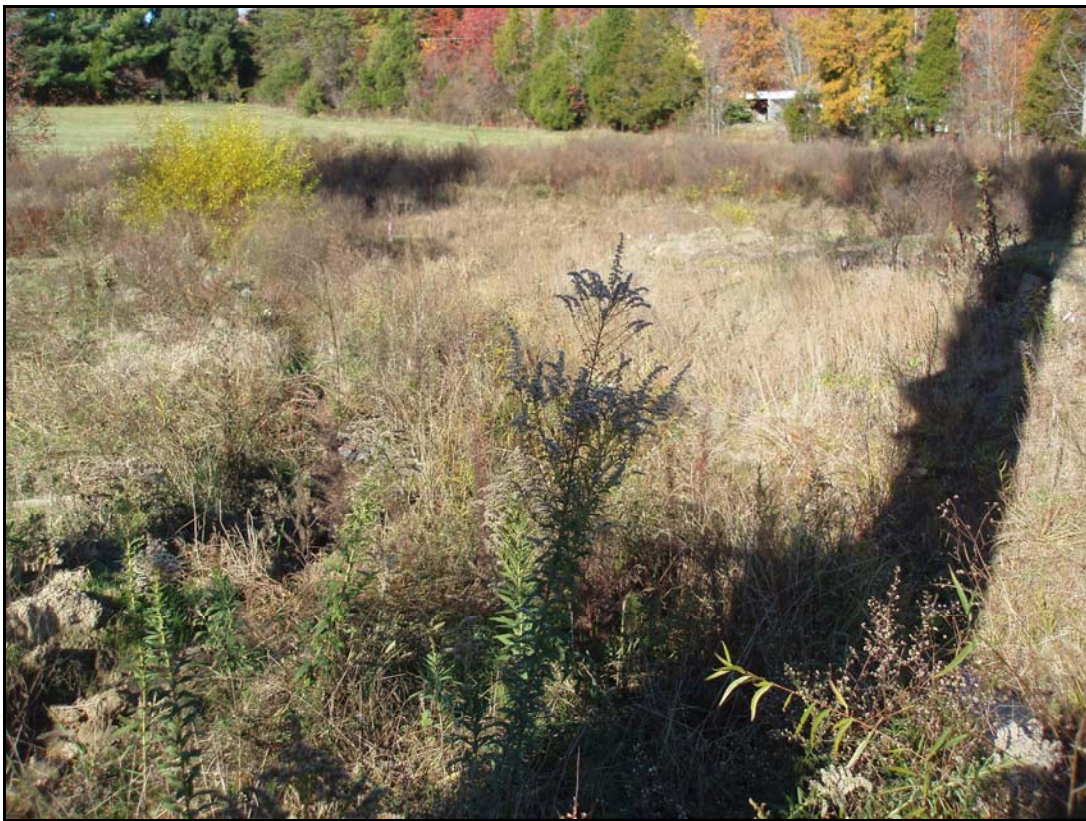
Photo Point 11b: View looking downstream on UT1 before it enters UTHR. 11/16/07 – MY-01

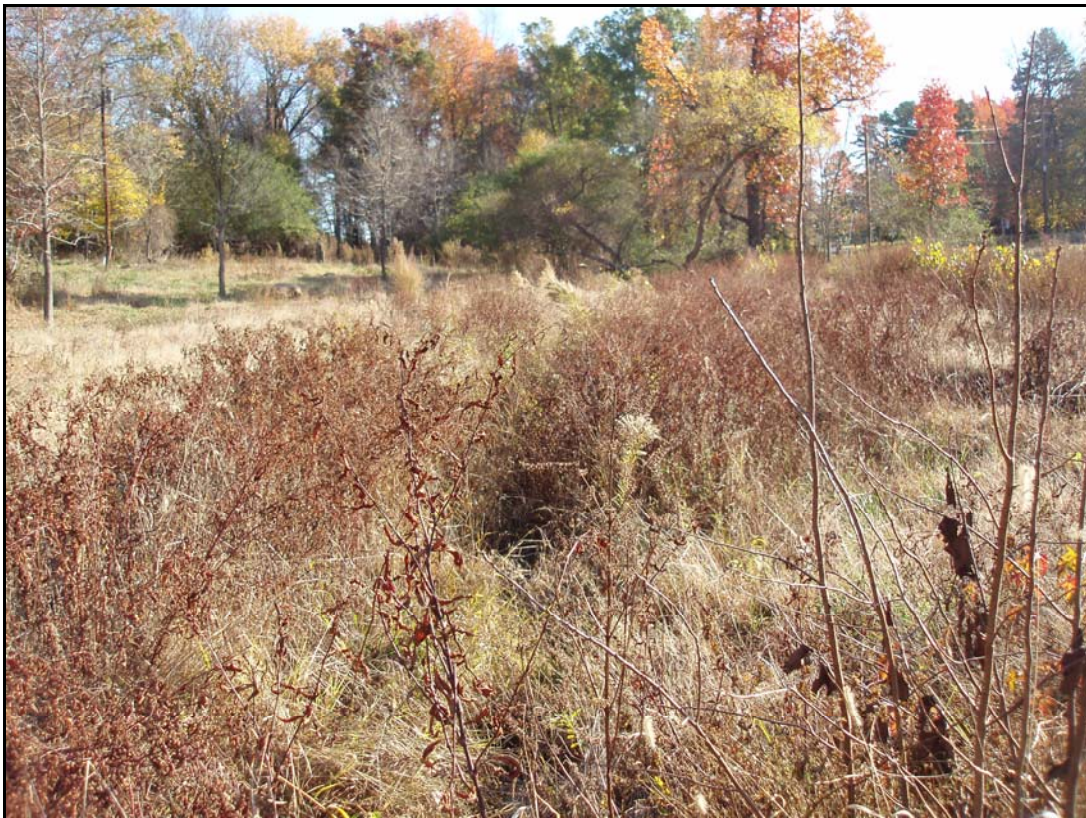
Photo Point 12b: View looking downstream on UT2 before it enters UTHR. 11/16/07 – MY-01
