**Glen Raven Stream Restoration
Monitoring Report – MY02
Alamance County, NC
Basin 03030002 - Contract # D05011-1**

October 2008

**MONITORING
PLAN VIEW**

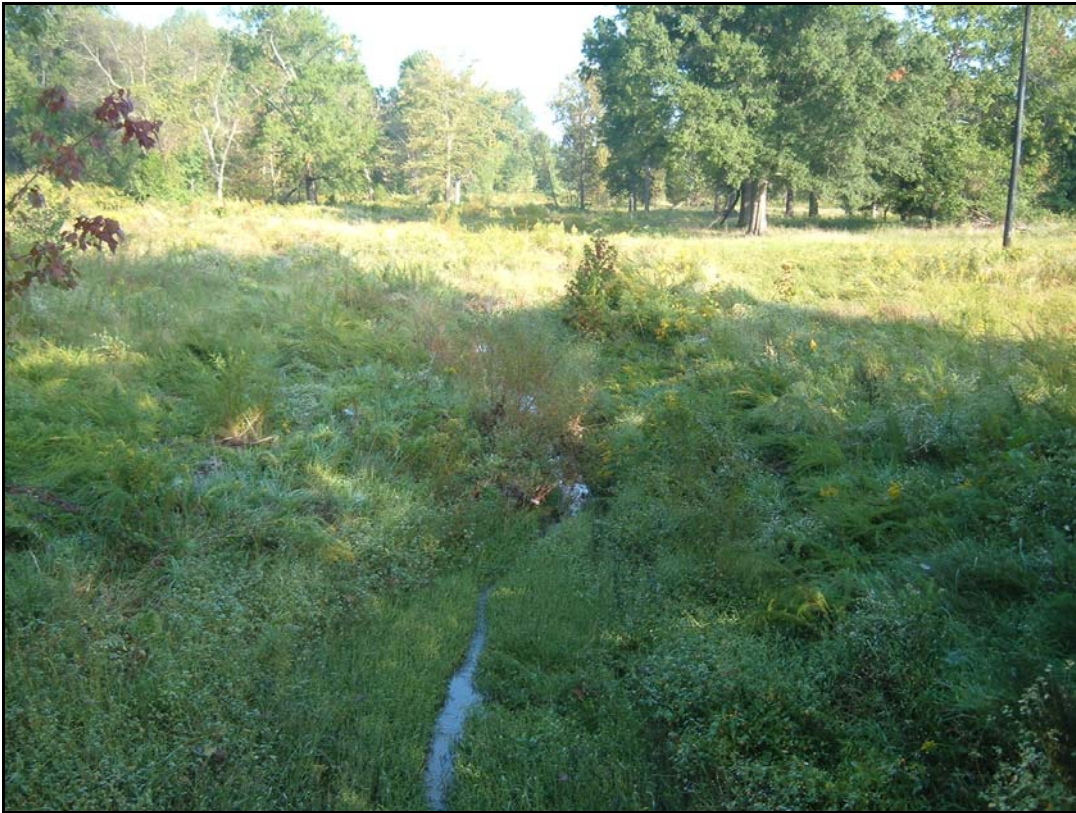
Photo Point 1: View looking north from Power Line Road. 9/29/08 – MY-02

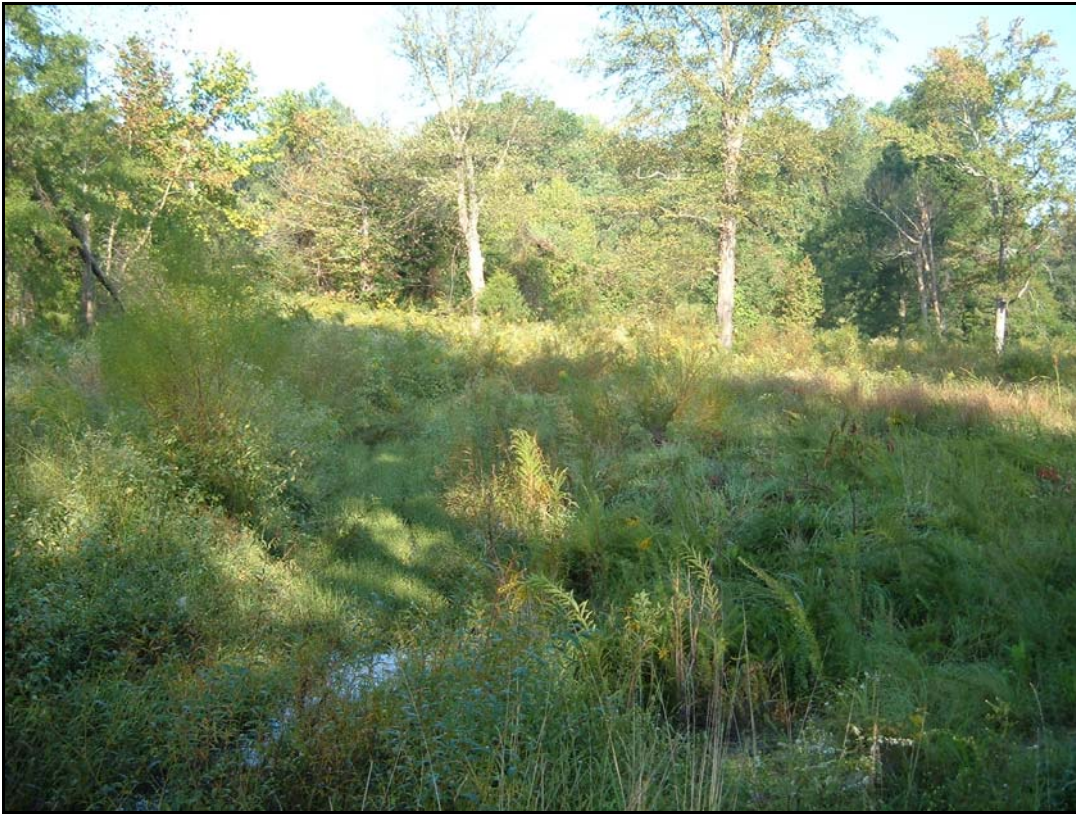
Photo Point 2b: View looking north near Station 13+25. 9/29/08 – MY-02
