**Glen Raven Stream Restoration
Monitoring Report – MY03
Alamance County, NC
Basin 03030002 - Contract # D05011-1**

December 2009

EXECUTIVE SUMMARY

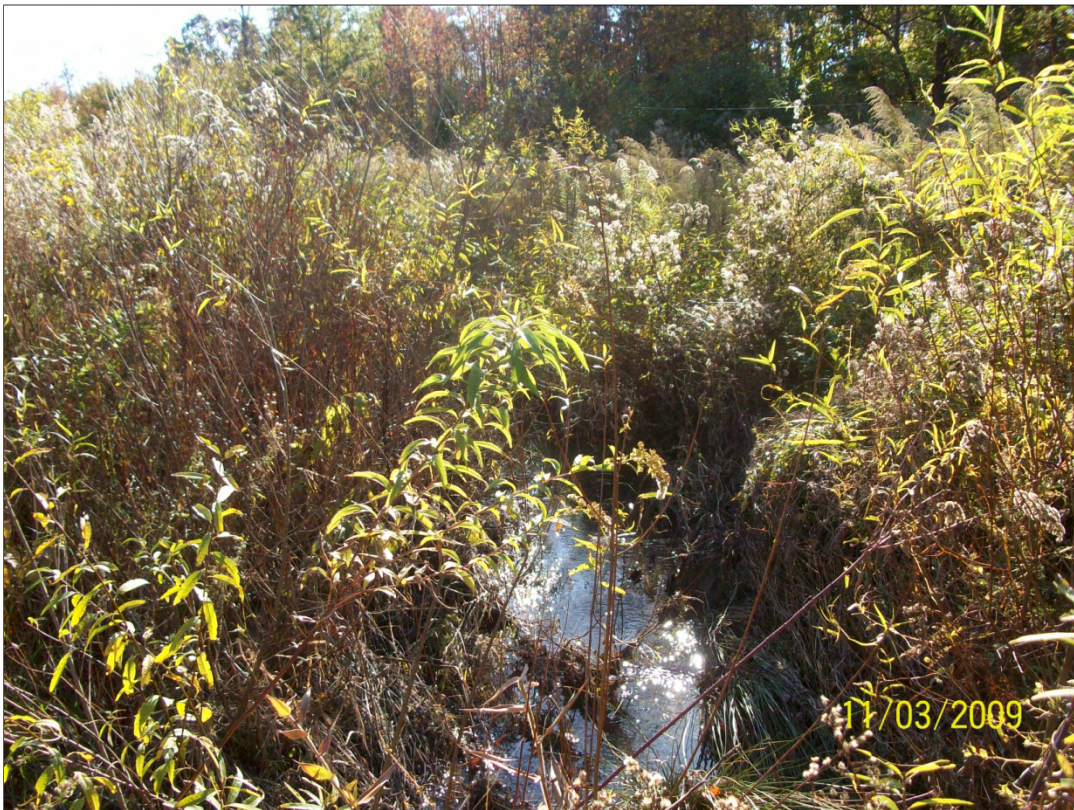
Photo Point 4a: View looking south near Station 22+75. 11/3/09 – MY-03

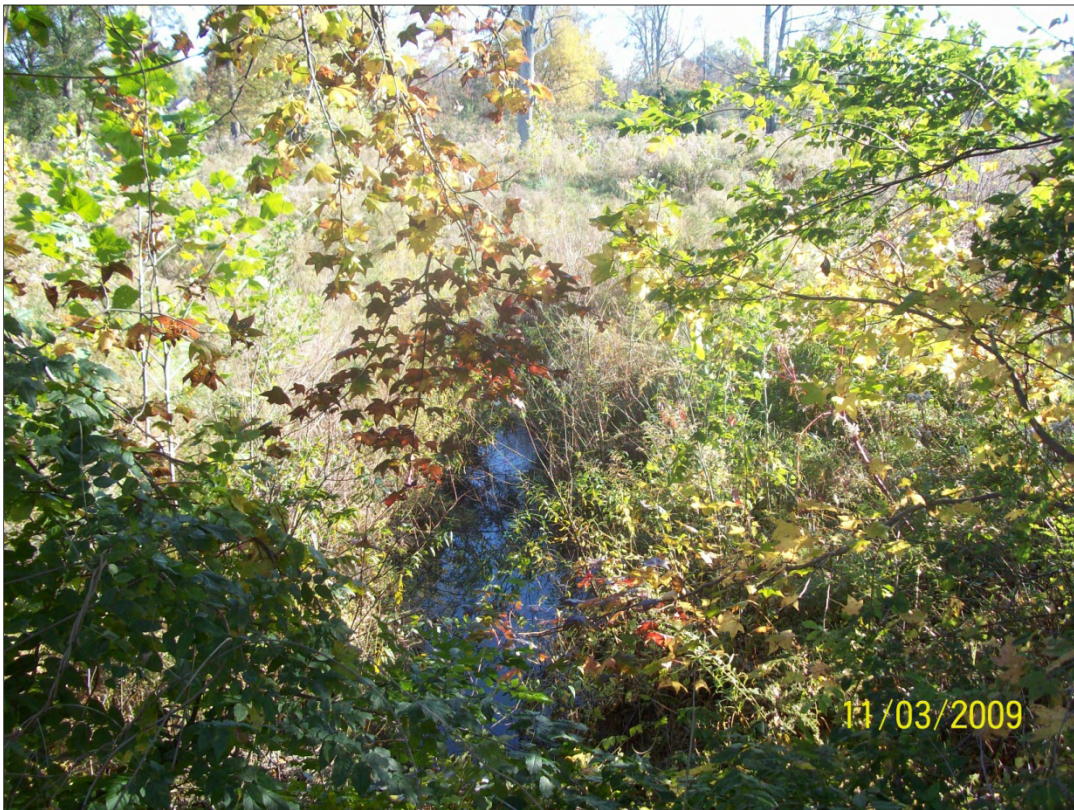
Photo Point 5: View looking south from Gerring Road culvert. 11/3/09 – MY-03

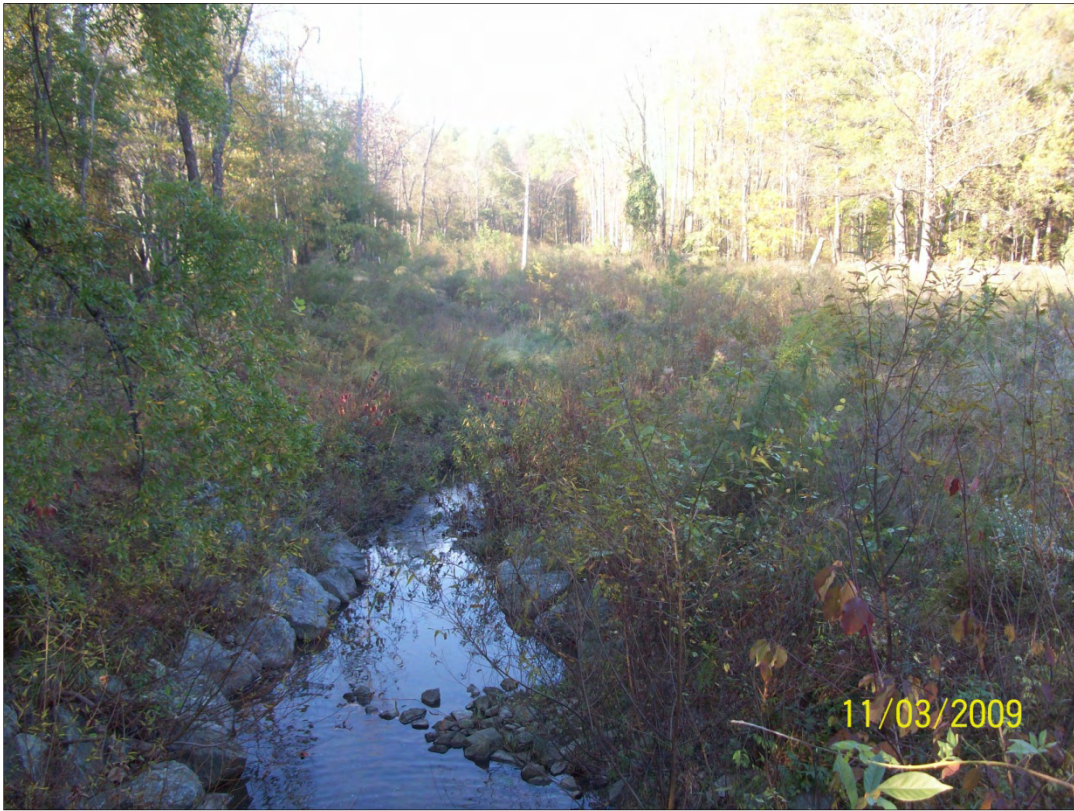
Photo Point 6: View looking north from Gerringer Road culvert. 11/3/09 – MY-03

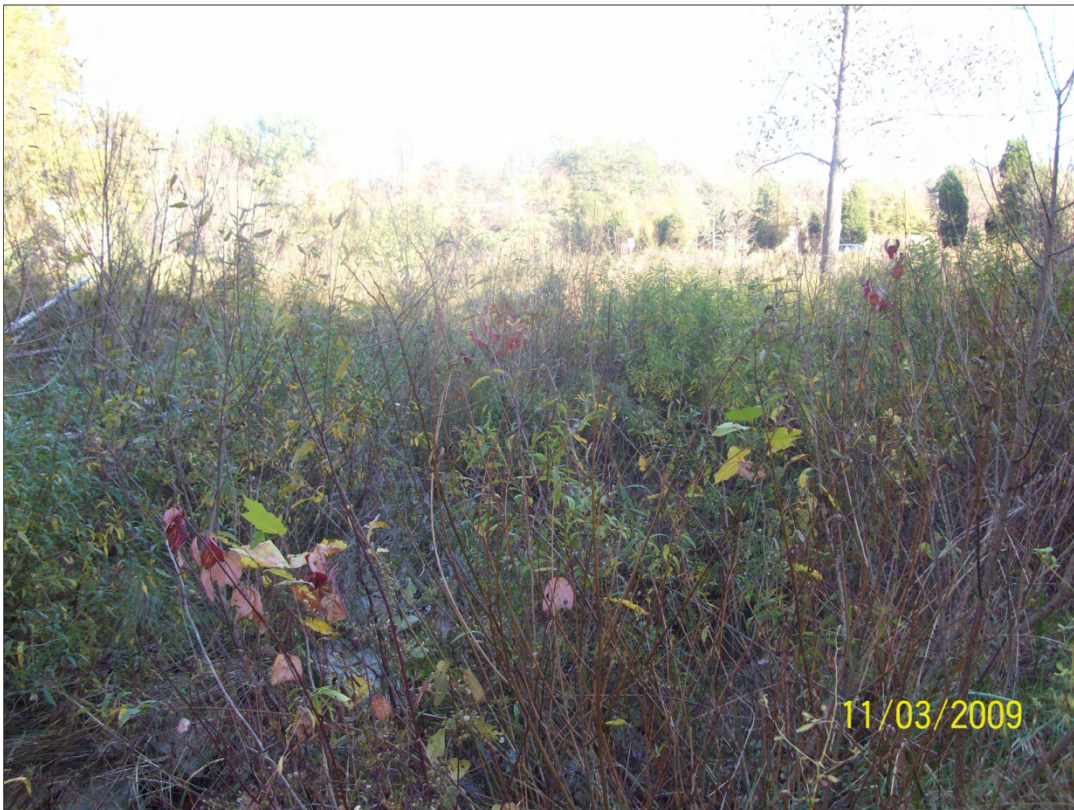
Photo Point 7a: View looking south at confluence of UT2 and UTHR. 11/3/09 – MY-03

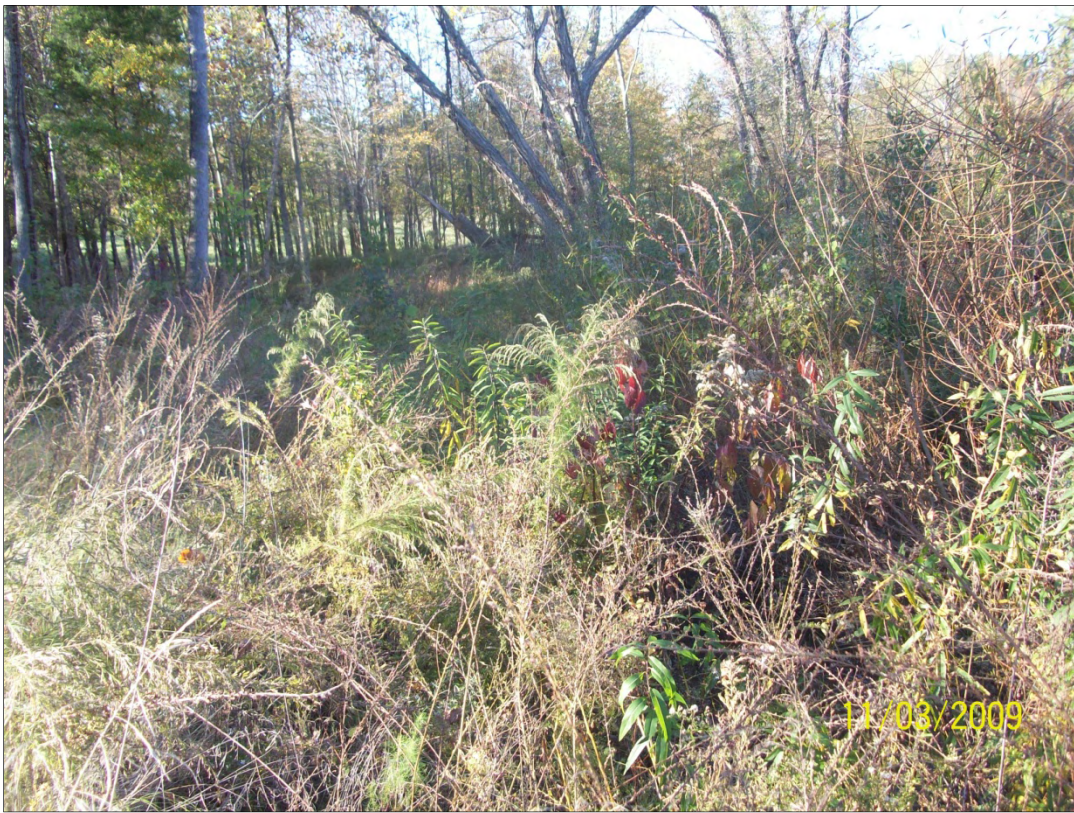
Photo Point 7b: View looking north near Station 31+15. 11/3/09 – MY-03

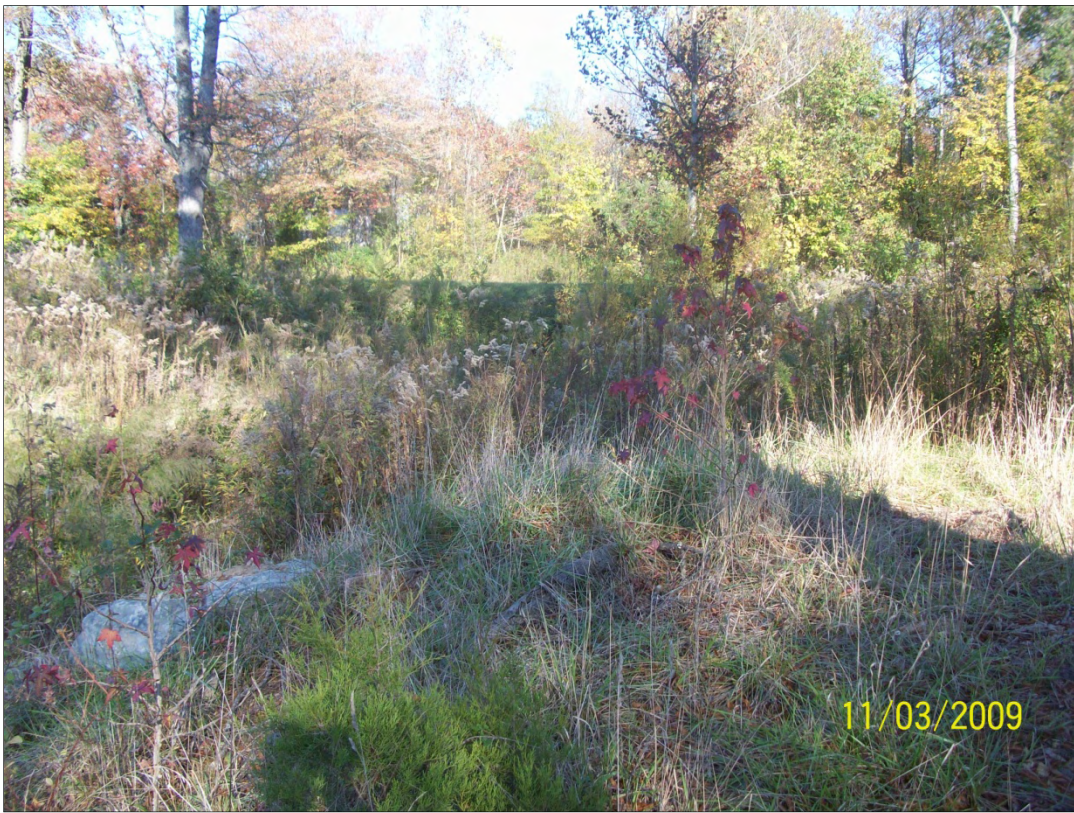
Photo Point 10a: View looking upstream on UT1 near Station 41+25. 11/3/09 – MY-03

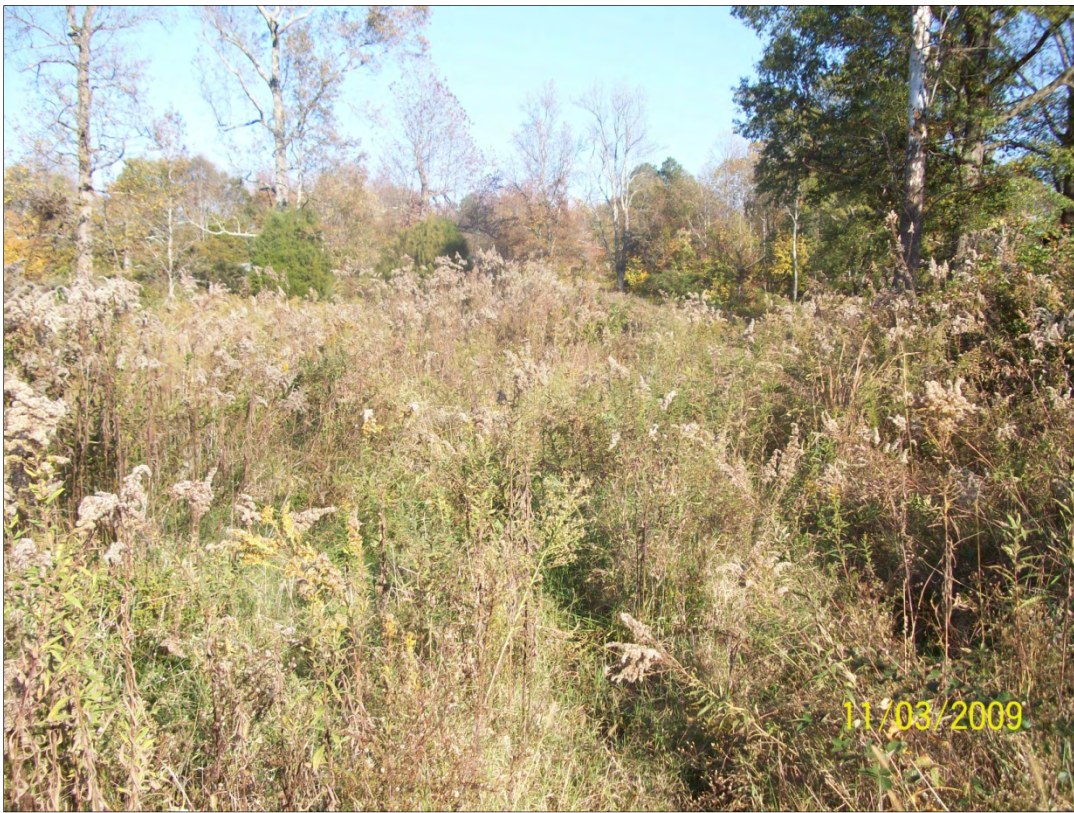
Photo Point 11a: View looking east on UT1 with Vegetation Plot #4 on right. 11/3/09 – MY-03

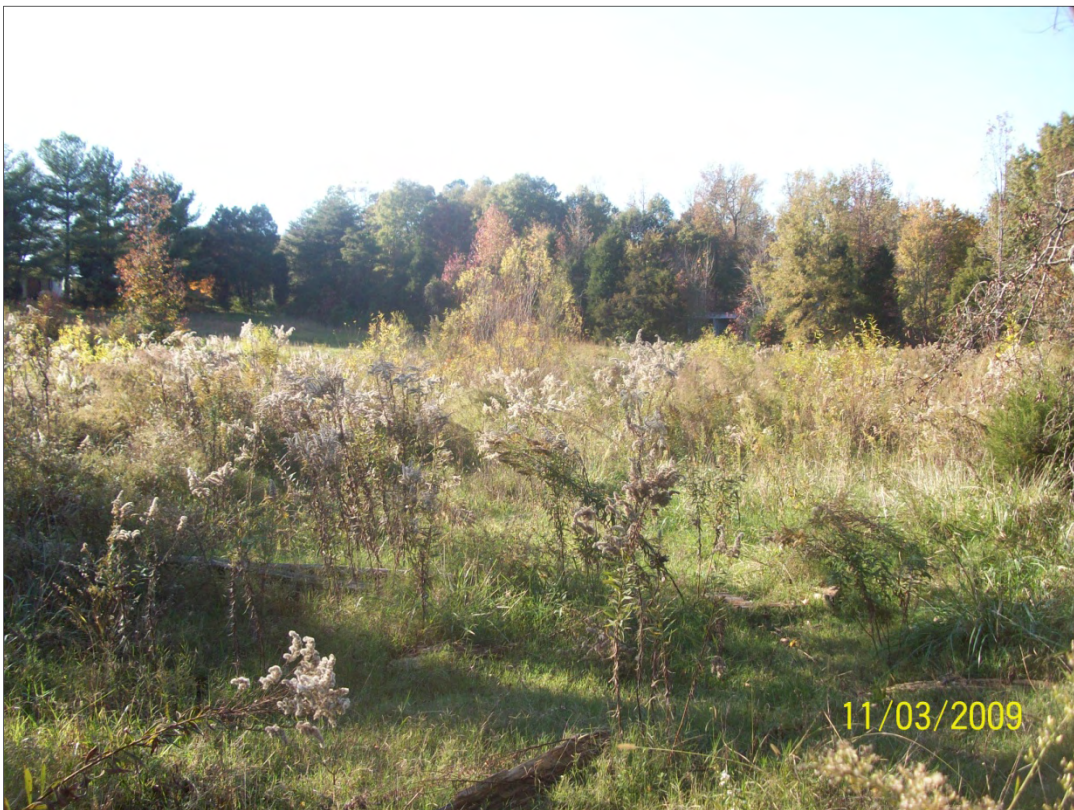
Photo Point 11b: View looking downstream on UT1 before it enters UTHR. 11/3/09 – MY-03

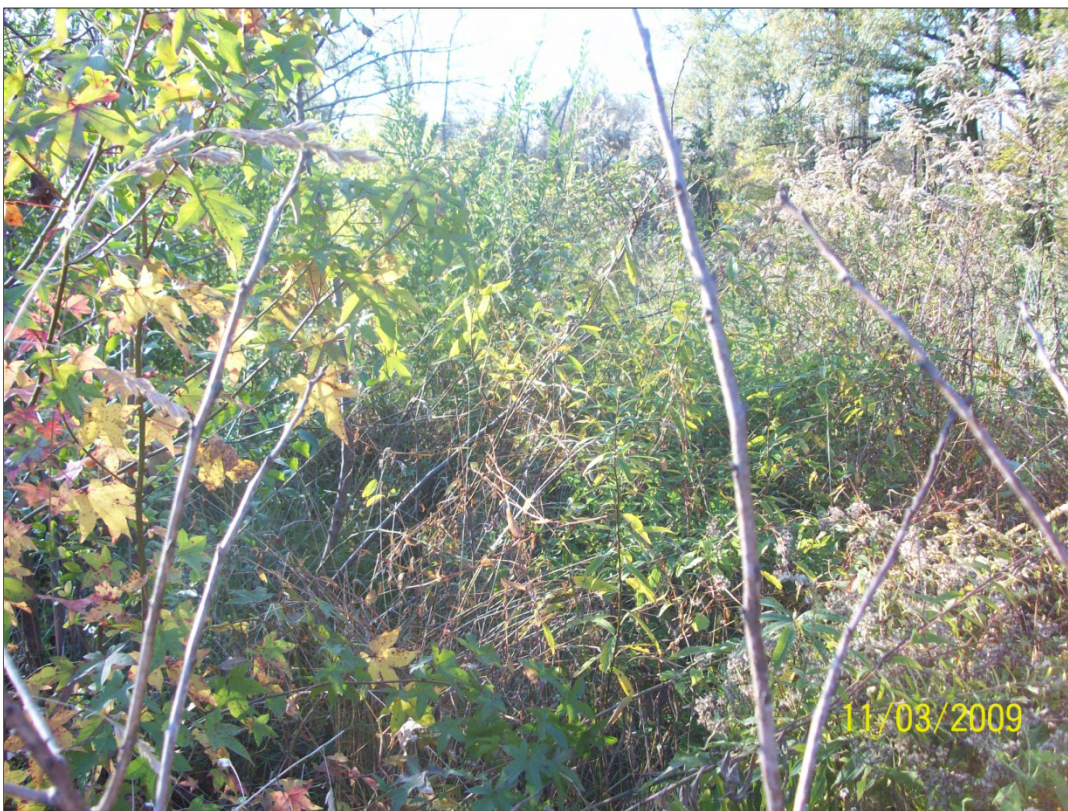
Photo Point 12b: View looking downstream on UT2 before it enters UTHR. 11/3/09 – MY-03
