**Glen Raven Stream Restoration  
Monitoring Report – MY04  
Alamance County, NC  
Basin 03030002 - Contract # D05011-1**

**2010**

Figure 1.	Vicinity Map .....	2
Figure 2.	Current Condition Plan View.....	6

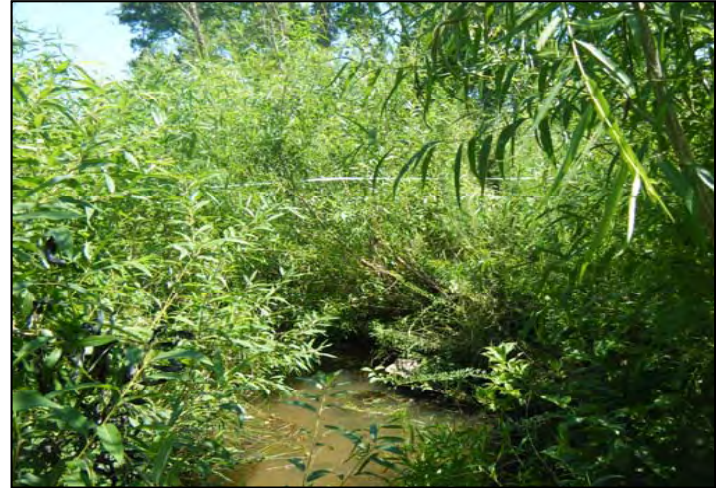
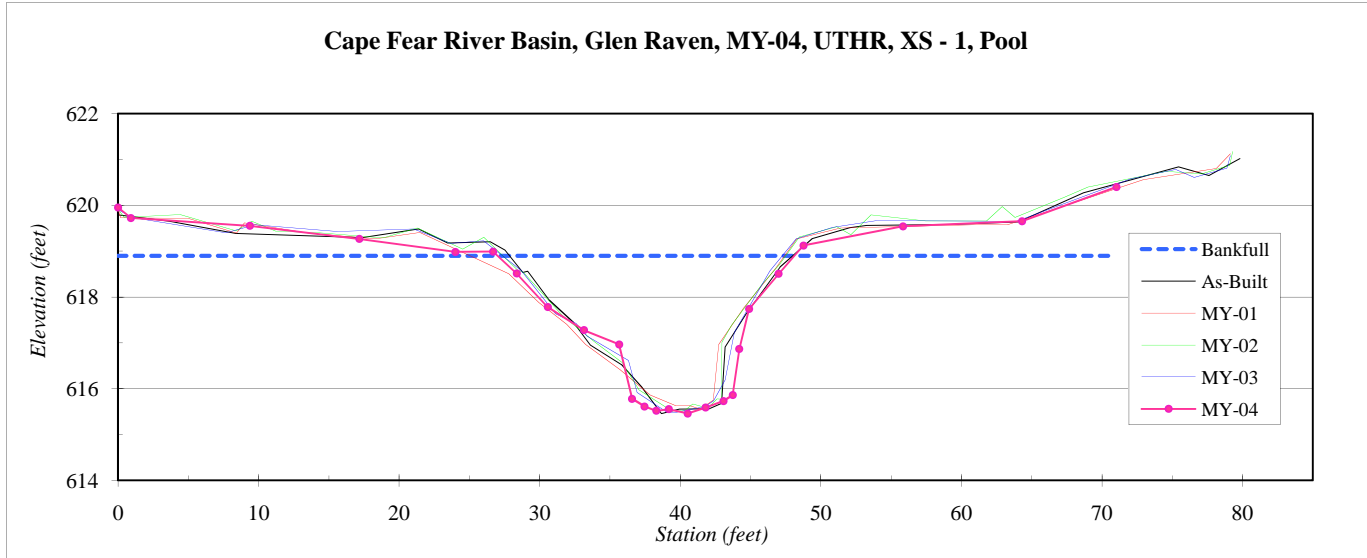
<b>River Basin:</b>	Cape Fear
<b>Watershed:</b>	Glen Raven, MY-04, UTHR
<b>XS ID</b>	XS - 1, Pool
<b>Drainage Area (sq mi):</b>	1.09
<b>Date:</b>	6/8/2010
<b>Field Crew:</b>	A. French, L. Lord

SUMMARY DATA	
<b>Bankfull Elevation:</b>	618.9
<b>Bankfull Cross-Sectional Area:</b>	39.8
<b>Bankfull Width:</b>	21.1
<b>Flood Prone Area Elevation:</b>	-
<b>Flood Prone Width:</b>	-
<b>Max Depth at Bankfull:</b>	3.4
<b>Mean Depth at Bankfull:</b>	1.9
<b>W / D Ratio:</b>	-
<b>Entrenchment Ratio:</b>	-
<b>Bank Height Ratio:</b>	1.0

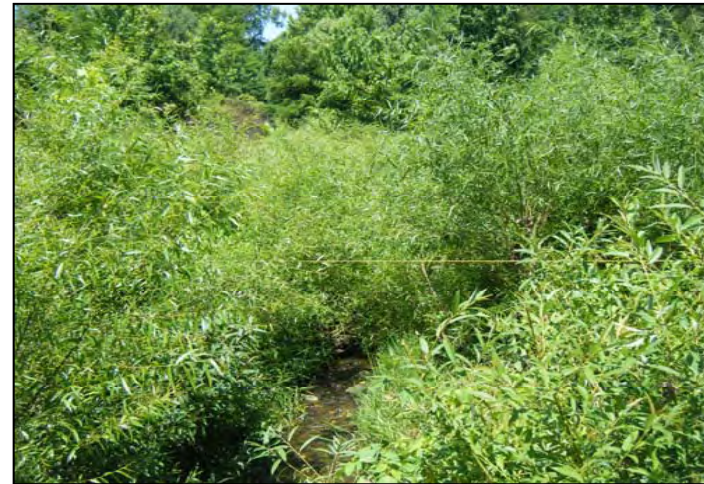
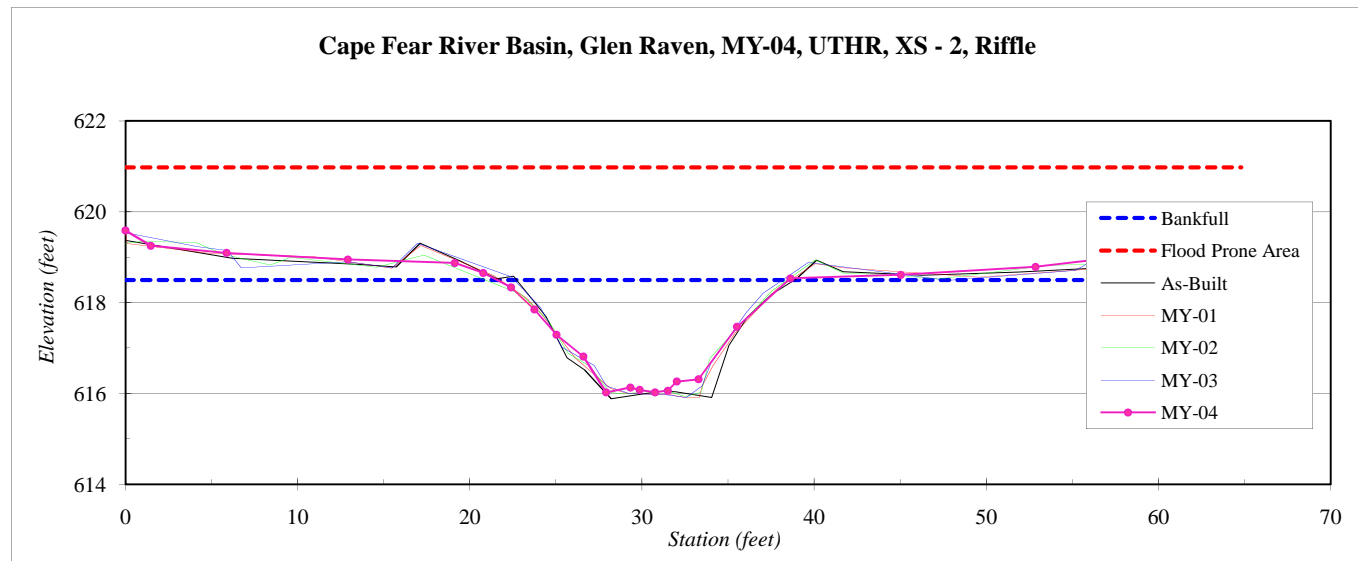
<b>River Basin:</b>	Cape Fear
<b>Watershed:</b>	Glen Raven, MY-04, UTHR
<b>XS ID</b>	XS - 2, Riffle
<b>Drainage Area (sq mi):</b>	1.09
<b>Date:</b>	6/8/2010
<b>Field Crew:</b>	A. French, L. Lord

SUMMARY DATA	
<b>Bankfull Elevation:</b>	618.5
<b>Bankfull Cross-Sectional Area:</b>	24.7
<b>Bankfull Width:</b>	17.0
<b>Flood Prone Area Elevation:</b>	621.0
<b>Flood Prone Width:</b>	>64
<b>Max Depth at Bankfull:</b>	2.5
<b>Mean Depth at Bankfull:</b>	1.5
<b>W / D Ratio:</b>	11.6
<b>Entrenchment Ratio:</b>	>2.8
<b>Bank Height Ratio:</b>	1.0

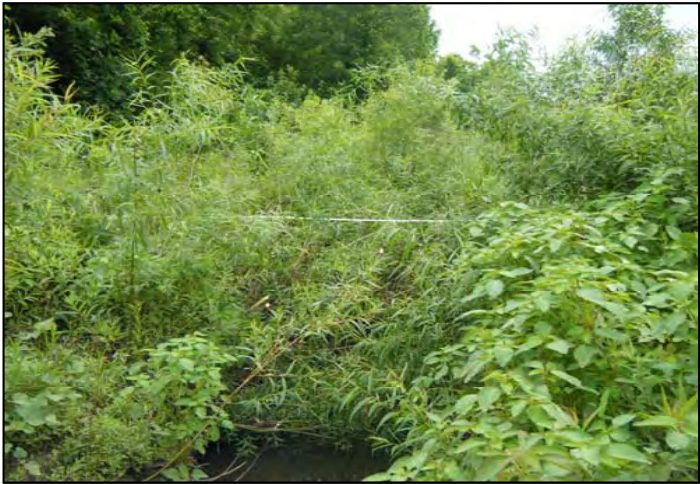
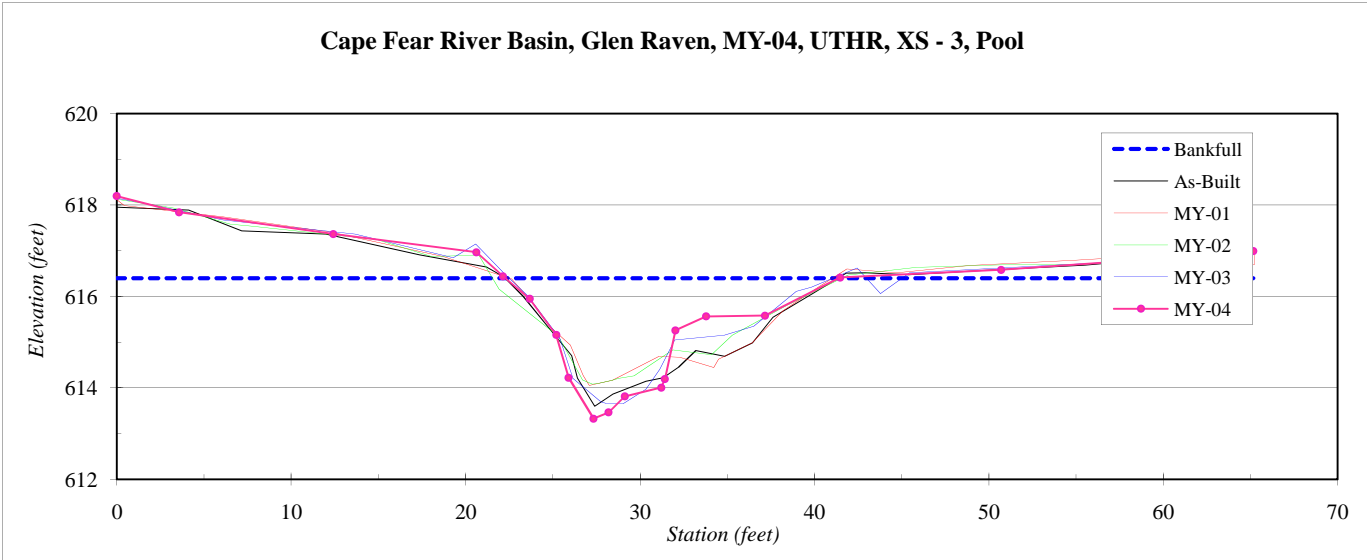
<b>River Basin:</b>	Cape Fear
<b>Watershed:</b>	Glen Raven, MY-04, UTHR
<b>XS ID</b>	XS - 3, Pool
<b>Drainage Area (sq mi):</b>	1.09
<b>Date:</b>	6/9/2010
<b>Field Crew:</b>	A. French, L. Lord

SUMMARY DATA	
<b>Bankfull Elevation:</b>	616.4
<b>Bankfull Cross-Sectional Area:</b>	24.7
<b>Bankfull Width:</b>	19.1
<b>Flood Prone Area Elevation:</b>	-
<b>Flood Prone Width:</b>	-
<b>Max Depth at Bankfull:</b>	3.1
<b>Mean Depth at Bankfull:</b>	1.3
<b>W / D Ratio:</b>	-
<b>Entrenchment Ratio:</b>	-
<b>Bank Height Ratio:</b>	1.0

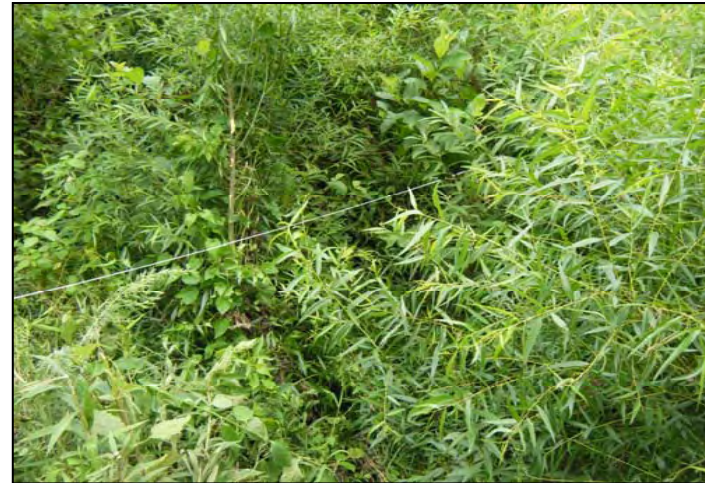
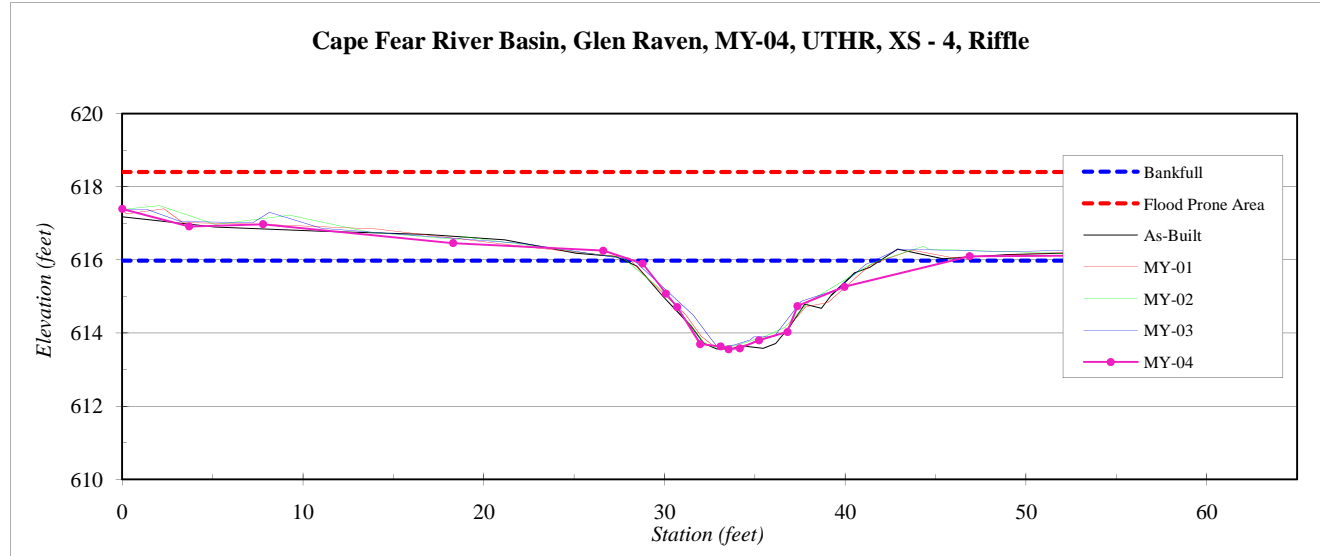
<b>River Basin:</b>	Cape Fear
<b>Watershed:</b>	Glen Raven, MY-04, UTHR
<b>XS ID</b>	XS - 4, Riffle
<b>Drainage Area (sq mi):</b>	1.09
<b>Date:</b>	6/9/2010
<b>Field Crew:</b>	A. French, L. Lord

SUMMARY DATA	
<b>Bankfull Elevation:</b>	616.0
<b>Bankfull Cross-Sectional Area:</b>	20.4
<b>Bankfull Width:</b>	17.9
<b>Flood Prone Area Elevation:</b>	618.4
<b>Flood Prone Width:</b>	>63
<b>Max Depth at Bankfull:</b>	2.4
<b>Mean Depth at Bankfull:</b>	1.1
<b>W / D Ratio:</b>	15.7
<b>Entrenchment Ratio:</b>	>3.5
<b>Bank Height Ratio:</b>	1.0

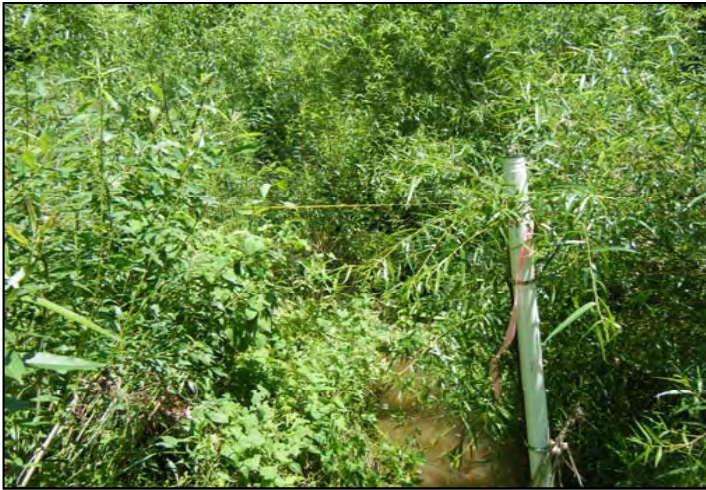
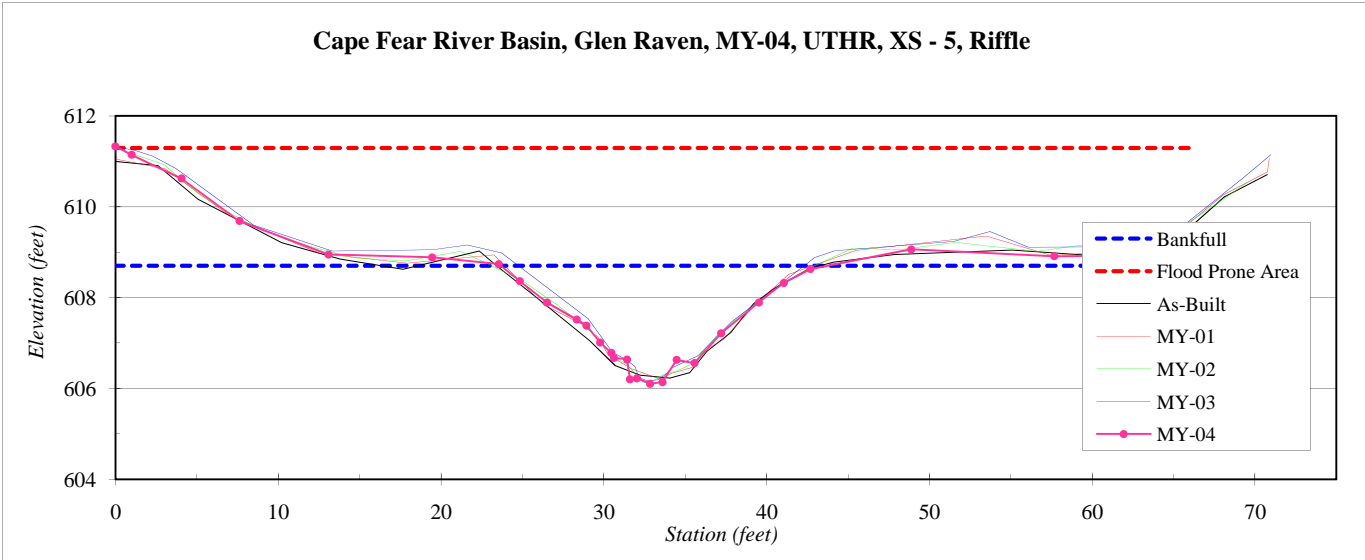
<b>River Basin:</b>	Cape Fear
<b>Watershed:</b>	Glen Raven, MY-04, UTHR
<b>XS ID</b>	XS - 5, Riffle
<b>Drainage Area (sq mi):</b>	1.09
<b>Date:</b>	6/14/2010
<b>Field Crew:</b>	A. French, L. Lord

SUMMARY DATA	
<b>Bankfull Elevation:</b>	608.7
<b>Bankfull Cross-Sectional Area:</b>	24.9
<b>Bankfull Width:</b>	20.0
<b>Flood Prone Area Elevation:</b>	611.3
<b>Flood Prone Width:</b>	>71
<b>Max Depth at Bankfull:</b>	2.6
<b>Mean Depth at Bankfull:</b>	1.2
<b>W / D Ratio:</b>	16.1
<b>Entrenchment Ratio:</b>	>2.3
<b>Bank Height Ratio:</b>	1.0

<b>Stream Type</b>	C4
--------------------	----

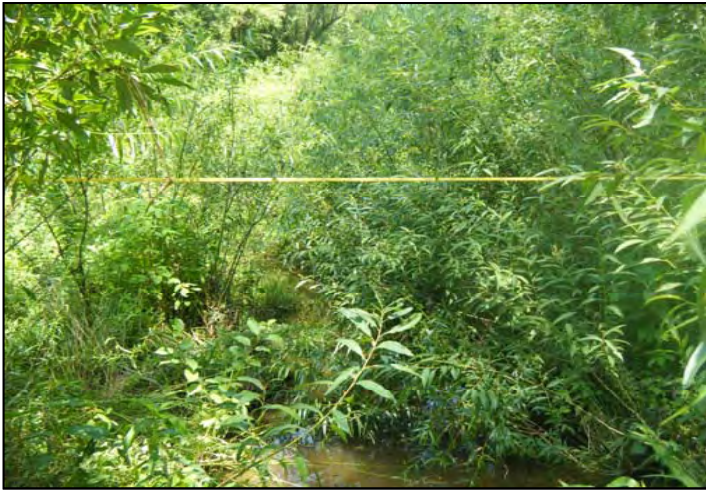
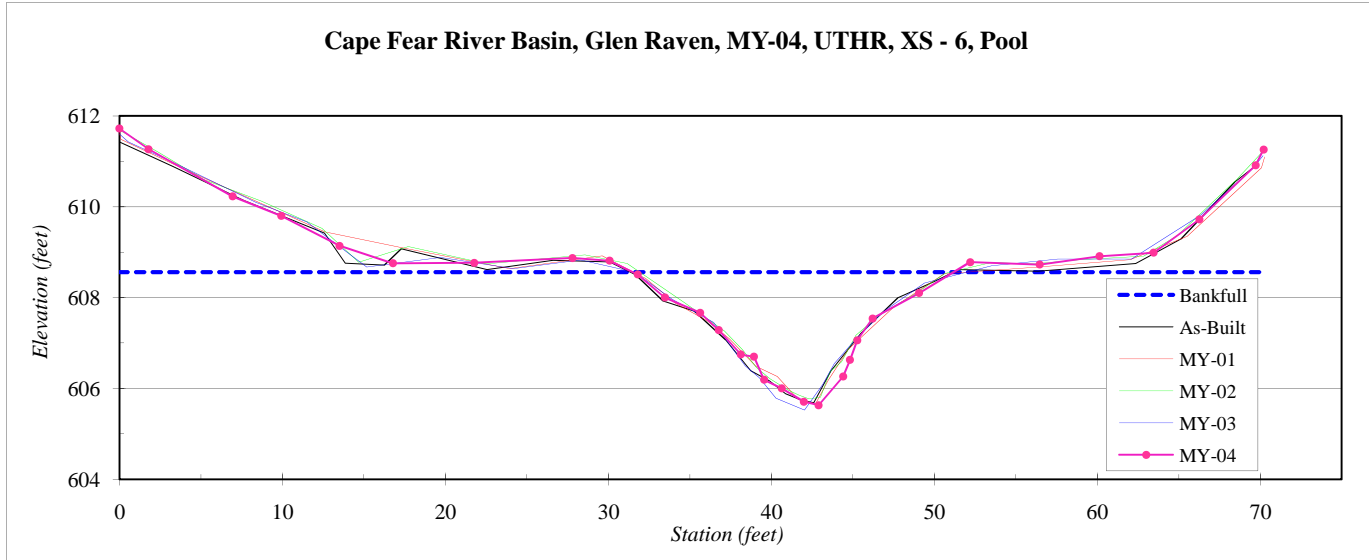
<b>River Basin:</b>	Cape Fear
<b>Watershed:</b>	Glen Raven, MY-04, UTHR
<b>XS ID</b>	XS - 6, Pool
<b>Drainage Area (sq mi):</b>	1.09
<b>Date:</b>	6/14/2010
<b>Field Crew:</b>	A. French, L. Lord

SUMMARY DATA	
<b>Bankfull Elevation:</b>	608.6
<b>Bankfull Cross-Sectional Area:</b>	27.3
<b>Bankfull Width:</b>	20.1
<b>Flood Prone Area Elevation:</b>	-
<b>Flood Prone Width:</b>	-
<b>Max Depth at Bankfull:</b>	3.0
<b>Mean Depth at Bankfull:</b>	1.4
<b>W / D Ratio:</b>	-
<b>Entrenchment Ratio:</b>	-
<b>Bank Height Ratio:</b>	1.0

Stream Type C4

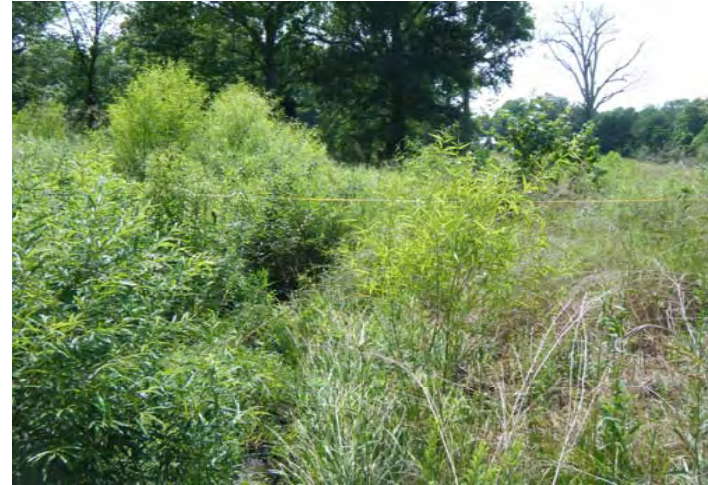
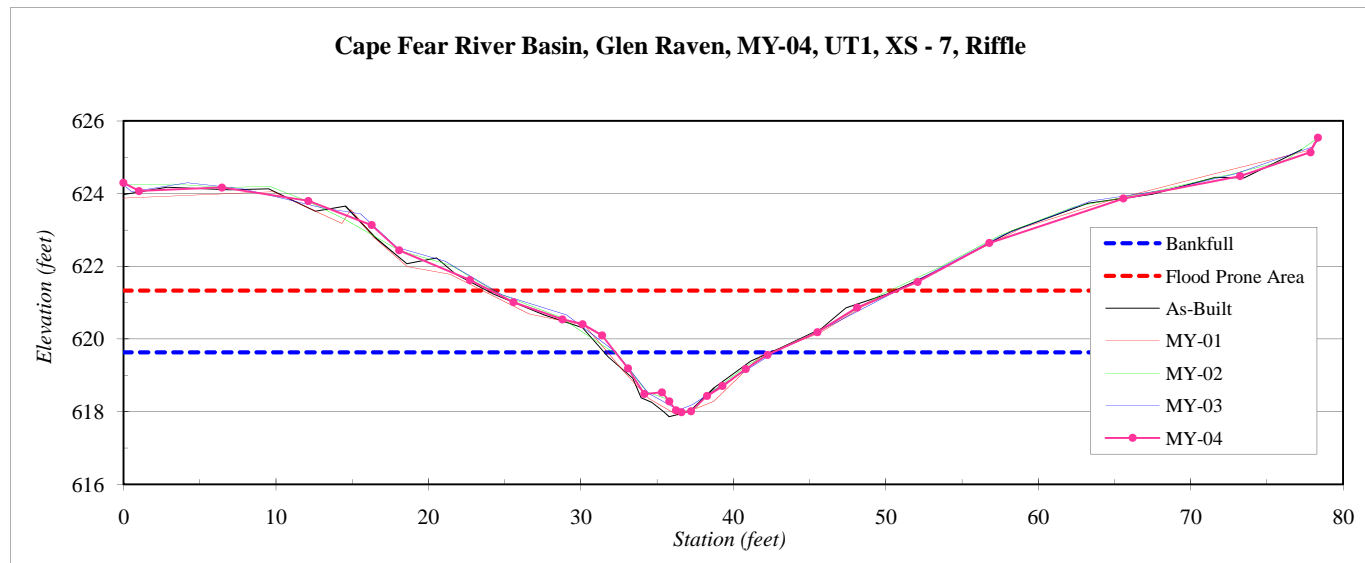
<b>River Basin:</b>	Cape Fear
<b>Watershed:</b>	Glen Raven, MY-04, UT1
<b>XS ID</b>	XS - 7, Riffle
<b>Drainage Area (sq mi):</b>	0.10
<b>Date:</b>	6/10/2010
<b>Field Crew:</b>	A. French, L. Lord

SUMMARY DATA	
<b>Bankfull Elevation:</b>	619.6
<b>Bankfull Cross-Sectional Area:</b>	9.2
<b>Bankfull Width:</b>	10.3
<b>Flood Prone Area Elevation:</b>	621.3
<b>Flood Prone Width:</b>	26
<b>Max Depth at Bankfull:</b>	1.7
<b>Mean Depth at Bankfull:</b>	0.9
<b>W / D Ratio:</b>	11.7
<b>Entrenchment Ratio:</b>	2.5
<b>Bank Height Ratio:</b>	1.0

Stream Type B4c

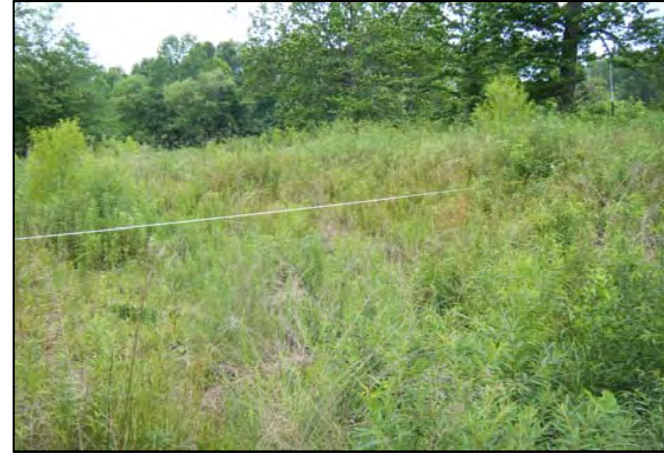
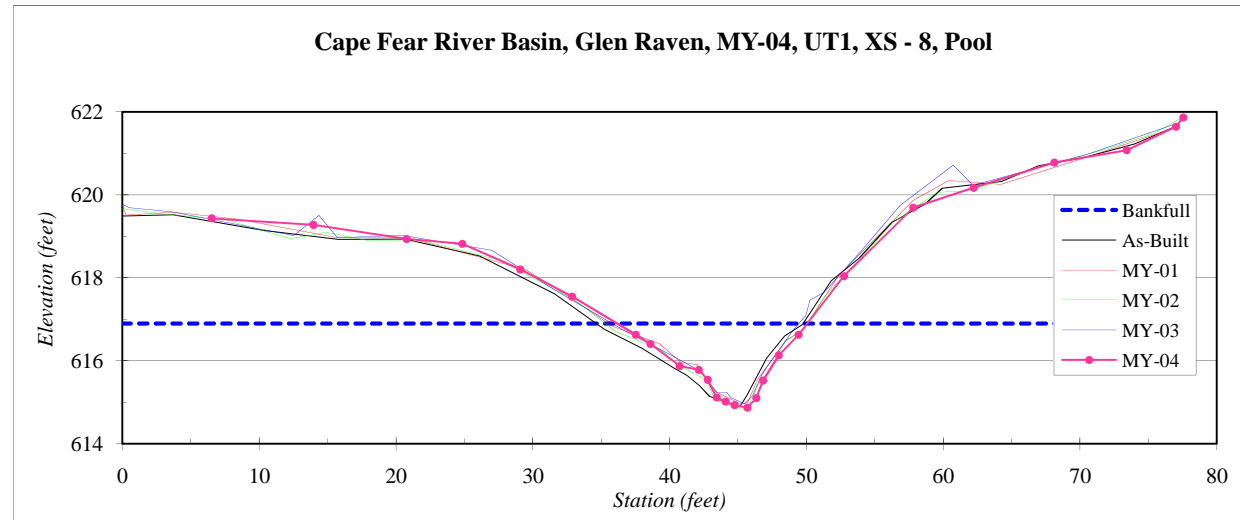
<b>River Basin:</b>	Cape Fear
<b>Watershed:</b>	Glen Raven, MY-04, UT1
<b>XS ID</b>	XS - 8, Pool
<b>Drainage Area (sq mi):</b>	0.10
<b>Date:</b>	6/10/2010
<b>Field Crew:</b>	A. French, L. Lord

SUMMARY DATA	
<b>Bankfull Elevation:</b>	616.9
<b>Bankfull Cross-Sectional Area:</b>	14.0
<b>Bankfull Width:</b>	13.9
<b>Flood Prone Area Elevation:</b>	-
<b>Flood Prone Width:</b>	-
<b>Max Depth at Bankfull:</b>	2.0
<b>Mean Depth at Bankfull:</b>	1.0
<b>W / D Ratio:</b>	-
<b>Entrenchment Ratio:</b>	-
<b>Bank Height Ratio:</b>	1.0

<b>Stream Type</b>	B4c
--------------------	-----

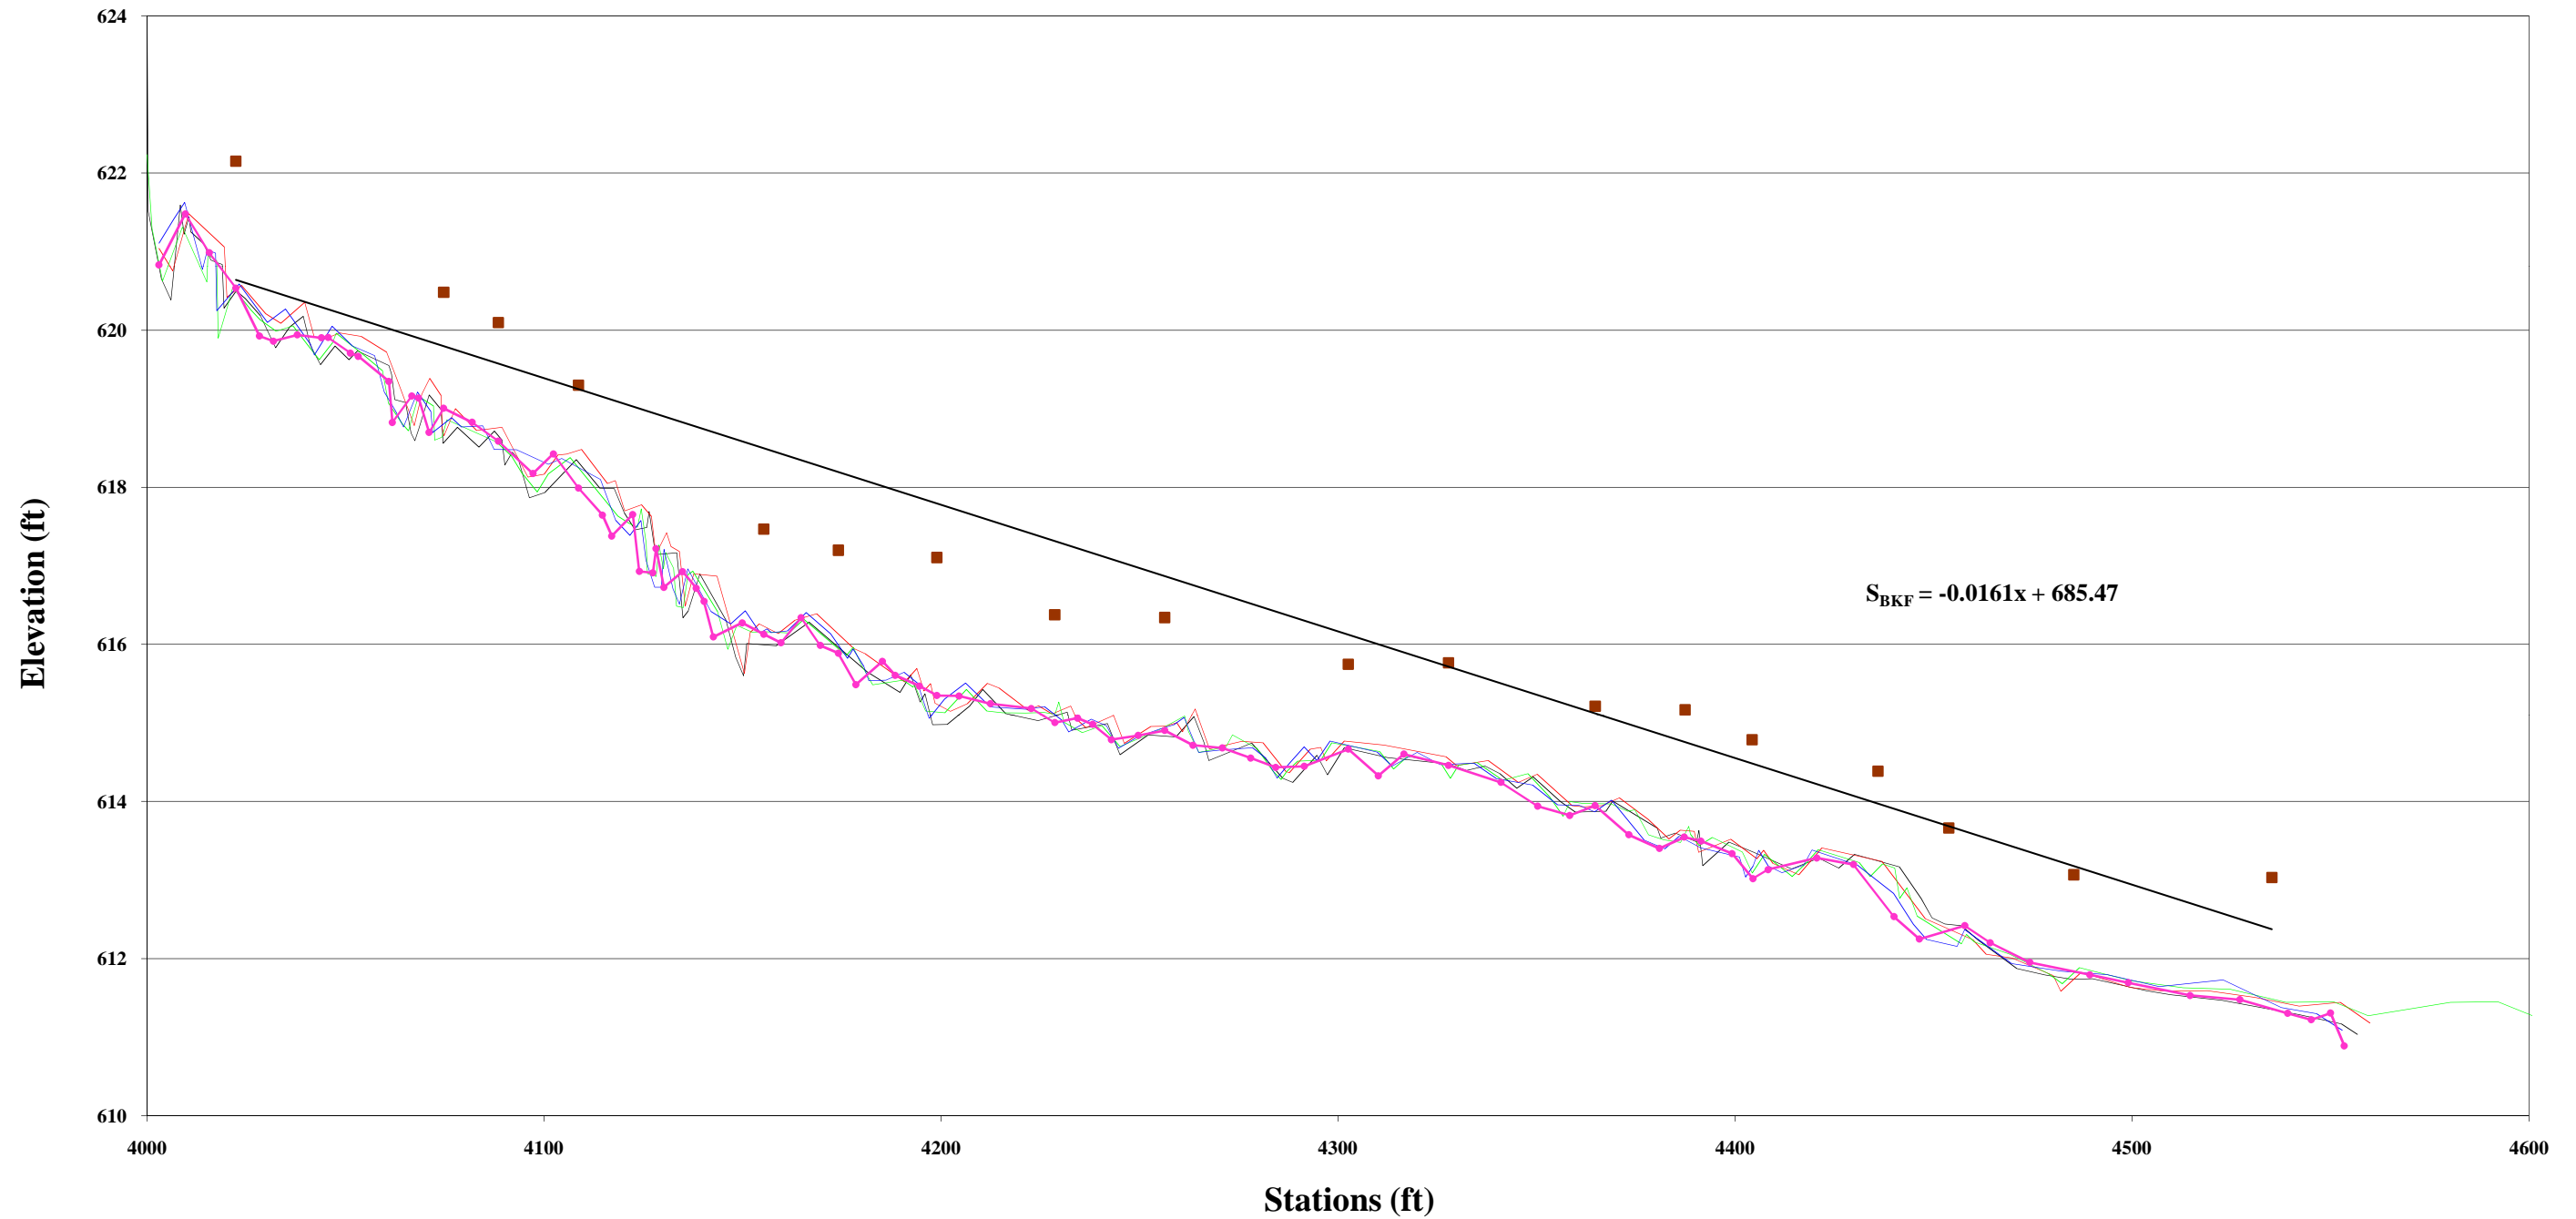
**Longitudinal Profile  
UT1 MY-04  
Stations 40+00 - 46+00**

Due to no flowing water in the channel, water surface and water surface slope were not recorded.

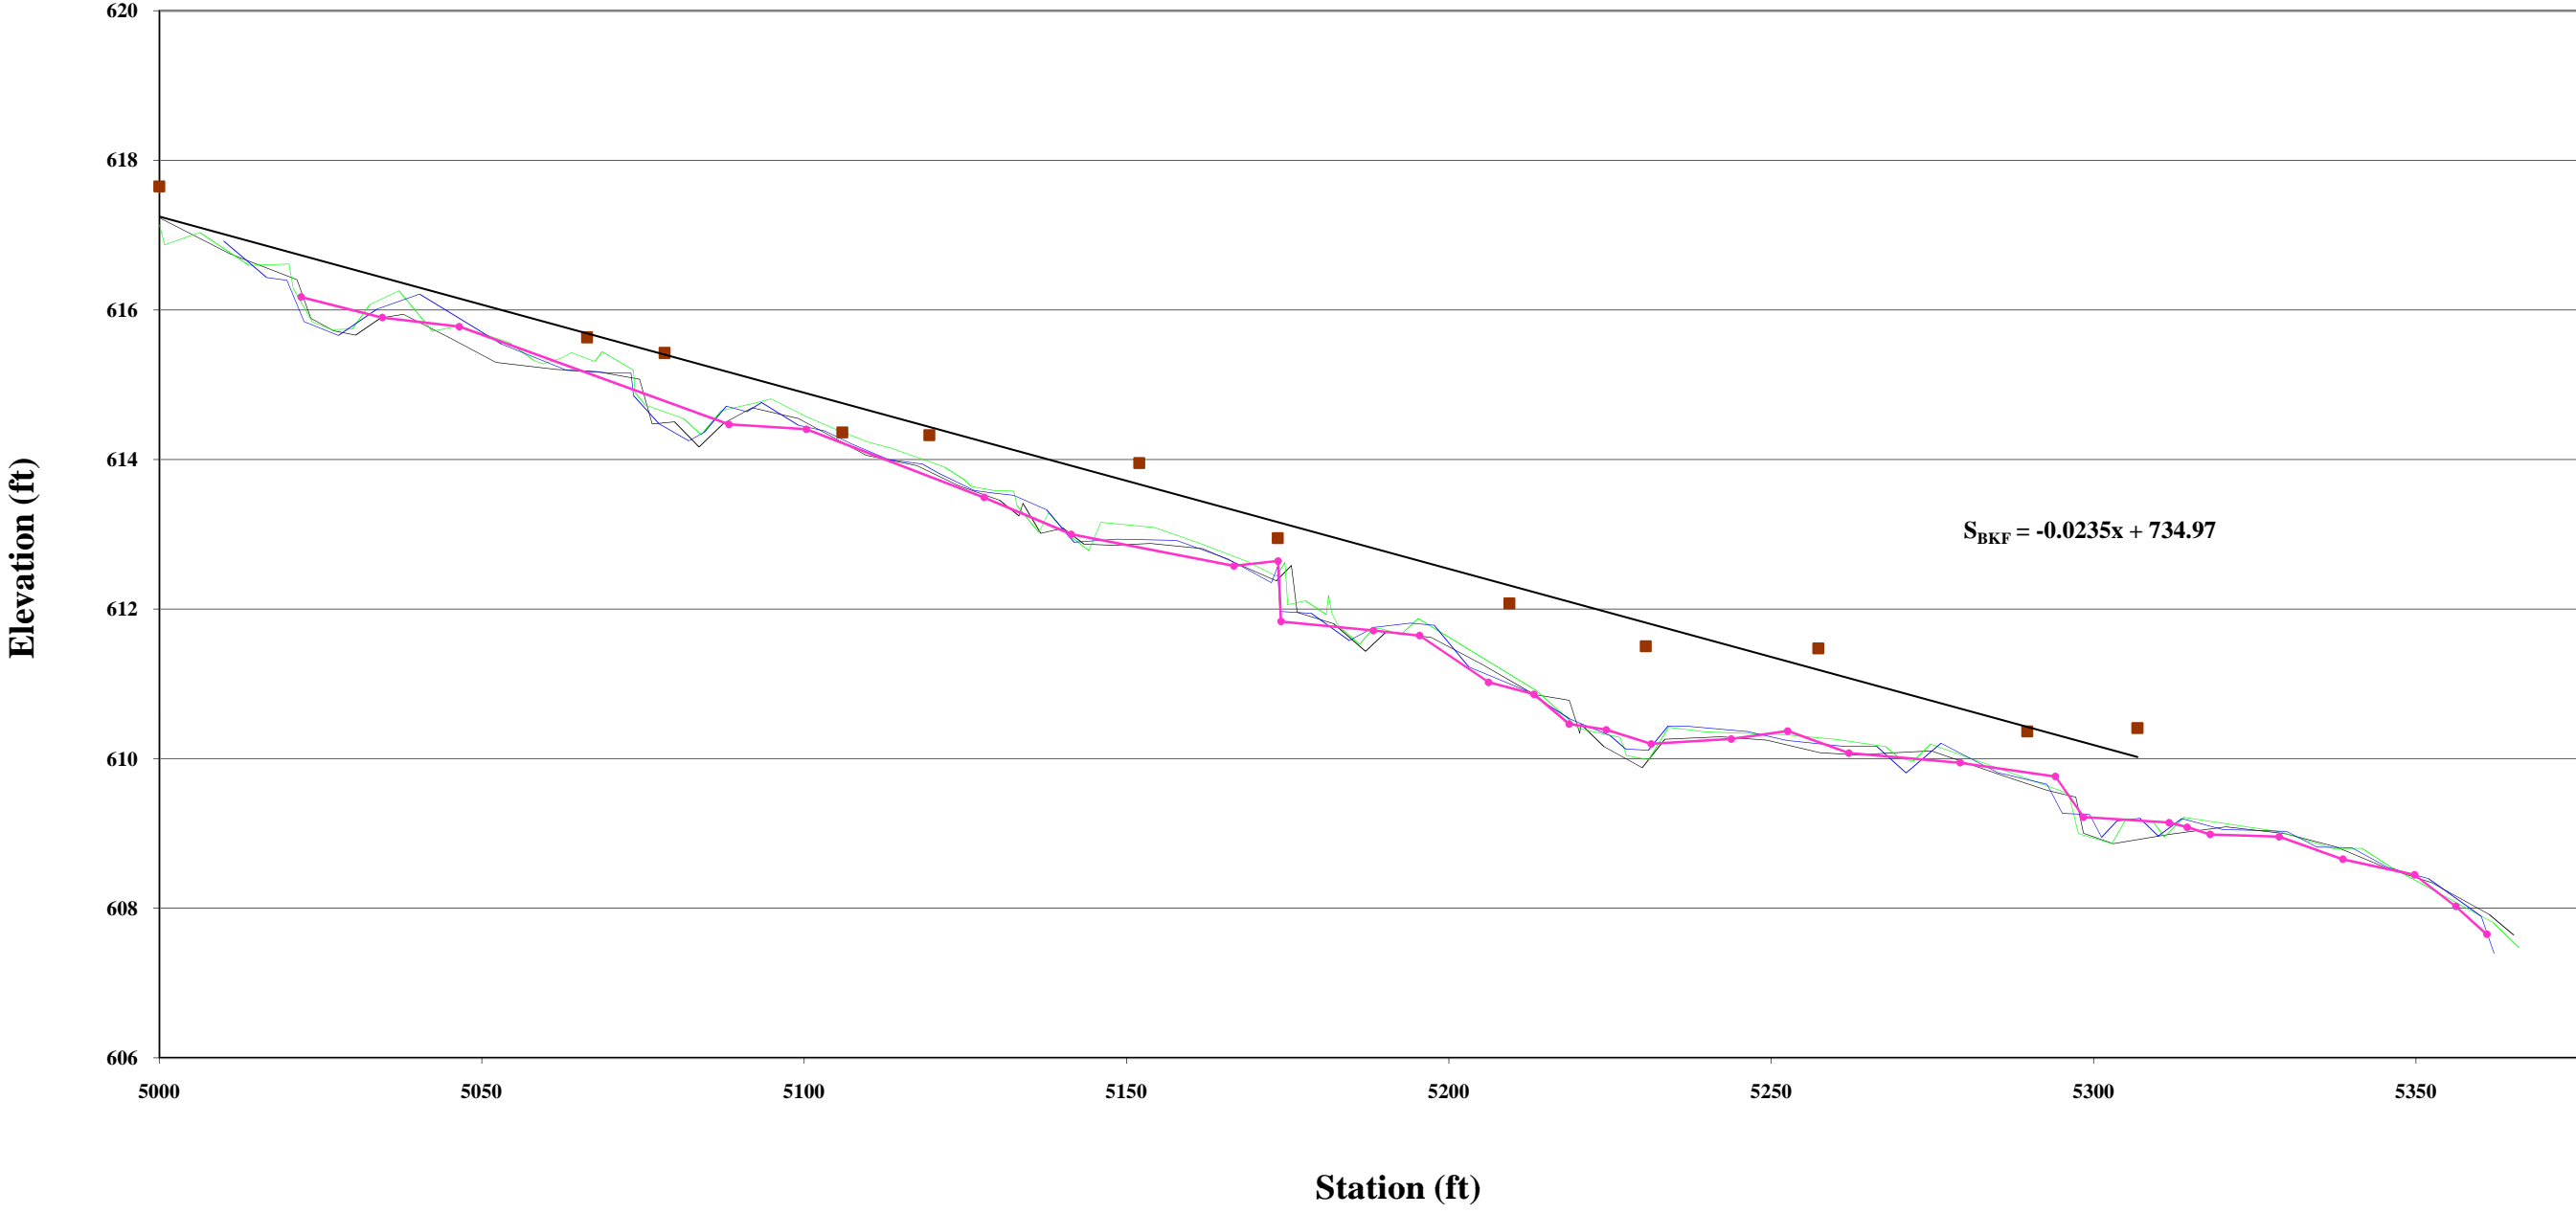
**Longitudinal Profile  
UT2 MY-04  
Stations 50+00 - 53+75**

\*No survey data taken during MY-01. Due to no flowing water in the channel, water surface and water surface slope were not recorded.
