**FINAL
ANNUAL MONITORING REPORT
GOLDSBORO HOUSING AUTHORITY**

**STREAM RESTORATION
WAYNE COUNTY, NORTH CAROLINA
(EEP Project Number 145, Contract No. 09070009)
Construction Completed October 2008**

Monitoring Year 4 of 5 (2012)

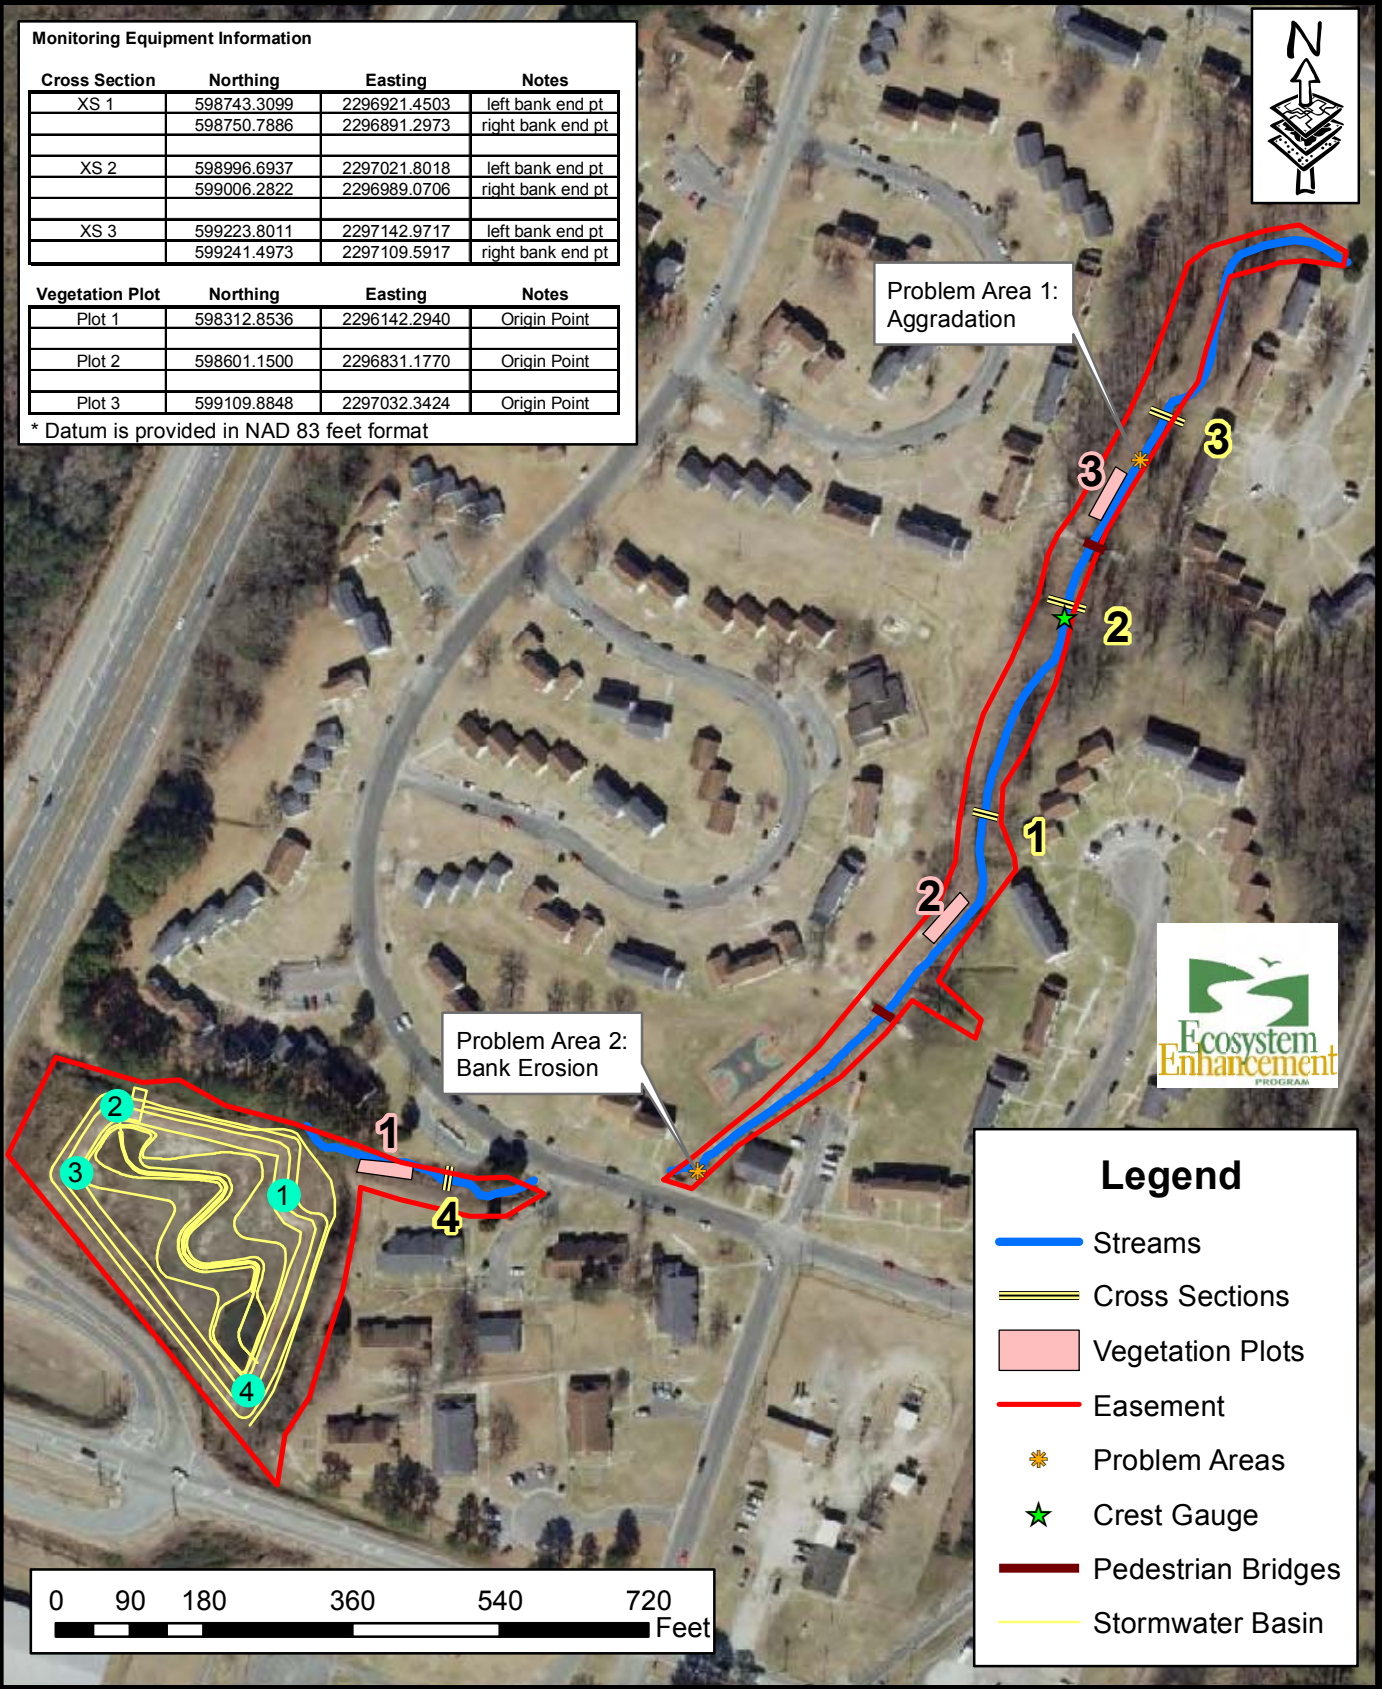
Figure 2. Current Conditions Plan View

CURRENT CONDITIONS PLAN VIEW
GOLDSBORO HOUSING AUTHORITY - EEP #145
STREAM RESTORATION PROJECT
Wayne County, North Carolina

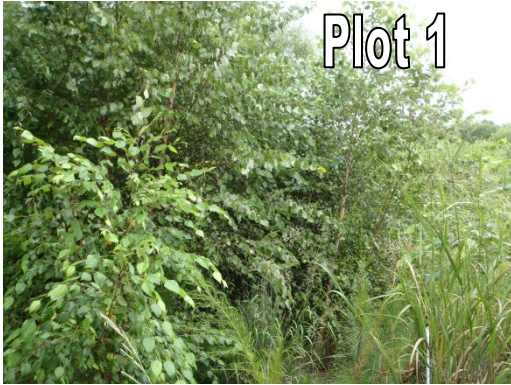
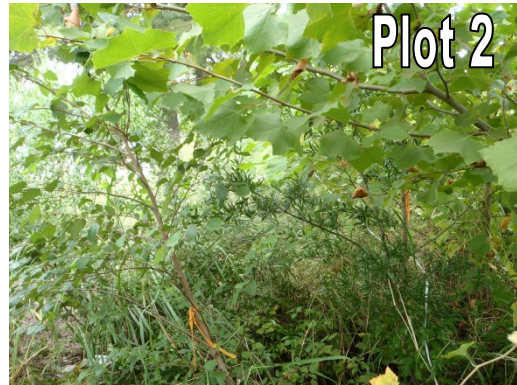
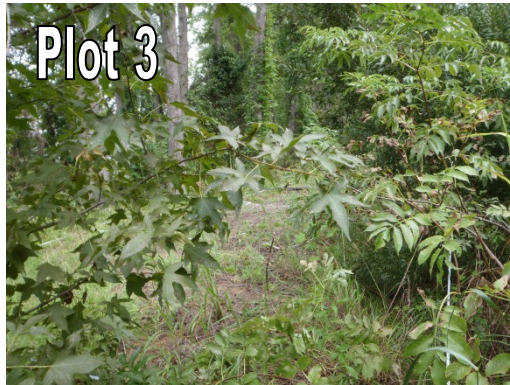
**Goldsboro Housing Authority
Year 4 (2012) Annual Monitoring
Vegetation Plot Photos (taken August 21, 2012)**
