**FINAL  
ANNUAL MONITORING REPORT  
GOLDSBORO HOUSING AUTHORITY**

**STREAM RESTORATION  
WAYNE COUNTY, NORTH CAROLINA  
(EEP Project Number 145, Contract No. 09070009)  
Construction Completed October 2008**

Monitoring Year 5 of 5 (2013)

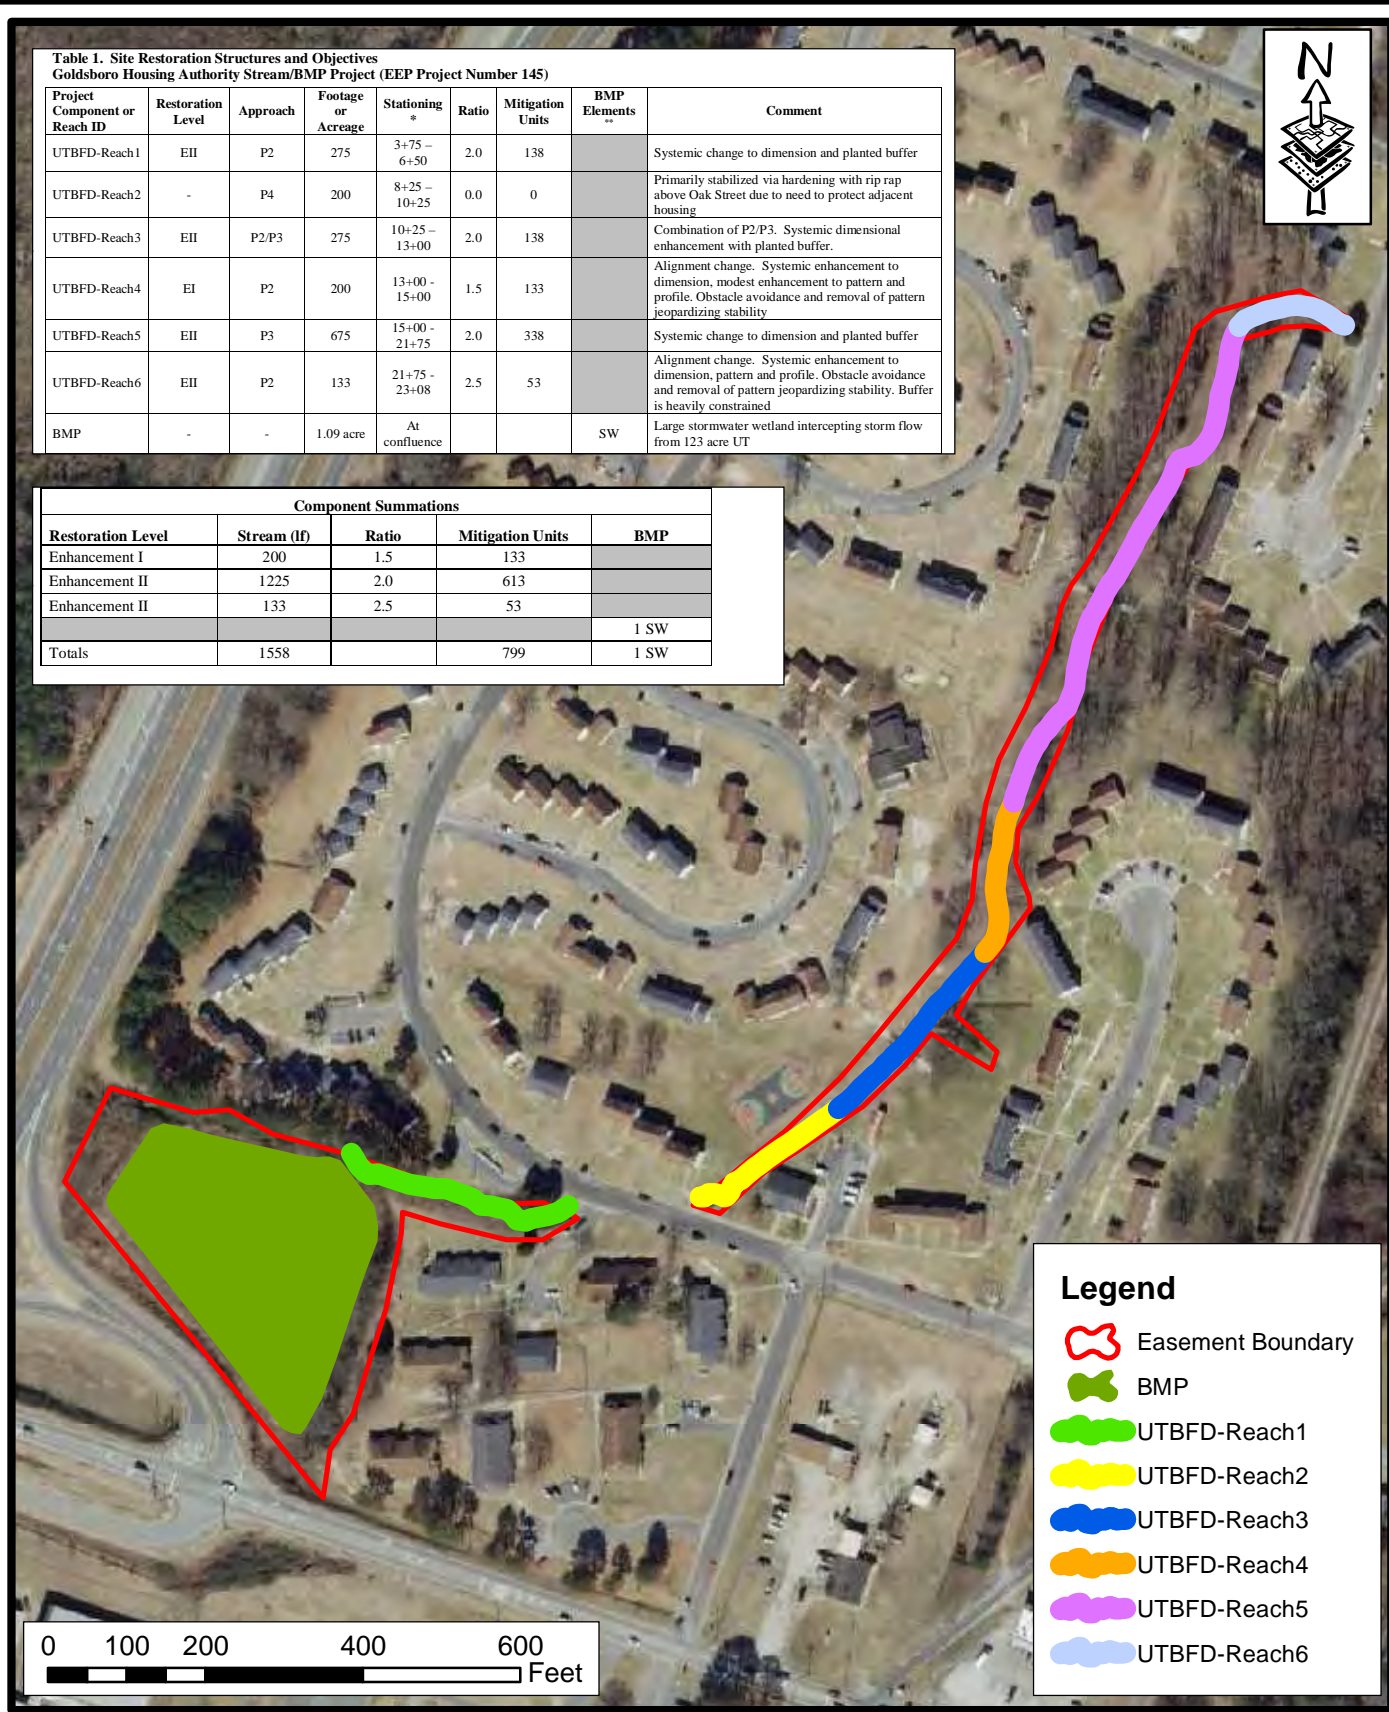
**FIGURE  
2**

One dense Japanese honeysuckle (*Lonicera japonica*) population was identified on the outer rim of the stormwater BMP. This area is identified on Figure 2 (Appendix B). Invasive species controls, consisting of two herbicide treatments, occurred during the summer of 2013. Treatments targeted Chinese privet (*Ligustrum sinense*), callery pear (*Pyrus calleryana*), and tree of heaven (*Ailanthus altissima*) throughout the area between Oak Street and Aster Court (see photo to right). Treatments included cutting and applying herbicide to stumps of larger woody stems, and foliar application of herbicide to smaller material.

Two stream areas of concern were noted within the Site as outlined in the following table (Figure 2, Appendix B).

<b>Map Identifier</b>	<b>Feature/Issue</b>	<b>Probable Cause</b>
Area of Concern 1	Aggradation at an upstream bend	Sediment deposition from culvert outlet
Area of Concern 2	Aggradation at a pool near veg plot 2	Sediment and trash deposition from the surrounding community

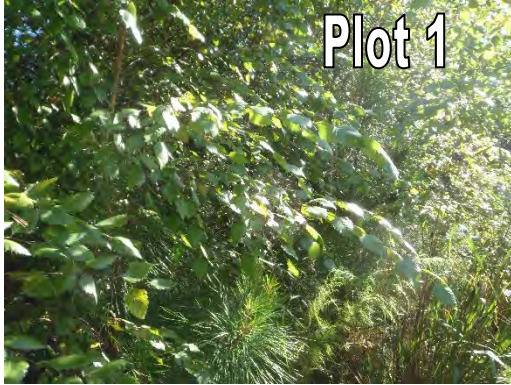
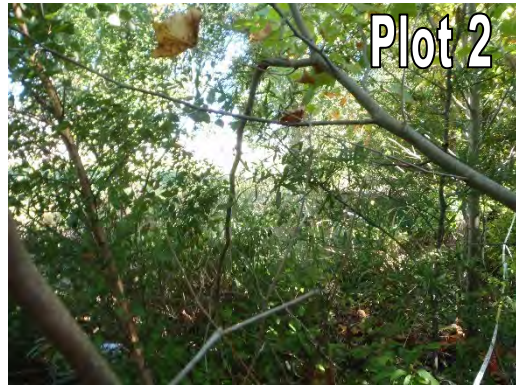
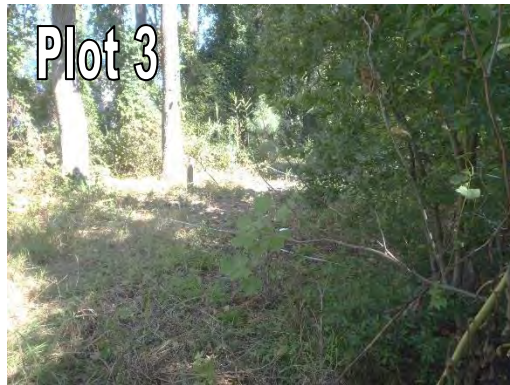
**Goldsboro Housing Authority  
Year 5 (2013) Annual Monitoring  
Vegetation Plot Photos (taken September 17, 2013)**

per acre at the end of year 5. Based on the number of stems counted, average densities were measured at 648 planted stems per acre (excluding livestakes) surviving in year 5 (2013). All three vegetation plots met success criteria based on planted stems, ranging from 404 to 1052 planted stems per acre, with 3 to 7 planted species noted per plot. When considering all stems including natural recruits, stem densities ranged from 1255 to 2185 native woody stems per acre with 8 to 10 species noted per plot (13 species Site wide). Supplemental planting of the Site occurred on February 3, 2012 with 460 containerized trees as follows. These trees appear to be vigorous with a high survival rate. Areas planted are depicted on mapping in Appendix G.
