**Goodman Property Stream Restoration Project  
Lenoir County, NC**

**2009 Annual Monitoring Report  
Year 1**

**NCEEP Project Number D000616  
Neuse River Basin**

Date: February, 2010

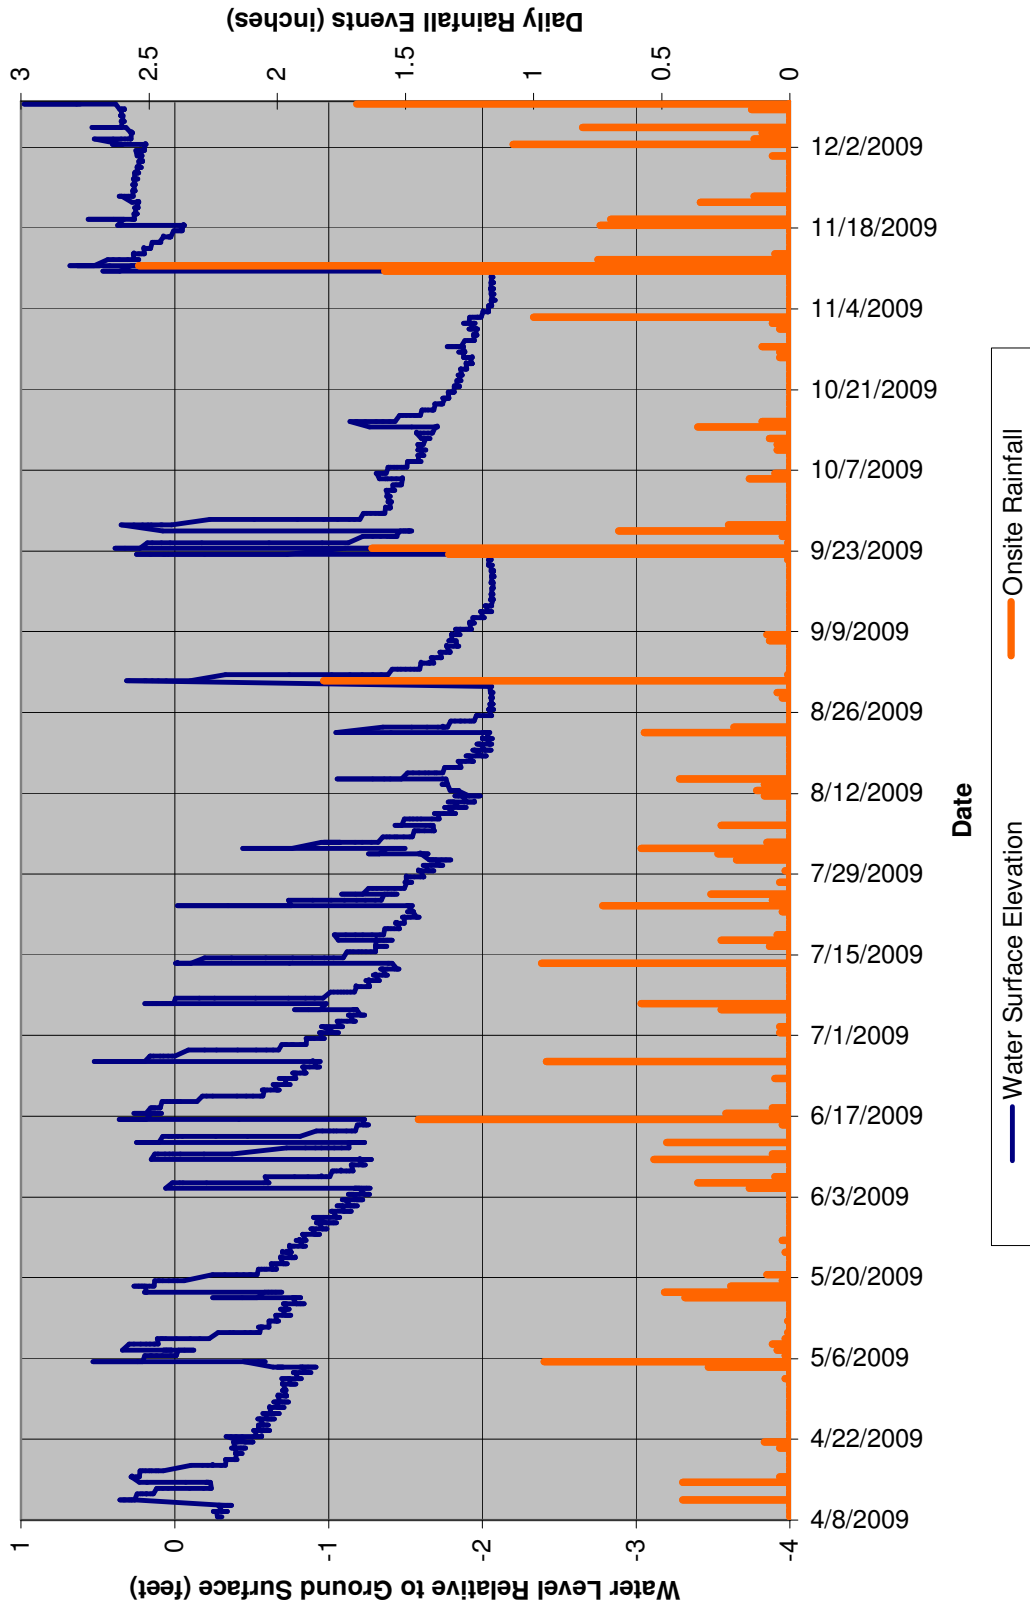
Goodman Monitoring Gauge #1 (2250035)

Figure F1 shows gauges 1 and 2 which are in the northern branch near the inlet pipe from the swamp run above the project. Due to its location, gauge 1 shows prolonged water flow in December which is corroborated by video evidence. Figure F2 illustrates the water flow at gauges 3 and 4 which is less robust, but present nevertheless. Gauges 3 and 4 are located near the head of the southern branch where the stream channel is shallow and the true watershed is the surrounding agricultural field. When rainfall is heavy enough, water does indeed drain from the surrounding field into the project area near these two gauges as well as at the head of this branch. Figure 4 in Appendix D shows how water from the surrounding agricultural field drains into this branch.

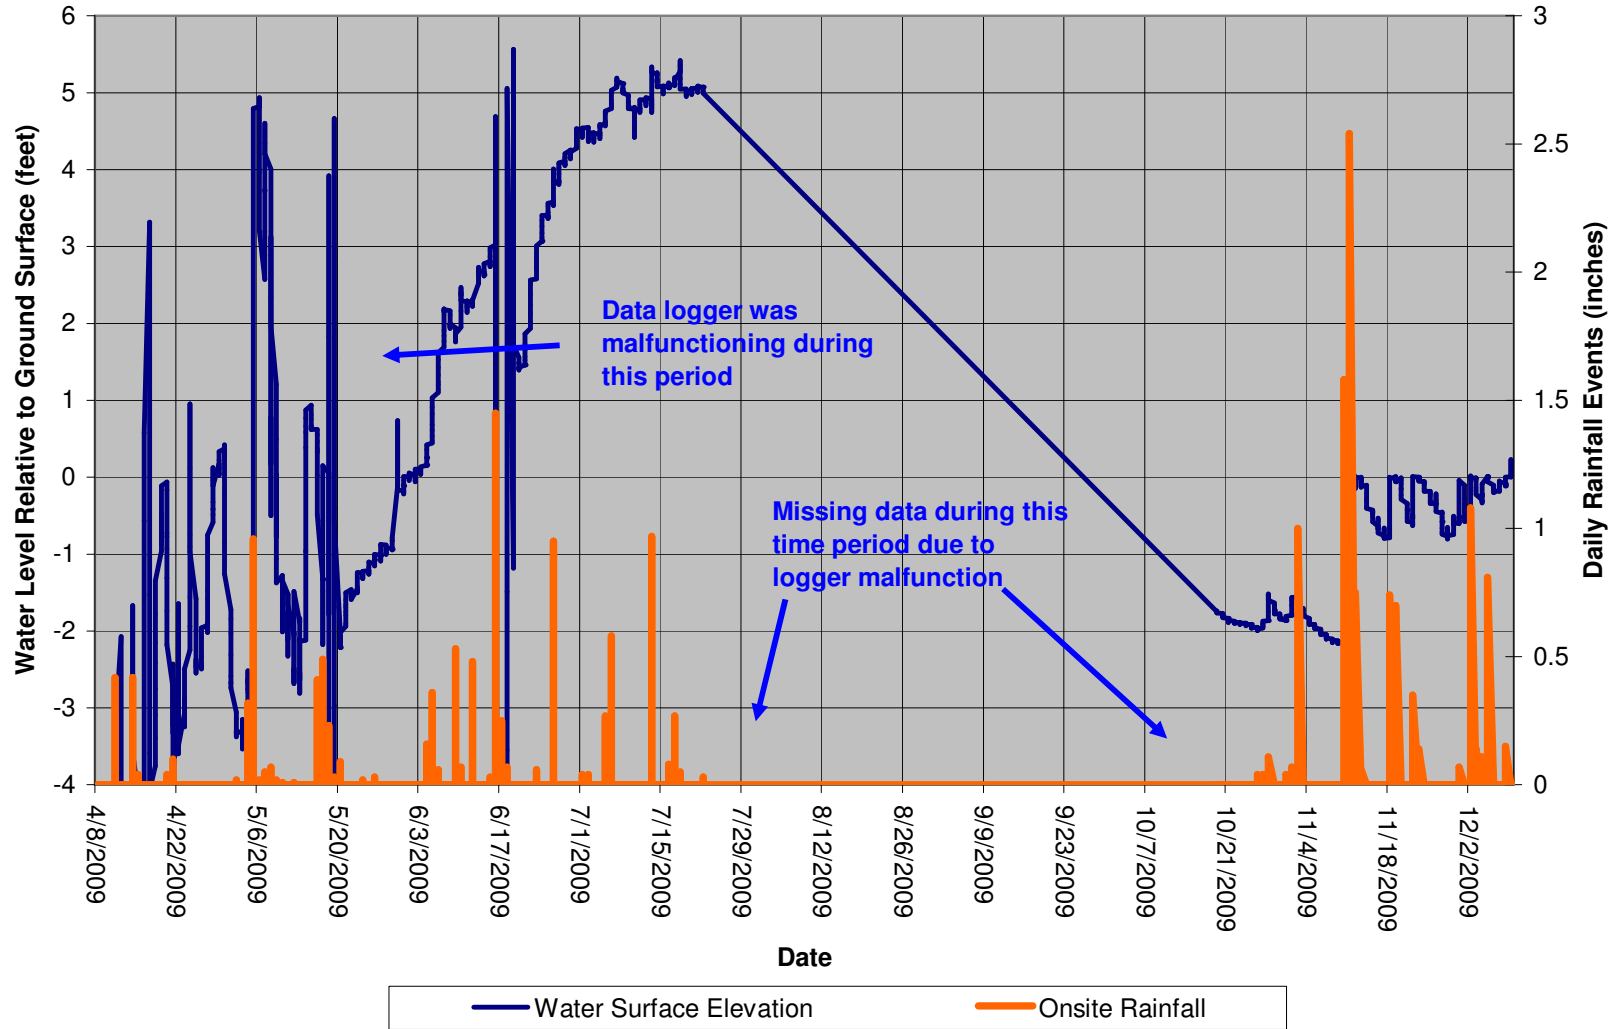
### Goodman Monitoring Gauge #8 (2342651)

Figure F4 contains the data from gauges 7 and 8 but due the malfunction of the data logger at gauge 8, the data for the first part of the year was not usable. The logger was replaced and the data from November and December show good flow at the outfall end of the project. Since gauge 8 is outside and slightly above the stream channel, each time the water level reaches the zero line (ground surface) it is an indication of overbank flooding. With each rainfall event, the water level at this end of the project rises out of the channel and slowly recedes back as indicated and corroborated with video evidence.
