**Goodman Property Stream Restoration Project
Lenoir County, NC**

**2010 Annual Monitoring Report
Year 2**

**NCEEP Project Number D000616
Neuse River Basin**

Date: November, 2010

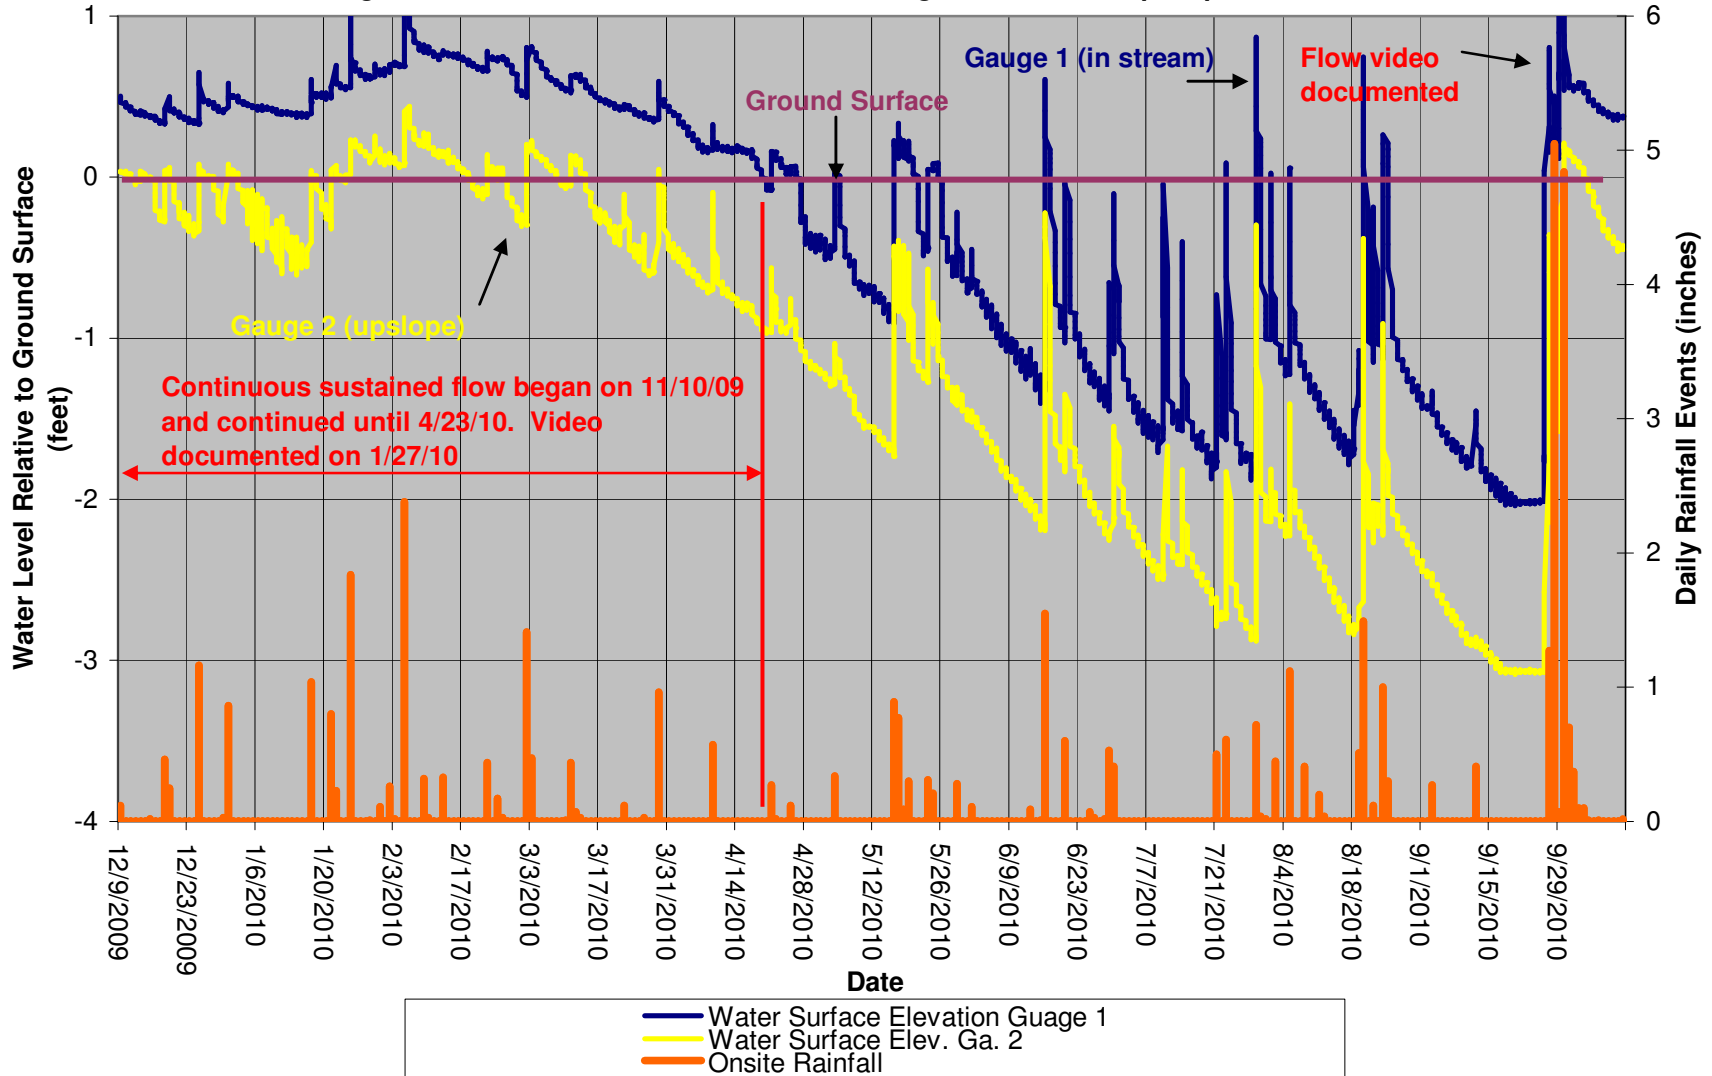
**Figure F1.
Goodman Monitoring Gauges #1 and #2**

Gauge #1 is located in the stream channel. Gauge #2 is located up slope out of the channel.

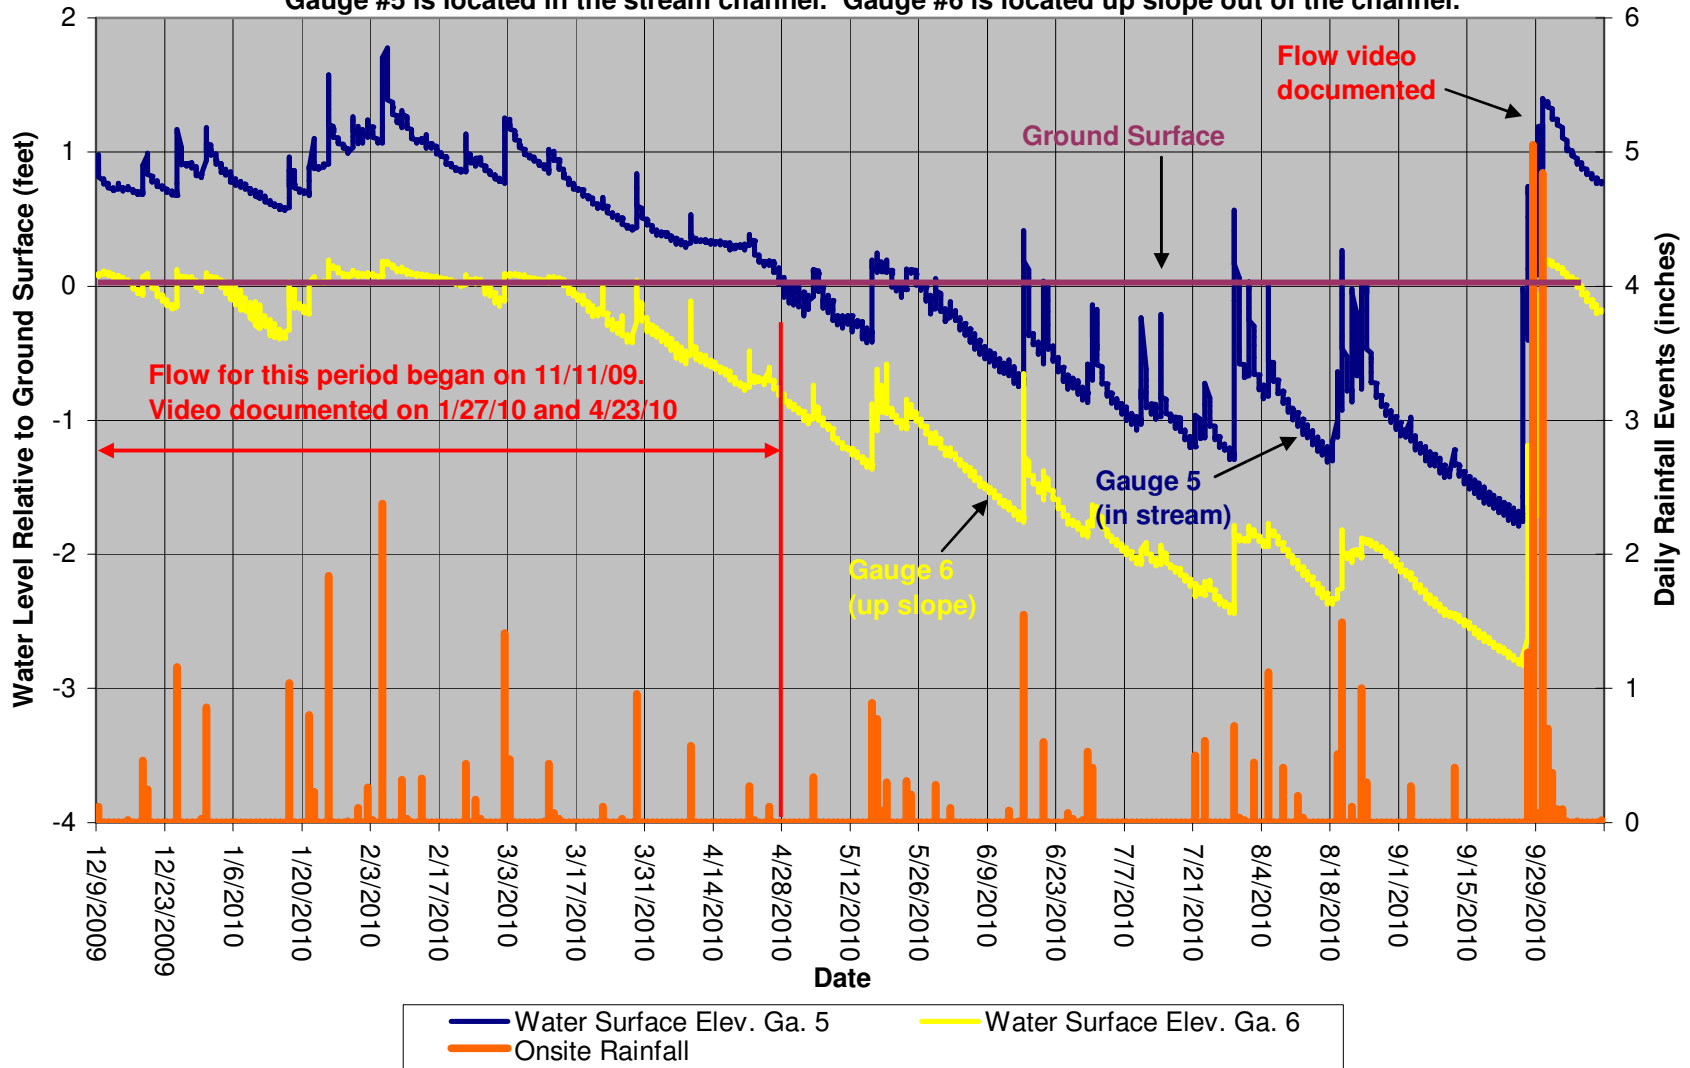
Figure F3.
Goodman Monitoring Gauges #5 and #6

Gauge #5 is located in the stream channel. Gauge #6 is located up slope out of the channel.

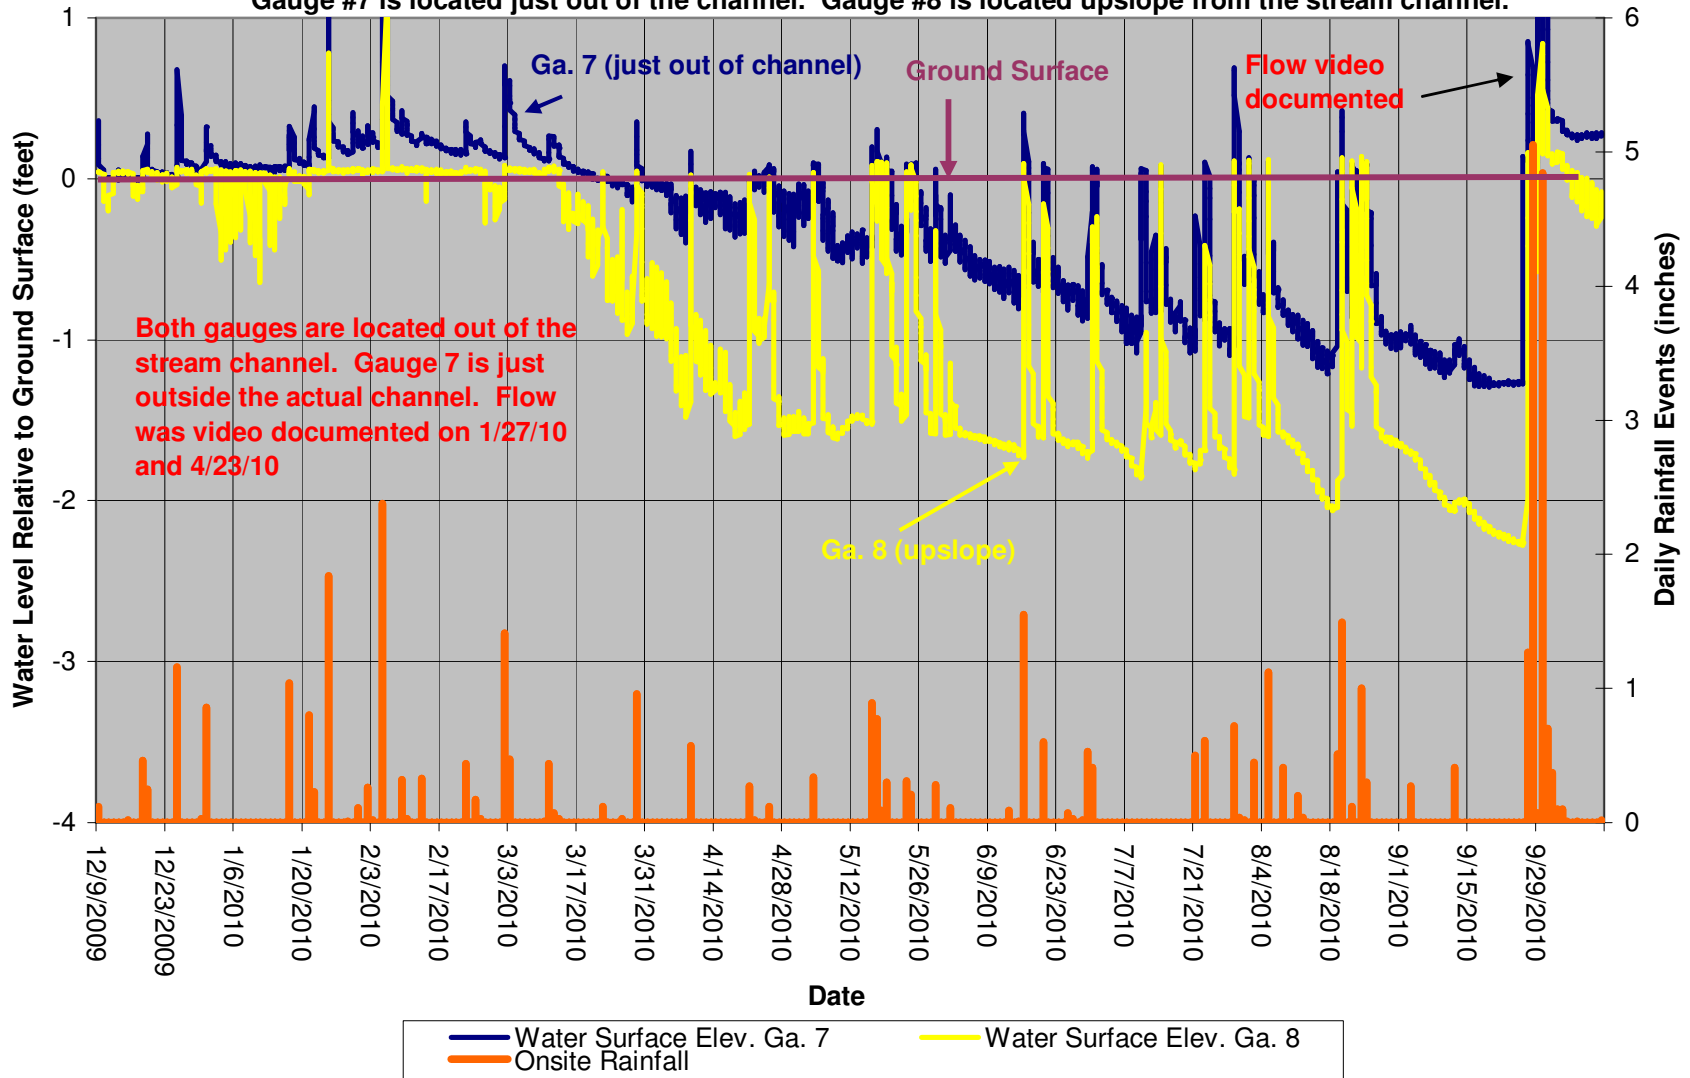
Figure F4.
Goodman Monitoring Gauges #7 and #8

Gauge #7 is located just out of the channel. Gauge #8 is located upslope from the stream channel.

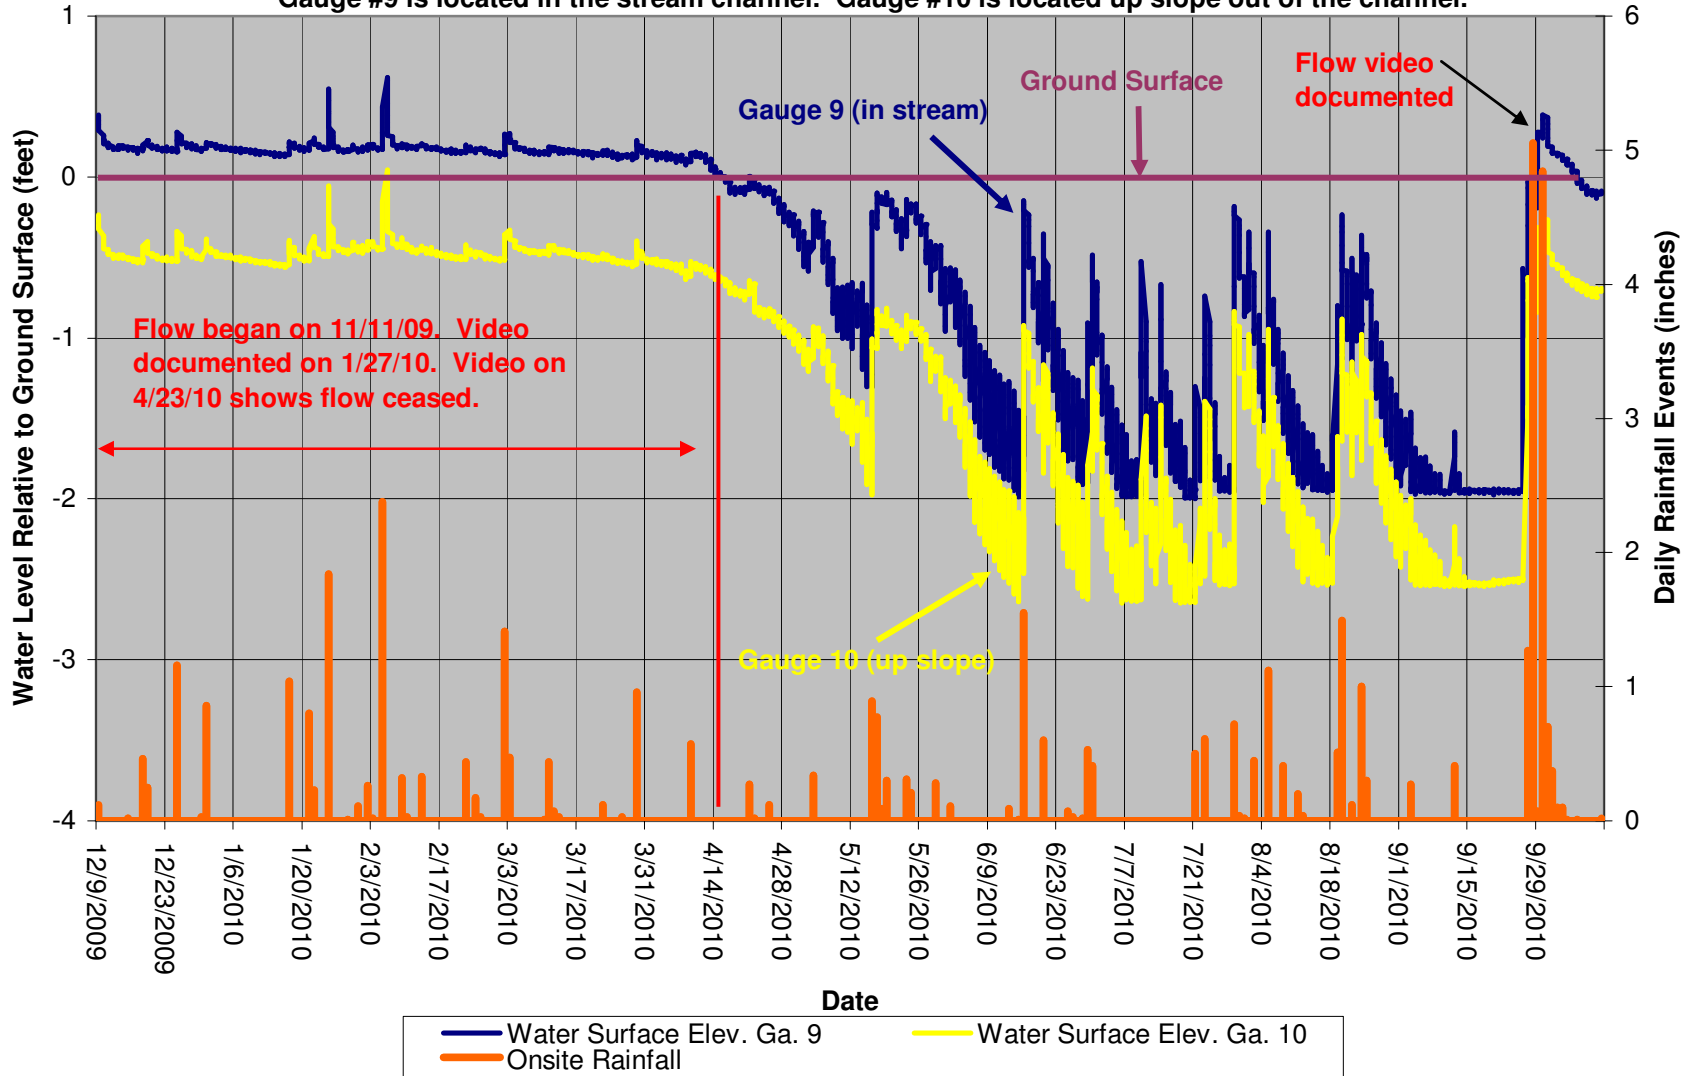
Figure F5.
Goodman Monitoring Gauges #9 and #10

Gauge #9 is located in the stream channel. Gauge #10 is located up slope out of the channel.

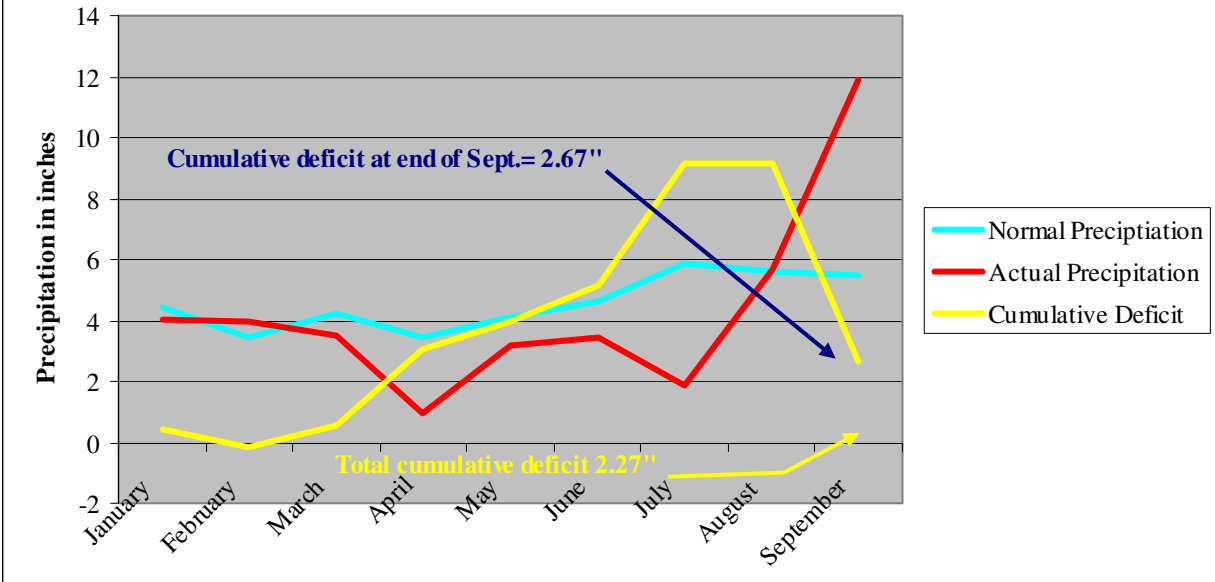
Figure P-1
2010 Reference Precipitation

Accumulated rainfall deficit through September 2010 was 2.67 inches. The deficit in July and August was slightly over 9 inches but was relieved in late September by a storm that dropped over 11 inches of rain during a 5 day period.
