**Goodman Property Stream Restoration Project  
Lenoir County, NC**

**2012 Annual Monitoring Report  
Year 4**

**NCEEP Project Number D000616  
Neuse River Basin**

Date: December, 2012

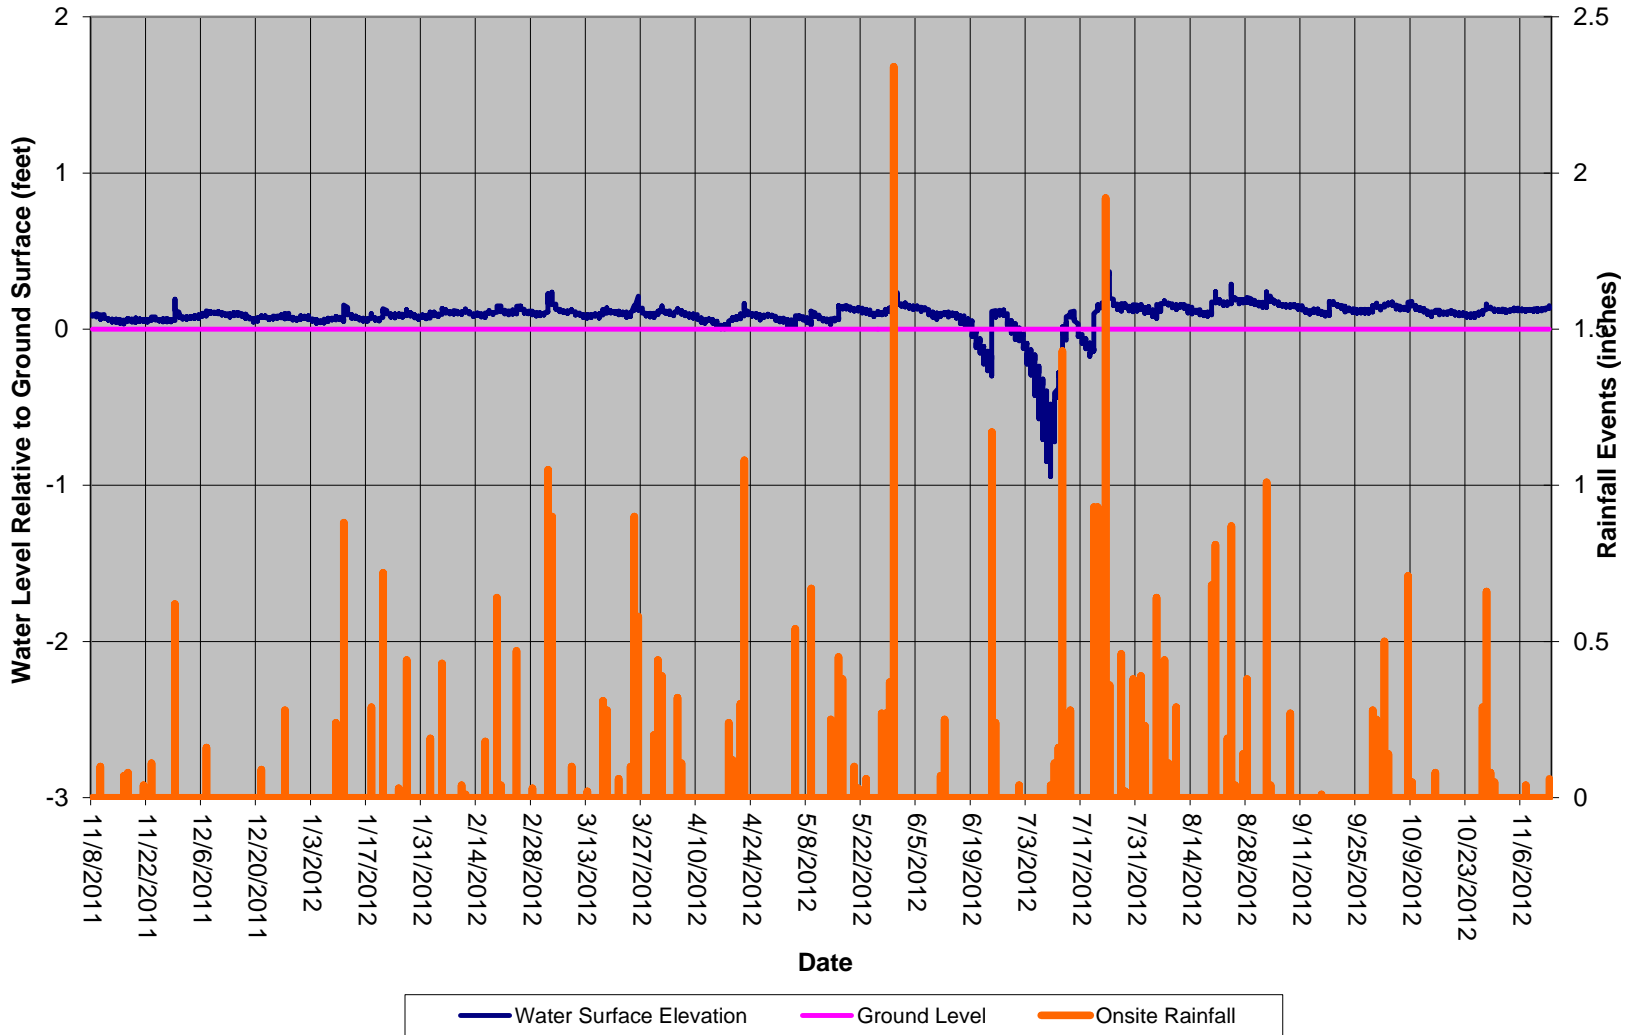
### Goodman Monitoring Gauge #9 (2255498) (Reference Gauge)

After four years of monitoring, it has become readily apparent that the southern branch of the project mirrors the reference site in duration of flow, showing sometimes shorter periods of flow or water depths that more closely approximate those in the reference area. The southern branch is fed strictly by rainfall and runoff from the adjacent field, while the northern branch is stream fed. A comparison of the flow patterns found in Figures F2 and F5 will illustrate this point. Since the northern branch of the project is stream fed, it should be expected to mirror the reference area, but in fact it shows better flow patterns than the reference area.
