**FINAL
ANNUAL MONITORING REPORT
GOOSE CREEK**

**STREAM RESTORATION
DURHAM COUNTY, NORTH CAROLINA
(EEP Project Number 147)**

Monitoring Year 2 of 5 (2010)

Prepared by:
Axiom Environmental, Inc.
20 Enterprise Street, Suite 7
Raleigh, North Carolina 27607

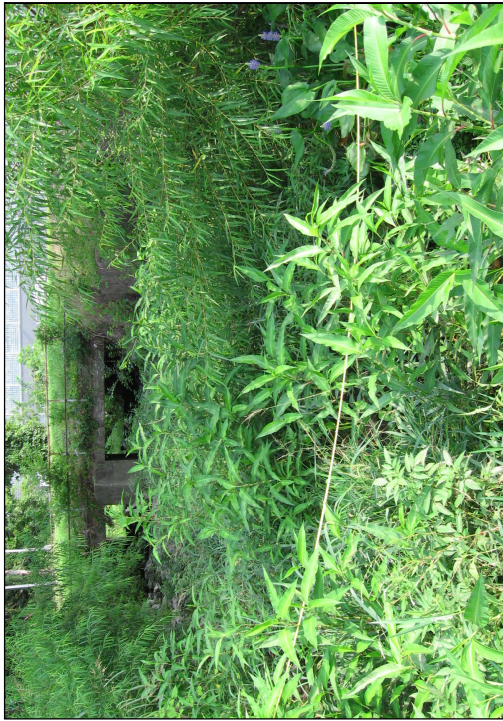
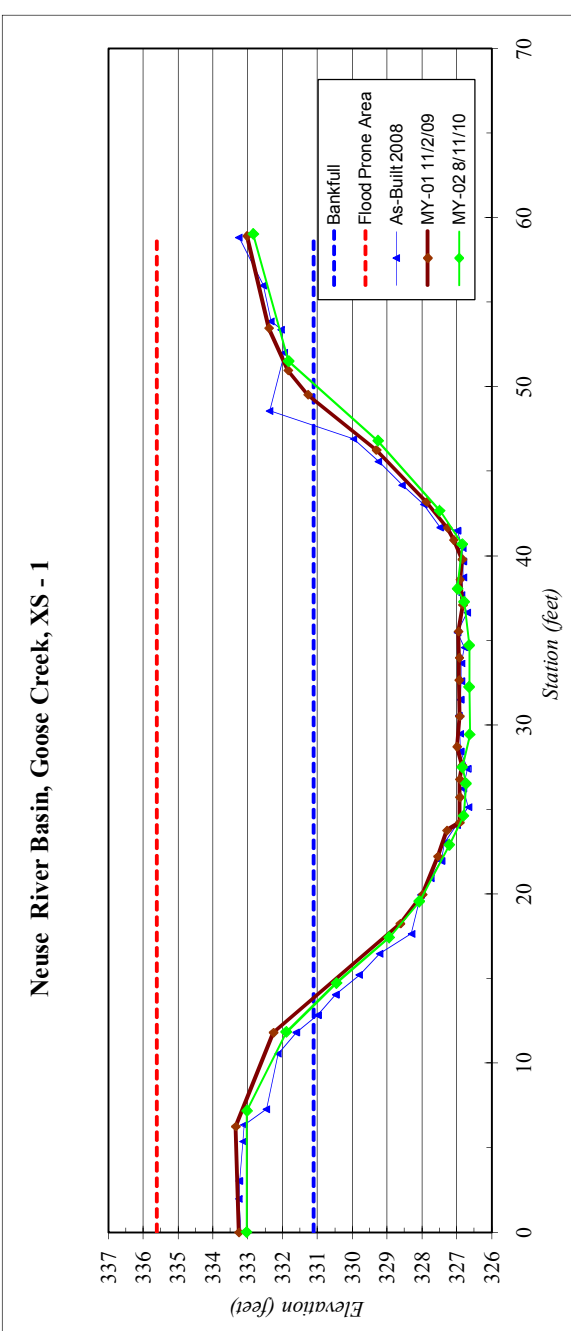
River Basin:	Neuse
Watershed:	Goose Creek
XS ID	XS - 1
Feature	Rifle
Date:	8/11/2010
Field Crew:	Dean, Perkinson

SUMMARY DATA	
Bankfull Elevation:	331.1
Bankfull Cross-Sectional Area:	120.7
Bankfull Width:	36.8
Flood Prone Area Elevation:	335.6
Flood Prone Width:	170.0
Max Depth at Bankfull:	4.5
Mean Depth at Bankfull:	3.3
W / D Ratio:	11.2
Entrenchment Ratio:	4.6
Bank Height Ratio:	1.0

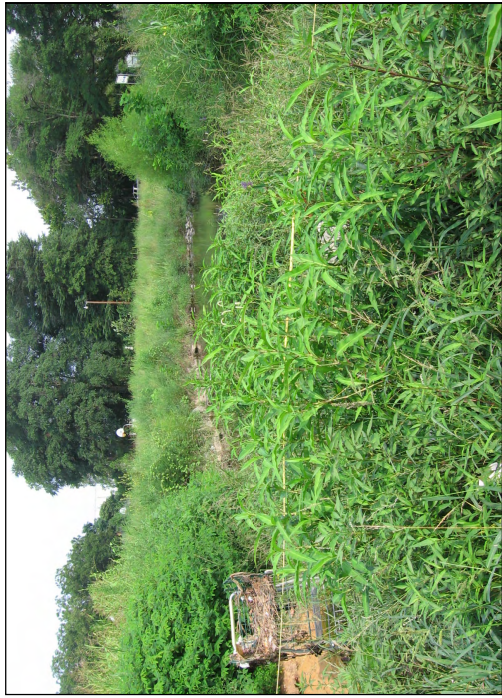
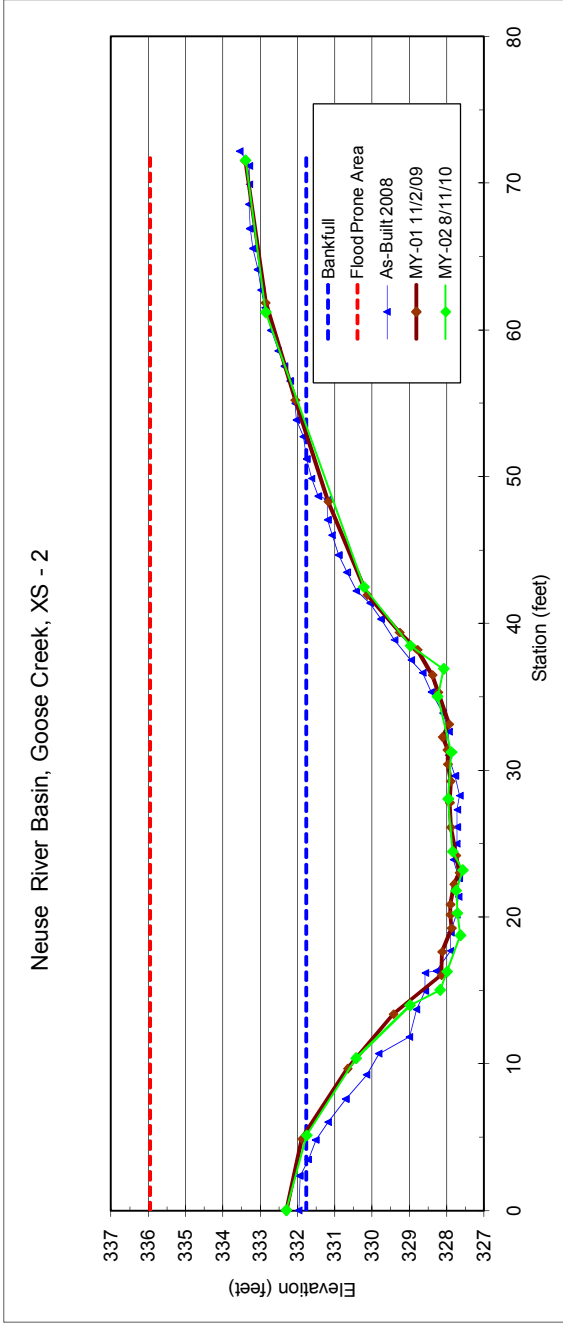
River Basin:	Neuse
Watershed:	Goose Creek
XS ID	XS - 2
Feature	Riffle
Date:	8/11/2010
Field Crew:	Dean, Perkinson

SUMMARY DATA	
Bankfull Elevation:	331.8
Bankfull Cross-Sectional Area:	120.8
Bankfull Width:	48.3
Flood Prone Area Elevation:	336.0
Flood Prone Width:	300.0
Max Depth at Bankfull:	4.2
Mean Depth at Bankfull:	2.5
W / D Ratio:	19.3
Entrenchment Ratio:	6.2
Bank Height Ratio:	1.0

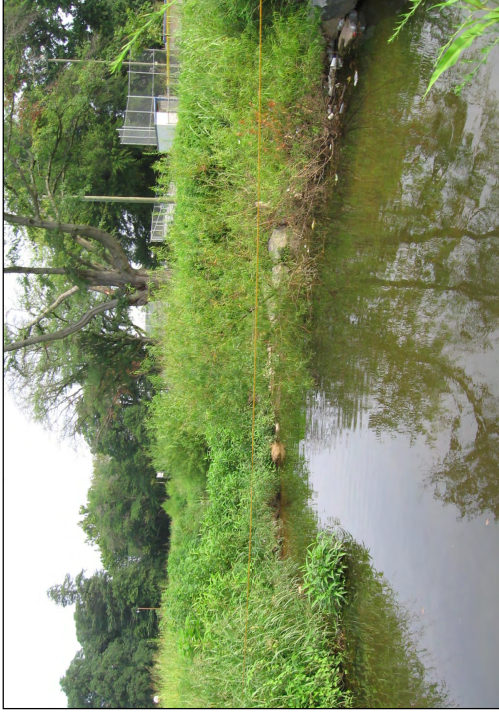
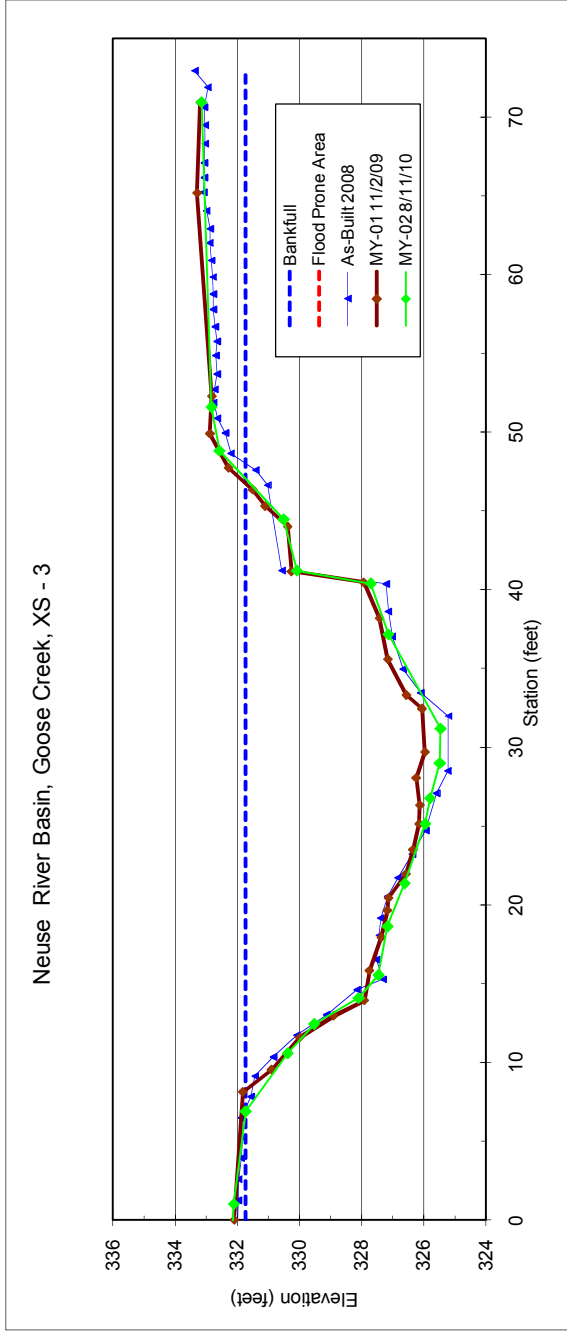
River Basin:	Neuse
Watershed:	Goose Creek
XS ID	XS - 3
Feature	Pool
Date:	8/11/2010
Field Crew:	Dean, Perkinson

SUMMARY DATA		
Bankfull Elevation:		331.7
Bankfull Cross-Sectional Area:		155.7
Bankfull Width:		40.3
Flood Prone Area Elevation:		-
Flood Prone Width:		-
Max Depth at Bankfull:		6.3
Mean Depth at Bankfull:		3.9
W/D Ratio:		-
Entrenchment Ratio:		-
Bank Height Ratio:		1.0

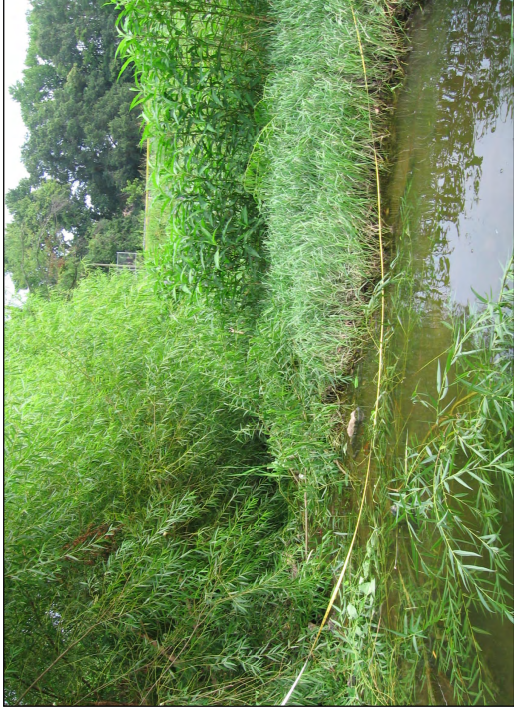
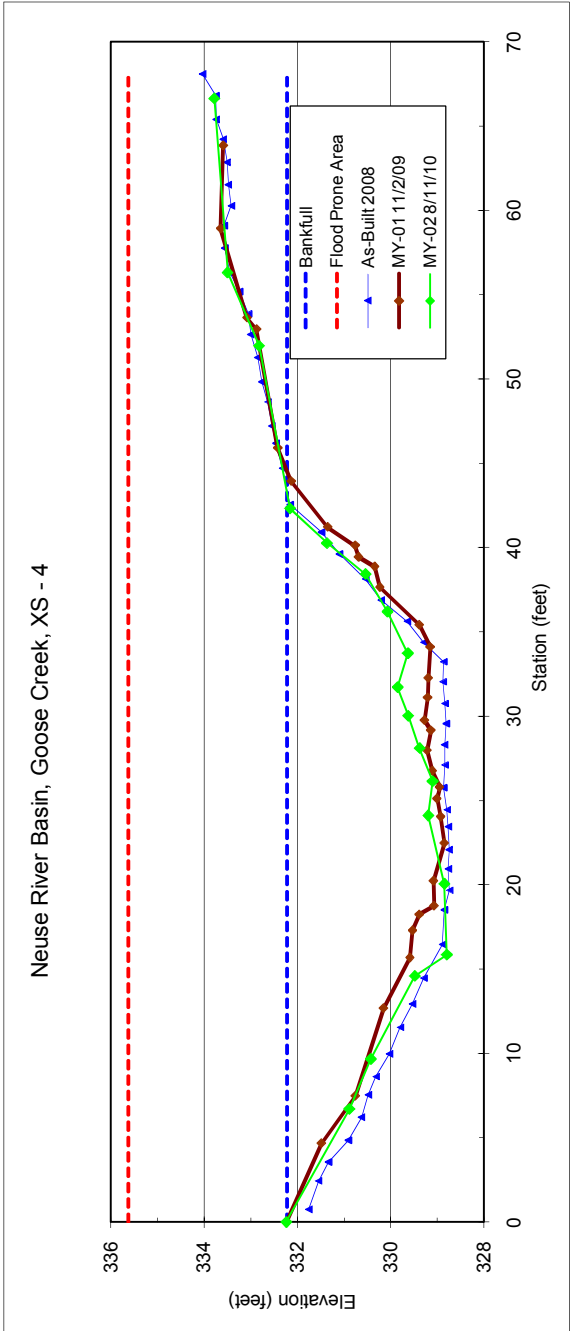
River Basin:	Neuse
Watershed:	Goose Creek
XS ID	XS - 4
Featurer	Riffle
Date:	8/11/2010
Field Crew:	Dean, Perkinson

SUMMARY DATA	
Bankfull Elevation:	332.2
Bankfull Cross-Sectional Area:	91.6
Bankfull Width:	43.3
Flood Prone Area Elevation:	335.6
Flood Prone Width:	240.0
Max Depth at Bankfull:	3.4
Mean Depth at Bankfull:	2.1
W / D Ratio:	20.5
Entrenchment Ratio:	5.5
Bank Height Ratio:	1.0

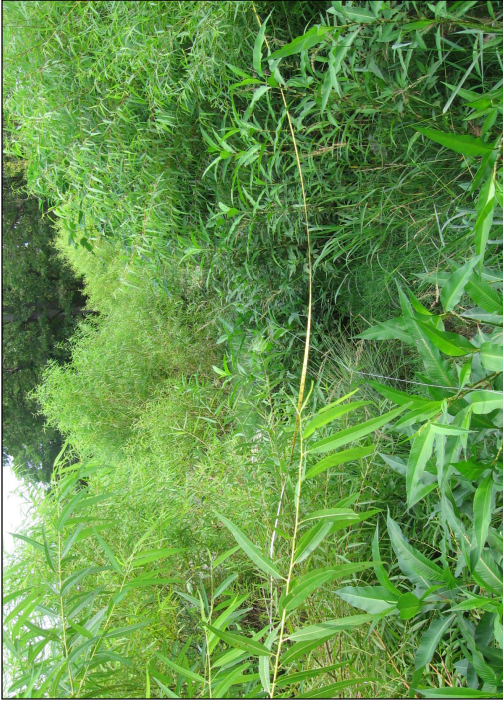
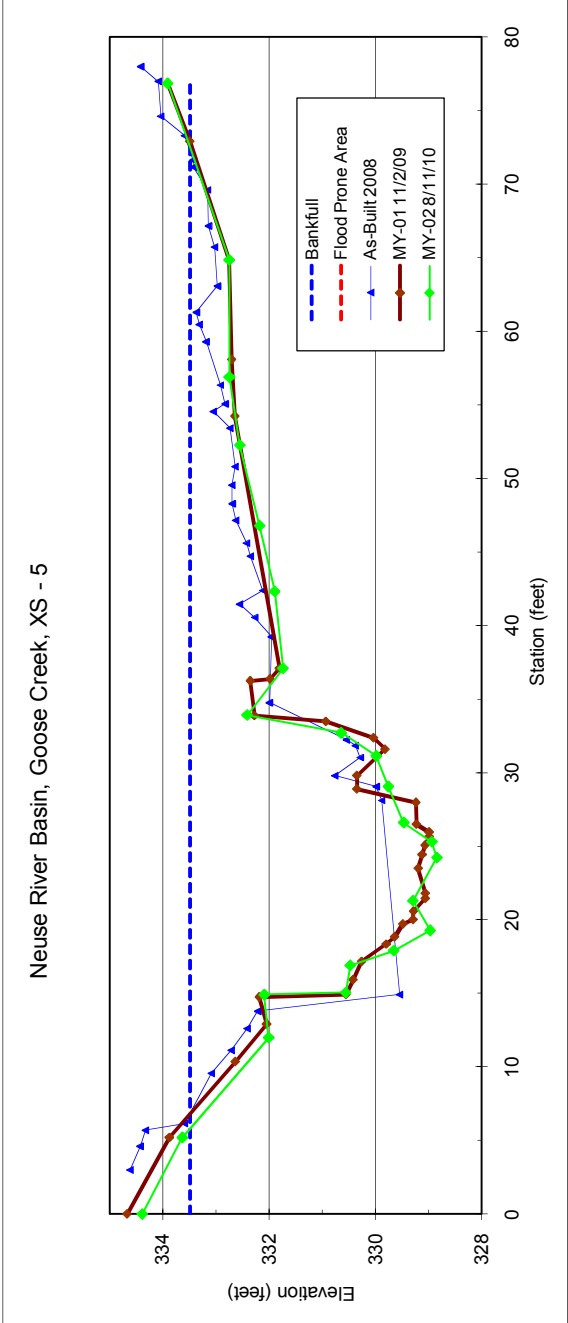
River Basin:	Neuse
Watershed:	Goose Creek
XS ID	XS - 5
Feature	Pool
Date:	8/11/2010
Field Crew:	Dean, Perkinson

Site include an area of bank erosion on the right bank just downstream of Cross-section 7 and at Cross-section 5 (Figure 2, Appendix A). In addition, vandalism of containerized plants and livestakes within the vicinity of Vegetation Plot 2 occurred shortly after planting in late spring/early summer of 2009. This Site is located in a public park and it is suspected that neighborhood kids pulled the plants out of the ground resulting in reduced numbers of planted stems. Naturally recruited stems of appropriate hardwood species are establishing within these areas; it is recommended to watch these areas closely.

SUMMARY DATA	
Bankfull Elevation:	333.4
Bankfull Cross-Sectional Area:	115.4
Bankfull Width:	65.9
Flood Prone Area Elevation:	-
Flood Prone Width:	-
Max Depth at Bankfull:	4.6
Mean Depth at Bankfull:	1.8
W / D Ratio:	-
Entrenchment Ratio:	-
Bank Height Ratio:	-

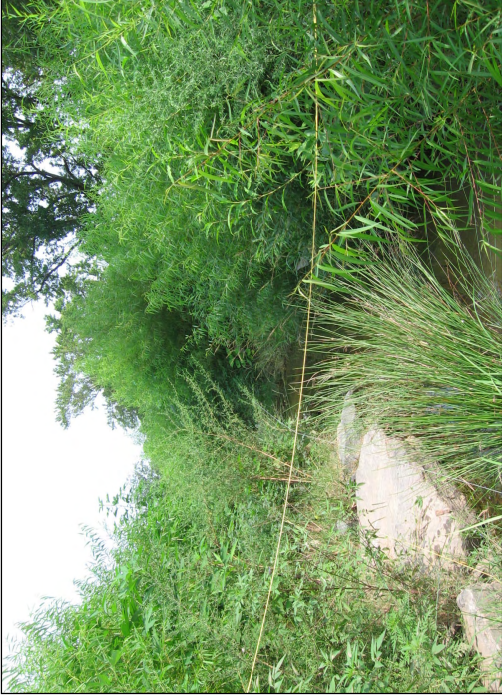
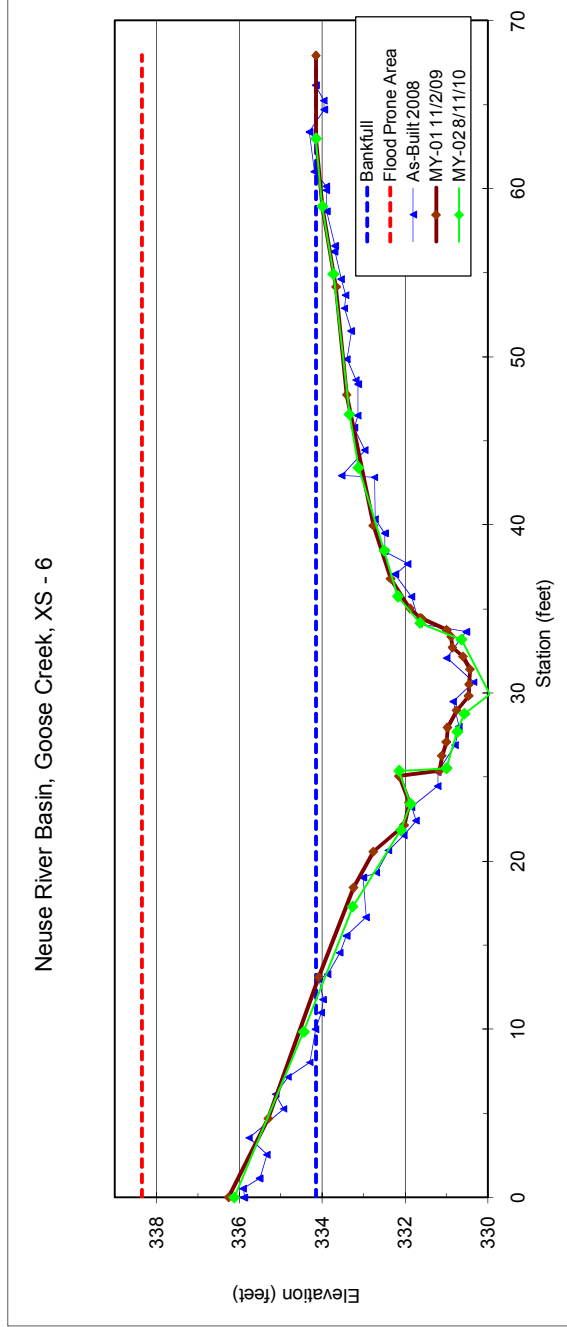
River Basin:	Neuse
Watershed:	Goose Creek
XS ID	XS - 6
Feature	Riffle
Date:	8/11/2010
Field Crew:	Dean, Perkinson

SUMMARY DATA	
Bankfull Elevation:	334.2
Bankfull Cross-Sectional Area:	72.5
Bankfull Width:	55.5
Flood Prone Area Elevation:	338.4
Flood Prone Width:	162.0
Max Depth at Bankfull:	4.2
Mean Depth at Bankfull:	1.3
W / D Ratio:	42.5
Entrenchment Ratio:	2.9
Bank Height Ratio:	1.0

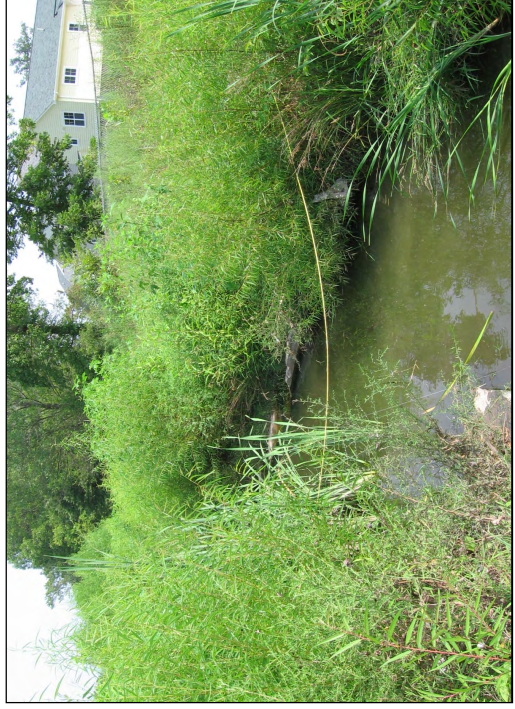
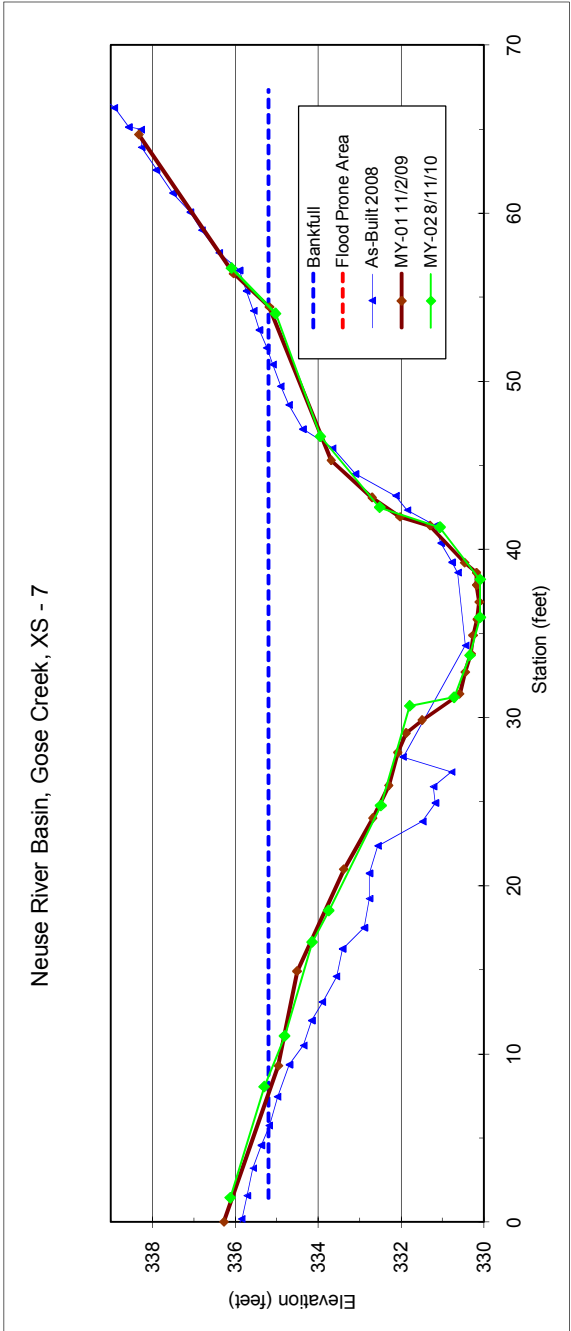
River Basin:	Neuse
Watershed:	Gose Creek
XS ID	XS - 7
Feature	Pool
Date:	8/11/2010
Field Crew:	Dean, Perkinson

SUMMARY DATA	
Bankfull Elevation:	335.2
Bankfull Cross-Sectional Area:	104.6
Bankfull Width:	45.5
Flood Prone Area Elevation:	-
Flood Prone Width:	-
Max Depth at Bankfull:	5.1
Mean Depth at Bankfull:	2.3
W / D Ratio:	-
Entrenchment Ratio:	-
Bank Height Ratio:	-

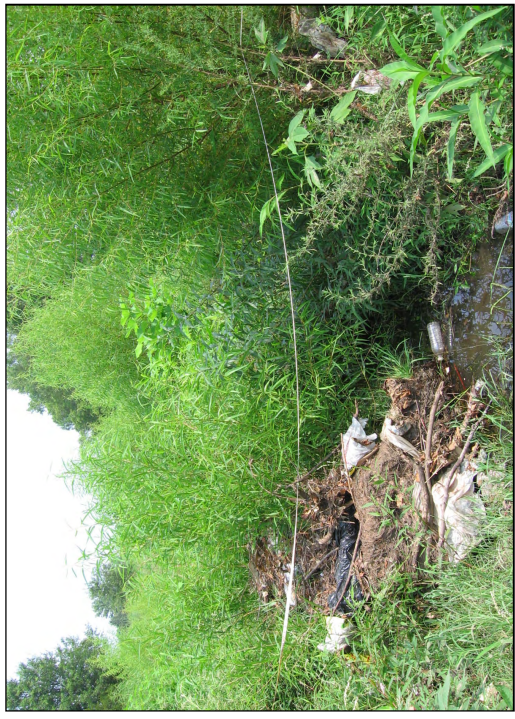
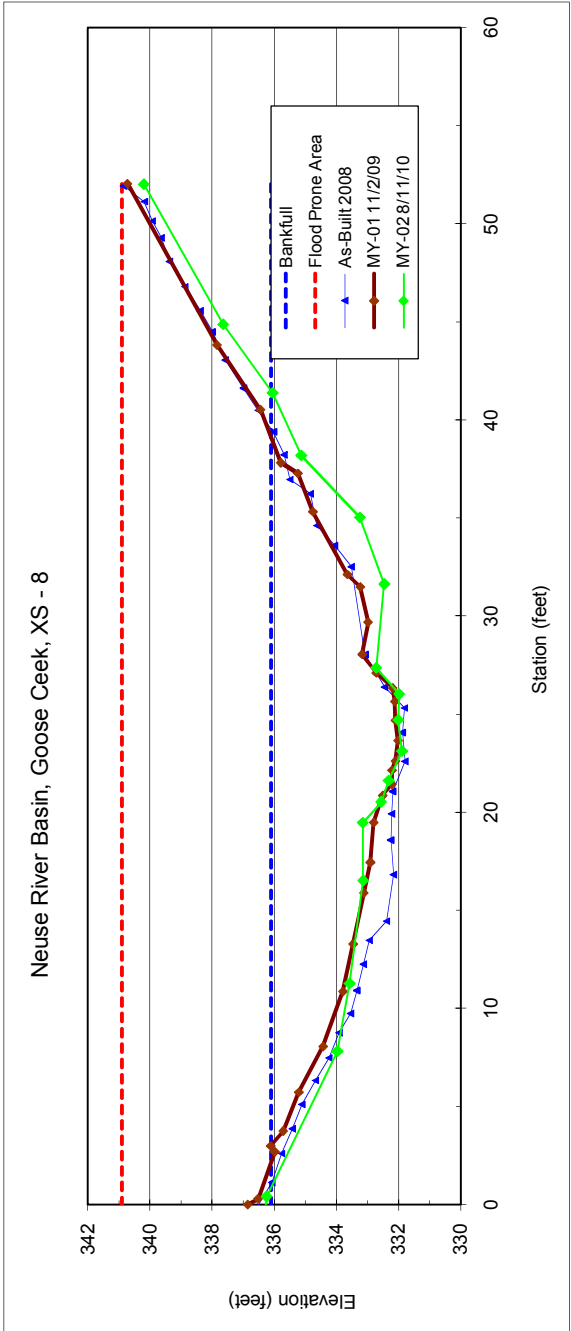
River Basin:	Neuse
Watershed:	Goose Creek
XS ID	XS - 8
Feature	Rifle
Date:	8/11/2010
Field Crew:	Dean, Perkinson

SUMMARY DATA	
Bankfull Elevation:	337.1
Bankfull Cross-Sectional Area:	87.7
Bankfull Width:	38.1
Flood Prone Area Elevation:	340.9
Flood Prone Width:	170.0
Max Depth at Bankfull:	3.8
Mean Depth at Bankfull:	2.3
W / D Ratio:	16.6
Entrenchment Ratio:	4.5
Bank Height Ratio:	1.0
