**FINAL
ANNUAL MONITORING REPORT
GOOSE CREEK**

**STREAM RESTORATION
DURHAM COUNTY, NORTH CAROLINA
(EEP Project Number 147, Contract Number 004681)**

Monitoring Year 4 of 5 (2012)

Prepared by:
Axiom Environmental, Inc.
218 Snow Avenue
Raleigh, North Carolina 27603

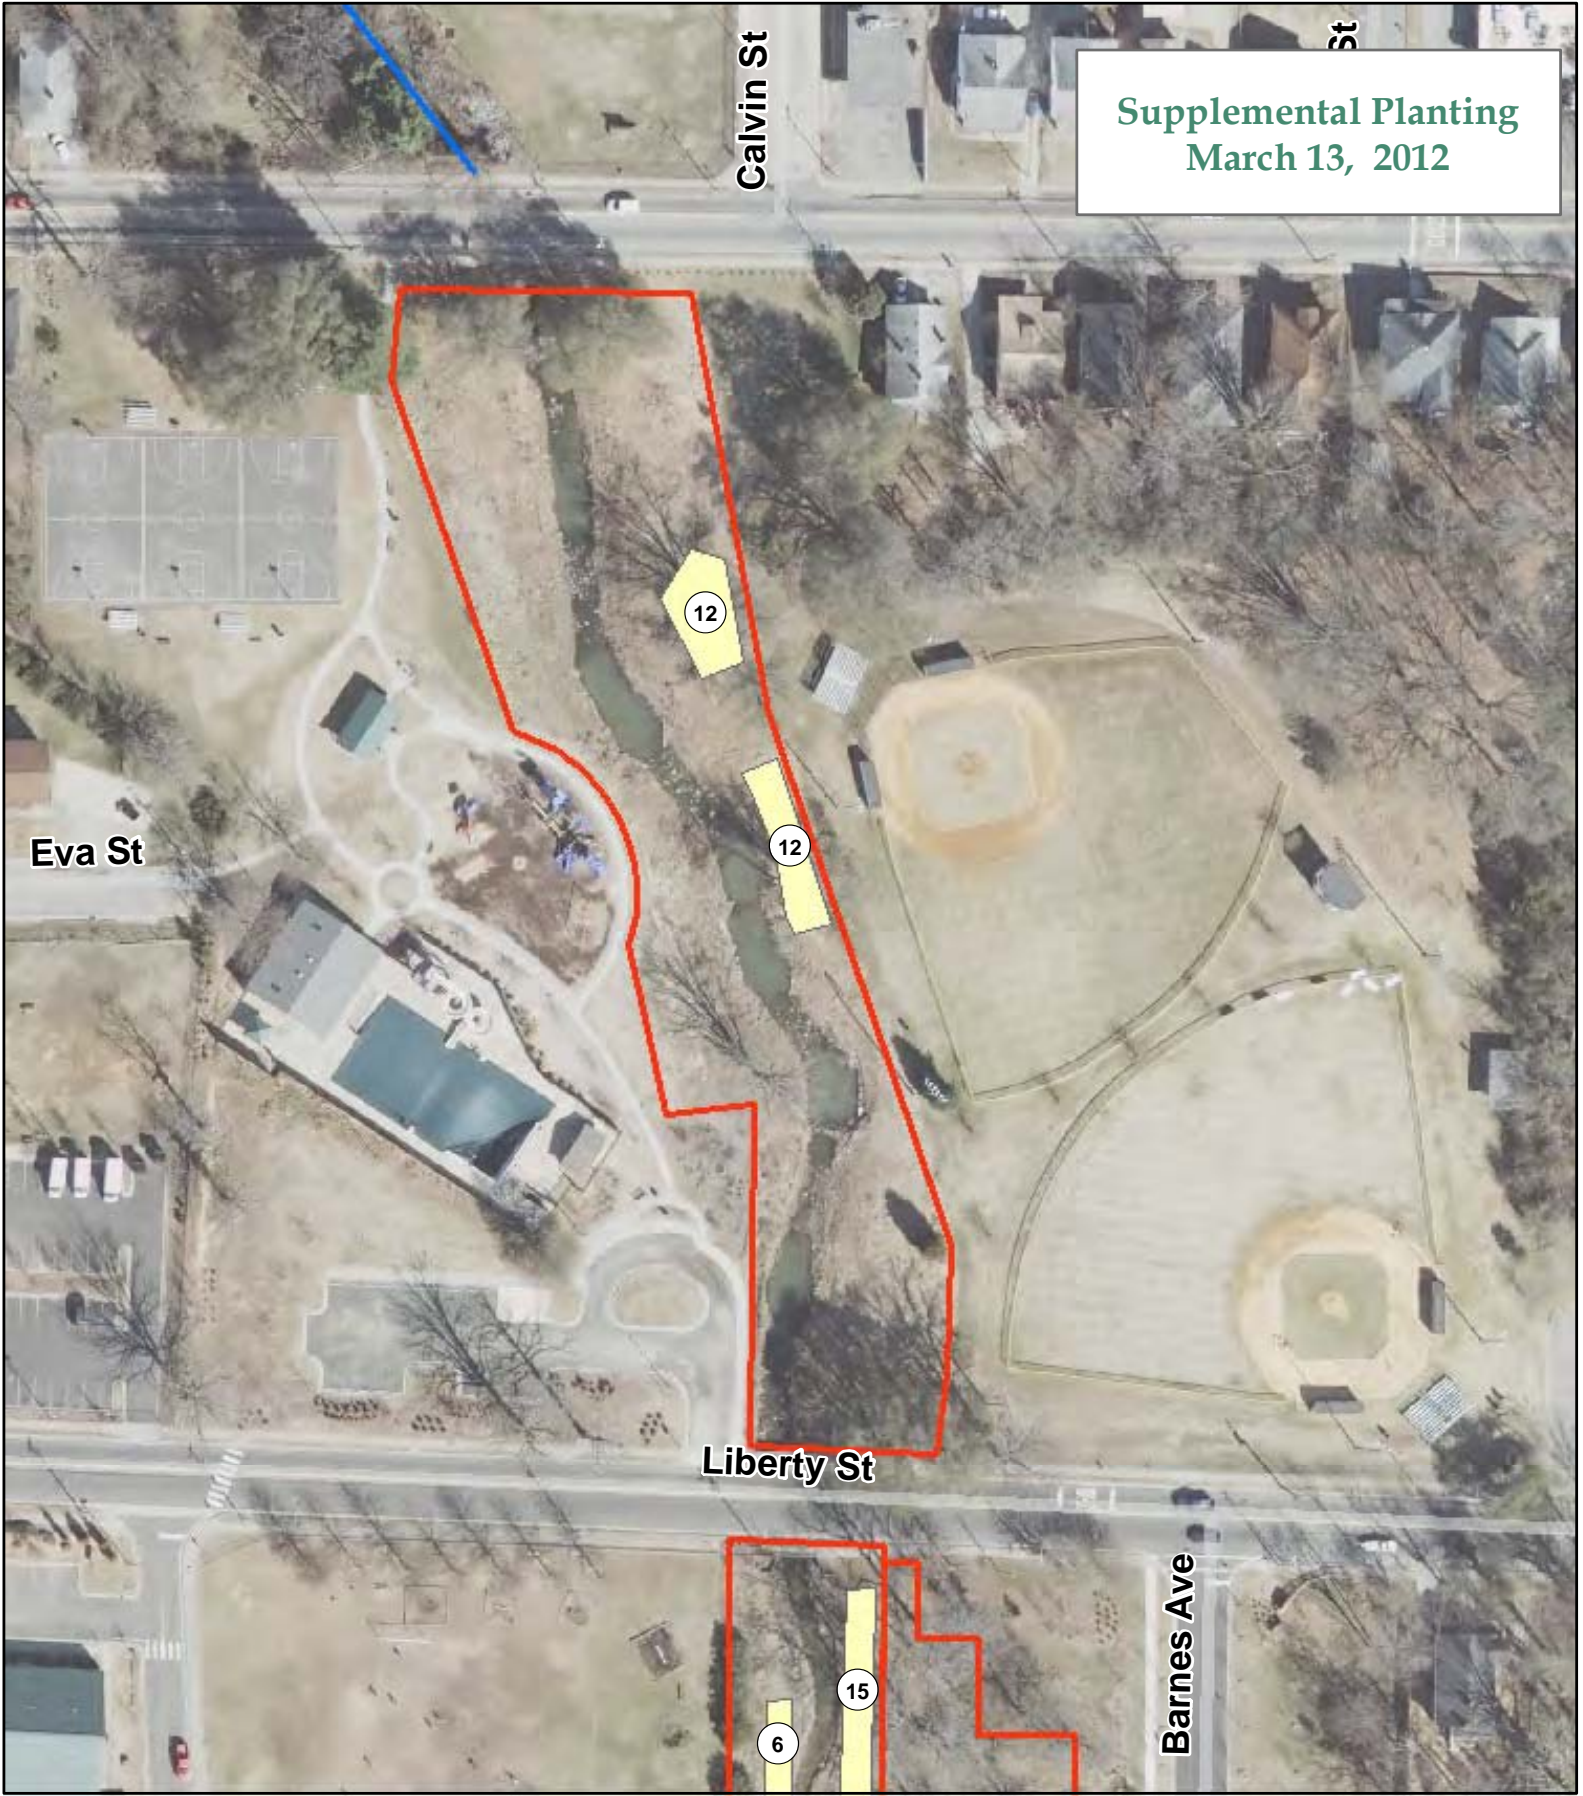
Supplemental Planting
March 13, 2012

NOTE:
Quantities of container plant material installed
for each area shown for each area. Areas are approximate.

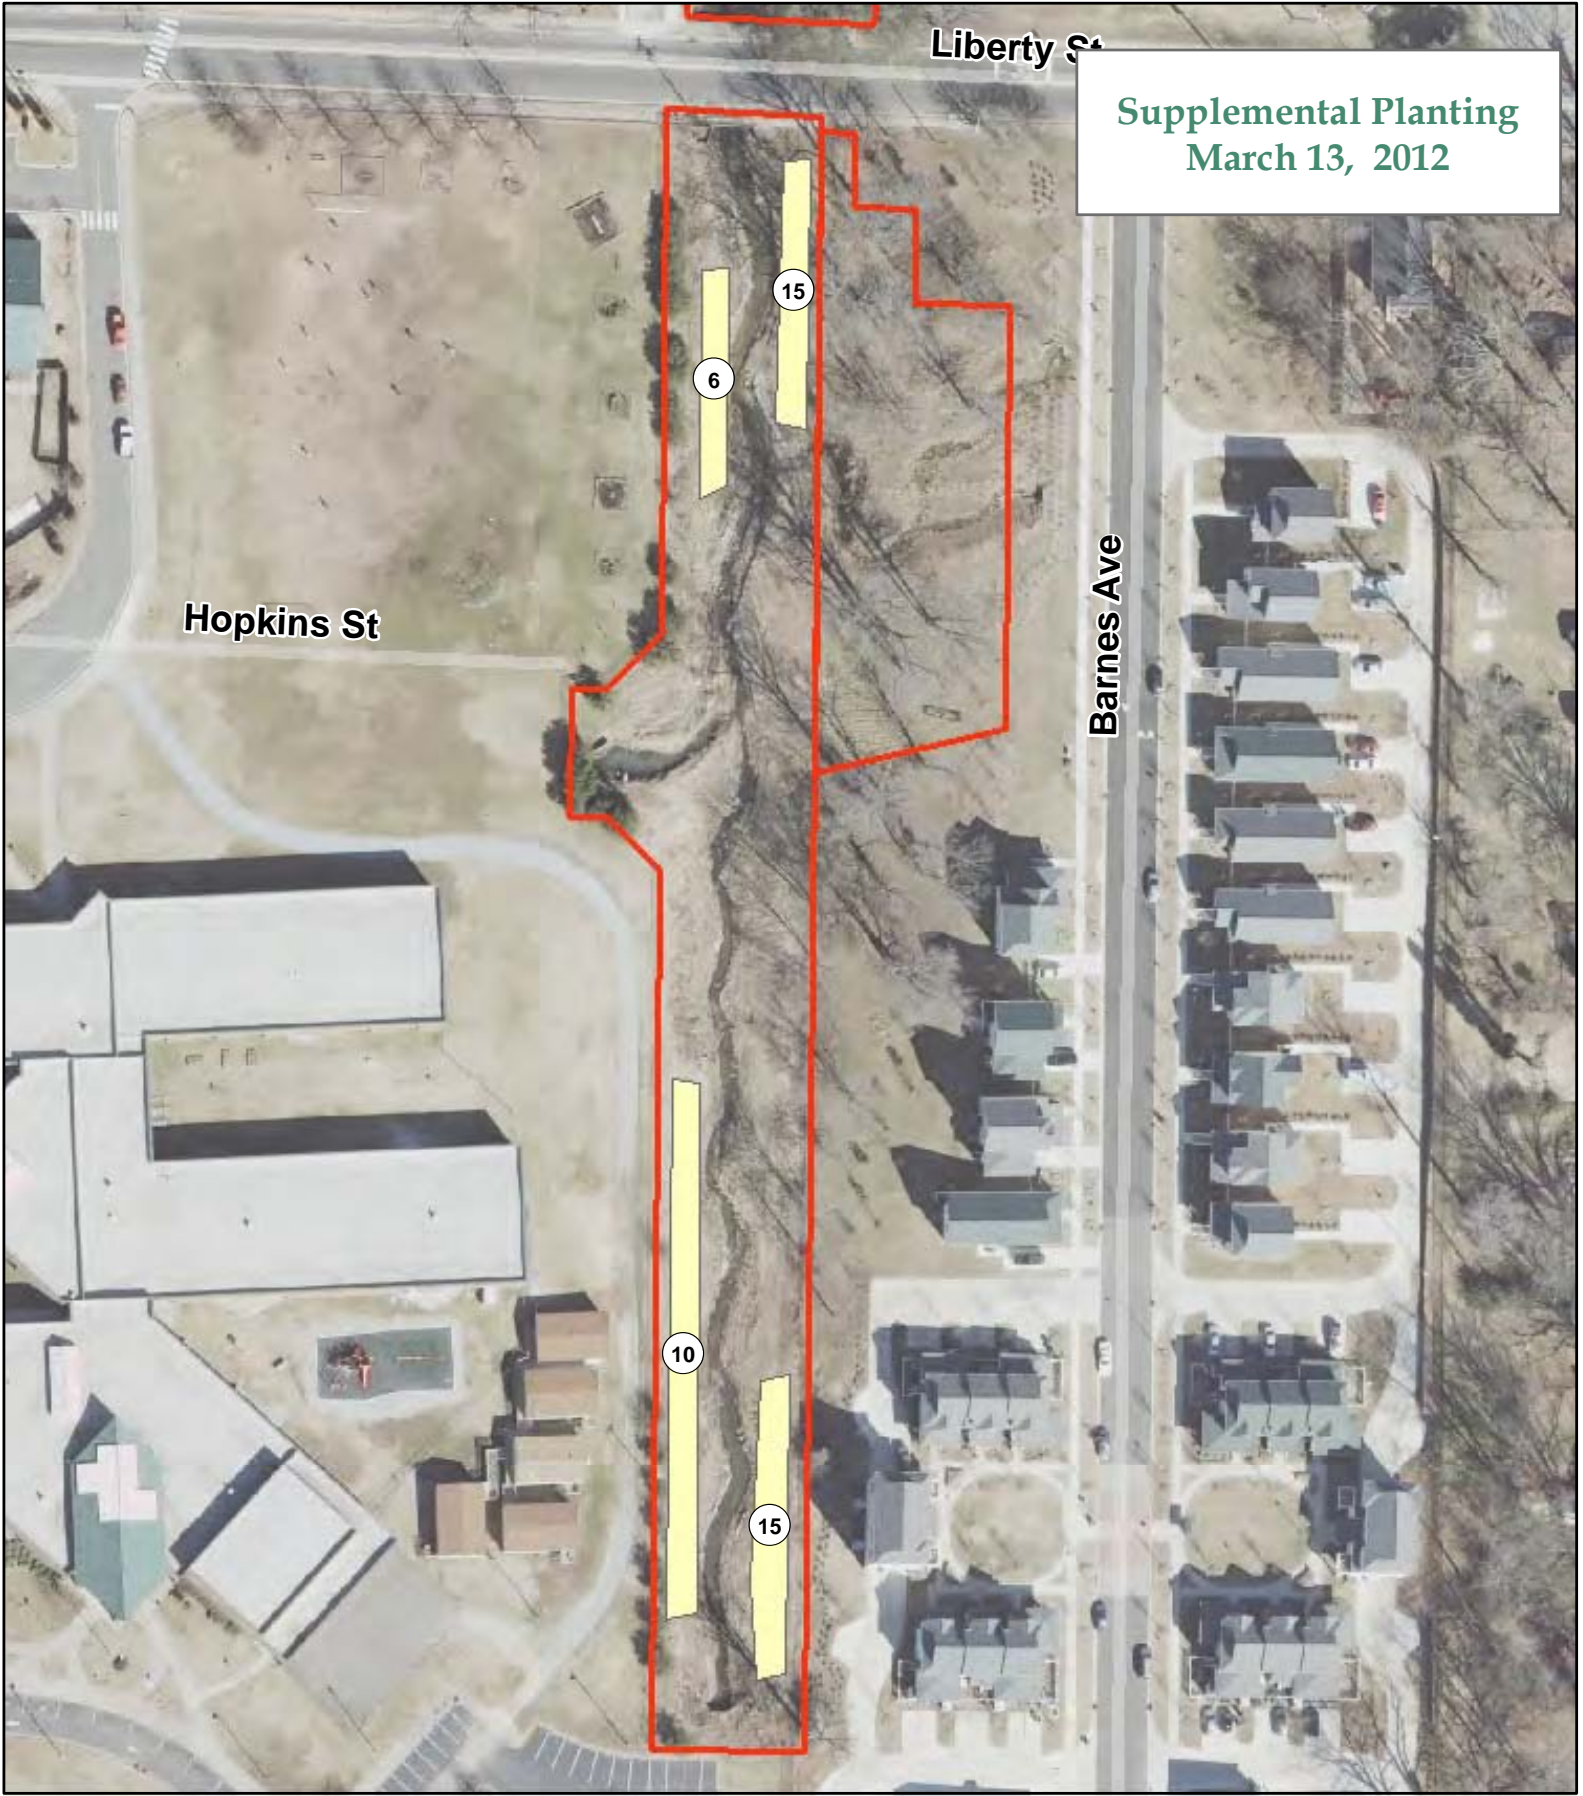
Supplemental Planting
March 13, 2012

NOTE:
Quantities of container plant material installed
for each area shown for each area. Areas are approximate.
