**Goose Creek (Greene Mitigation)
Stream Enhancement Project
EEP Project No. 92709
2010 Monitoring Report: Year 2 of 5**

**Construction Completed: February 2005
Submission Date: March 2011**

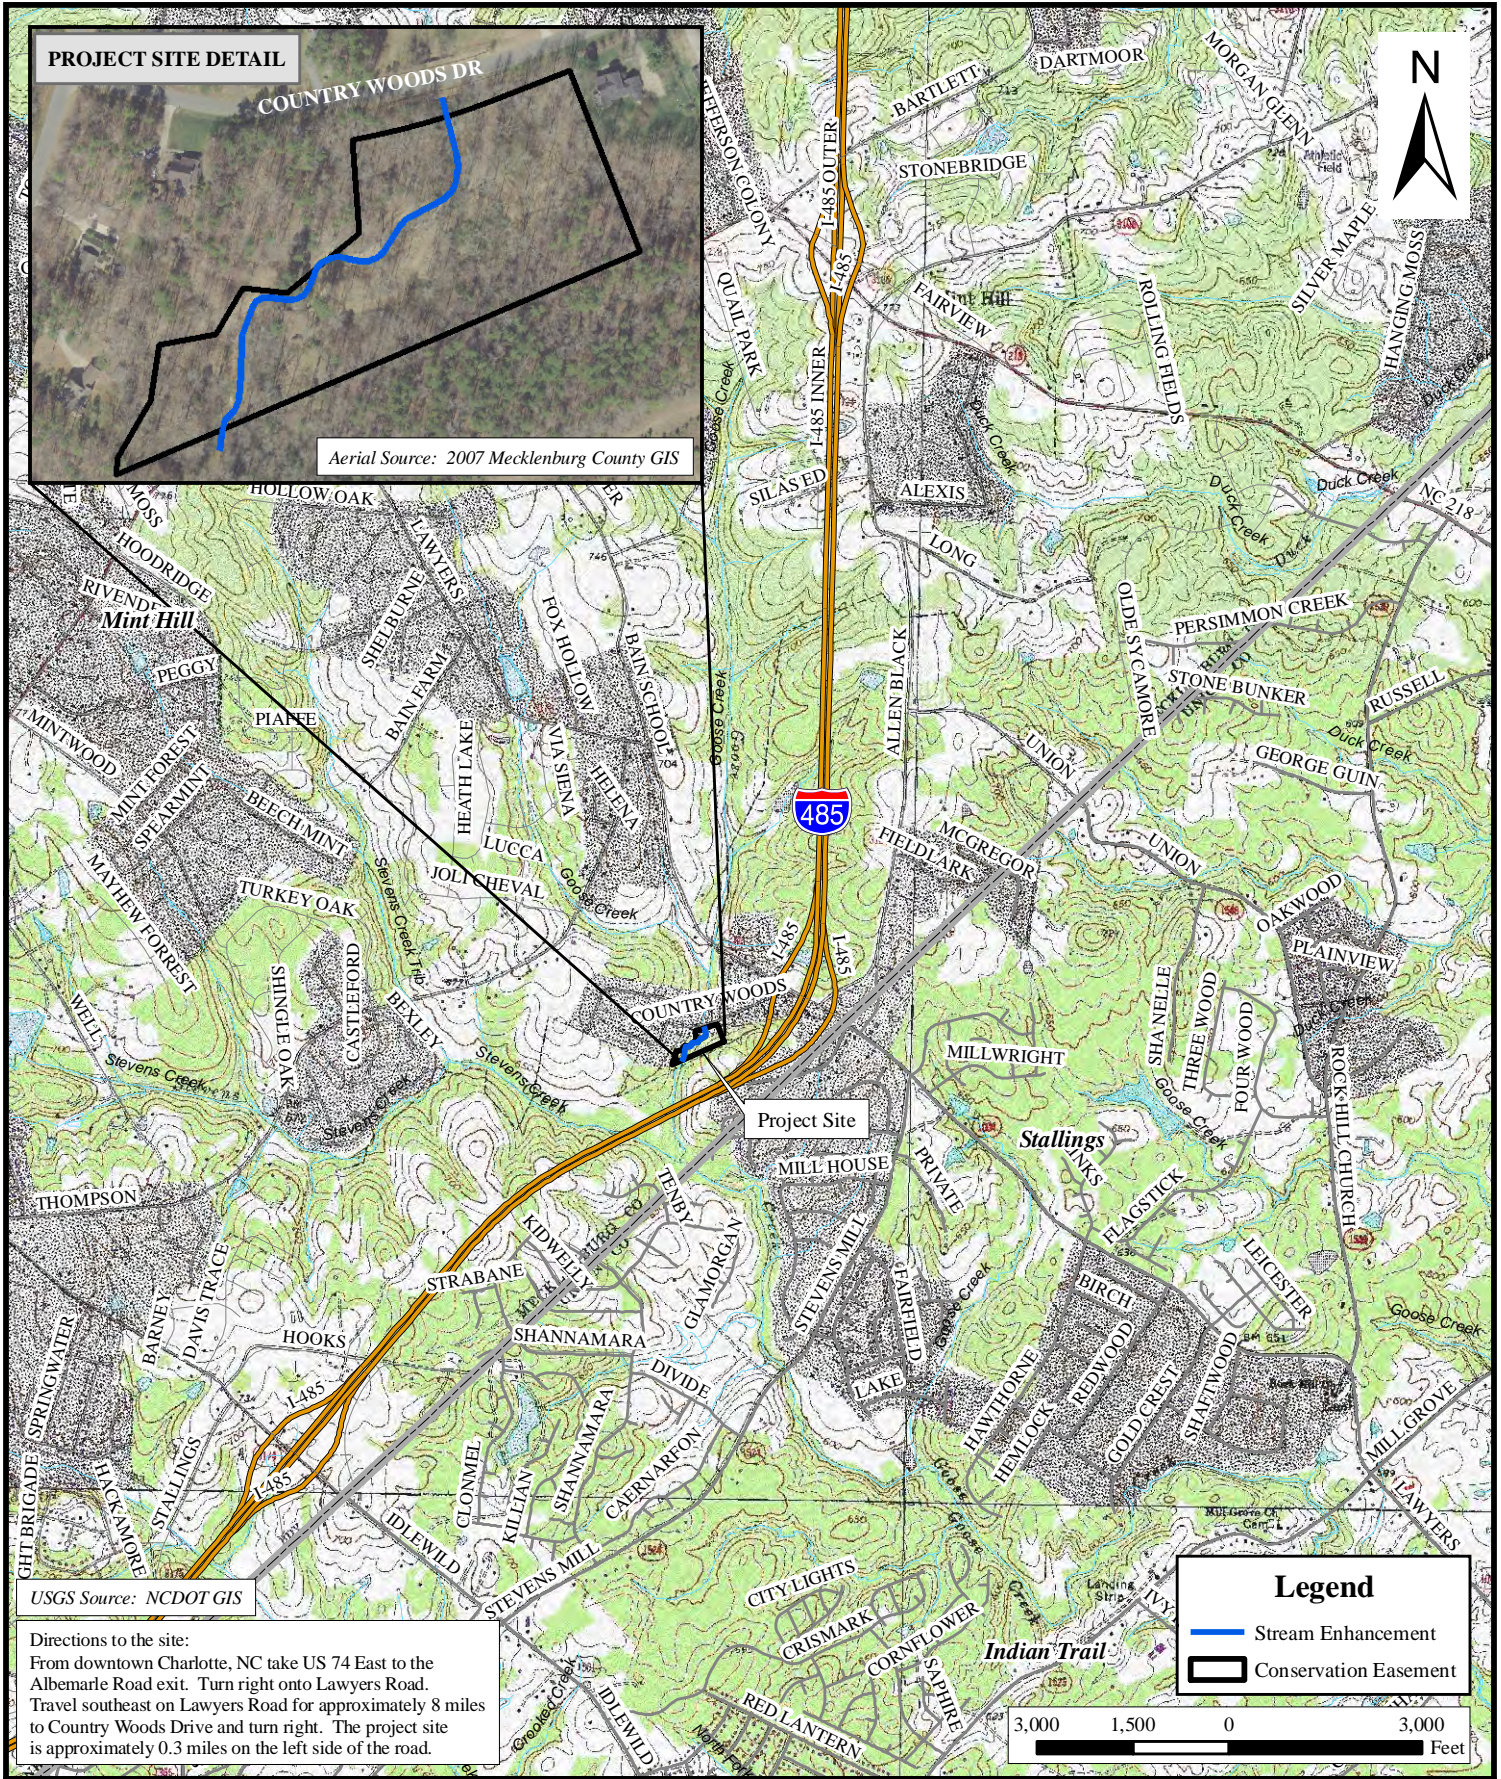
APPENDIX 1.2
 CURRENT CONDITION PLAN VIEW

Near station 4+00 feet (ft), a debris jam that has formed has temporarily affected the profile. This change in the profile is not a significant change that appears to be permanent. The debris jam and accumulated sediment will probably be flushed out of the system with future rain events. Other areas that are being watched include a stressed boulder toe with dislodged boulders and a failed structure at the end of the project that is no longer providing adequate bank protection. This structure is not providing the intended protection as it has become dislodged, and the neighboring bank has exhibited bank erosion. The structure may need to be removed.
