**UT Goose Creek (Greene Mitigation)
Stream Enhancement Project
EEP Project No. 92709
2011 Monitoring Report: Year 3**

**Construction Completed: February 2005
Submission Date: April 2012**

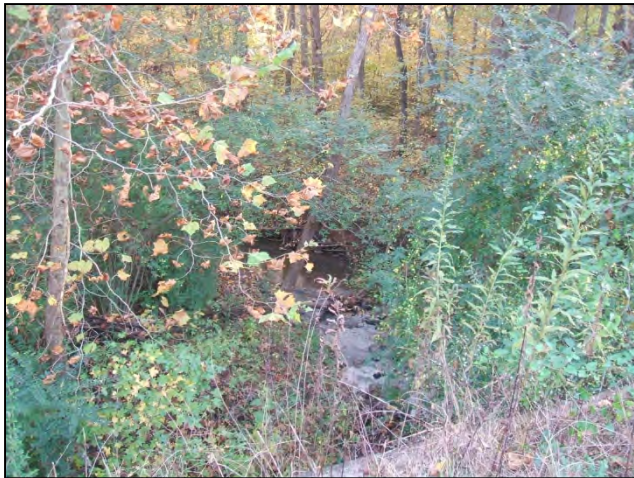
Photo Point 1: View Downstream Right Bank
(MY 1 - 11/2009)

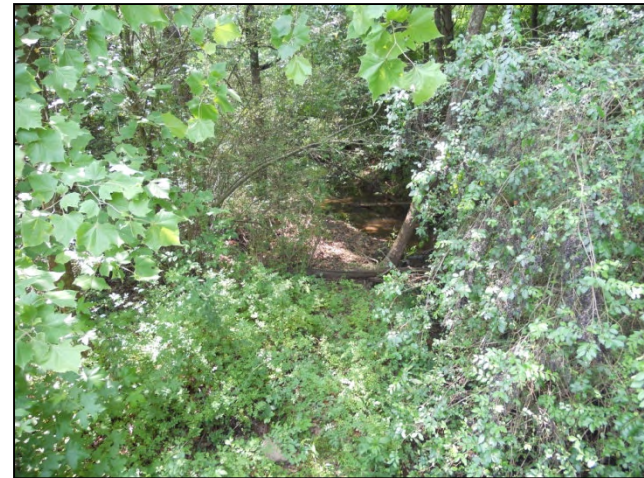
Photo Point 1: View Downstream Right Bank
(MY 3 - 6/2011)
