Gray Farm Stream Restoration Monitoring Report – Year One

Contract # D05016-2

Iredell County, North Carolina

March 2007

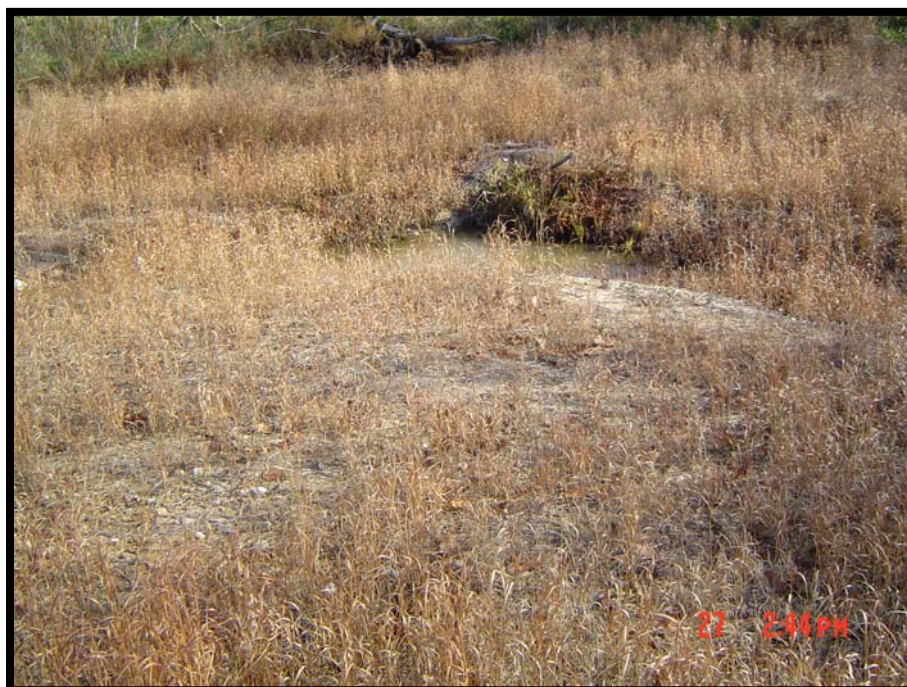
On Reach 2, two insignificant areas of bare floodplain were observed. These appear to be due to localized poor soils which have inhibited plant growth on the floodplain and are shown on Sheets 14 through 16. Photos are included in Appendix A.

Typical Bare Floodplain—Reach 2—Year 1 (2006)
