Gray Farm Stream Restoration Monitoring Report – Year Two

**Contract # D05016-2
EEP Project # 92219**

Iredell County, North Carolina

December 2007

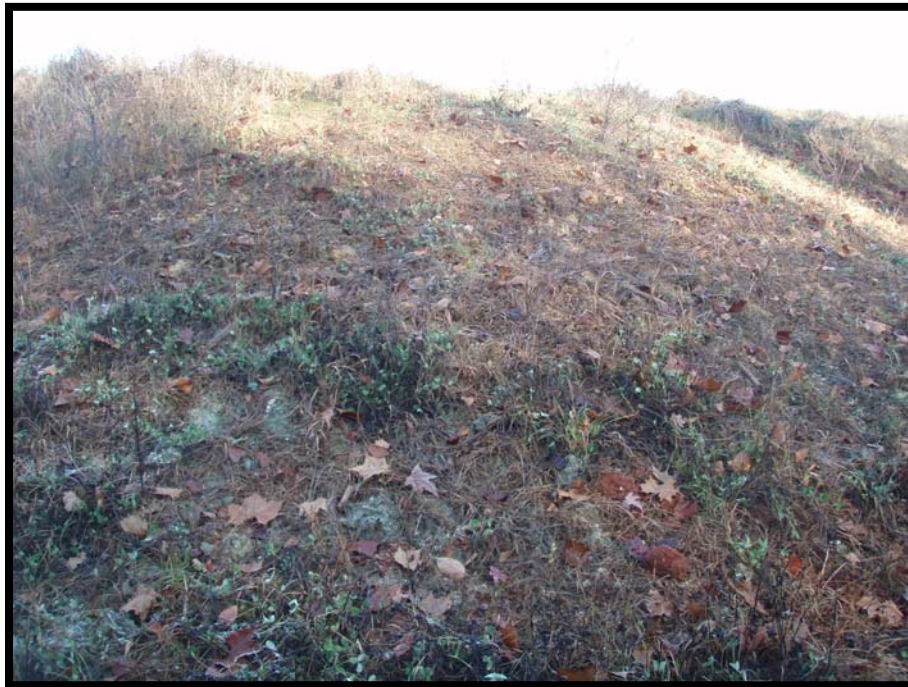
During a field inspection on November 27 & 28, 2007, a total of twelve localized areas of bare banks and floodplain were observed on Reaches 1 and 2. These areas appear to be due primarily to either surface flows or poor soil conditions. Drought conditions during the growing season have likely contributed as well. These areas are shown on Sheets 6 through 9 (Reach 1) and Sheets 14 through 16 (Reach 2). Photos are included in Appendix A.

Photo 2—Typical Bare Floodplain—Reach 1—Year 2 (2007)

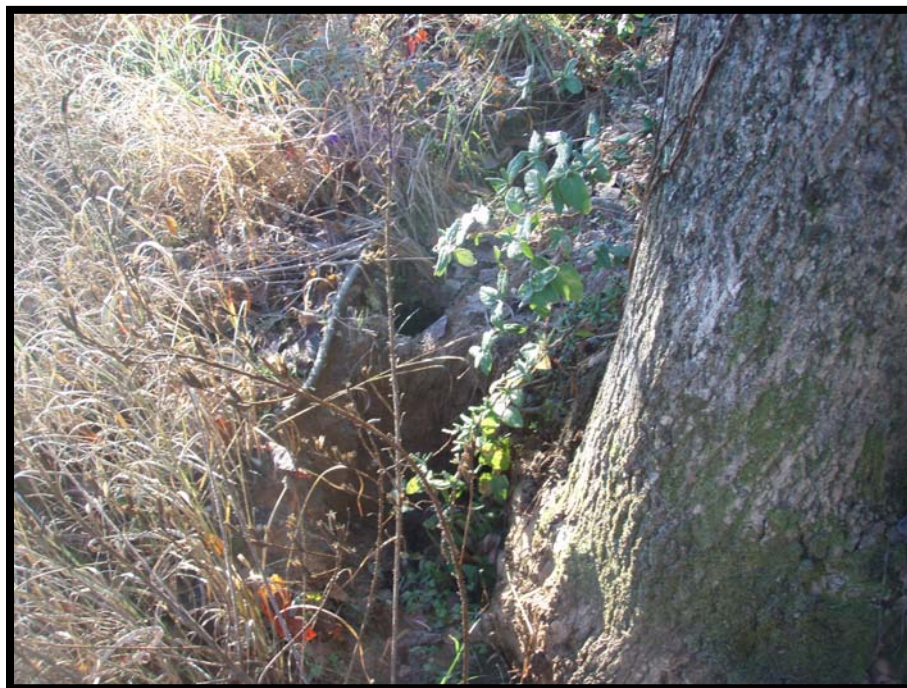
Photo 4—Exposed Roots—Reach 1—Year 2 (2007)

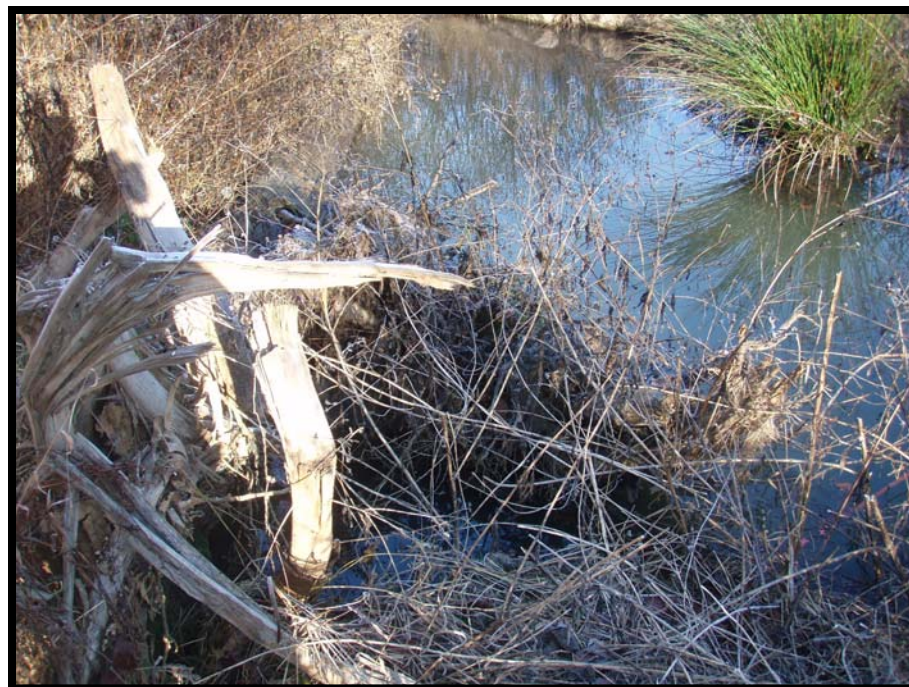
An assessment of channel stability was also performed on November 27 & 28, 2007, by S&EC. Areas of concern that were observed and documented included some minor localized bank scour and four stressed structures. Detail of such scour is evidenced in cross-section 6 (pool). These problem areas are shown on Sheets 6 through 9 for Reach 1 and Sheets 14 through 16 for Reach 2 (Problem Area Plan View).

Typical Stressed Structure/Bank Scour—Reach 1—Year 2 (2007)
