# **Gray Farm Stream Restoration Monitoring Report – Year Three**

**Contract # D05016-2  
EEP Project # 92219**

**Iredell County, North Carolina**

**December 2008**

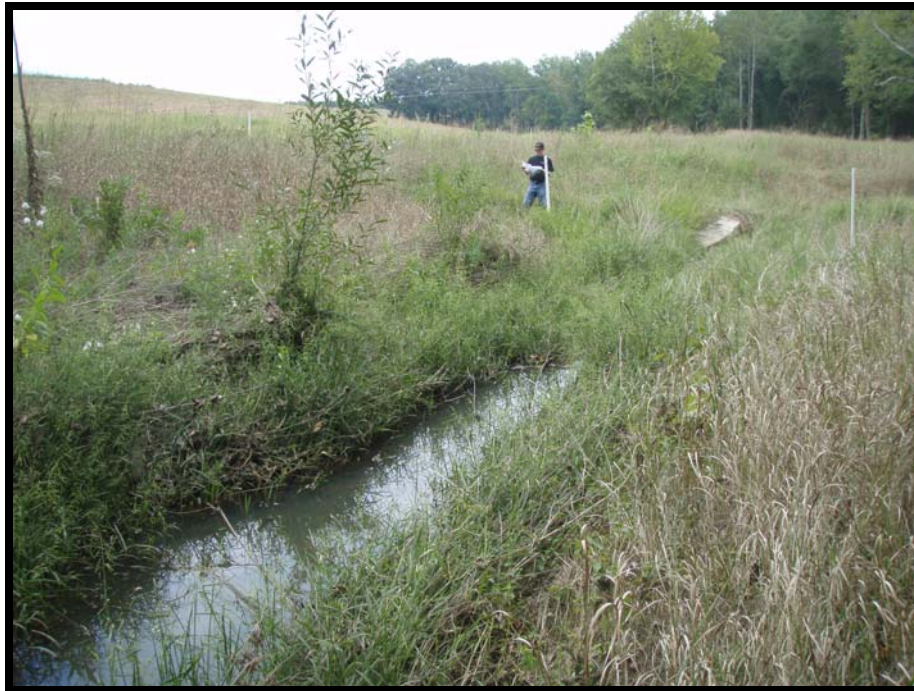
**Vegetation Monitoring Plot—Reach 1—Bank 2—Year 3 (2008)**

Although some vegetation plots showed an increase of live stakes following the drought conditions during the 2007 growing season, other plots did not. This lack of resurgence, especially in Reach 1 Bank Plot 2, is attributed to dense herbaceous vegetation along stream banks. Most surviving live stakes appear healthy and are growing vigorously.

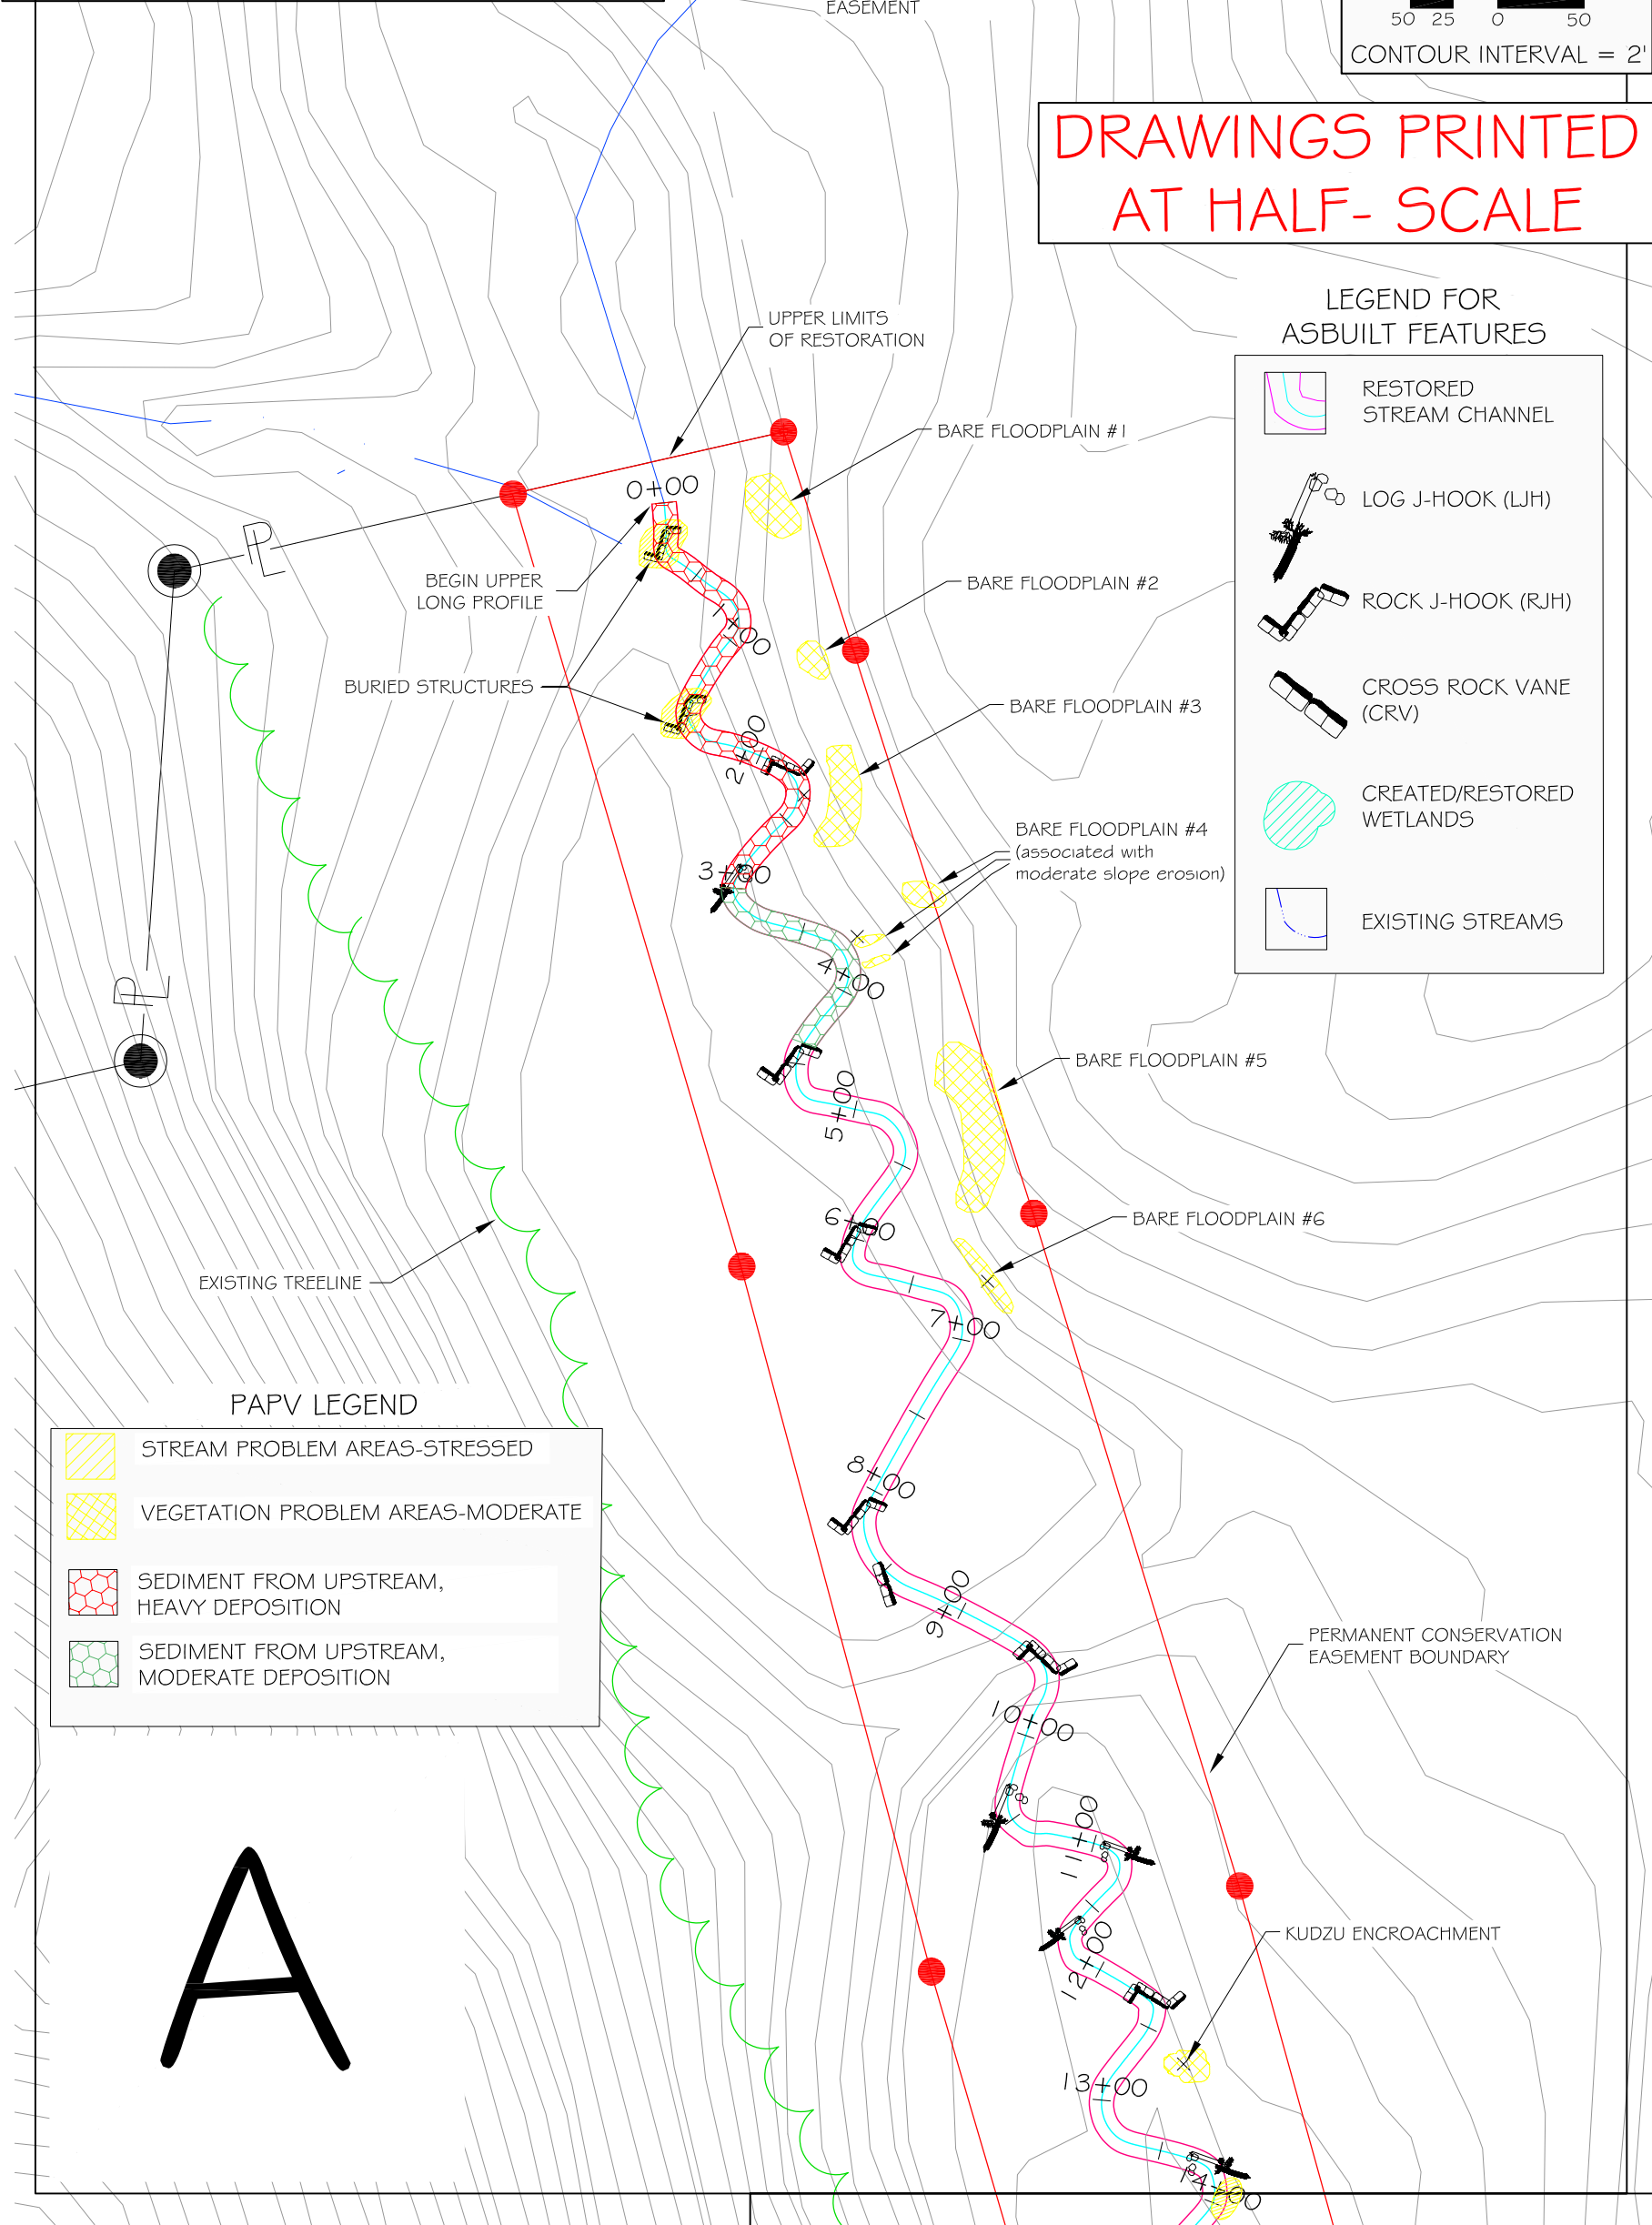
REACH 1 - PROBLEM AREA PLAN VIEW - A

<b>Reach 1</b>			
<b>Feature/Issue</b>	<b>Station # / Range</b>	<b>Probable Cause</b>	<b>Photo #</b>
Bare Floodplain	0+00 - 0+50	Surface flow / Poor soil quality	1-2
	1+00 - 1+40	Surface flow / Poor soil quality	
	2+00 - 2+60	Surface flow / Poor soil quality	
	3+50 - 4+00	Surface flow / Poor soil quality	
	4+50 - 5+75	Surface flow / Poor soil quality	
	6+10 - 6+90	Surface flow / Poor soil quality	
	37+80 - 38+50	Surface flow / Poor soil quality	
	42+00 - 42+50	Surface flow / Poor soil quality	
	42+75 - 43+30	Surface flow / Poor soil quality	
Bare Bank	50+00 - 50+60	Surface flow / Poor soil quality	3
	40+70 - 41+00	Bank Scour	
<b>Reach 2</b>			
<b>Feature/Issue</b>	<b>Station # / Range</b>	<b>Probable Cause</b>	<b>Photo #</b>
Bare Floodplain	3+25 - 3+35	Surface flow / Poor soil quality	4
	5+30 - 5+50	Surface flow / Poor soil quality	
	20+75 - 20+85	Surface flow / Poor soil quality

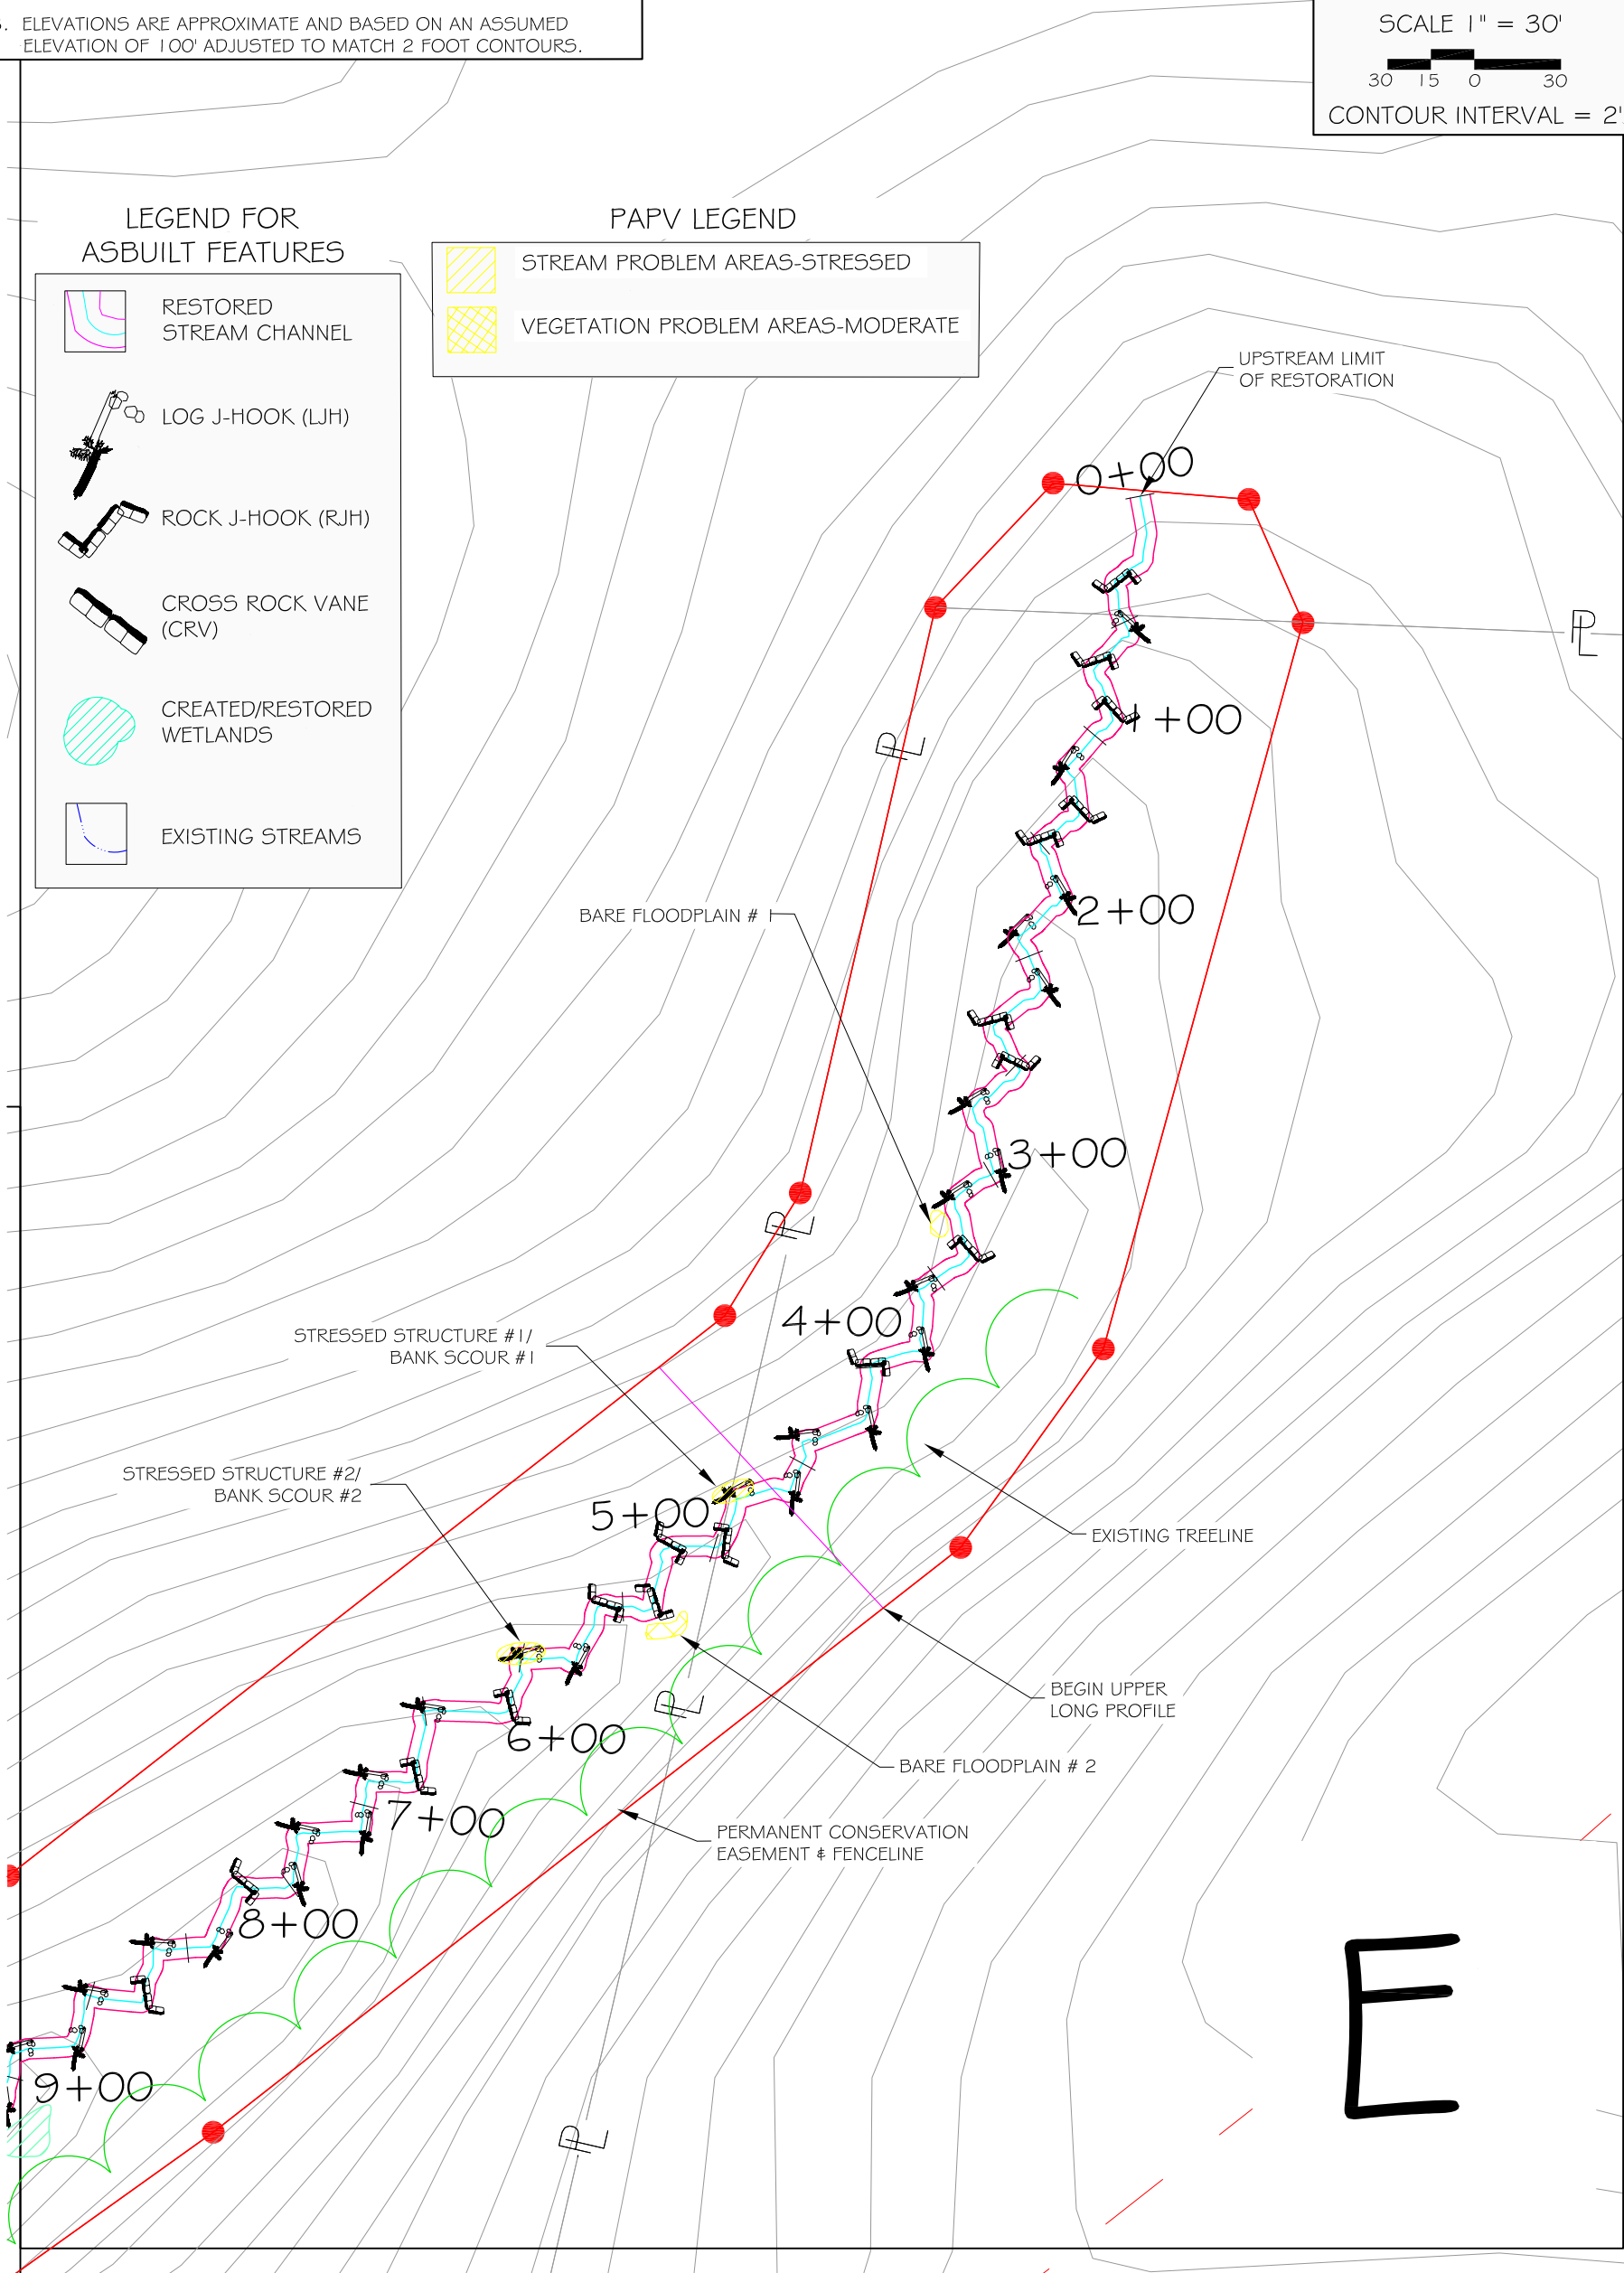
REACH 2 - PROBLEM AREA PLAN VIEW - E

<b>Feature Issue</b>	<b>Station numbers</b>	<b>Suspected Cause</b>	<b>Photo number</b>
Bank Scour	4+80	Surface flow	4
	6+00	Surface flow	
	16+60	Surface flow	
	12+70 - 12+80	Surface flow	
Undercut Bank	47+00 - 47+50	Increased water velocity from nearby tributary	5
Structures	4+80	Stressed structure - Bank Scour	4
	6+00	Stressed structure - Bank Scour	
	16+60	Stressed structure - Bank Scour	
	12+70 - 12+80	Stressed structures - Bank Scour
