# **Gray Farm Stream Restoration Monitoring Report – Year Five**

**Contract # D05016-2  
EEP Project # 92219**

**Iredell County, North Carolina**

**December 2010**

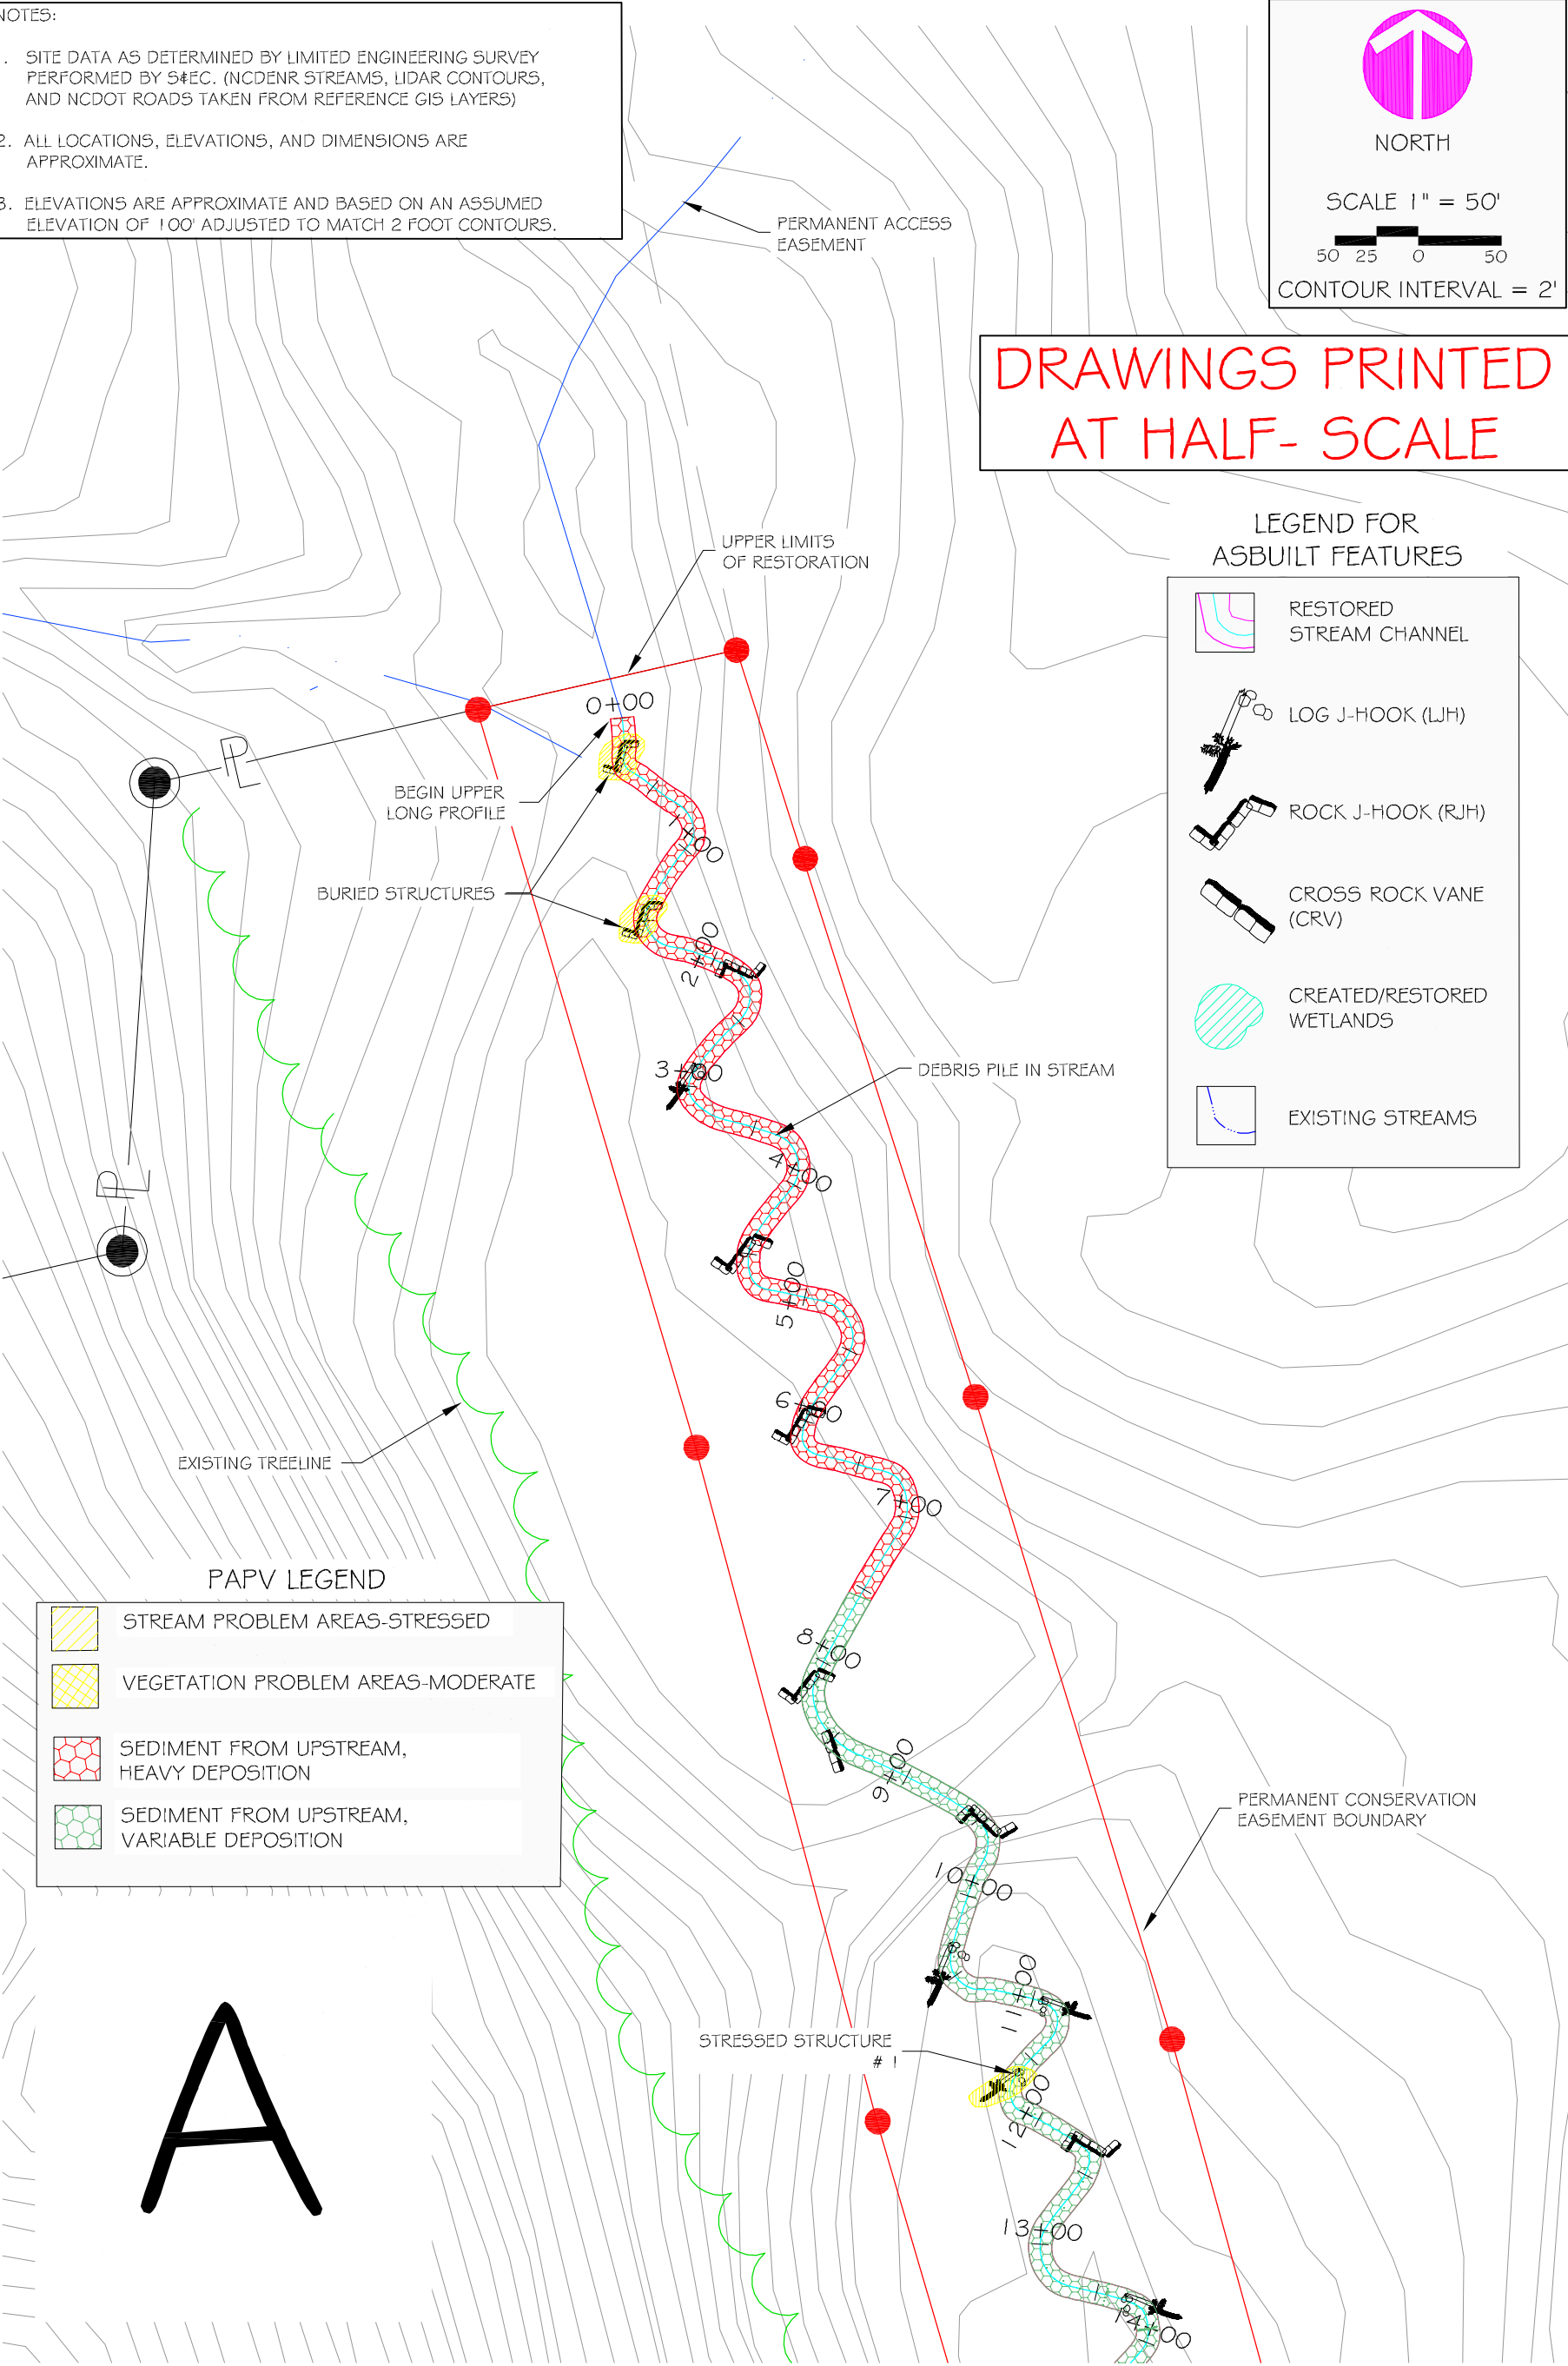
REACH 1 - PROBLEM AREA PLAN VIEW - A

<b>Reach 1</b>			
<b>Feature Issue</b>	<b>Station numbers</b>	<b>Suspected Cause</b>	<b>Photo number</b>
Bank Scour	24+75	Surface flow	1-2
	30+00	Surface flow	
	41+60	Surface flow	
	43+05	Surface flow - Settling fill	
Undercut Bank	47+00 - 47+50	Increased water velocity from nearby tributary	3
Structures	0+30	Buried Structure - Upstream Sediment	4
	1+50	Buried Structure - Upstream Sediment	
	11+75	Stressed structure - Bank Scour	1-2
	24+75	Stressed structure - Bank Scour	
	31+60	Stressed structure - Bank Scour	
	41+60	Stressed structure - Bank Scour	
	43+05	Stressed structure - Bank Scour

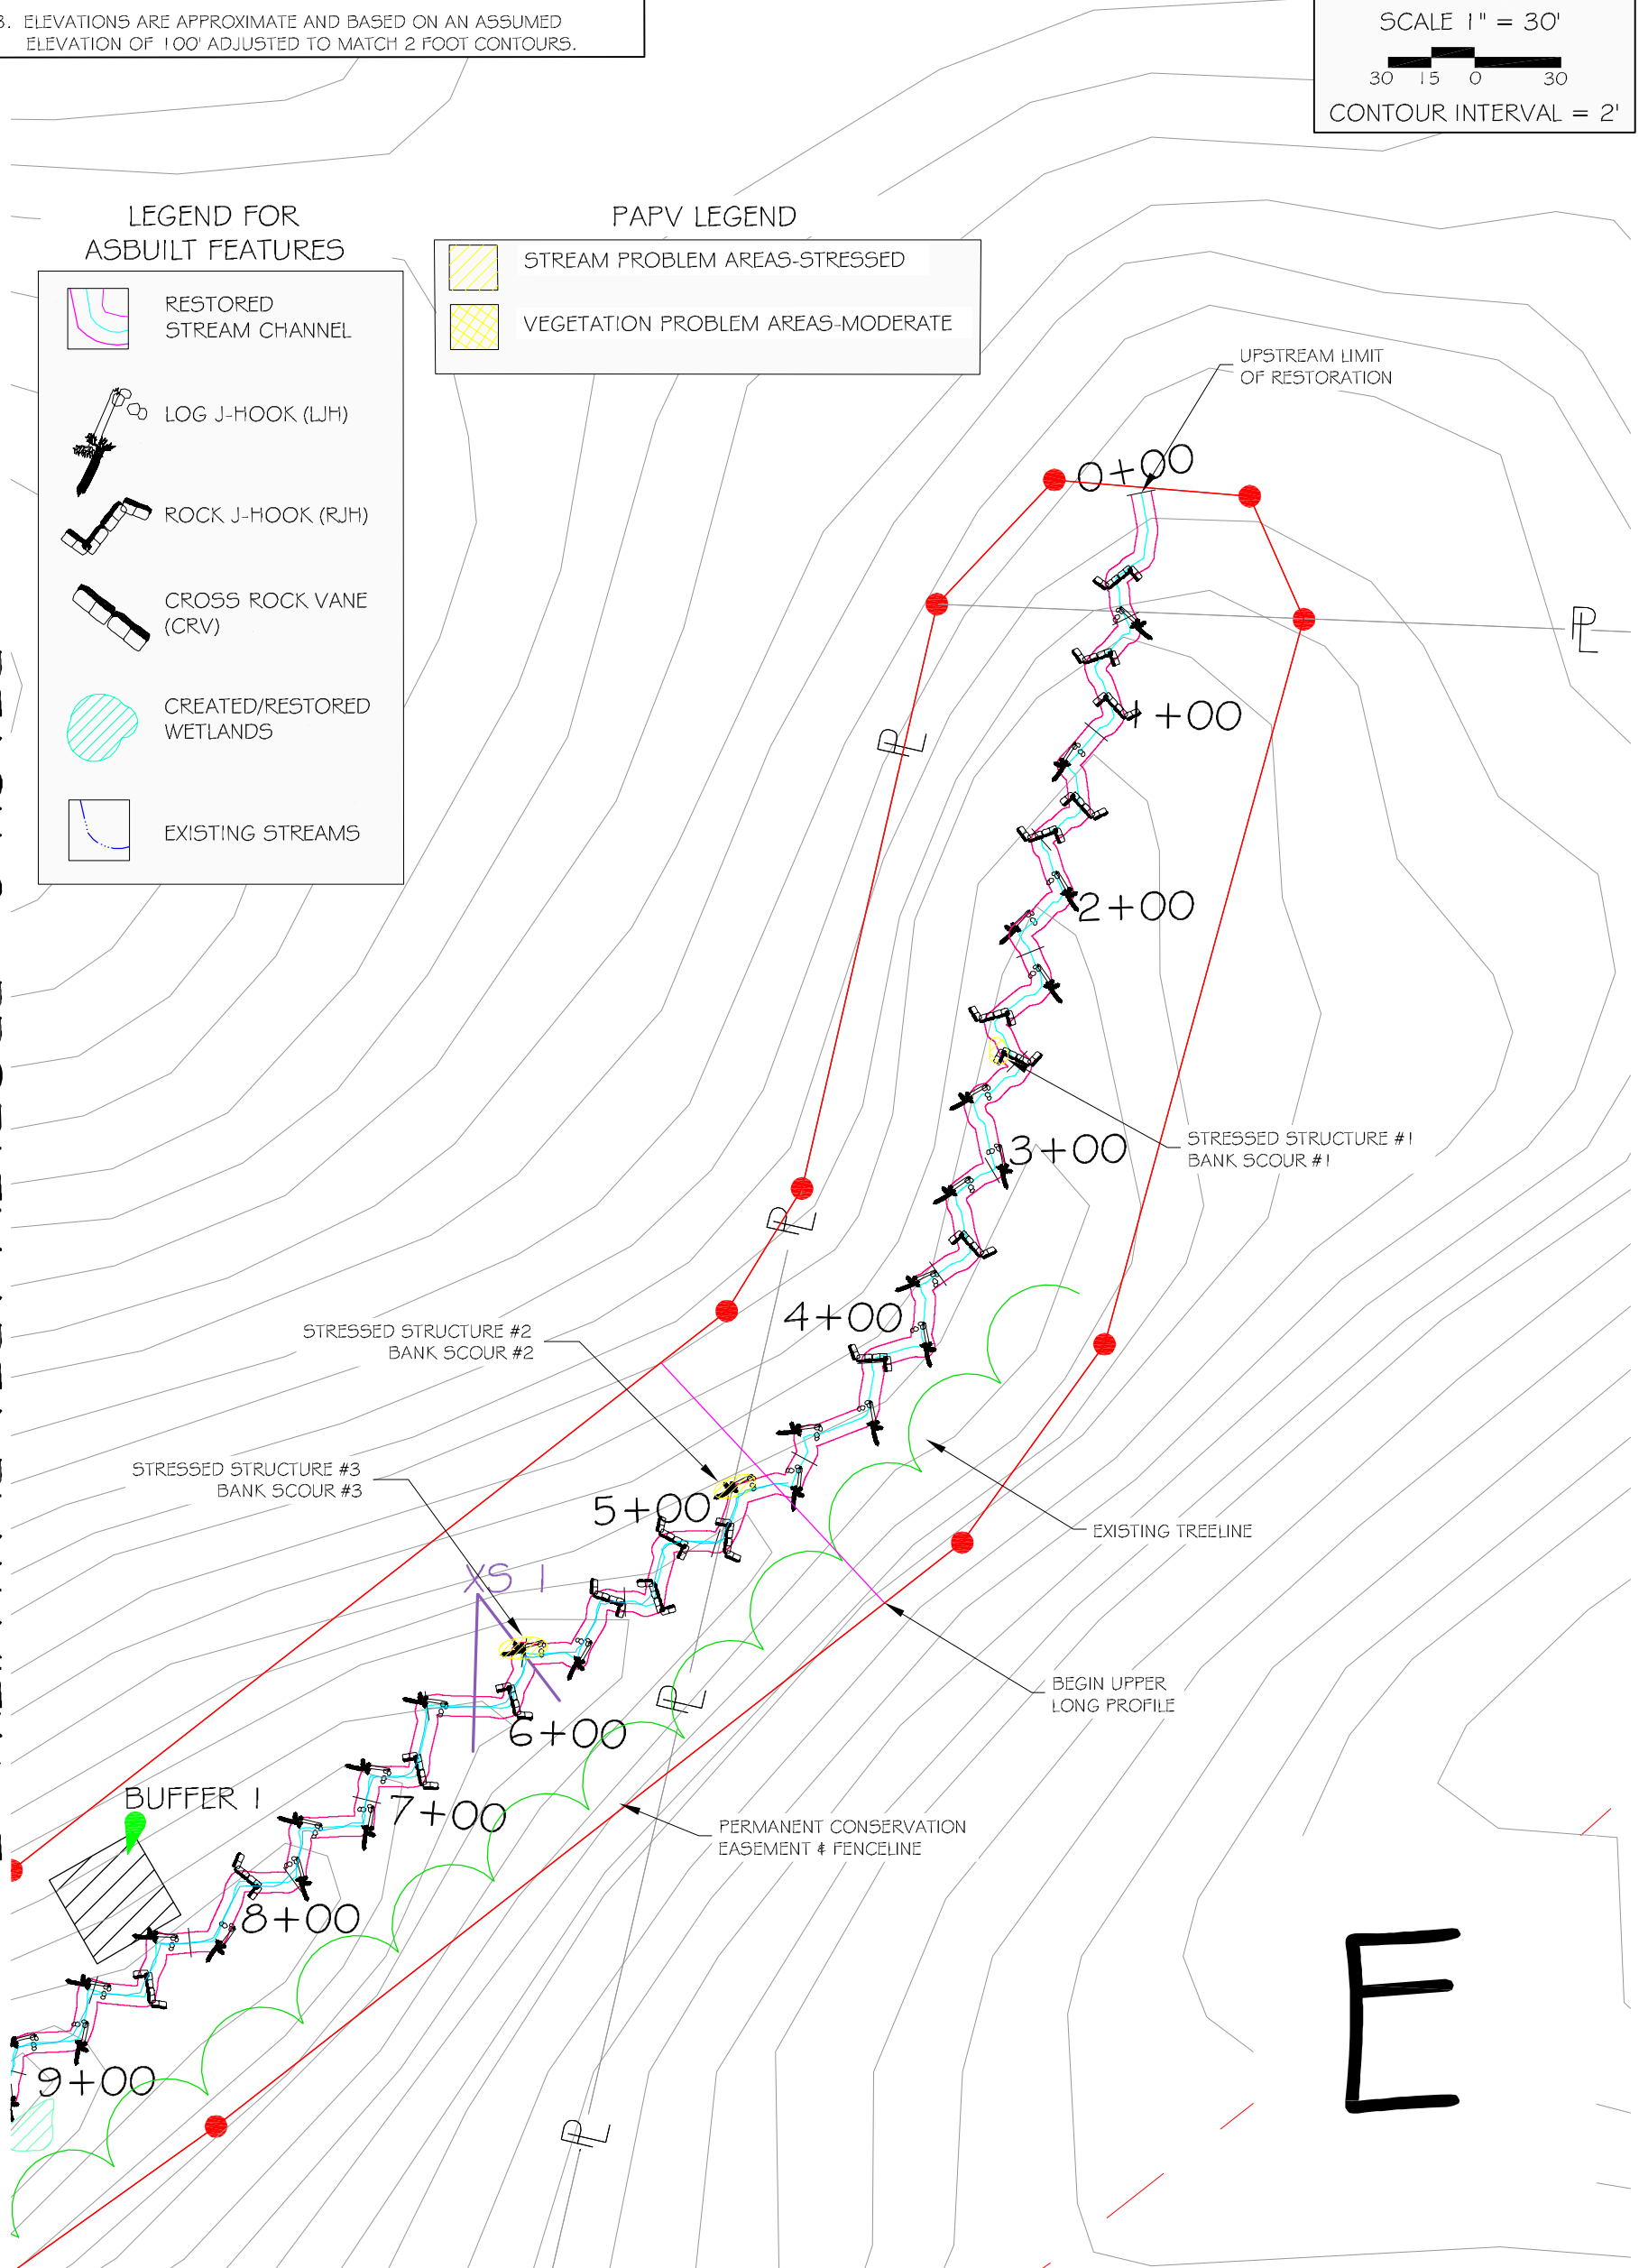
**REACH 2 - PROBLEM AREA PLAN VIEW - E**

<b>Reach 2</b>			
<b>Feature Issue</b>	<b>Station numbers</b>	<b>Suspected Cause</b>	<b>Photo number</b>
Bank Scour	2+50	Surface Flow	5
	4+80	Surface flow	
	6+00	Surface flow	
	16+60	Surface flow	
	12+70 - 12+80	Surface flow	
Channel Scour	16+10	High Stormwater Flow	N/A
Structures	2+50	Stressed Structure - Bank Scour	5
	4+80	Stressed structure - Bank Scour	
	6+00	Stressed structure - Bank Scour	
	16+60	Stressed structure - Bank Scour	
	12+70 - 12+80	Stressed structures - Bank Scour
