Year 2 Monitoring Report
FINAL
Greenbrier Stream Mitigation Project

Yadkin County, North Carolina

Monitoring Year 2

Submission Date:
December 2021

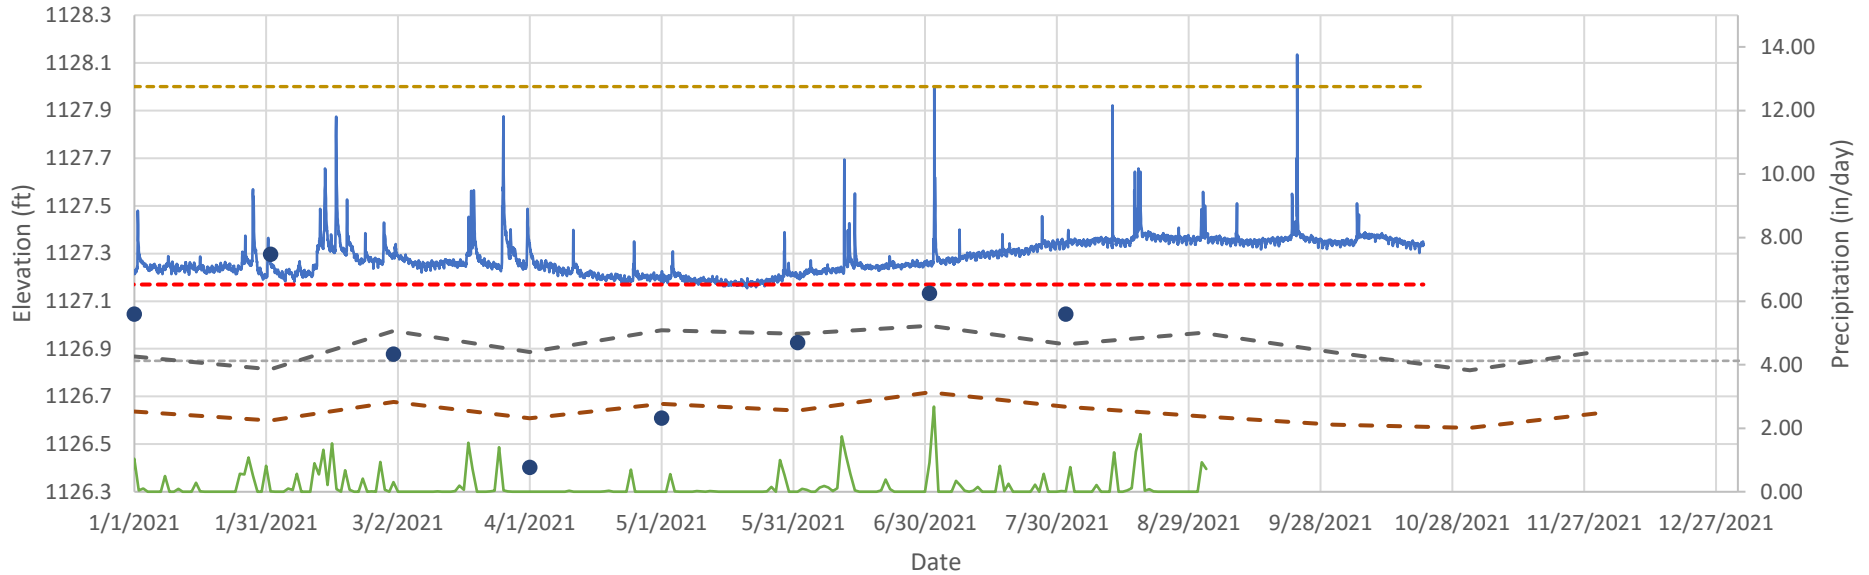
GBSG1

Note: The Meadowbrook rain gauge batteries died on 9/2/21 so no rain data was collected for September and October.

This Project utilizes a tipping bucket rain gauge installed at another EPR-completed stream restoration approximately 0.75 miles to the southeast (Meadowbrook, DMS project no. 100024) to accurately document rainfall at the Site. The rainfall data can be compared to the flow gauge data to verify that high flows at the Site are correlated with rainfall events. The monitoring gauges were downloaded regularly throughout Monitoring Year 2. Rainfall data is presented in Figure 3. Monthly Rainfall Summary Data and the precipitation and water level hydrographs are included in Appendix D. When the rain gauge was downloaded during MY2 monitoring in October 2021, it was determined that the batteries in the logger had expired around 9/2/2021. For this reason, no rainfall data was collected for September and October. The batteries were replaced in early November 2021.

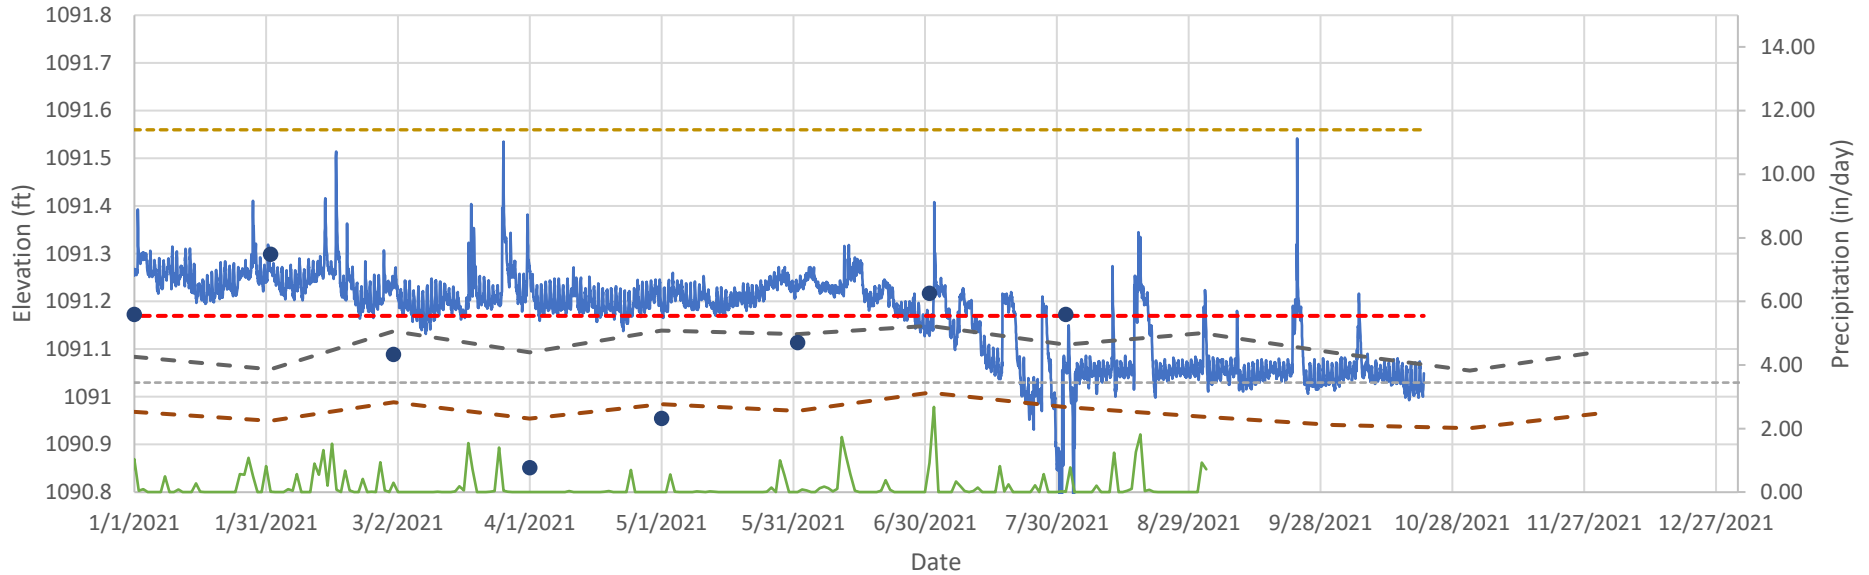
GBSG3

Note: The Meadowbrook rain gauge batteries died on 9/2/21 so no rain data was collected for September and October.
