Year 3 Monitoring Report
FINAL
Greenbrier Stream Mitigation Project

Yadkin County, North Carolina

Monitoring Year 3

Submission Date:
December 2022

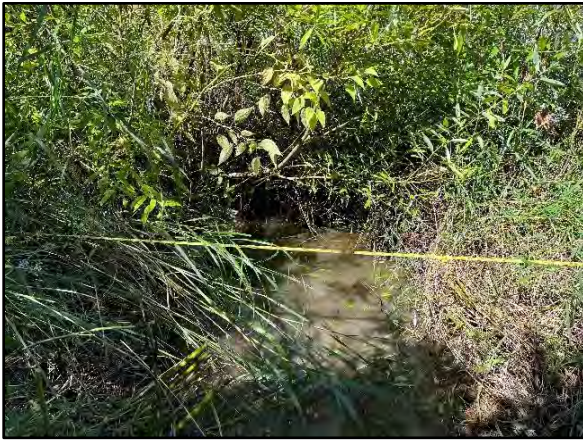
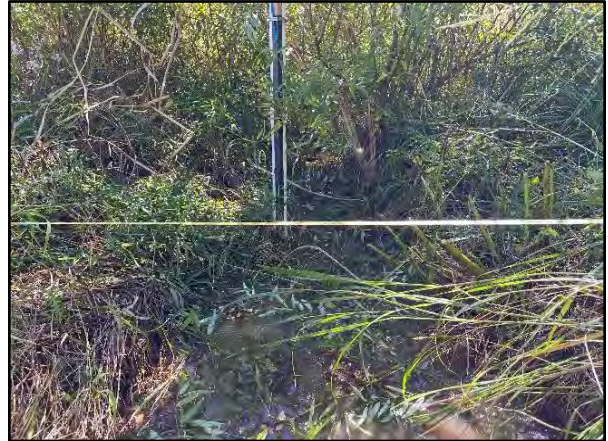
XS1 looking upstream

XS1 looking downstream

MY0	MY1	MY2	MY3	MY4	MY5	MY+
Bankfull Elevation - Based on AB Bankfull Area	1127.92	1127.87	1128.35	1128.35			
Bank Height Ratio - Based on AB-Bankfull Area	1.00	1.09	0.8	0.79			
Thalweg Elevation	1126.47	1126.23	1126.82	1126.79			
LTOB Elevation	1127.92	1128.02	1128.04	1128.03			
LTOB Max Depth	1.45	1.79	1.22	1.24			
LTOB Cross Sectional Area	6.70	7.87	4.17	4.78			
Entrenchment Ratio	-	-	-	-

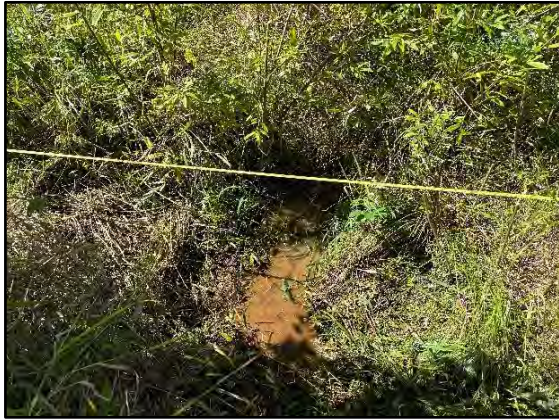
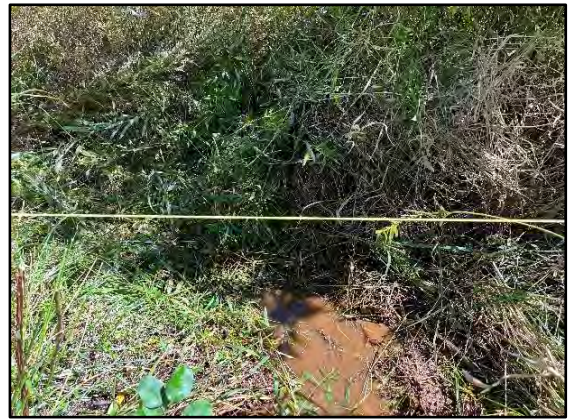
XS2 looking upstream

XS2 looking downstream

MY0	MY1	MY2	MY3	MY4	MY5	MY+
Bankfull Elevation - Based on AB Bankfull Area	1120.53	1120.61	1120.65	1120.69			
Bank Height Ratio - Based on AB-Bankfull Area	1.00	0.94	0.98	0.88			
Thalweg Elevation	1119.35	1119.47	1119.50	1119.58			
LTOB Elevation	1120.53	1120.55	1120.63	1120.56			
LTOB Max Depth	1.18	1.08	1.13	0.98			
LTOB Cross Sectional Area	3.97	3.59	3.86	3.19			
Entrenchment Ratio	>10.12	>10.11	>10.17	>10.09

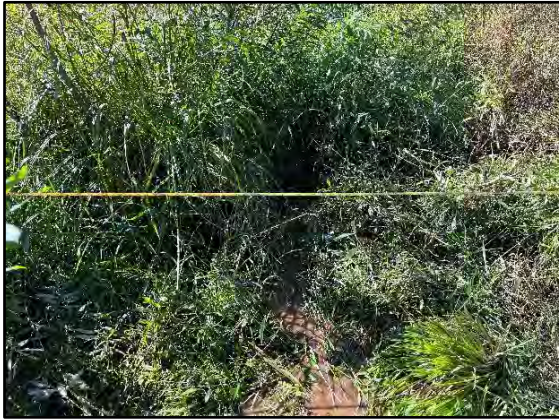
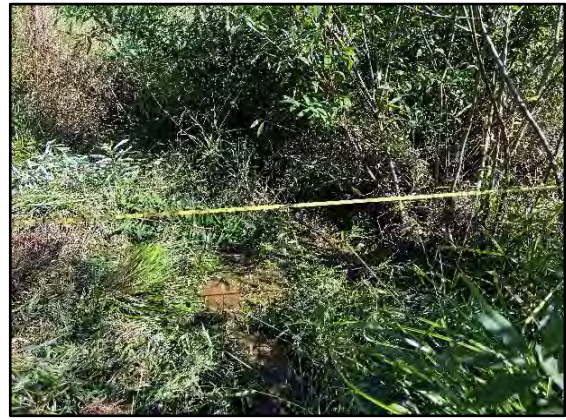
- *The identified LTB in a few of the cross sections seems slightly off (ex. cross section 3). Please review the data and confirm its accuracy.*
 - **After reviewing cross sections, XS-5 LTB was changed to a lower elevation on the opposite bank. XS-5 now has a bankfull area that is closer to As-built conditions and the bank height ratio is near 1.0. All other cross sections reviewed had reasonable LTB calls that coincide with previous monitoring years' stationing and elevation.**

XS3 looking upstream

XS3 looking downstream

MY0	MY1	MY2	MY3	MY4	MY5	MY+
Bankfull Elevation - Based on AB Bankfull Area	1097.81	1097.90	1098.07	1098.13			
Bank Height Ratio - Based on AB-Bankfull Area	1.00	0.97	0.79	0.72			
Thalweg Elevation	1097.18	1097.28	1097.35	1097.46			
LTOB Elevation	1097.81	1097.88	1097.92	1097.94			
LTOB Max Depth	0.63	0.60	0.57	0.48			
LTOB Cross Sectional Area	2.99	2.84	2.05	1.60			
Entrenchment Ratio	6.39	5.80	5.75	4.86
