Year 4 Monitoring Report
Final
Greenbrier Stream Mitigation Project
Yadkin County, North Carolina
Monitoring Year 4

Data Collection Period:
April, September – October 2023

Submission Date:
December 2023

NCDEQ Contract No. 7616
DMS ID No. 100086
USACE Action ID No. SAW-2018-01755
NCDWR ID: 20181272
Yadkin River Basin
HUC 03040101

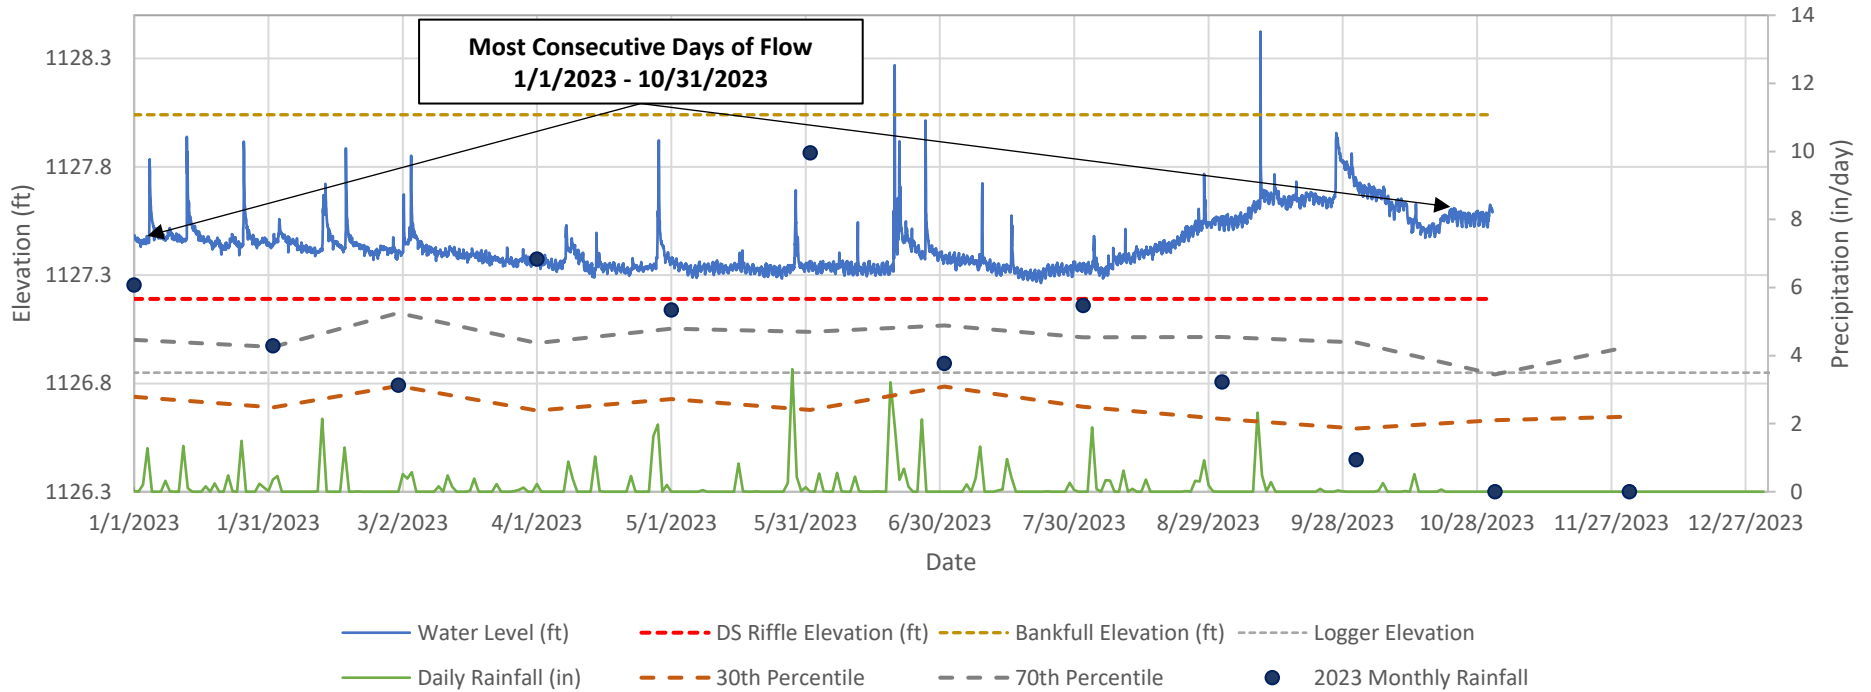
GBSG1

NOTE: Rain Gauge was not operational 3/1/2023-4/13/2023 due to a low battery. Rainfall data was supplemented these dates from AgACIS station YADKINVILLE 0.2 E, NC

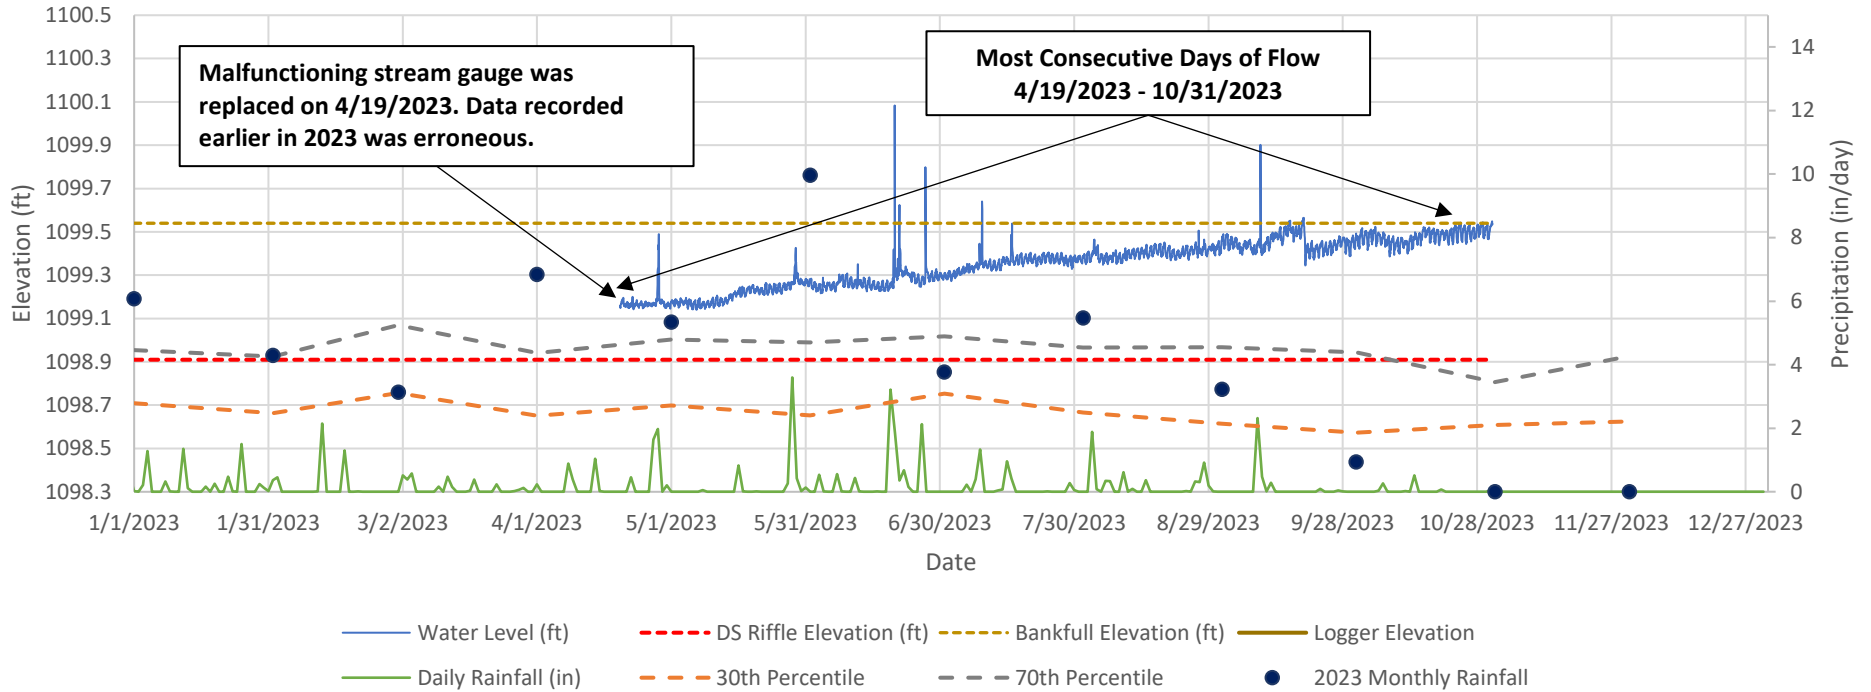
GBSG2

NOTE: Rain Gauge was not operational 3/1/2023-4/13/2023 due to a low battery. Rainfall data was supplemented these dates from AcAGIS station YADKINVILLE 0.2 E, NC
This gauge was faulty from 1/1/2023-4/11/2023

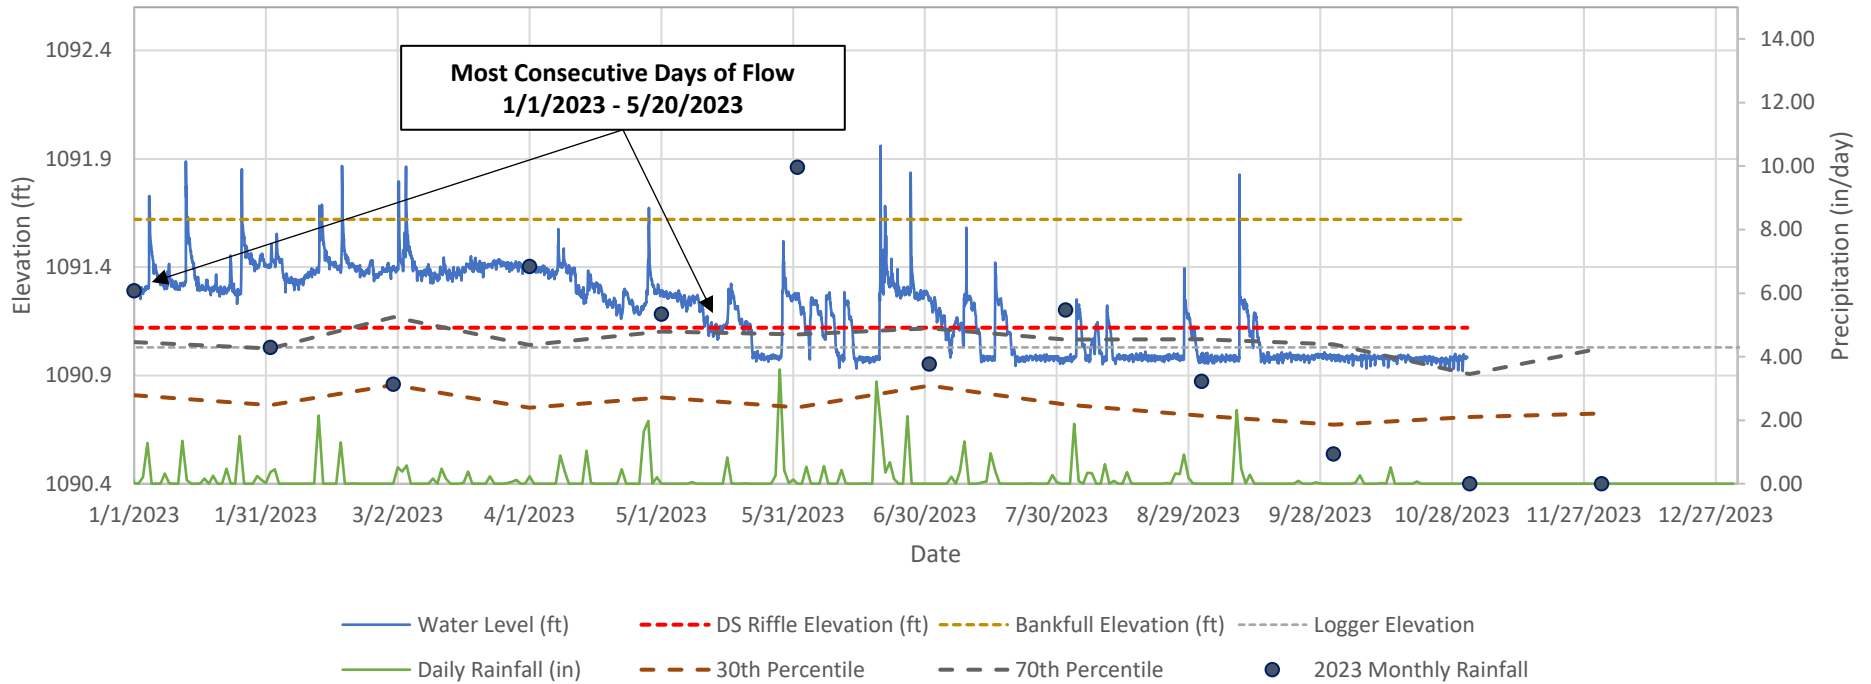
GBSG3

NOTE: Rain Gauge was not operational 3/1/2023-4/13/2023 due to a low battery. Rainfall data was supplemented these dates from AcAGIS station YADKINVILLE 0.2 E, NC
