**FINAL**  
**ANNUAL MONITORING REPORT**  
**YEAR 1 (2012)**  
**GREENBRIER CREEK STREAM/WETLAND/BUFFER RESTORTION SITE**  
**ALAMANCE AND CHATHAM COUNTIES, NORTH CAROLINA**  
**(EEP Project No. 671, Contract No. 004801)**  
**Construction Completed January 2011**

February 2013

Prepared by:  
Axiom Environmental, Inc.  
218 Snow Avenue  
Raleigh, North Carolina 27603

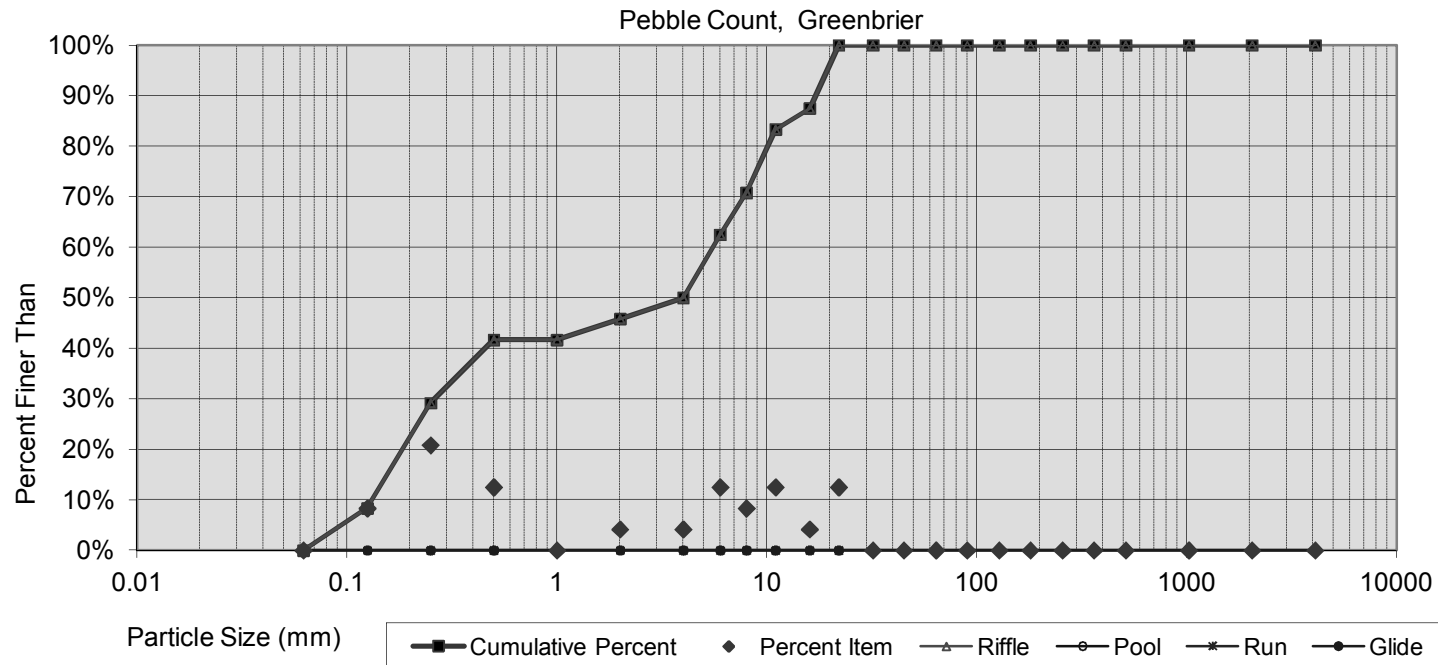
Note: **Cross Section 10**

Size percent less than (mm)					Percent by substrate type					
D16	D35	D50	D84	D95	silt/clay	sand	gravel	cobble	boulder	bedrock
0.161	0.35	4.0	12	19	0%	46%	54%	0%	0%	0%

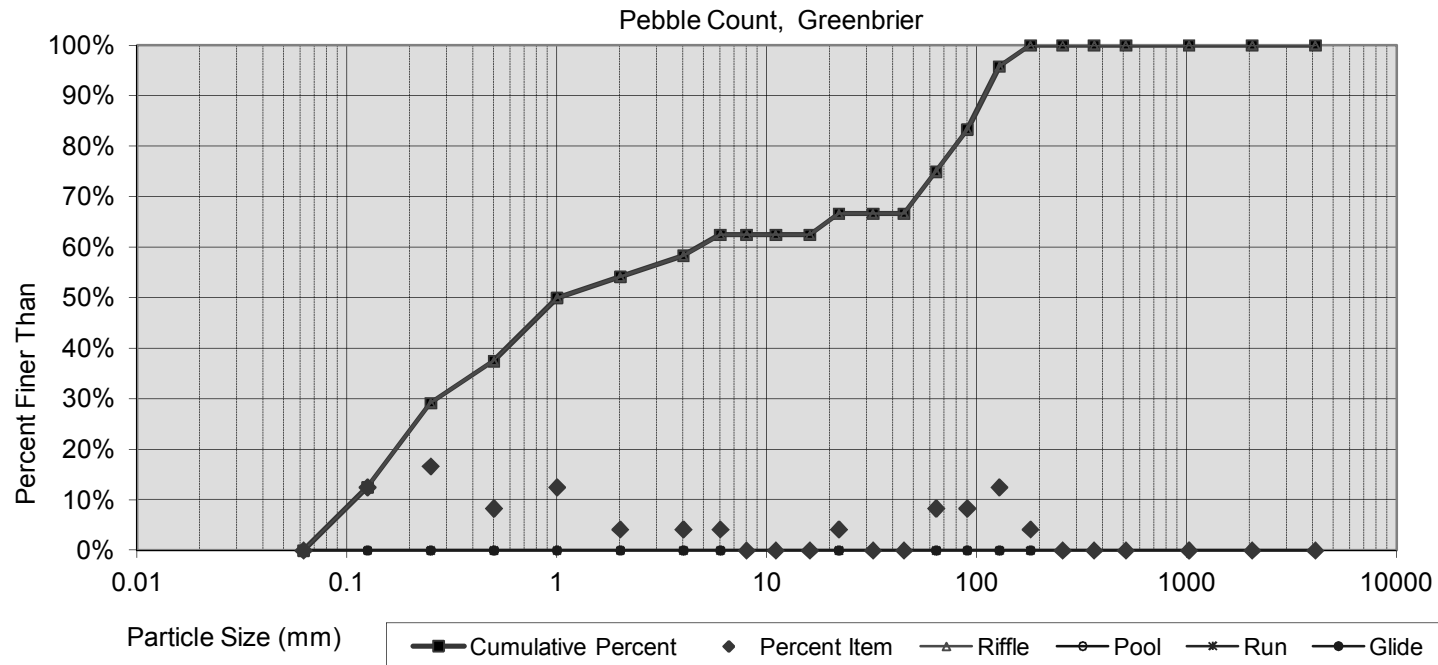
Note: **Cross Section 11**

Size percent less than (mm)					Percent by substrate type					
D16	D35	D50	D84	D95	silt/clay	sand	gravel	cobble	boulder	bedrock
0.145	0.41	1.0	92	125	0%	54%	21%	25%	0%	0%

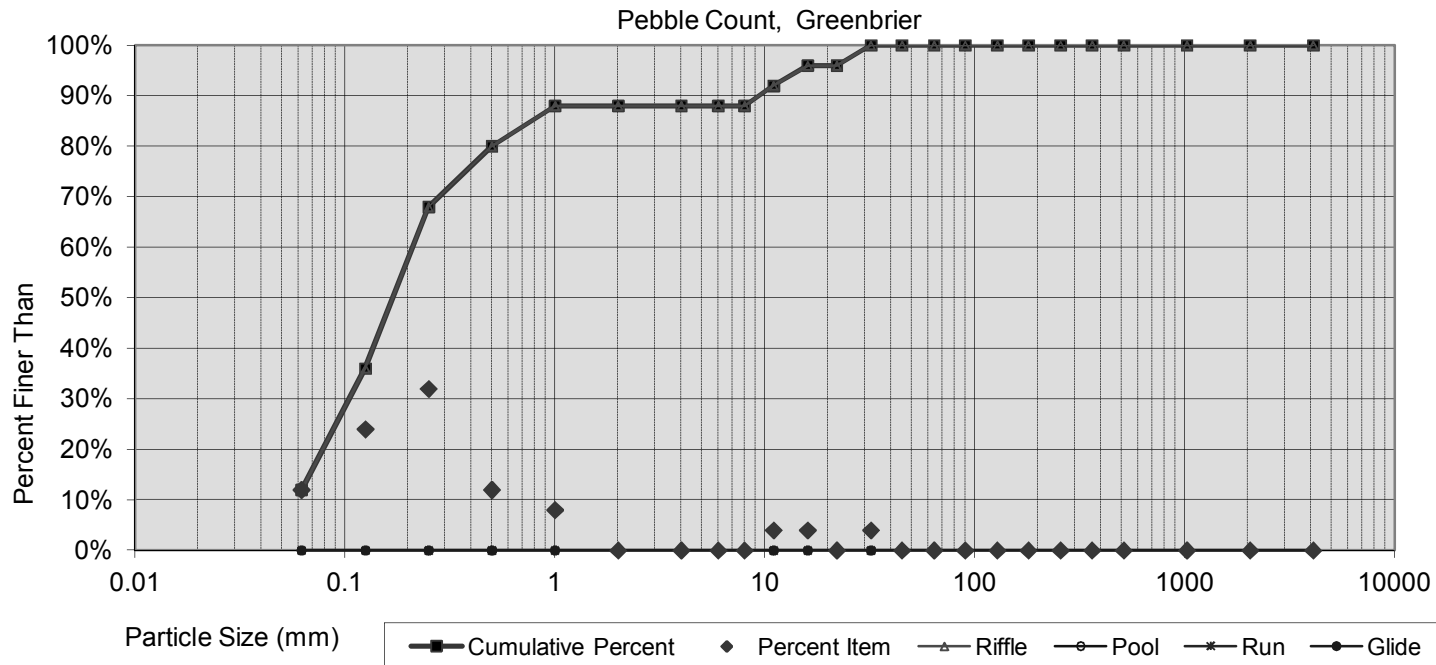
Note: **Cross Section 12**

Size percent less than (mm)					Percent by substrate type					
D16	D35	D50	D84	D95	silt/clay	sand	gravel	cobble	boulder	bedrock
0.070	0.12	0.2	1	15	12%	76%	12%	0%	0%	0%

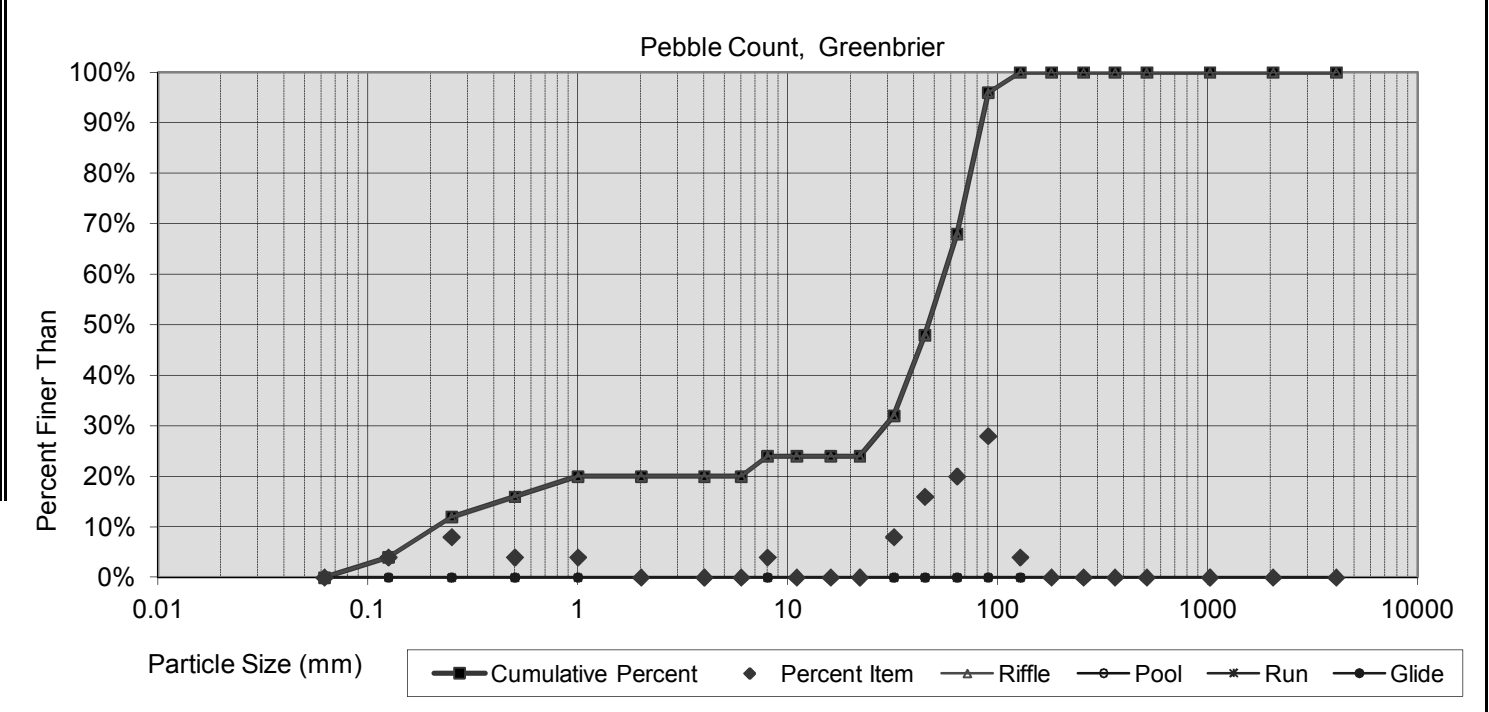
Pebble Count,
	Greenbrier
	---
	---
Note:	<b>Cross Section 14</b>

Size percent less than (mm)					Percent by substrate type					
D16	D35	D50	D84	D95	silt/clay	sand	gravel	cobble	boulder	bedrock
0.500	34.11	46.6	78	89	0%	20%	48%	32%	0%	0%

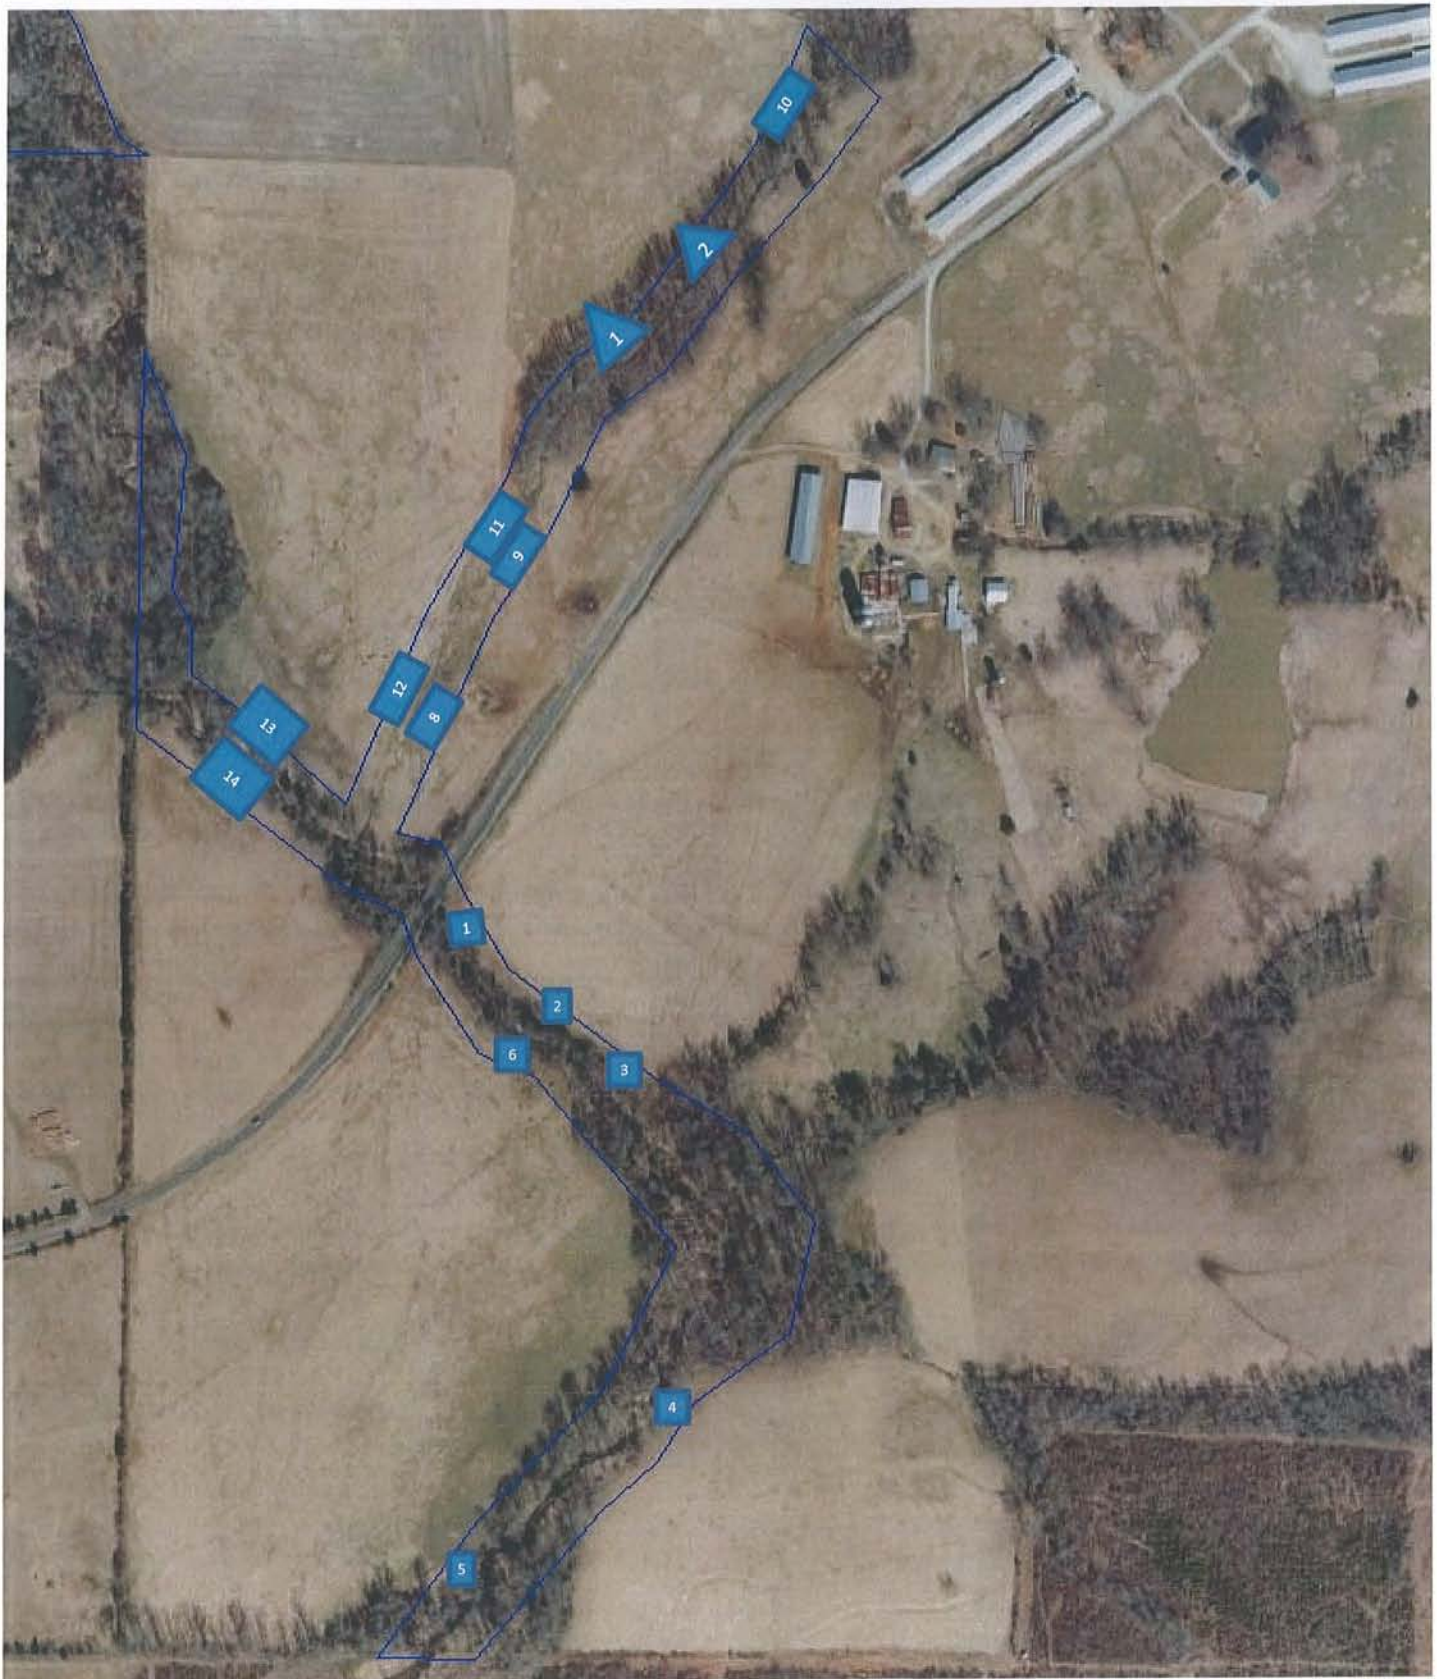
Greenbrier Creek Stream Restoration  
Alamance/Chatham Counties  
Vegetation Warranty Map

In general, some of plant survival in the Zone 4 and Zone 5 planting zones did not meet the warranty requirement. The table below outlines necessary replanting areas. Surviving stems were subtracted from the warranty criteria (544/acre for Zone 4 and 348 per acre for Zone 5) so that the "Total plants needed" column is the number of remaining stems needed get warranty criteria (544/348) stems per acre in areas with deficient vegetation. Planting densities were averaged into planting zones and are identified on the attached Supplemental Planting Map.

Location	Planting Zone	Acres	Total plants needed
Zone 5 (Unnamed Tributary)	Zone 5	0.8	114
Unnamed Tributary (St 400+00 - 407+00) & mainstem (St 106+50 - 100+00)	Zone 4	3	1254
Right, mainstem (St 200+00 - 205+50)	Zone 4	0.6	158
Left, mainstem (St 200+00 - 206+00)	Zone 4	0.7	217
Left, mainstem (St 212+50 - 214+00)	Zone 4	0.2	89
Right, mainstem (St 210+50 - 219+00)	Zone 4	1	121
<b>Total</b>		<b>6.3</b>	<b>1,952</b>
