**FINAL
ANNUAL MONITORING REPORT
YEAR 2 (2013)
GREENBRIER CREEK STREAM/WETLAND/BUFFER RESTORATION SITE
ALAMANCE AND CHATHAM COUNTIES, NORTH CAROLINA
(EEP Project No. 671, Contract No. 004801)
Construction Completed January 2011**

September 2013

Prepared by:
Axiom Environmental, Inc.
218 Snow Avenue
Raleigh, North Carolina 27603

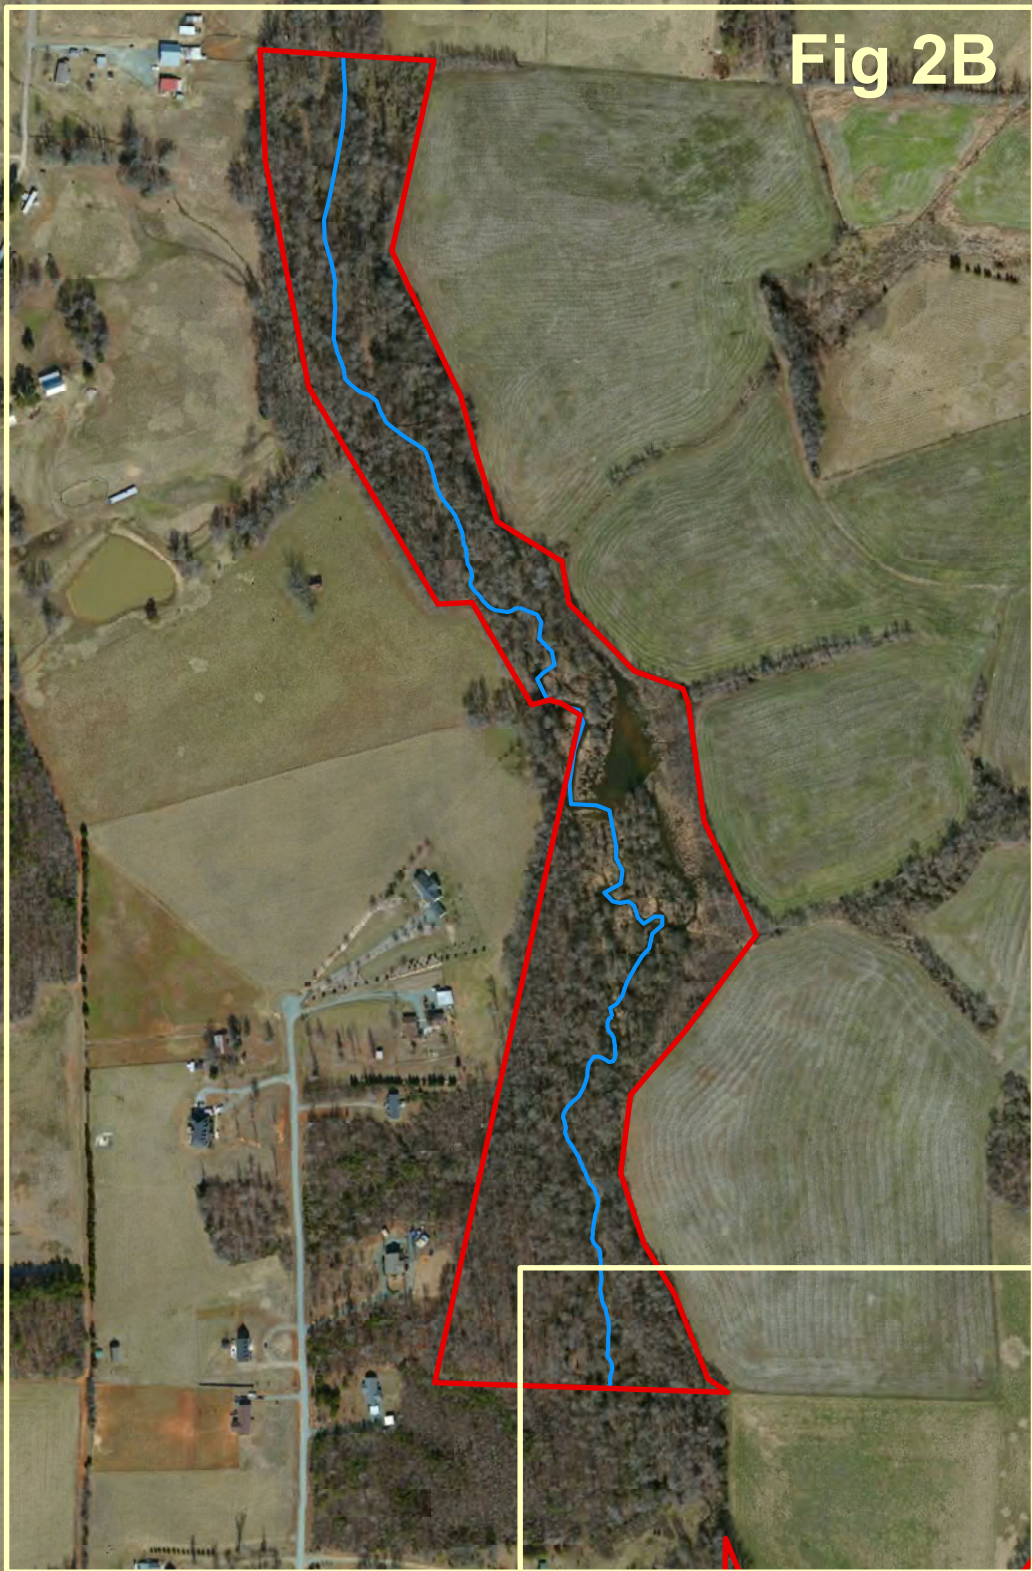
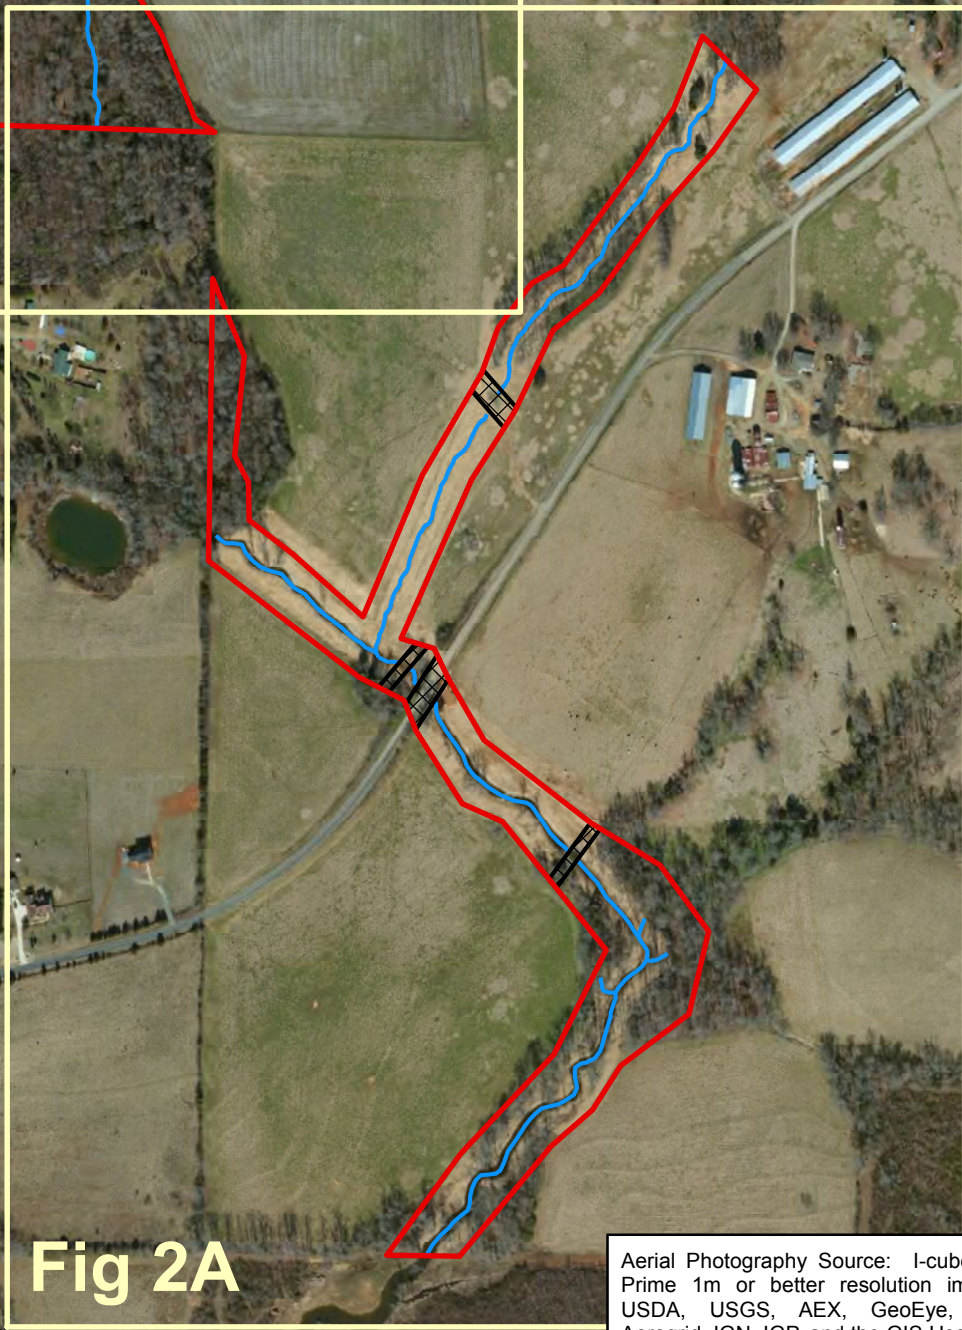
Fig 2B

Beaver have been an ongoing issue on the Site and are being closely monitored. Three previously noted beaver dams located 1) downstream of the Staley Snow Camp bridge crossing, 2) at Cross-section 12, and 3) at Cross-section 13 were removed by APHIS in May 2013 and were not present during monitoring activities. Currently, one large, well-established impoundment is located on the preservation reach consisting of several beaver dams. One large dam was destroyed in the summer of 2013, but it appears as though the beaver are still active in this area. Few woody stems are surviving in the impoundment footprint, and no natural recruits are becoming established at this time. This impoundment area is shown on the Current Conditions Plan View Map (Figure 2B).
