**FINAL
ANNUAL MONITORING REPORT
YEAR 3 (2014)
GREENBRIER CREEK STREAM/WETLAND/BUFFER RESTORATION SITE
ALAMANCE AND CHATHAM COUNTIES, NORTH CAROLINA
(EEP Project No. 671, Contract No. 004801)
Construction Completed January 2011**

October 2014

Prepared by:
Axiom Environmental, Inc.
218 Snow Avenue
Raleigh, North Carolina 27603

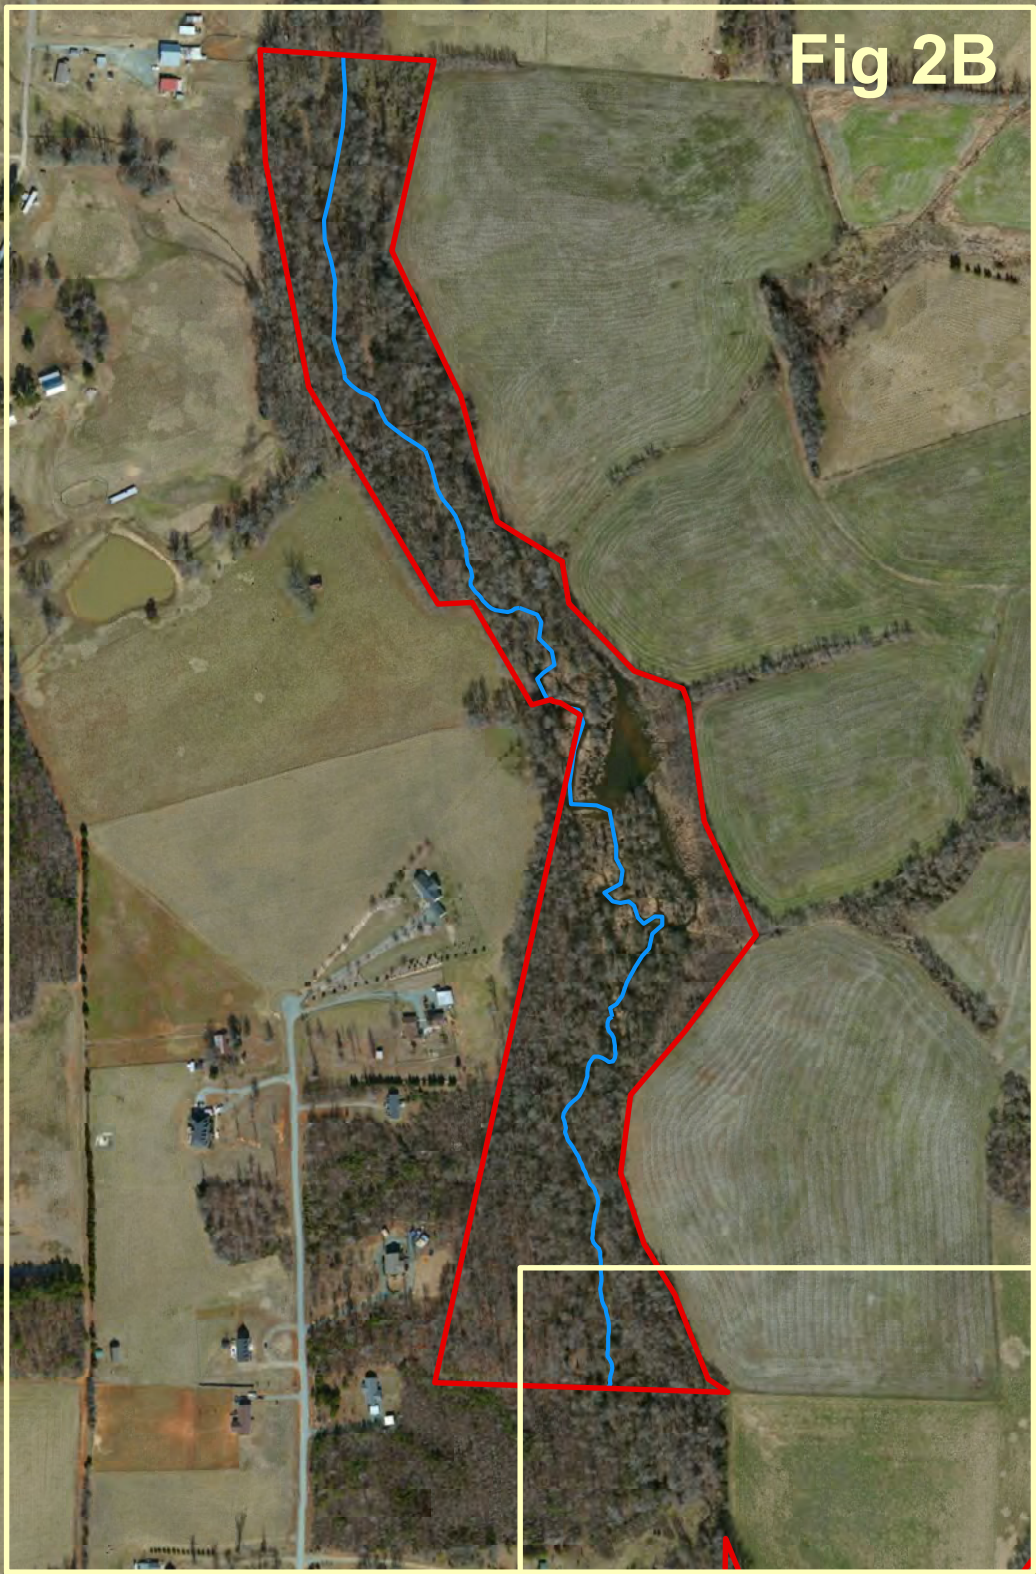
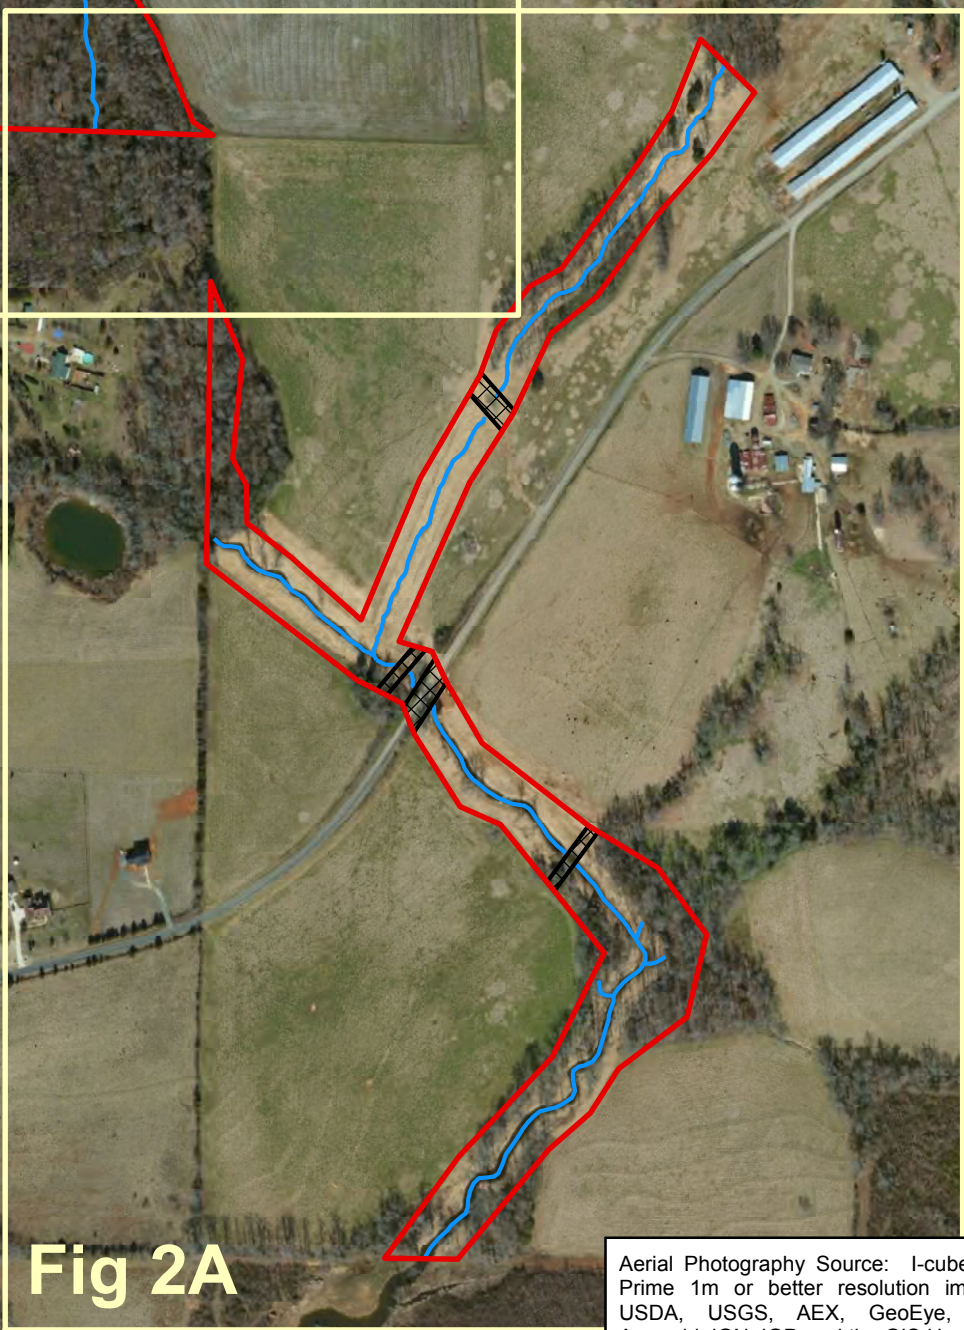
Fig 2B

With the exception of the impounded area, vegetation within the preservation reach is well-established with scattered occurrences of invasive species. Two small but dense populations of Tree of Heaven (*Ailanthus altissima*) were observed on the eastern edge of the preservation reach (Figure 2B, Appendix A). Additionally, Japanese honeysuckle (*Lonicera japonica*), Chinese privet (*Ligustrum sinense*), and *microstegium* (*Microstegium vimineum*) were observed scattered throughout the reach.

Beaver have been an ongoing issue on the Site and are being closely monitored. One previously noted beaver dam located at Cross-section 8 was removed, likely during a heavy flow event, and was not present during monitoring activities. Another previously noted dam located downstream of the Staley Snow Camp bridge crossing was located and is still intact (Dam 1, Figure 2A, Appendix B). Currently, one large, well-established impoundment is located on the preservation reach consisting of two major beaver dams (Dams 2 and 3, Figure 2B, Appendix B). One large dam was destroyed in the summer of 2013, but it appears as though the beaver are still active in this area. Few woody stems are surviving in the impoundment footprint, which consists of mostly standing water, and no natural recruits are becoming established at this time. This impoundment area is shown on the Current Conditions Plan View Map (Figure 2B, Appendix B).

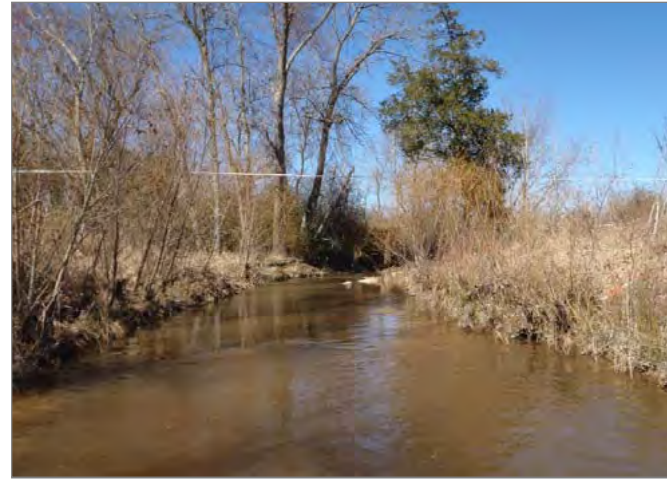
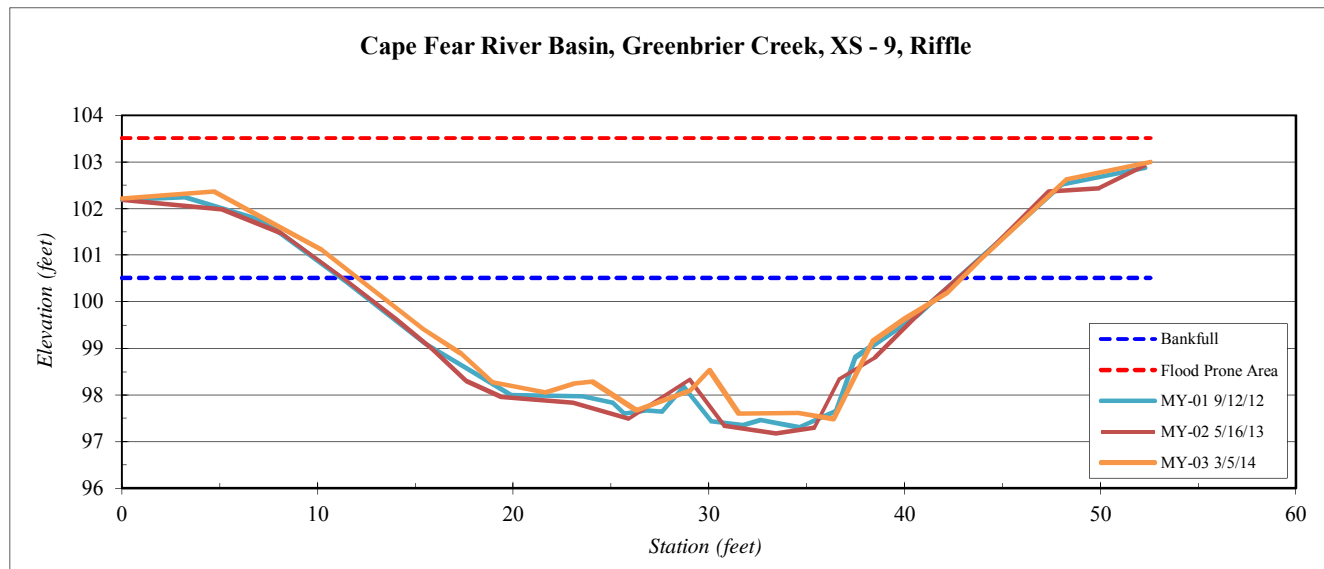
River Basin:	Cape Fear
Watershed:	Greenbrier Creek
XS ID	XS - 9, Riffle
Feature	Riffle
Date:	3/4/2014
Field Crew:	Perkinson, Jernigan

SUMMARY DATA	
Bankfull Elevation:	100.5
Bankfull Cross-Sectional Area:	60.0
Bankfull Width:	30.9
Flood Prone Area Elevation:	103.5
Flood Prone Width:	100.0
Max Depth at Bankfull:	3.0
Mean Depth at Bankfull:	1.9
W / D Ratio:	15.9
Entrenchment Ratio:	3.2
Bank Height Ratio:	1.7

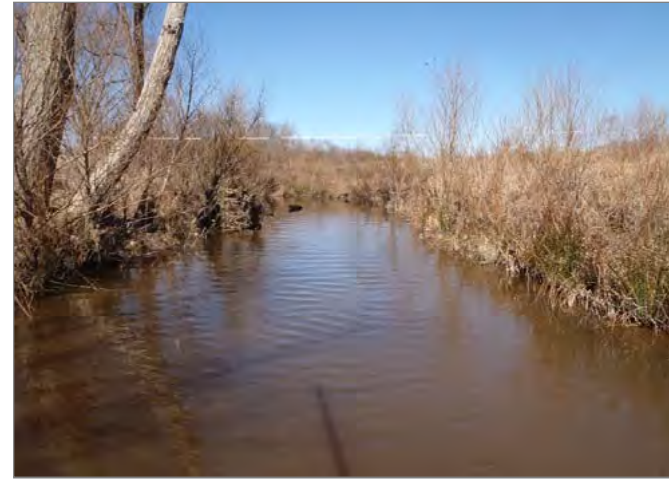
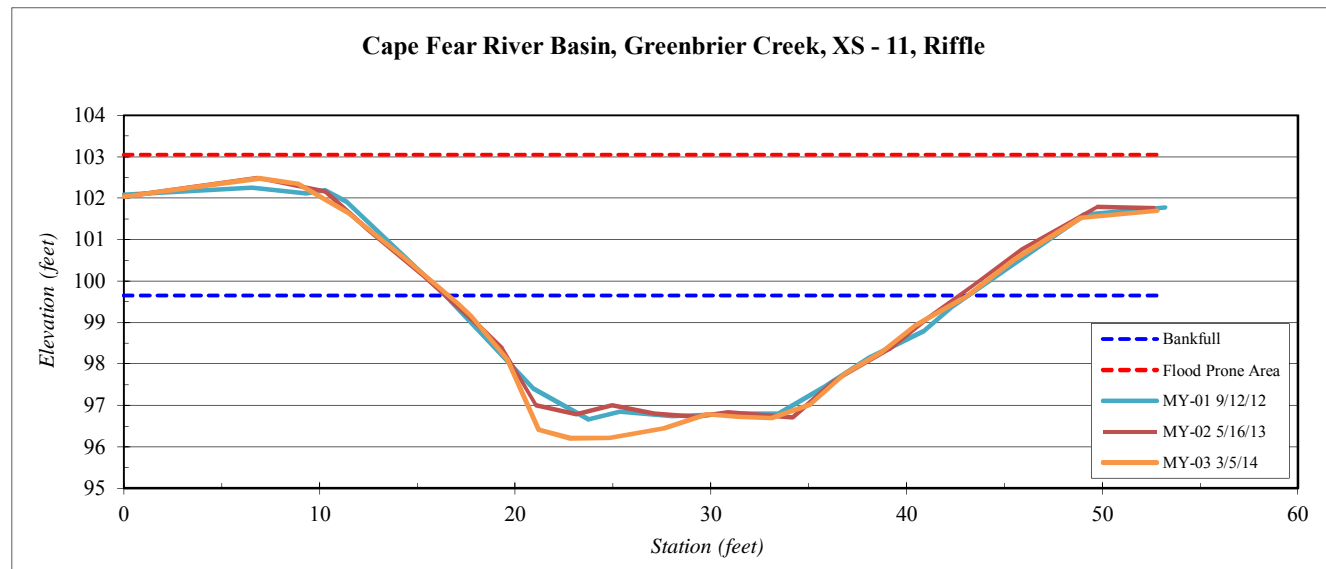
River Basin:	Cape Fear
Watershed:	Greenbrier Creek
XS ID	XS - 11, Riffle
Feature	Riffle
Date:	3/4/2014
Field Crew:	Perkinson, Jernigan

SUMMARY DATA	
Bankfull Elevation:	99.7
Bankfull Cross-Sectional Area:	59.2
Bankfull Width:	26.5
Flood Prone Area Elevation:	103.1
Flood Prone Width:	100.0
Max Depth at Bankfull:	3.4
Mean Depth at Bankfull:	2.2
W / D Ratio:	11.9
Entrenchment Ratio:	3.8
Bank Height Ratio:	1.6

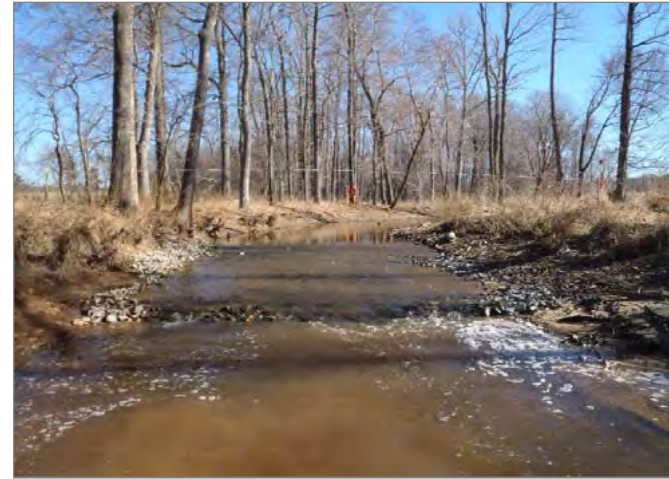
River Basin:	Cape Fear
Watershed:	Greenbrier Creek
XS ID	XS - 14, Riffle
Feature	Riffle
Date:	3/4/2014
Field Crew:	Perkinson, Jernigan

SUMMARY DATA	
Bankfull Elevation:	98.0
Bankfull Cross-Sectional Area:	56.6
Bankfull Width:	37.0
Flood Prone Area Elevation:	100.1
Flood Prone Width:	100.0
Max Depth at Bankfull:	2.1
Mean Depth at Bankfull:	1.5
W / D Ratio:	24.2
Entrenchment Ratio:	2.7
Bank Height Ratio:	1.0

Stream Type	E
--------------------	---

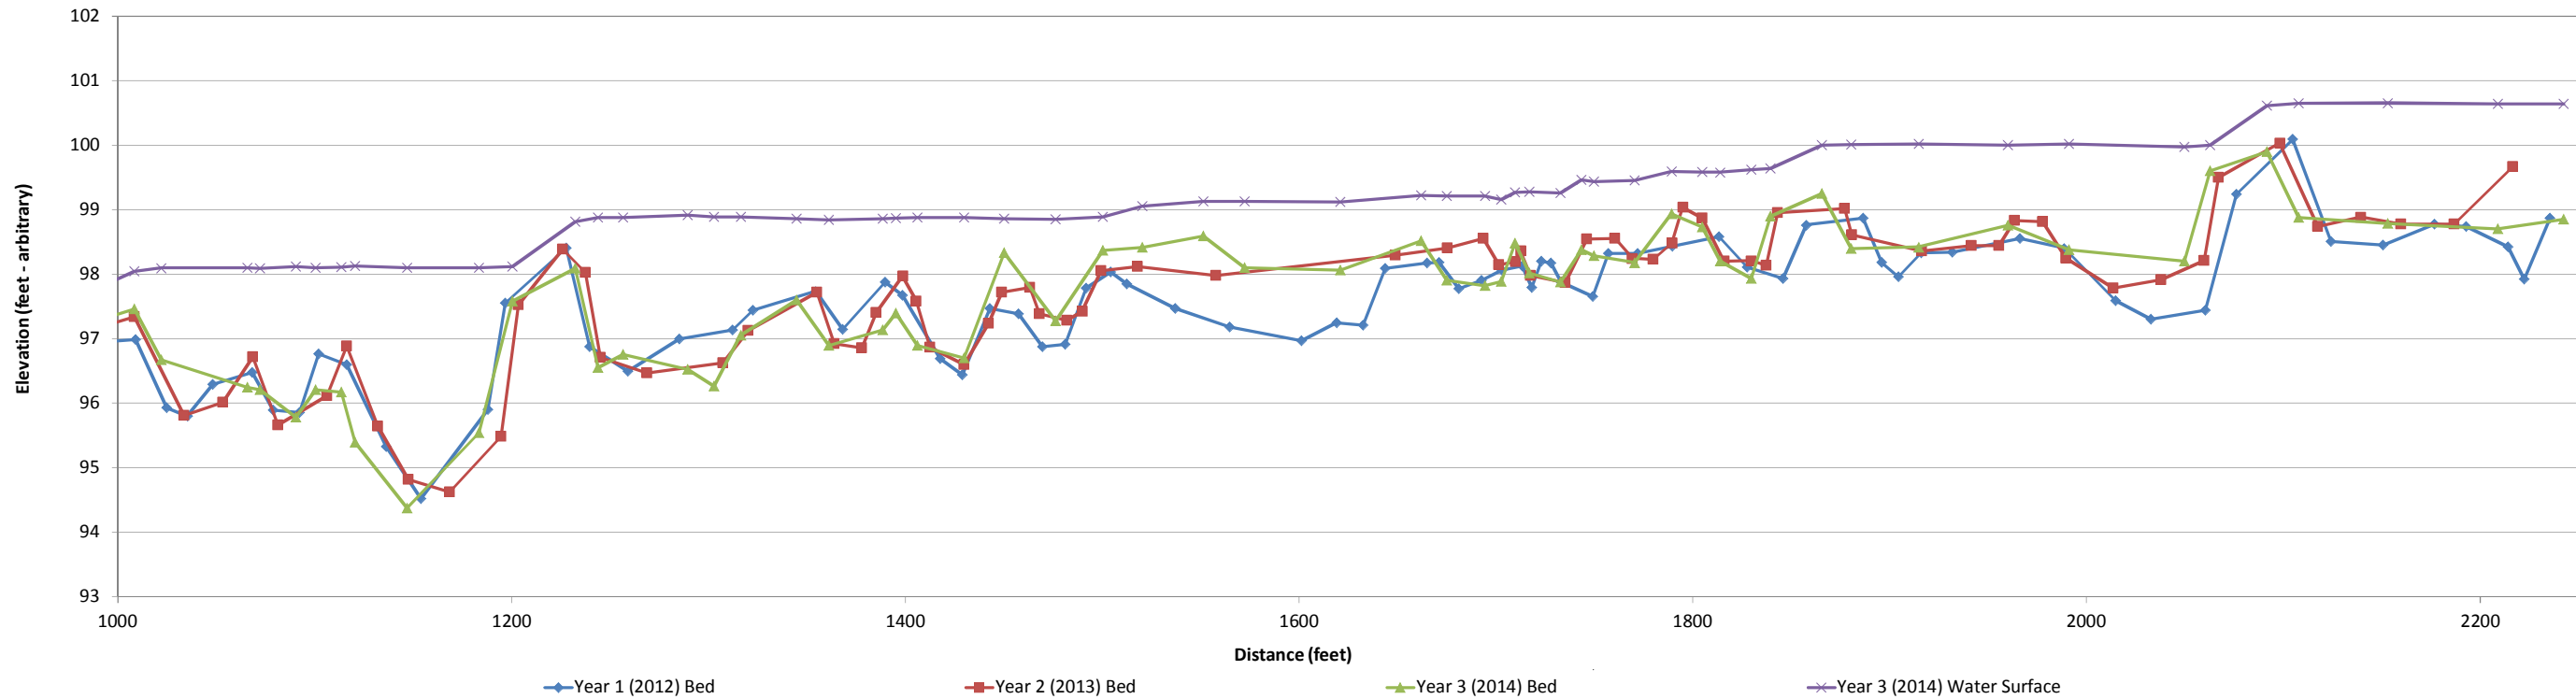
Greenbrier Year 3 (2014) Profile - Unnamed Tributary 00+00 to 09+00

* No water in channel during field measurements.

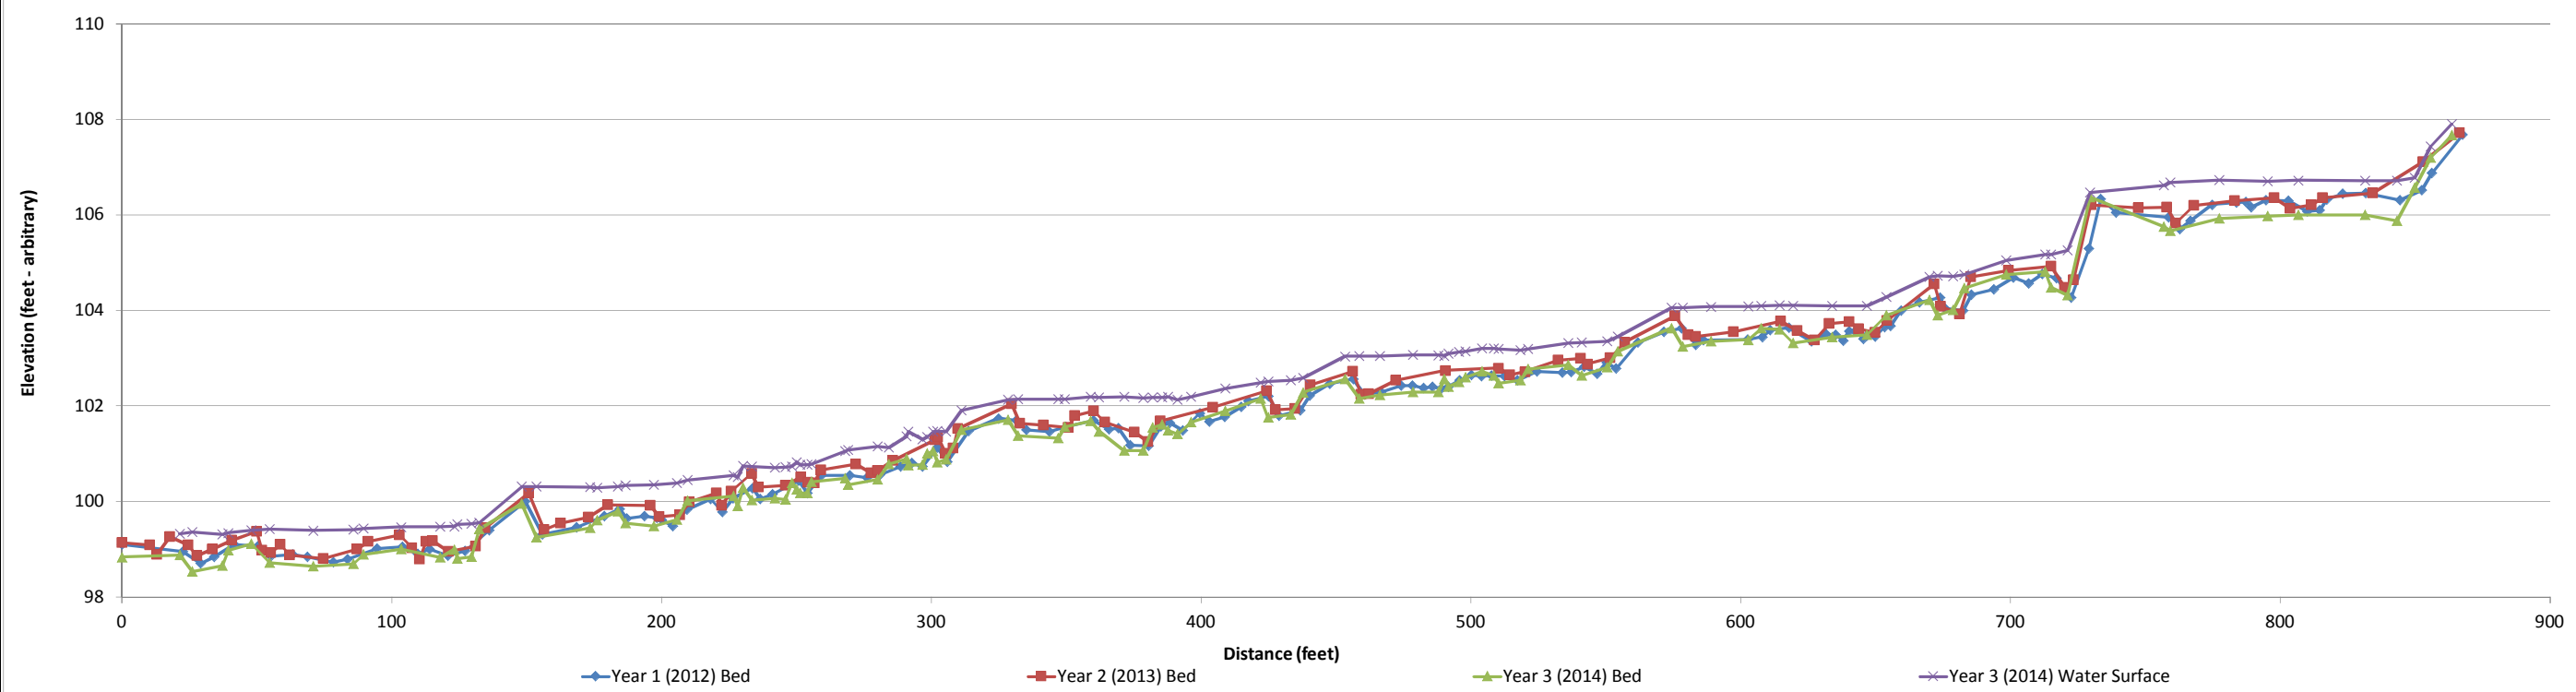
Note: **Cross Section 2**

Size percent less than (mm)					Percent by substrate type					
D16	D35	D50	D84	D95	silt/clay	sand	gravel	cobble	boulder	bedrock
#N/A	1.83	25.3	76	111	20%	16%	44%	20%	0%	0%

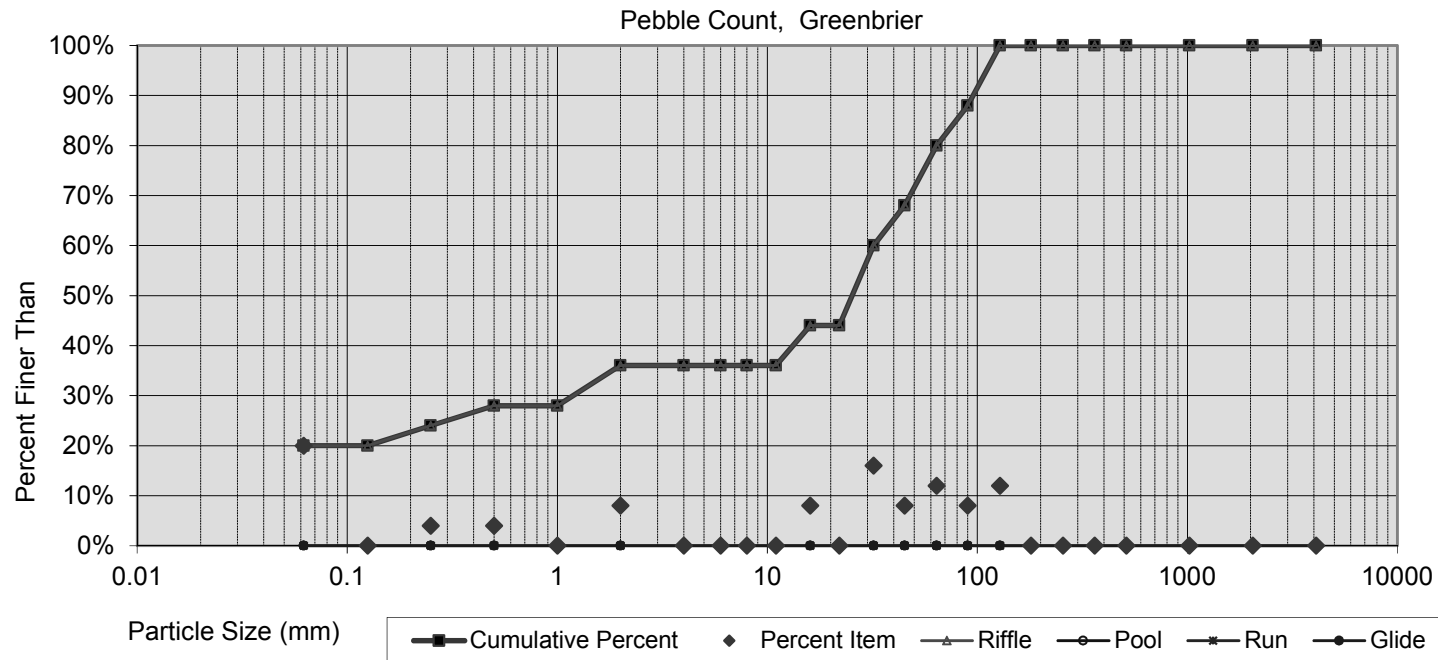
Note: **Cross Section 5**

Size percent less than (mm)					Percent by substrate type					
D16	D35	D50	D84	D95	silt/clay	sand	gravel	cobble	boulder	bedrock
18.762	34.85	47.7	70	88	0%	12%	68%	20%	0%	0%

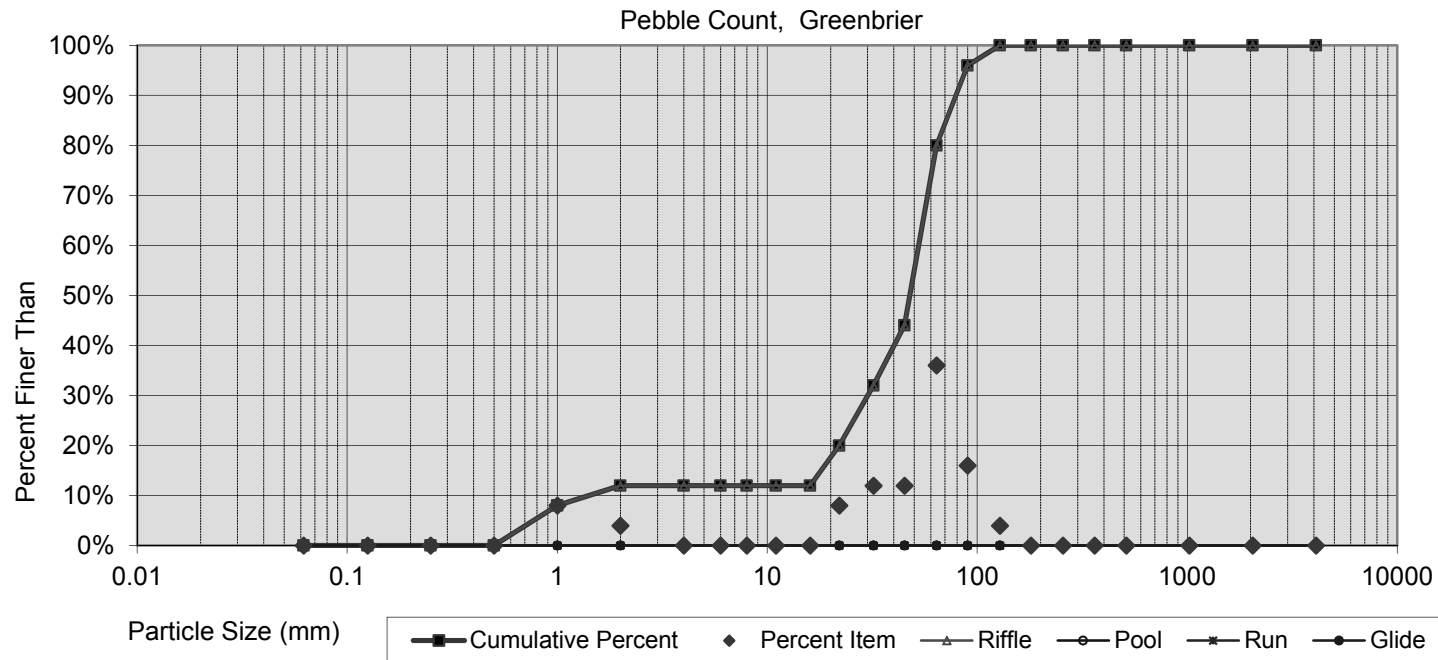
Note: **Cross Section 6**

Size percent less than (mm)					Percent by substrate type					
D16	D35	D50	D84	D95	silt/clay	sand	gravel	cobble	boulder	bedrock
16.000	31.02	51.4	90	124	0%	16%	44%	40%	0%	0%

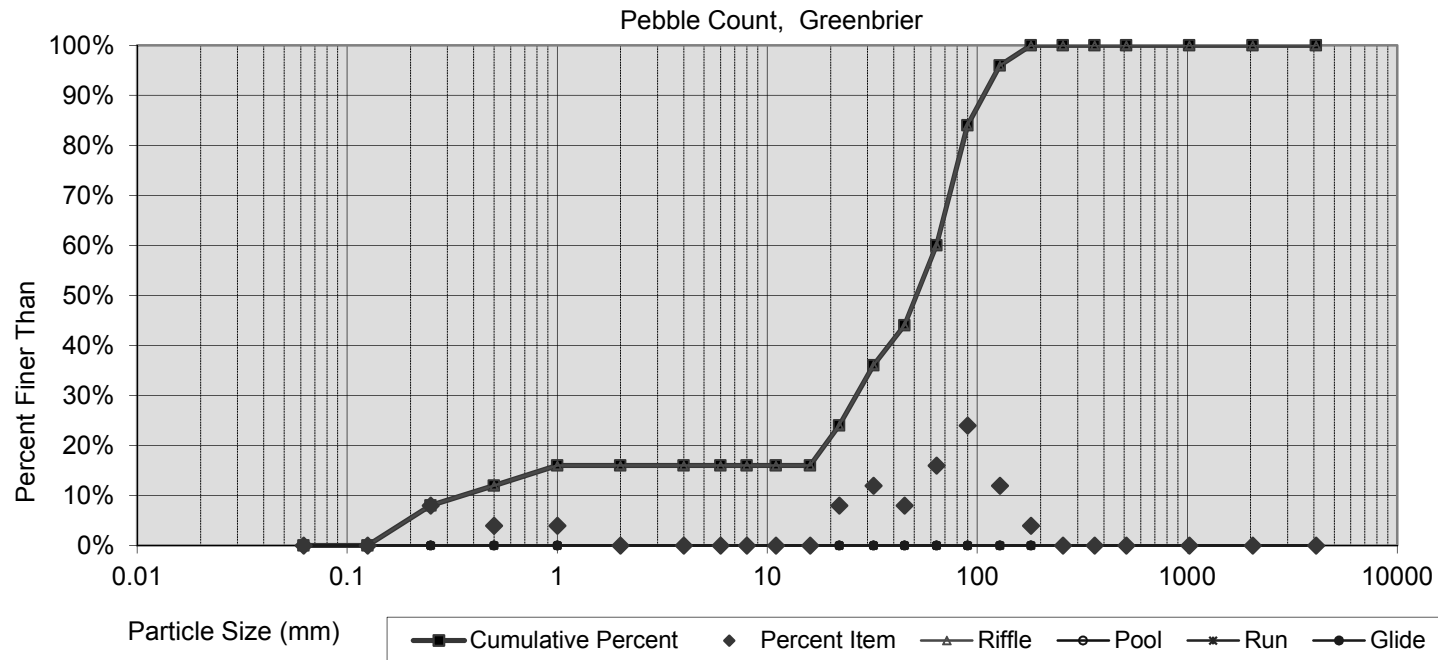
Note: **Cross Section 7**

Size percent less than (mm)					Percent by substrate type					
D16	D35	D50	D84	D95	silt/clay	sand	gravel	cobble	boulder	bedrock
0.630	5.42	11.7	30	43	4%	28%	68%	0%	0%	0%

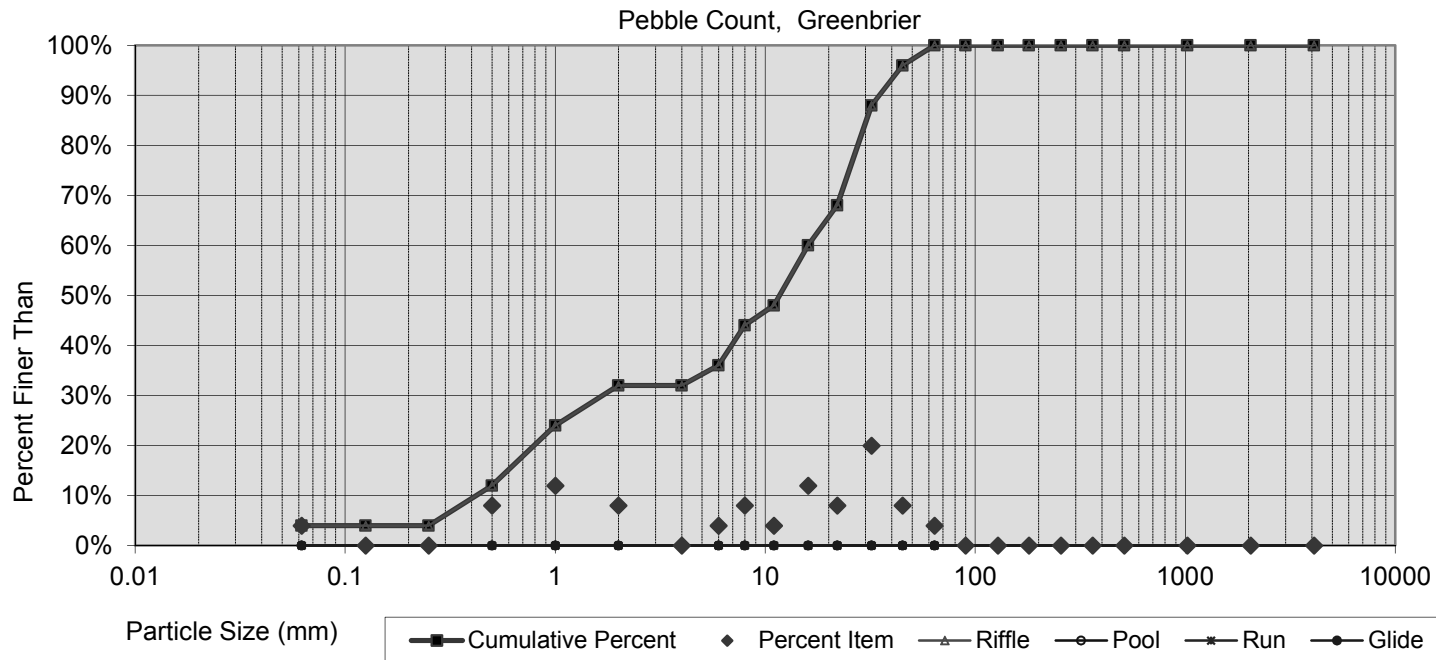
Note: **Cross Section 9**

Size percent less than (mm)					Percent by substrate type					
D16	D35	D50	D84	D95	silt/clay	sand	gravel	cobble	boulder	bedrock
0.074	0.17	0.7	16	41	12%	40%	48%	0%	0%	0%

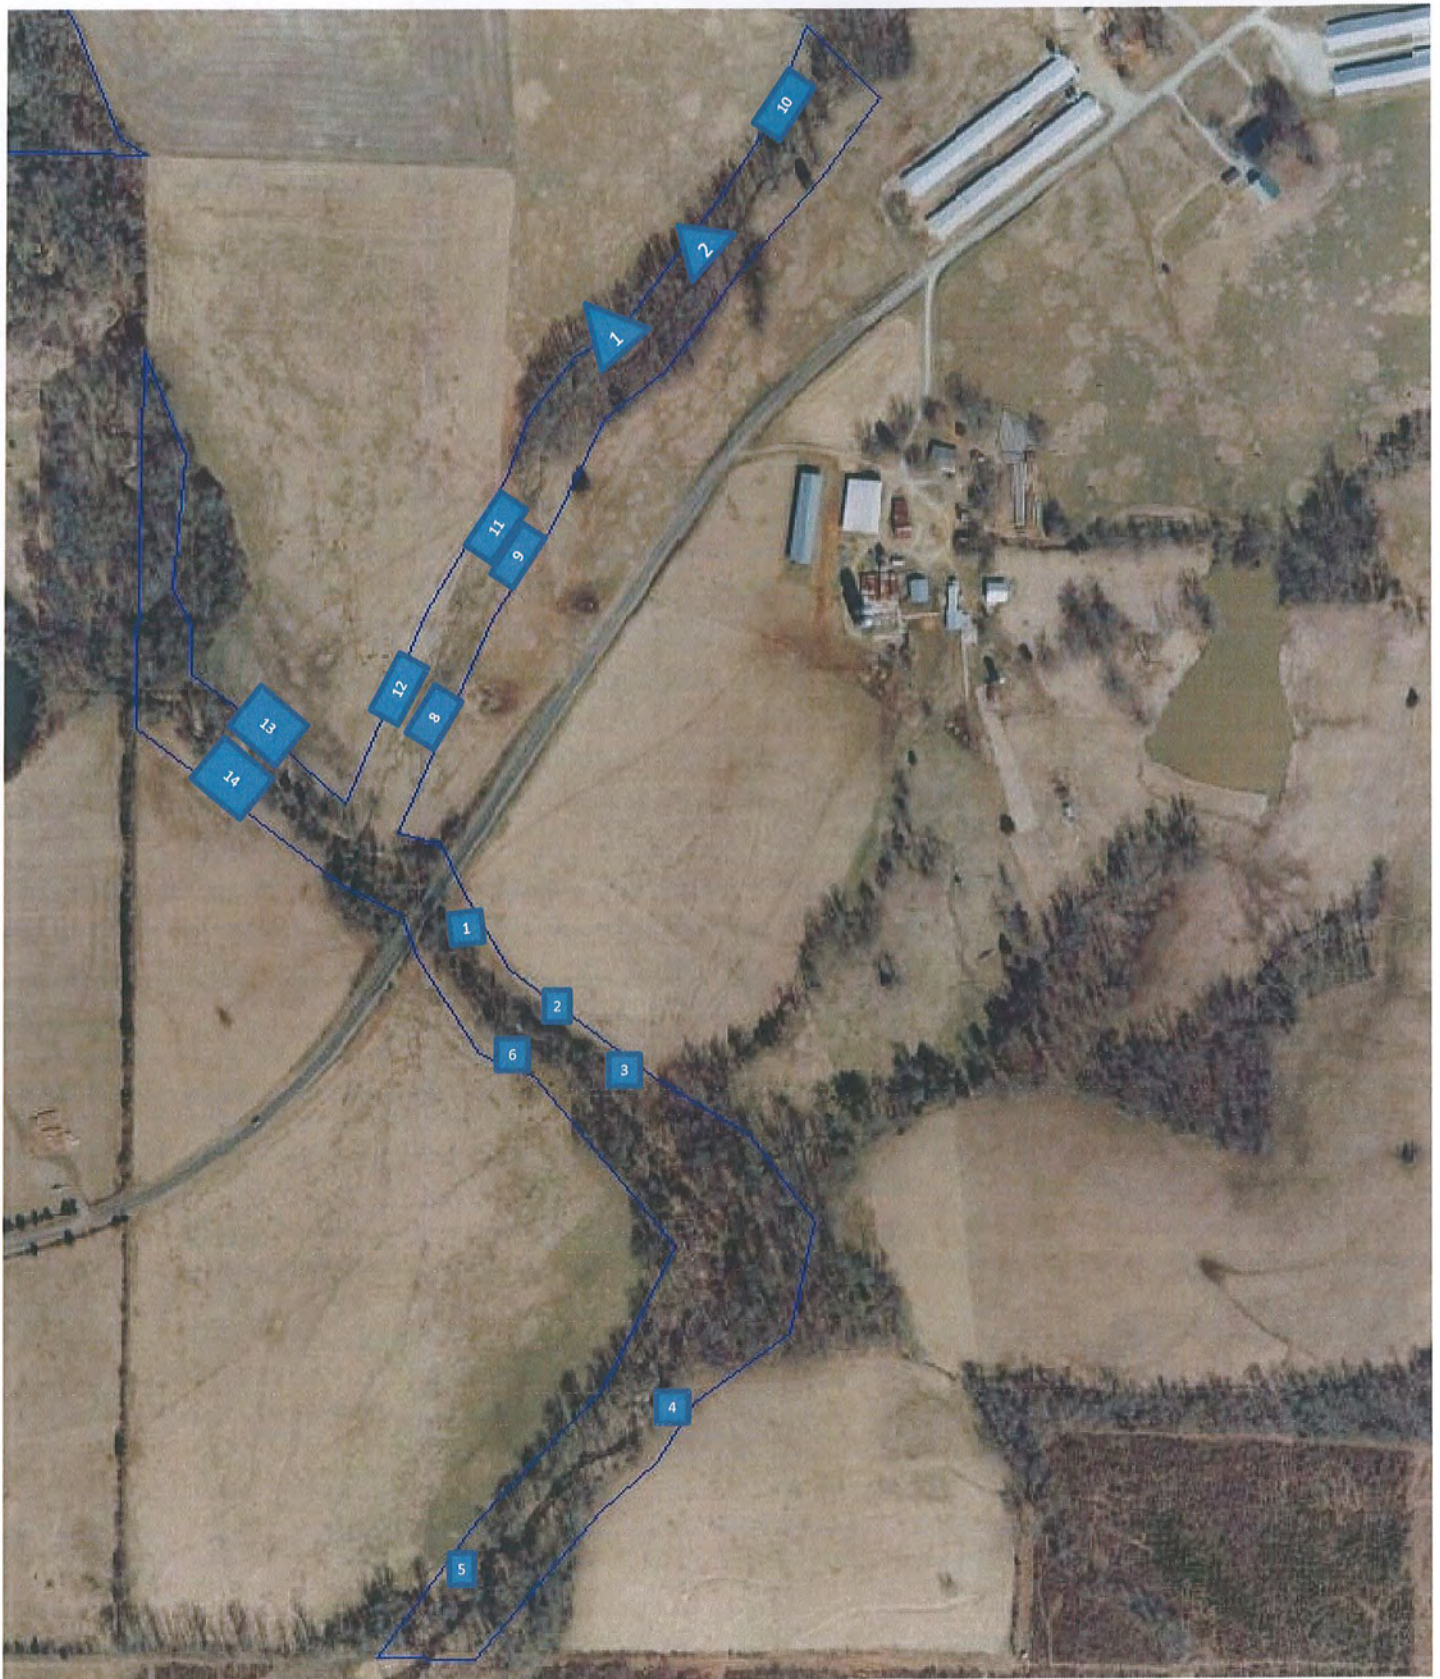
Greenbrier Creek Stream Restoration
Alamance/Chatham Counties
Vegetation Warranty Map

In general, some of plant survival in the Zone 4 and Zone 5 planting zones did not meet the warranty requirement. The table below outlines necessary replanting areas. Surviving stems were subtracted from the warranty criteria (544/acre for Zone 4 and 348 per acre for Zone 5) so that the "Total plants needed" column is the number of remaining stems needed get warranty criteria (544/348) stems per acre in areas with deficient vegetation. Planting densities were averaged into planting zones and are identified on the attached Supplemental Planting Map.

Location	Planting Zone	Acres	Total plants needed
Zone 5 (Unnamed Tributary)	Zone 5	0.8	114
Unnamed Tributary (St 400+00 - 407+00) & mainstem (St 106+50 - 100+00)	Zone 4	3	1254
Right, mainstem (St 200+00 - 205+50)	Zone 4	0.6	158
Left, mainstem (St 200+00 - 206+00)	Zone 4	0.7	217
Left, mainstem (St 212+50 - 214+00)	Zone 4	0.2	89
Right, mainstem (St 210+50 - 219+00)	Zone 4	1	121
Total		6.3	1,952
