**FINAL
ANNUAL MONITORING REPORT
YEAR 4 (2015)
GREENBRIER CREEK STREAM/WETLAND/BUFFER RESTORATION SITE
ALAMANCE AND CHATHAM COUNTIES, NORTH CAROLINA
(DMS Project No. 671, Contract No. 004801)
Construction Completed January 2011**

October 2015

Prepared by:
Axiom Environmental, Inc.
218 Snow Avenue
Raleigh, North Carolina 27603

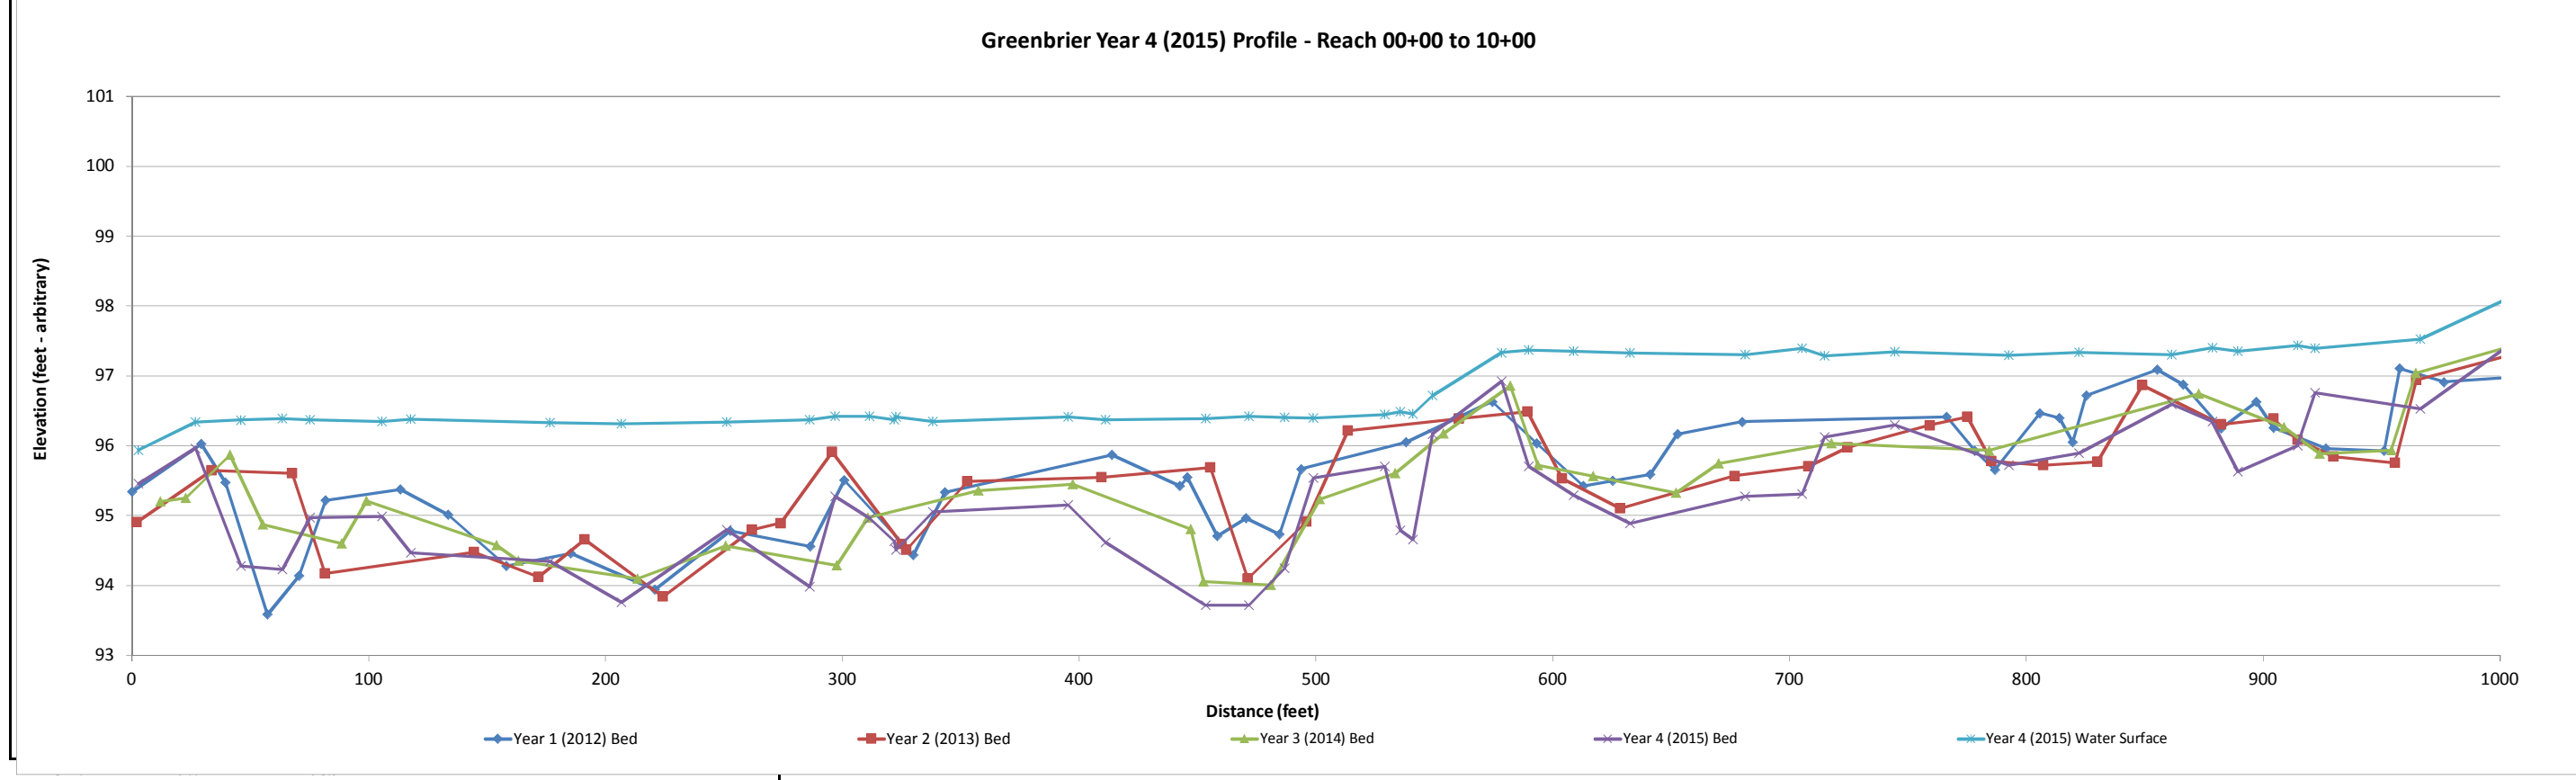
Project Name Greenbrier - Year 4 (2015) Profile
Reach Main Reach (00+00 - 10+00)
Feature Profile
Date 3/26/15
Crew Perkinson, Jernigan

2012	2013	2014	2015
Avg. Water Surface Slope	0.0017	0.0010	0.0020	0.0019
Riffle Length	29	34	72	64
Avg. Riffle Slope	0.0050	0.0006	0.0074	0.0087
Pool Length	18	27	52	58
Avg. Pool Slope	0.0000	0.0000	0.0004	0.0006

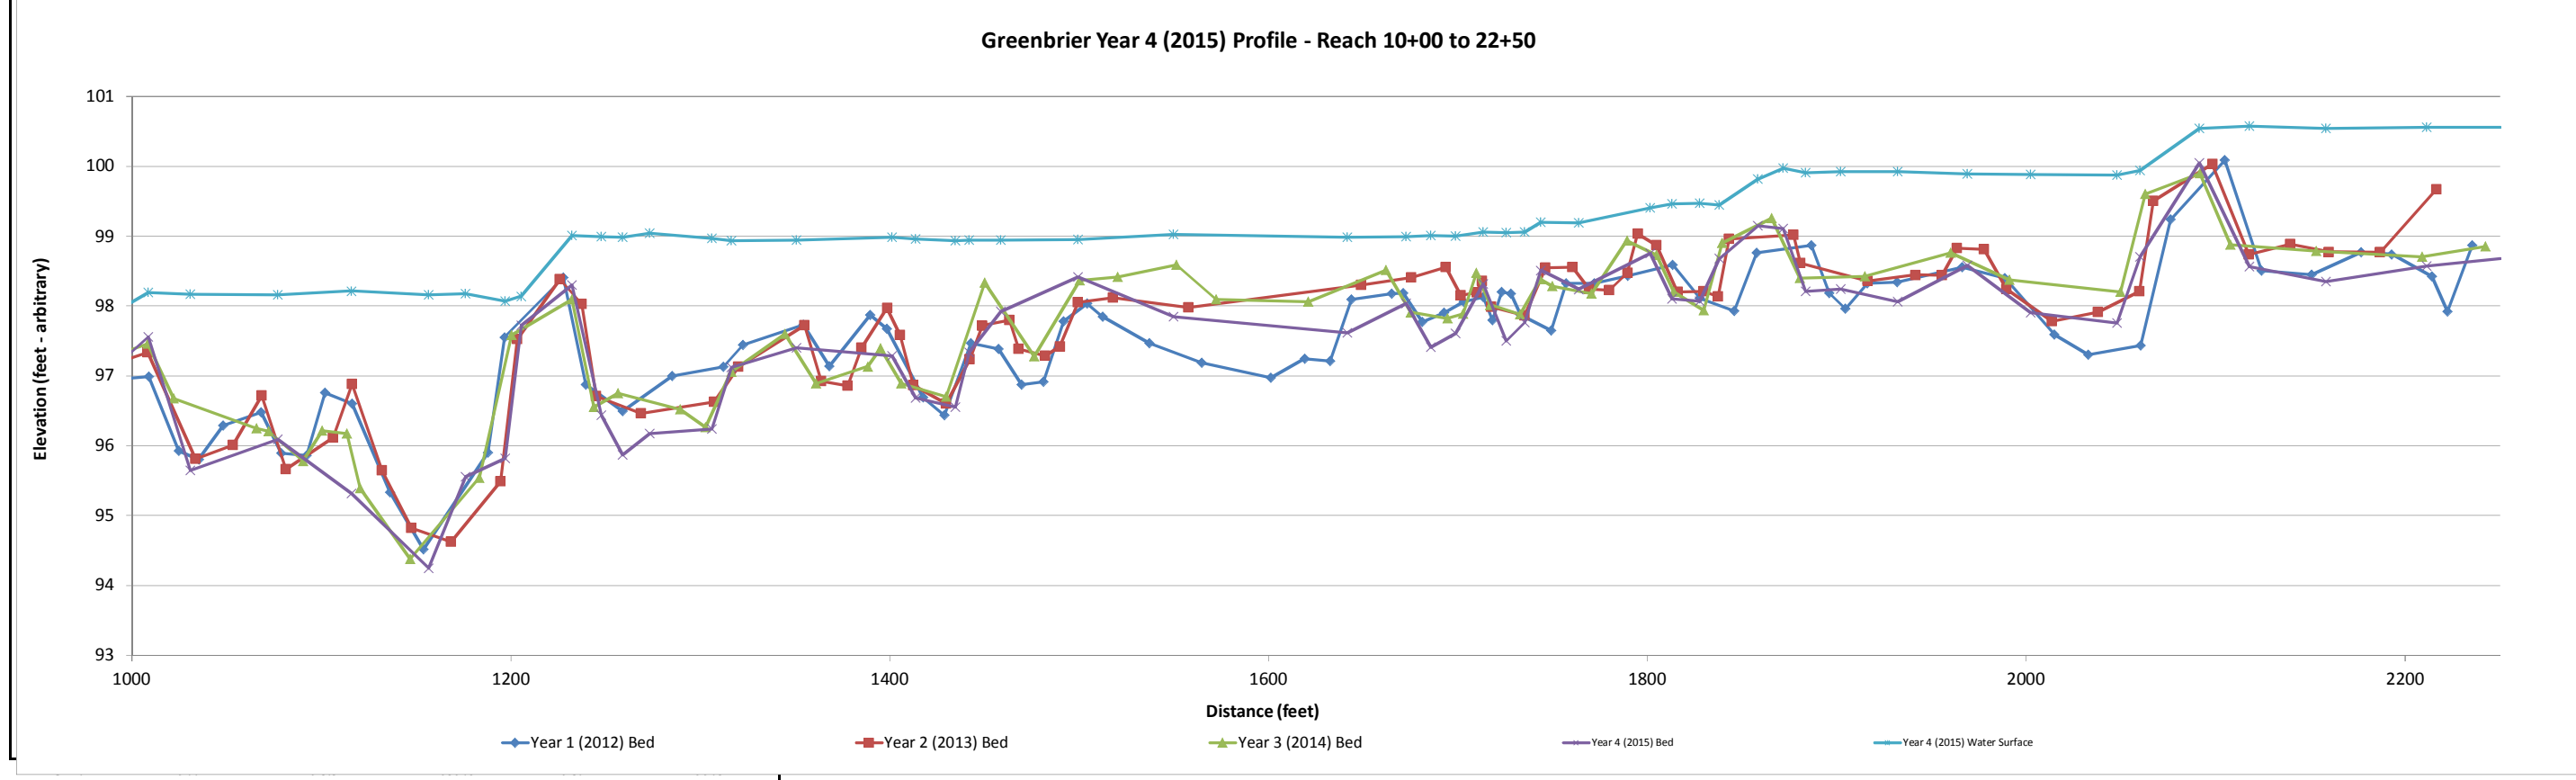
Project Name Greenbrier - Year 4 (2015) Profile
Reach Main Reach (10+00 - 22+50)
Feature Profile
Date 3/26/15
Crew Perkinson, Jernigan

2012	2013	2014	2015
Avg. Water Surface Slope	0.0017	0.0010	0.0020	0.0019
Riffle Length	29	34	72	64
Avg. Riffle Slope	0.0050	0.0006	0.0074	0.0087
Pool Length	18	27	52	58
Avg. Pool Slope	0.0000	0.0000	0.0004	0.0006

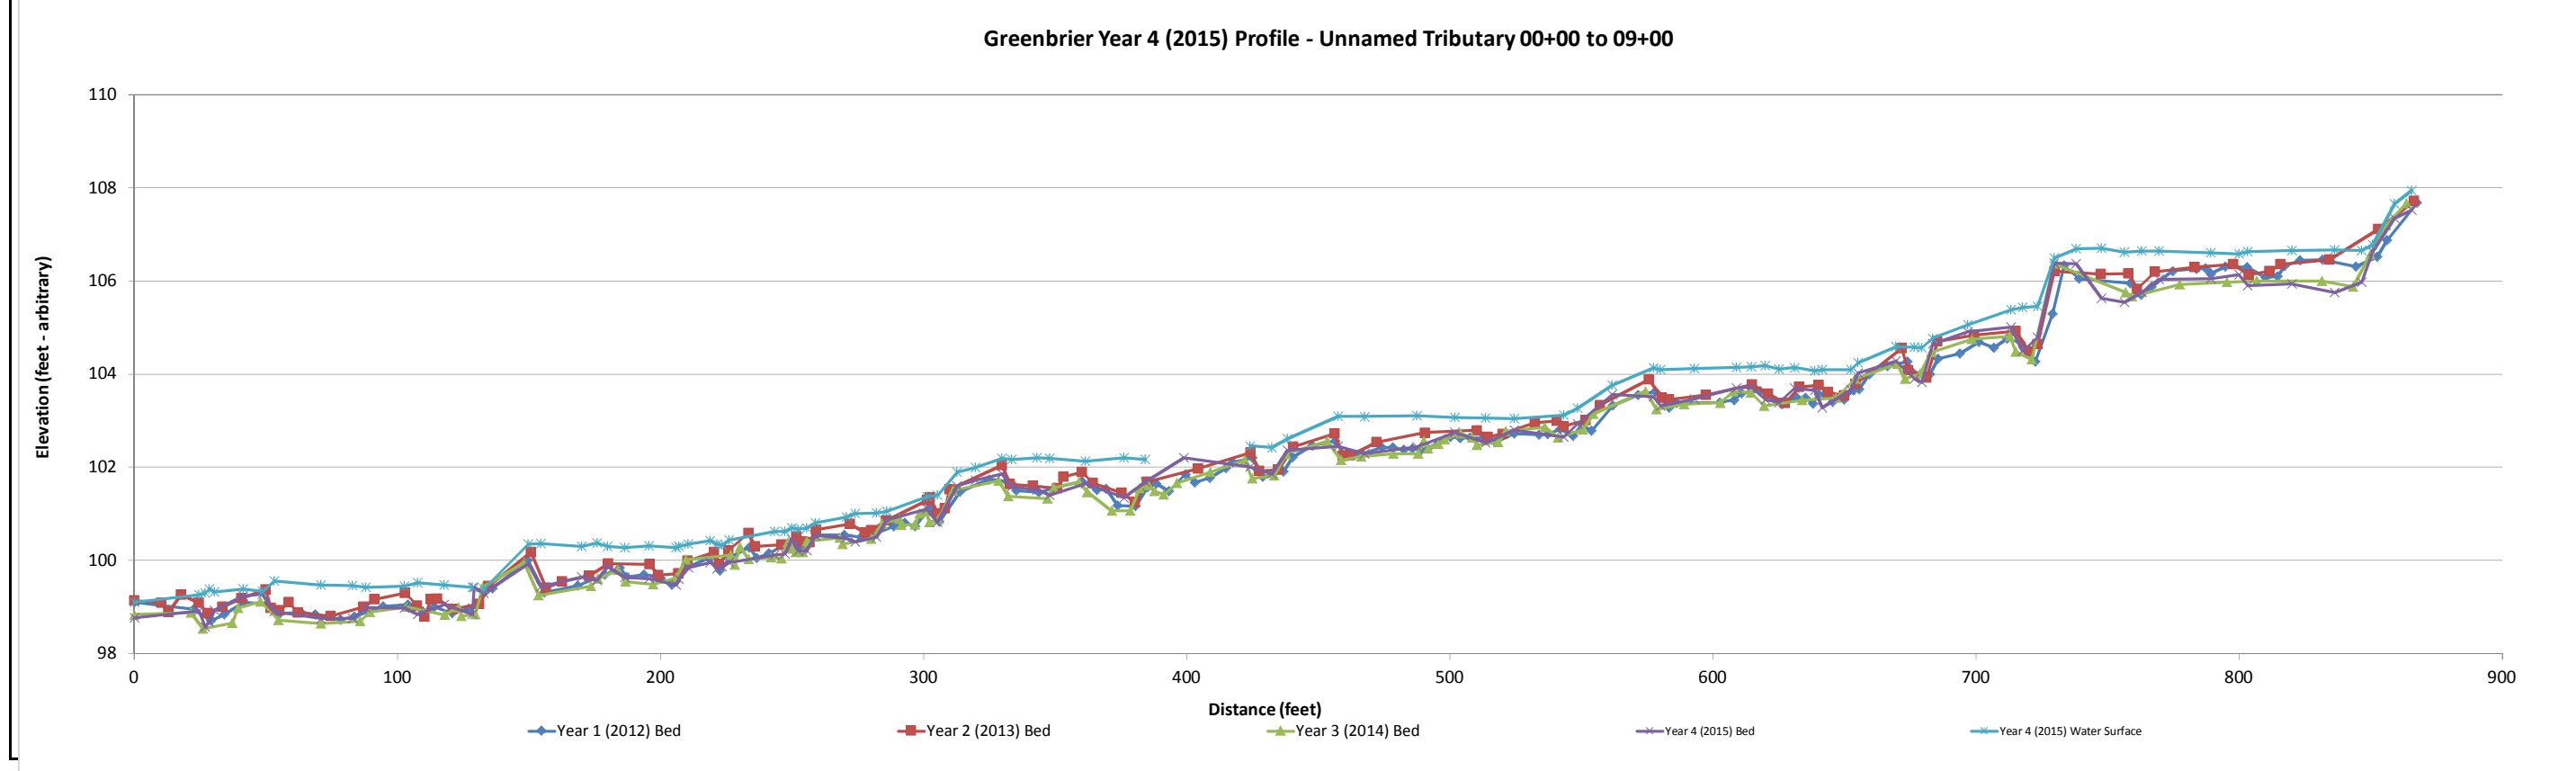
Project Name Greenbrier - Year 4 (2015) Profile
Reach Unnamed Tributary (00+00 - 09+00)
Feature Profile
Date 3/26/15
Crew Perkinson, Jernigan

2012*	2013	2014	2015
Avg. Water Surface Slope	----	0.0092	0.0102	
Riffle Length	10	16	14	
Avg. Riffle Slope	----	0.0124	0.0206	
Pool Length	9	6	15	
Avg. Pool Slope	----	0.0008	0.0038

* No water in channel during field measurements.

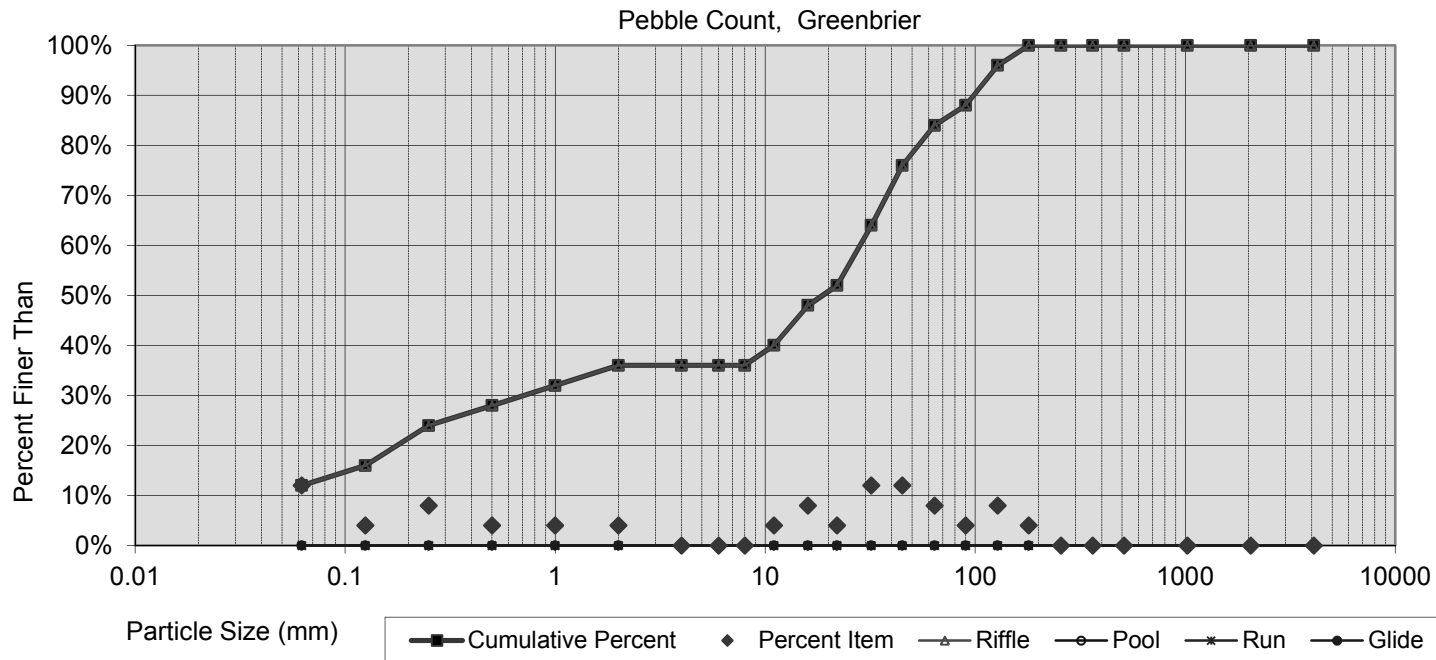
Note: **Cross Section 2**

Size percent less than (mm)					Percent by substrate type					
D16	D35	D50	D84	D95	silt/clay	sand	gravel	cobble	boulder	bedrock
0.125	1.68	18.8	64	122	12%	24%	48%	16%	0%	0%

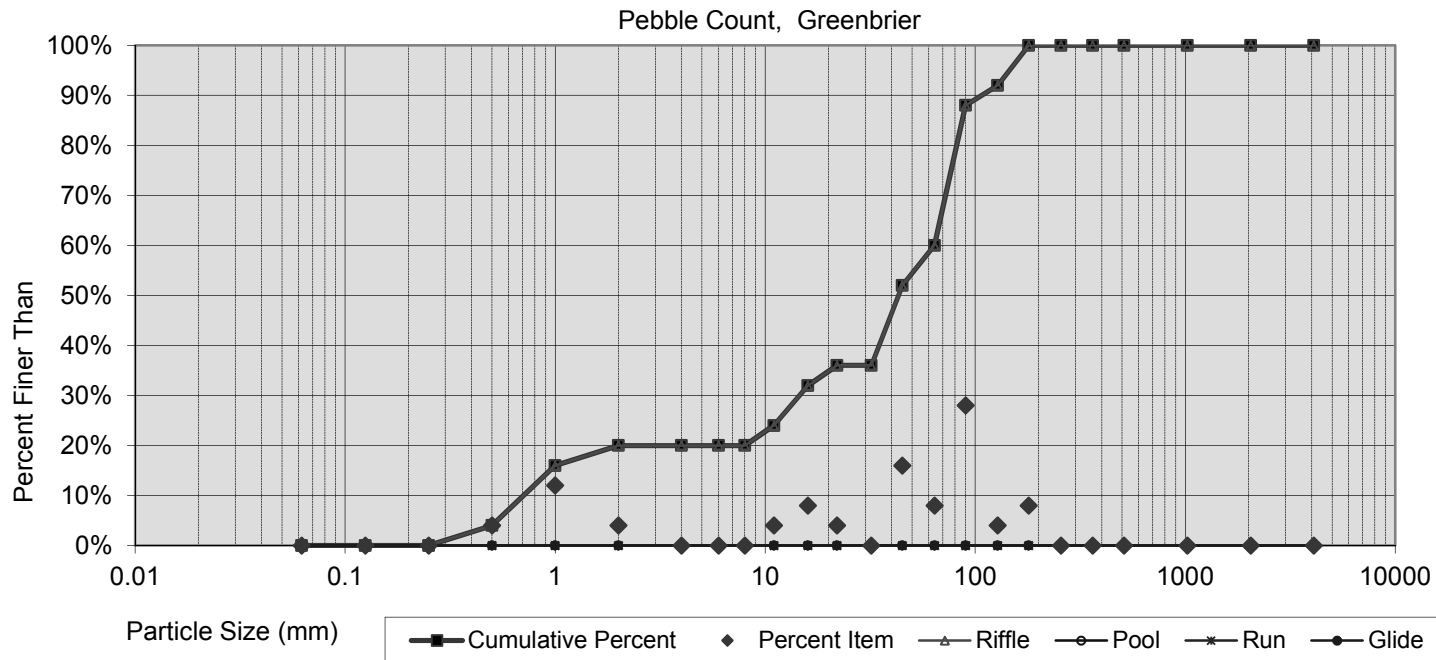
Note: **Cross Section 5**

Size percent less than (mm)					Percent by substrate type					
D16	D35	D50	D84	D95	silt/clay	sand	gravel	cobble	boulder	bedrock
1.000	20.32	43.1	86	145	0%	20%	40%	40%	0%	0%

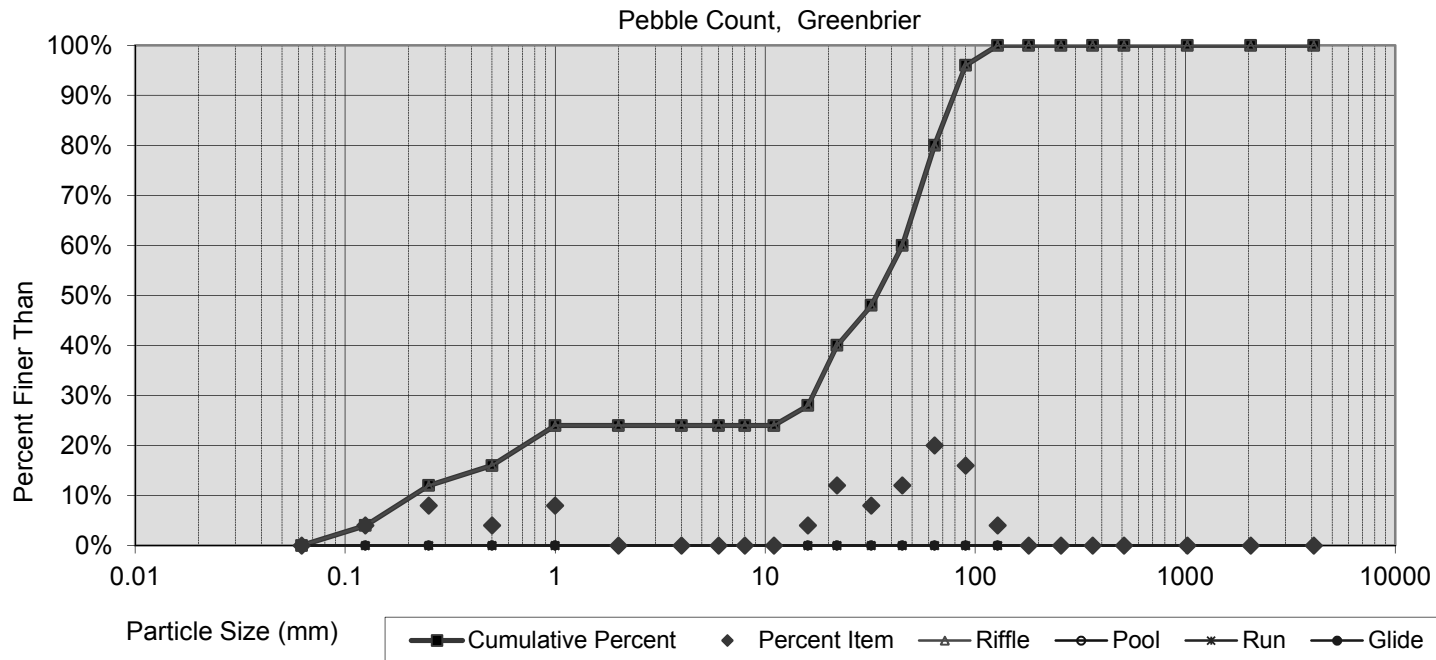
Note: **Cross Section 6**

Size percent less than (mm)					Percent by substrate type					
D16	D35	D50	D84	D95	silt/clay	sand	gravel	cobble	boulder	bedrock
0.500	19.27	33.9	70	88	0%	24%	56%	20%	0%	0%

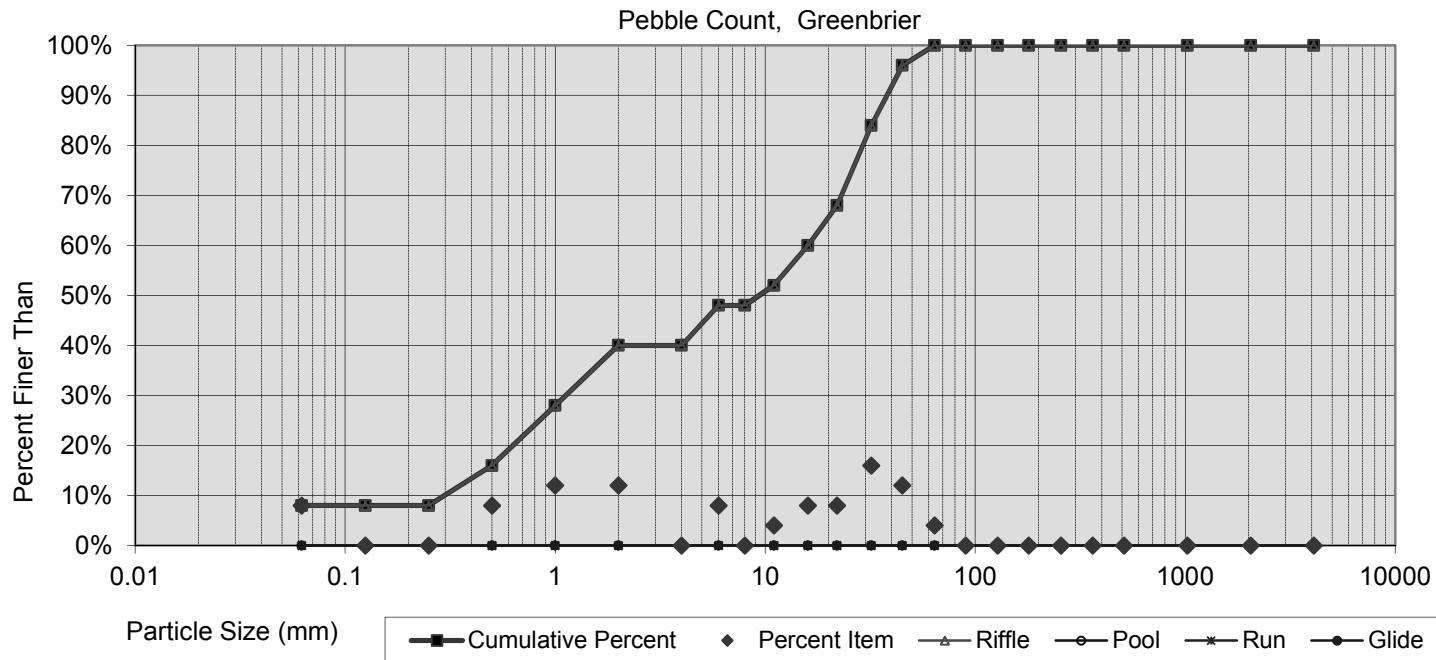
Note: **Cross Section 7**

Size percent less than (mm)					Percent by substrate type					
D16	D35	D50	D84	D95	silt/clay	sand	gravel	cobble	boulder	bedrock
0.500	1.50	9.4	32	44	8%	32%	60%	0%	0%	0%

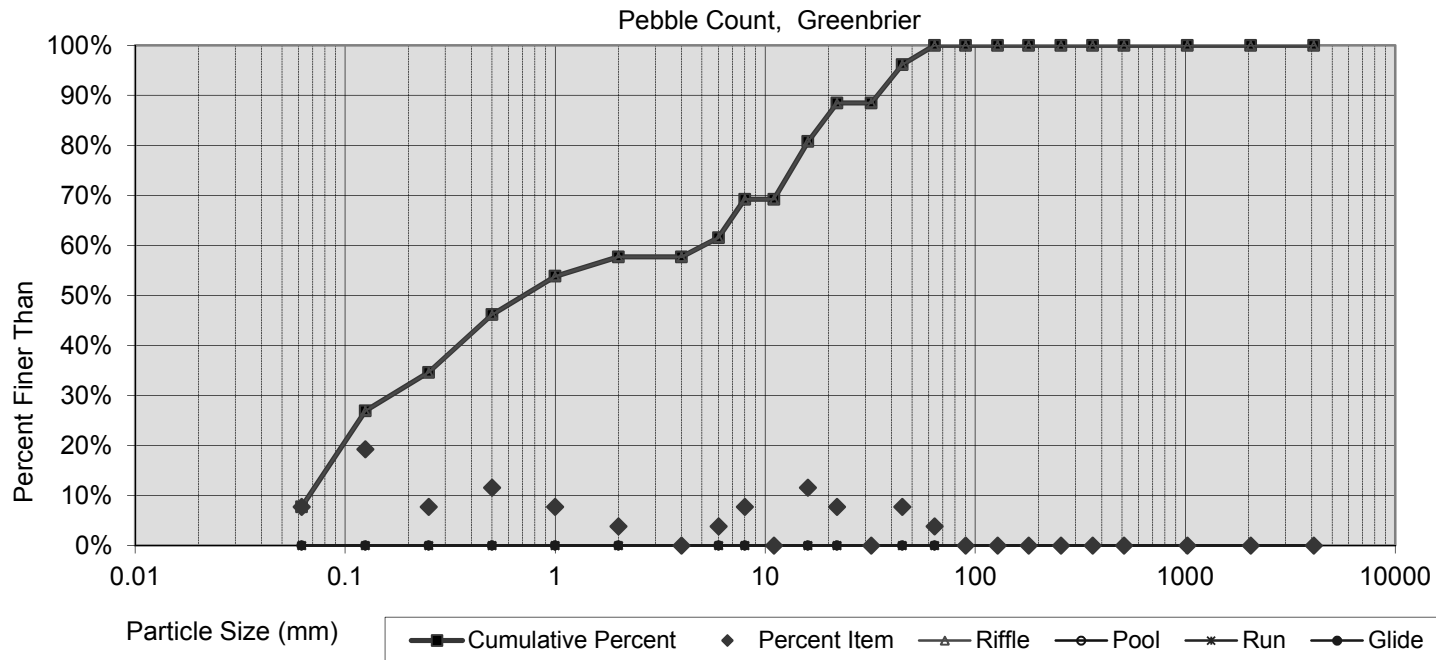
Note: **Cross Section 9**

Size percent less than (mm)					Percent by substrate type					
D16	D35	D50	D84	D95	silt/clay	sand	gravel	cobble	boulder	bedrock
0.084	0.26	0.7	18	43	8%	50%	42%	0%	0%	0%

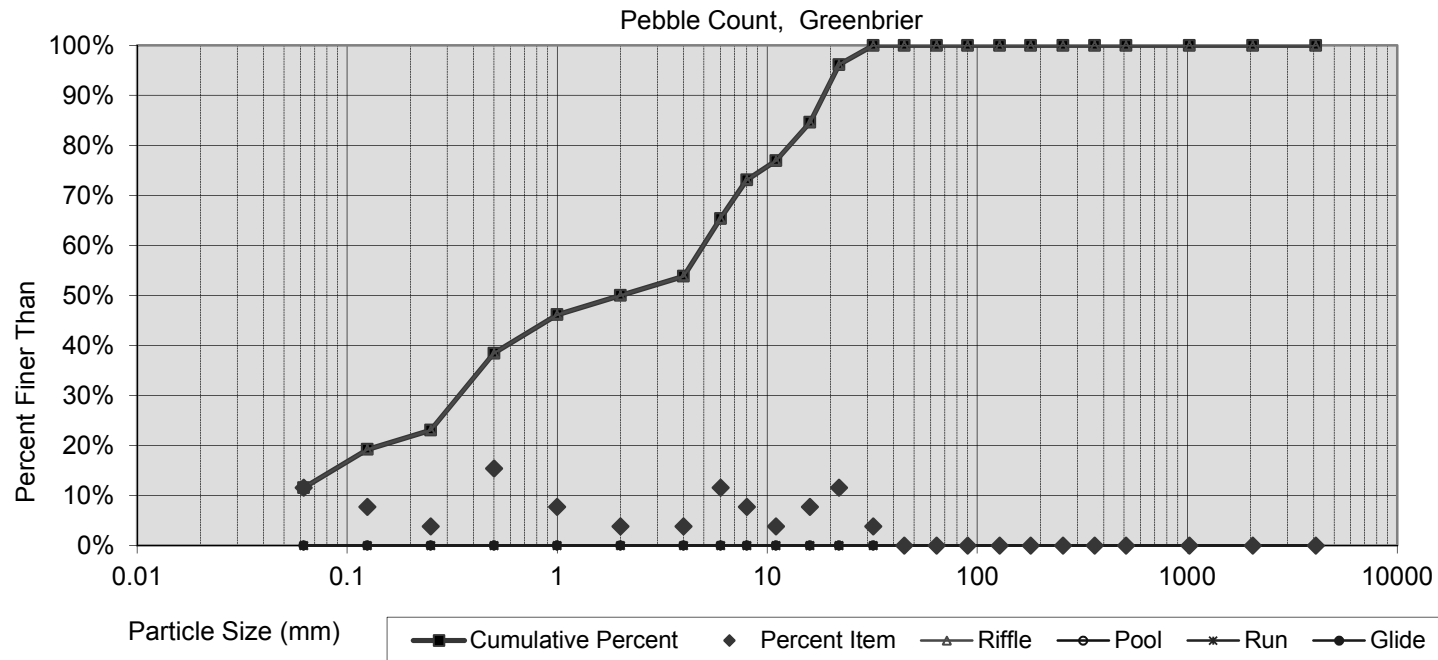
Note: **Cross Section 11**

Size percent less than (mm)					Percent by substrate type					
D16	D35	D50	D84	D95	silt/clay	sand	gravel	cobble	boulder	bedrock
0.093	0.43	2.0	16	21	12%	38%	50%	0%	0%	0%

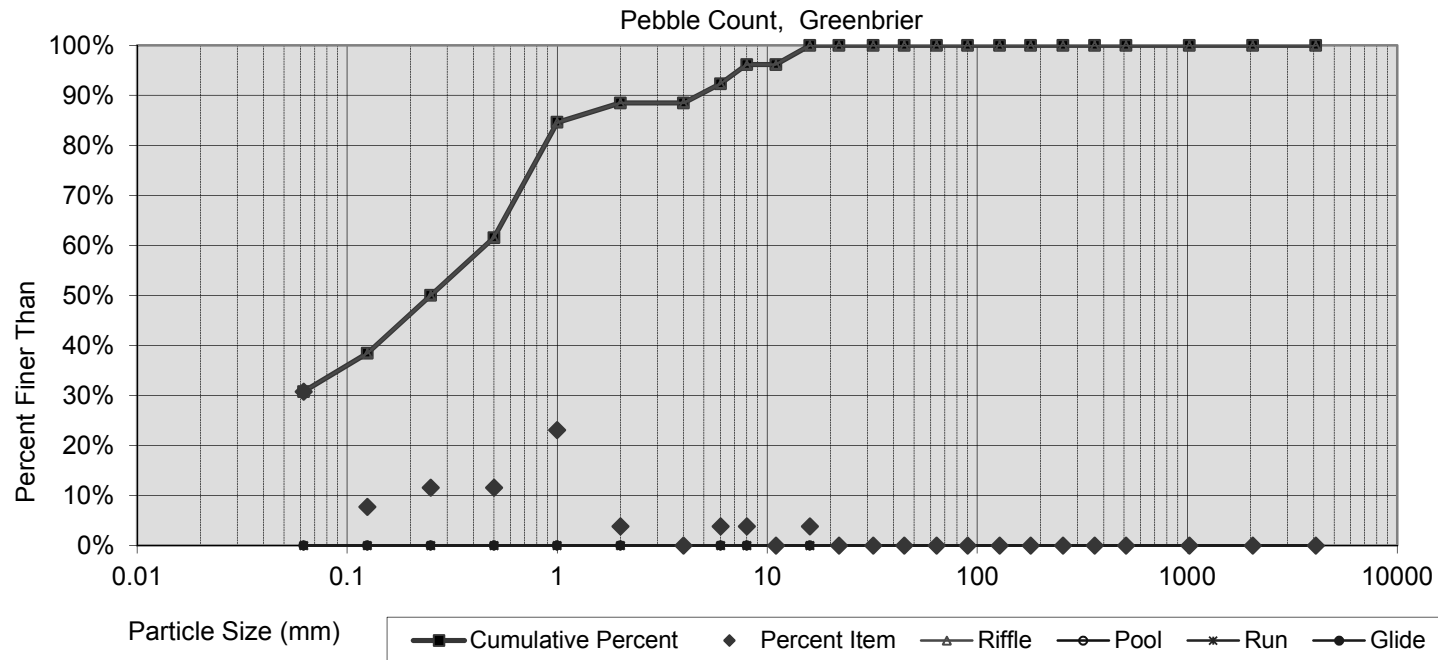
Note: **Cross Section 12**

Size percent less than (mm)					Percent by substrate type					
D16	D35	D50	D84	D95	silt/clay	sand	gravel	cobble	boulder	bedrock
#N/A	0.09	0.3	1	7	31%	58%	12%	0%	0%	0%

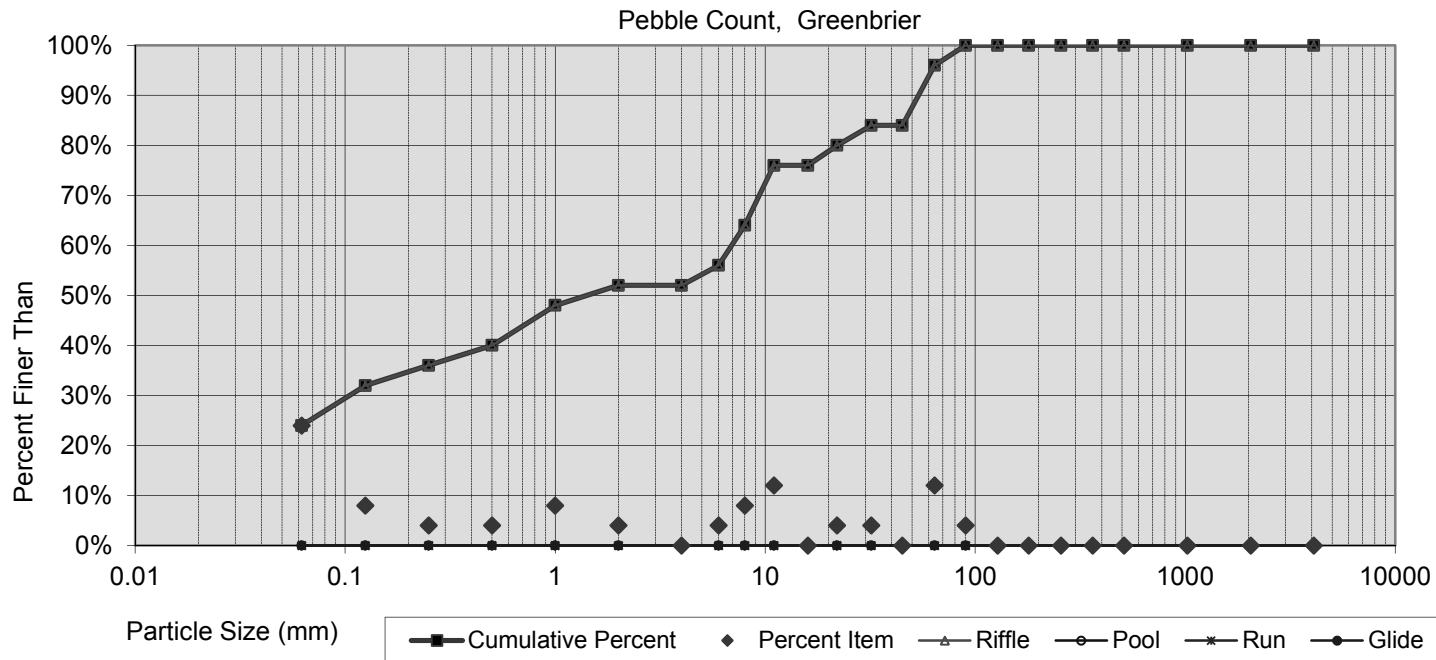
Note: **Cross Section 14**

Size percent less than (mm)					Percent by substrate type					
D16	D35	D50	D84	D95	silt/clay	sand	gravel	cobble	boulder	bedrock
#N/A	0.21	1.4	32	62	24%	28%	44%	4%	0%	0%
