**FINAL
ANNUAL MONITORING REPORT
YEAR 5 (2016)
GREENBRIER CREEK STREAM/WETLAND/BUFFER RESTORATION SITE
ALAMANCE AND CHATHAM COUNTIES, NORTH CAROLINA
(DMS Project No. 671, Contract No. 004801)
Construction Completed January 2011**

November 2016

Prepared by:
Axiom Environmental, Inc.
218 Snow Avenue
Raleigh, North Carolina 27603

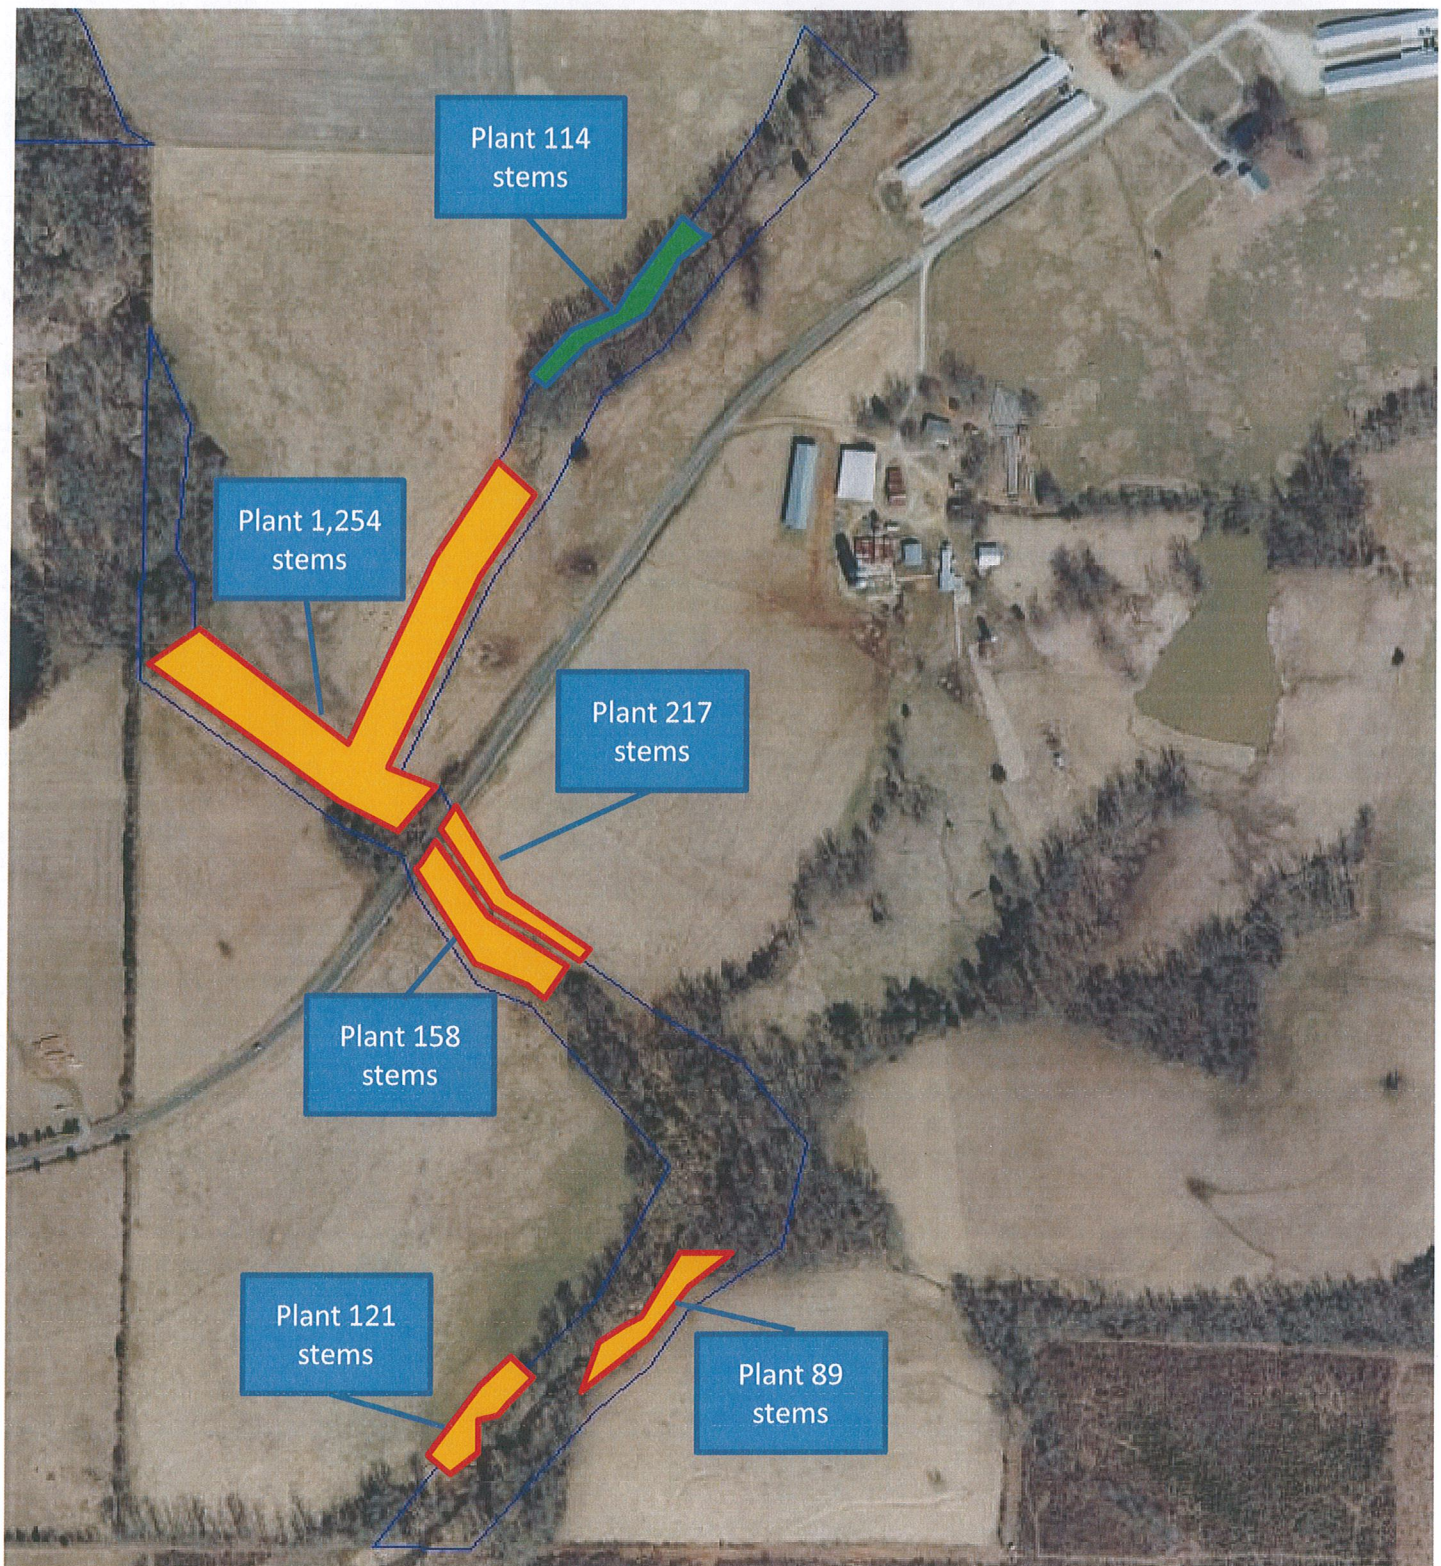
Greenbrier Creek Stream Restoration
Alamance/Chatham Counties
Vegetation Warranty Map

In general, some of plant survival in the Zone 4 and Zone 5 planting zones did not meet the warranty requirement. The table below outlines necessary replanting areas. Surviving stems were subtracted from the warranty criteria (544/acre for Zone 4 and 348 per acre for Zone 5) so that the "Total plants needed" column is the number of remaining stems needed get warranty criteria (544/348) stems per acre in areas with deficient vegetation. Planting densities were averaged into planting zones and are identified on the attached Supplemental Planting Map.

Location	Planting Zone	Acres	Total plants needed
Zone 5 (Unnamed Tributary)	Zone 5	0.8	114
Unnamed Tributary (St 400+00 - 407+00) & mainstem (St 106+50 - 100+00)	Zone 4	3	1254
Right, mainstem (St 200+00 - 205+50)	Zone 4	0.6	158
Left, mainstem (St 200+00 - 206+00)	Zone 4	0.7	217
Left, mainstem (St 212+50 - 214+00)	Zone 4	0.2	89
Right, mainstem (St 210+50 - 219+00)	Zone 4	1	121
Total		6.3	1,952
