Year Two Monitoring Report

GROUNDHOG HOLLOW PROJECT

NCDMS Project #100049 (Contract #7417) | RFP 16-007277 (Issued 6/21/2017)

Alexander County, North Carolina
Catawba River Basin
HUC 03050101

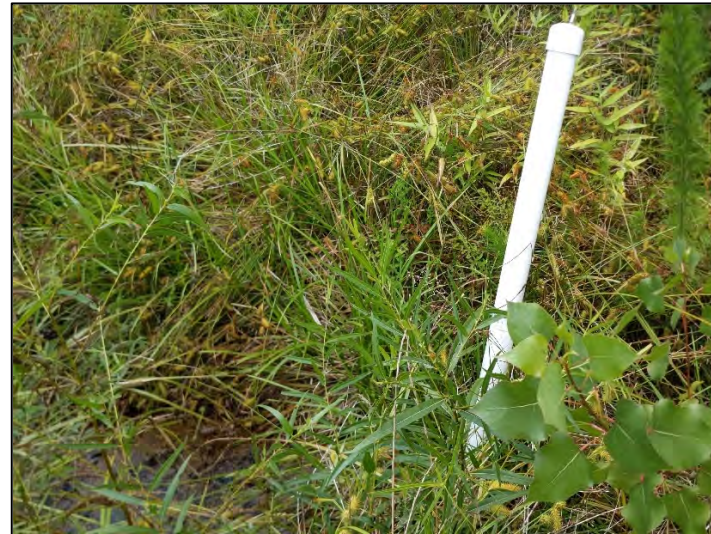
Stage Recorder GF2-B (7/6/2022)

The stage recorder is present on the CCPV however is obscured by the XS 18 label and can be hard to see. The gage has been shifted slightly on the figure for clarification. The stream structure callout has been updated.

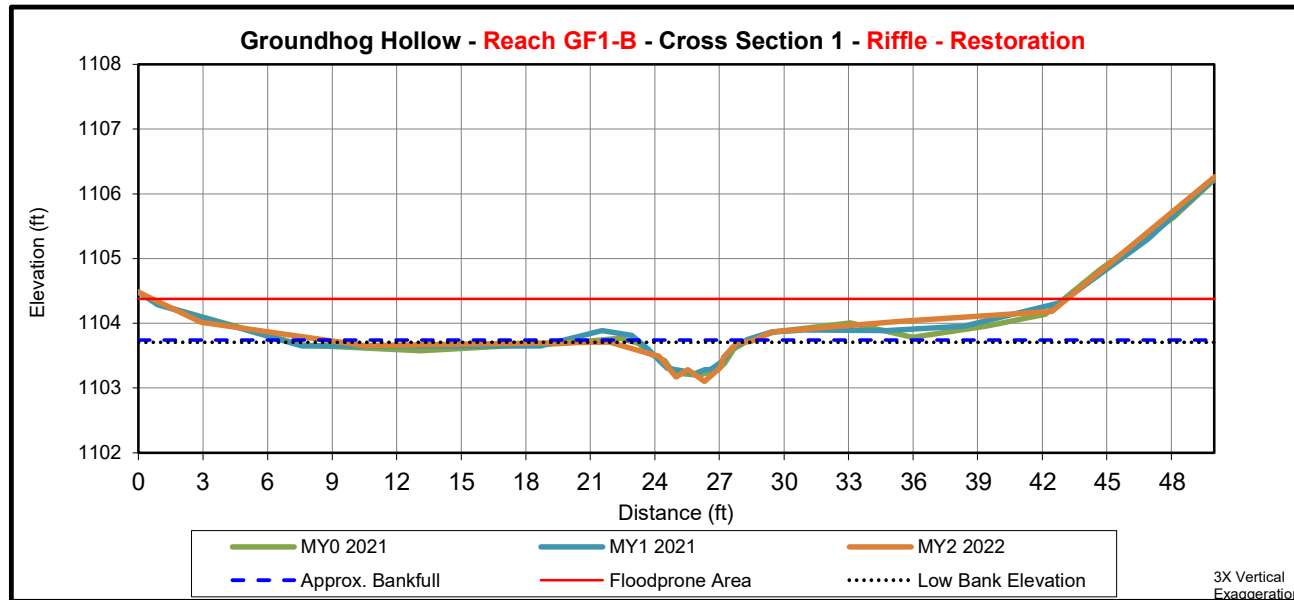
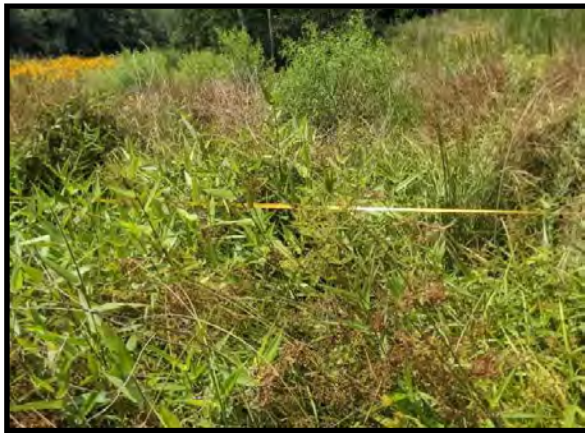
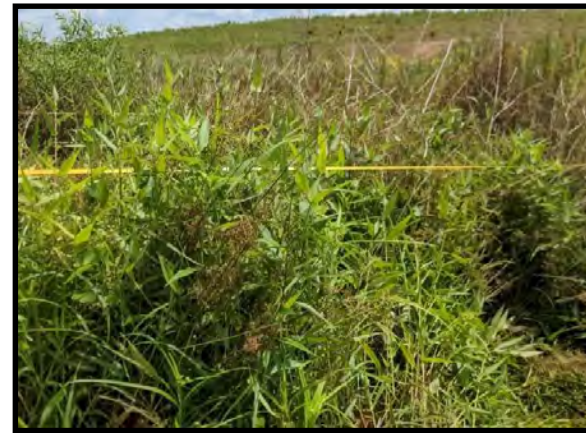
Cross Section 1 (Riffle)						
	MY0	MY1	MY2	MY3	MY5	MY7	MY+
Bankfull Elevation (ft) - Based on AB-XSA¹	1103.77	1103.8	1103.7				
Bankfull Width (ft) ¹	6.3	5.8	6.7				
Floodprone Width (ft) ¹	50.0	42.7	>42.5				
Bankfull Max Depth (ft) ²	0.6	0.6	0.6				
Low Bank Elevation (ft)	1103.77	1103.9	1103.7				
Bankfull Cross Sectional Area (ft ²) ²	1.9	2.3	1.7				
Bankfull Entrenchment Ratio ¹	7.9	7.4	>6.3				
Bankfull Bank Height Ratio ¹	1.0	1.1	0.9

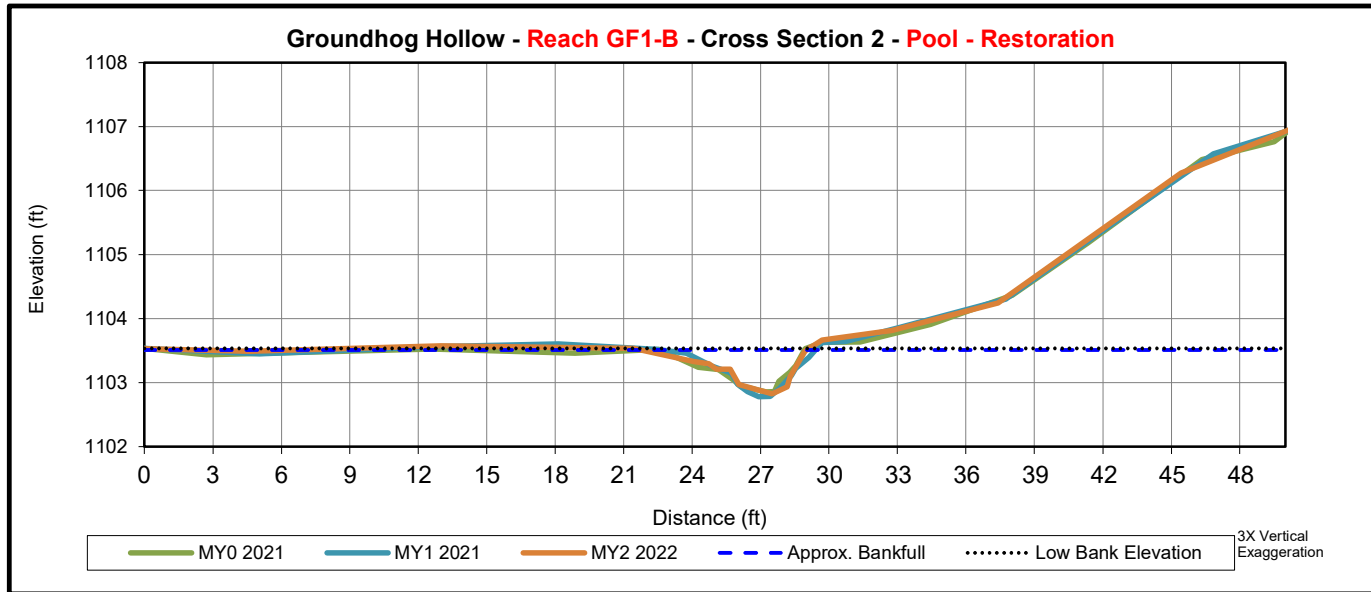
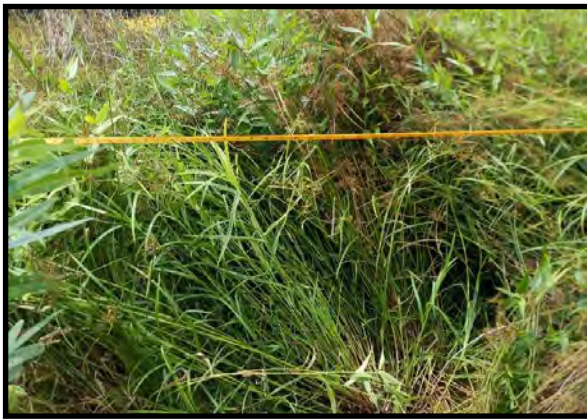
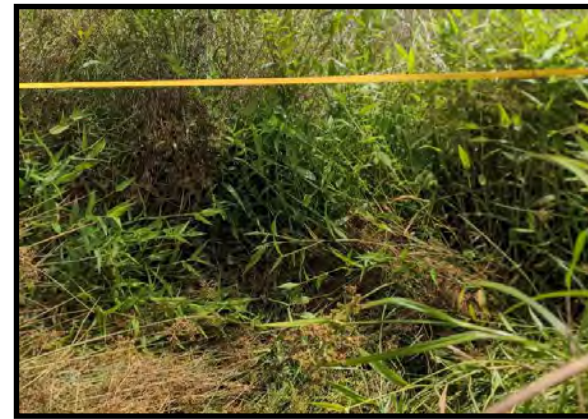
Cross Section 2 (Pool)						
	MY0	MY1	MY2	MY3	MY5	MY7	MY+
Bankfull Elevation (ft) - Based on AB-XSA¹	1103.52	1103.5	1103.5				
Bankfull Width (ft) ¹	6.4	6.8	7.2				
Floodprone Width (ft) ¹	-	-	-				
Bankfull Max Depth (ft) ²	0.7	0.7	0.7				
Low Bank Elevation (ft)	1103.52	1103.5	1103.5				
Bankfull Cross Sectional Area (ft ²) ²	2.3	2.3	2.5				
Bankfull Entrenchment Ratio ¹	-	-	-				
Bankfull Bank Height Ratio ¹	-	-	-

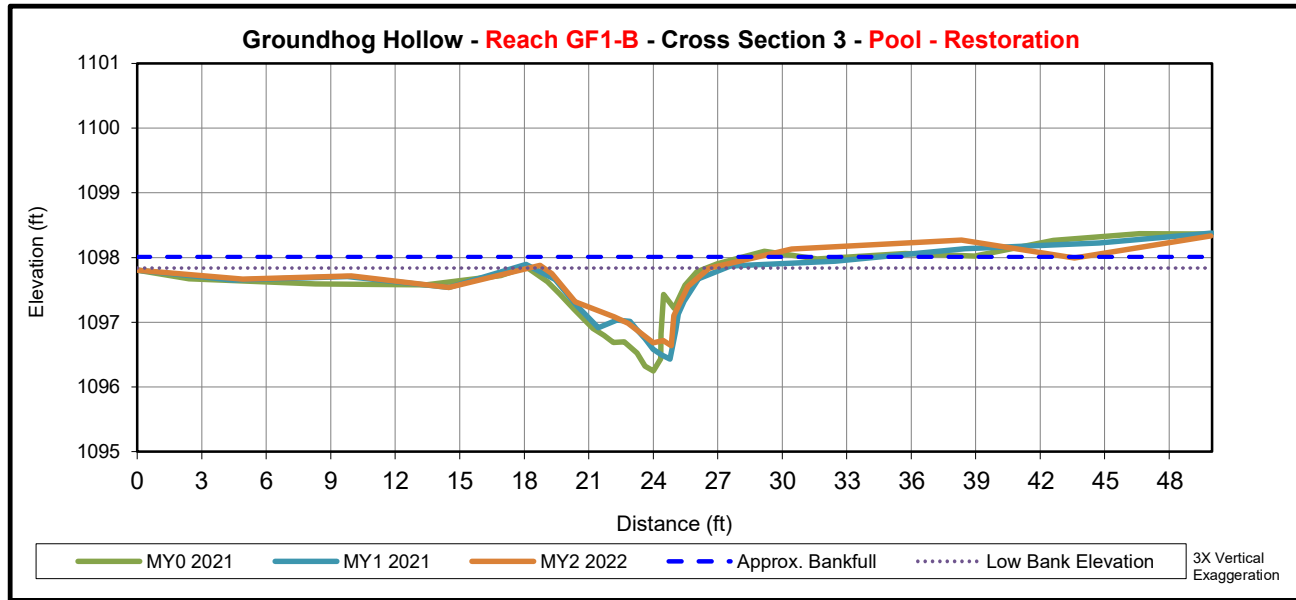
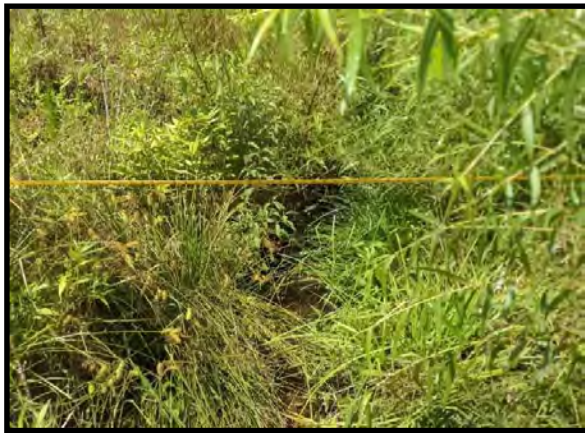
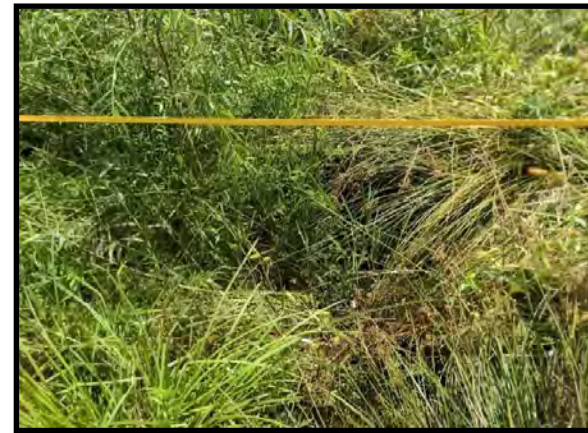
Cross Section 3 (Pool)						
	MY0	MY1	MY2	MY3	MY5	MY7	MY+
Bankfull Elevation (ft) - Based on AB-XSA¹	1097.86	1097.9	1098.0				
Bankfull Width (ft) ¹	8.5	9.5	7.9				
Floodprone Width (ft) ¹	-	-	-				
Bankfull Max Depth (ft) ²	1.6	1.4	1.2				
Low Bank Elevation (ft)	1097.86	1097.9	1097.8				
Bankfull Cross Sectional Area (ft ²) ²	6.1	5.8	4.7				
Bankfull Entrenchment Ratio ¹	-	-	-				
Bankfull Bank Height Ratio ¹	-	-	-

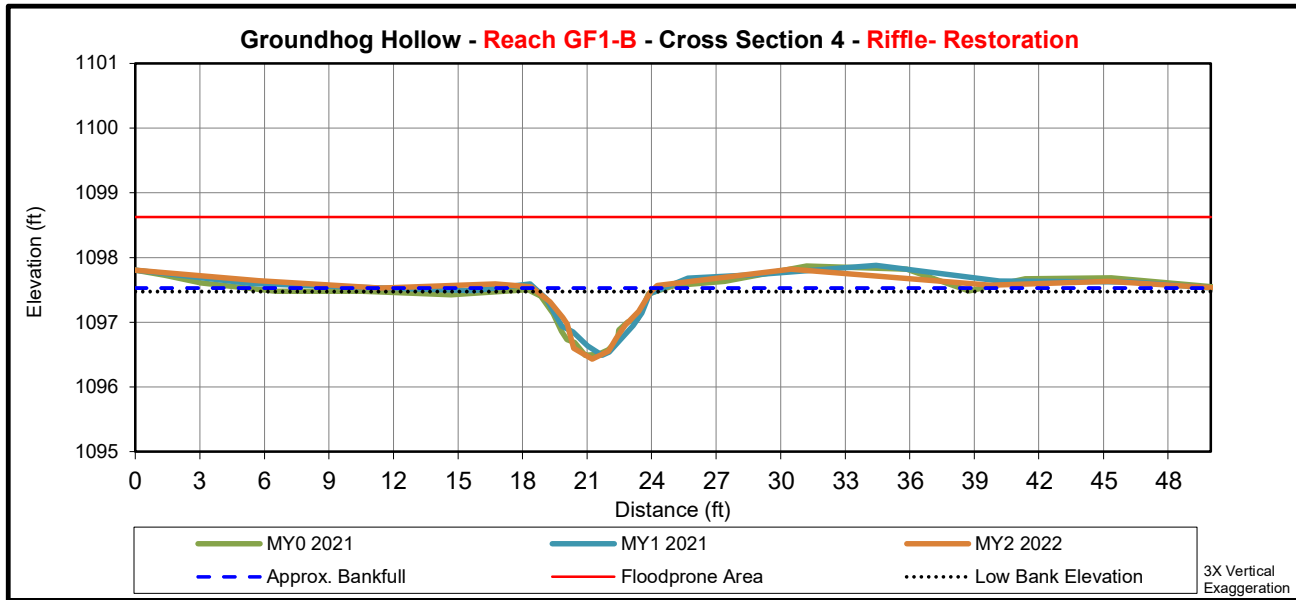
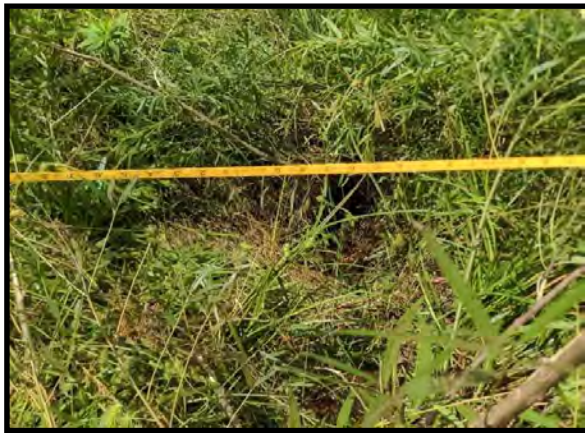
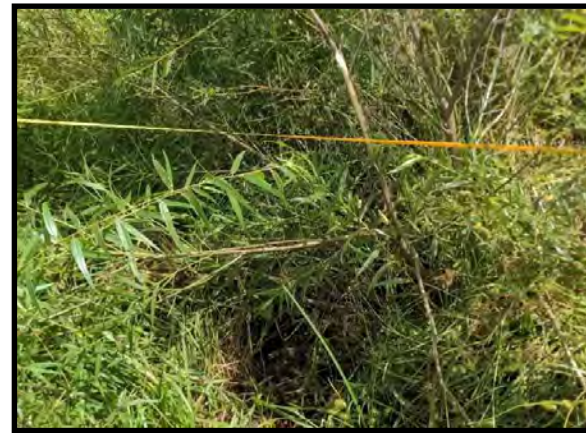
Cross Section 4 (Riffle)						
	MY0	MY1	MY2	MY3	MY5	MY7	MY+
Bankfull Elevation (ft) - Based on AB-XSA¹	1097.50	1097.5	1097.5				
Bankfull Width (ft) ¹	6.2	6.2	5.7				
Floodprone Width (ft) ¹	>50.6	>50.7	>50.6				
Bankfull Max Depth (ft) ²	1.0	1.1	1.0				
Low Bank Elevation (ft)	1097.50	1097.6	1097.5				
Bankfull Cross Sectional Area (ft ²) ²	3.3	3.9	3.0				
Bankfull Entrenchment Ratio ¹	8.2	>8.2	>8.9				
Bankfull Bank Height Ratio ¹	1.0	1.1	0.9
