Year Three Monitoring Report

GROUNDHOG HOLLOW PROJECT

NCDMS Project #100049 (Contract #7417) | RFP 16-007277 (Issued 6/21/2017)

Alexander County, North Carolina
Catawba River Basin
HUC 03050101

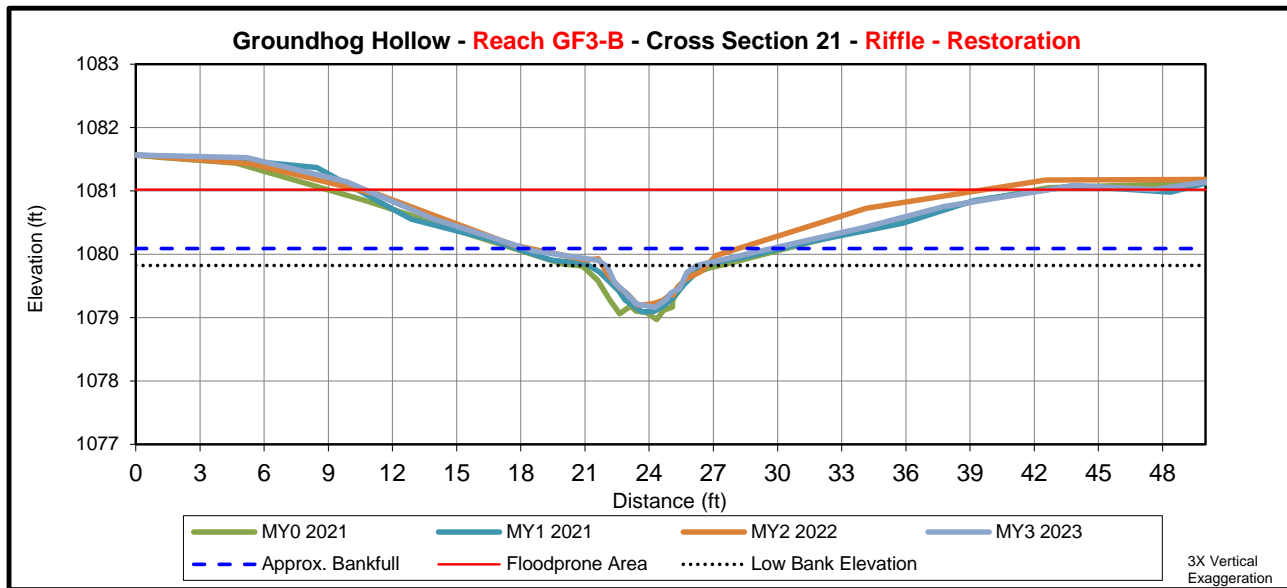
Cross Section 21 (Riffle)						
	MY0	MY1	MY2	MY3	MY5	MY7	MY+
Bankfull Elevation (ft) - Based on AB-XSA¹	1079.84	1079.9	1080.0	1080.1			
Bankfull Width (ft) ¹	7.6	5.5	7.9	4.6			
Floodprone Width (ft) ¹	25.6	27.1	>23.8	31.9			
Bankfull Max Depth (ft) ²	0.9	0.8	0.7	0.7			
Low Bank Elevation (ft)	1079.84	1079.8	1079.9	1079.8			
Bankfull Cross Sectional Area (ft ²) ²	2.9	2.3	2.2	1.7			
Bankfull Entrenchment Ratio ¹	3.4	4.9	>3.0	6.9			
Bankfull Bank Height Ratio ¹	1.0	0.9	0.9	0.7

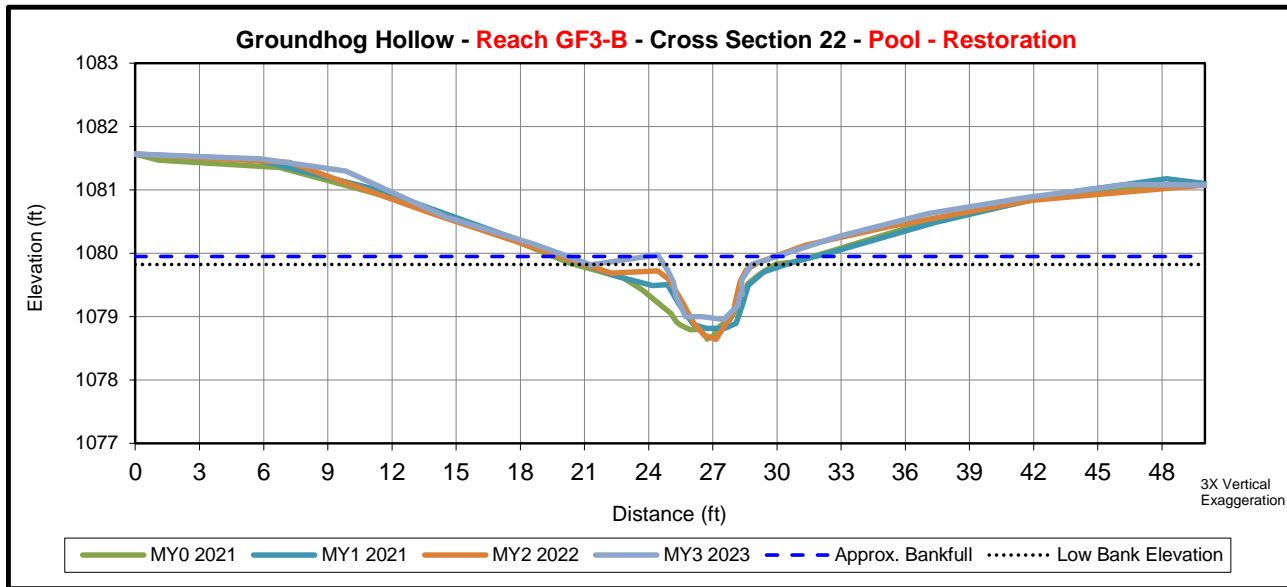
Cross Section 22 (Pool)						
	MY0	MY1	MY2	MY3	MY5	MY7	MY+
Bankfull Elevation (ft) - Based on AB-XSA¹	1079.61	1079.8	1079.9	1080.0			
Bankfull Width (ft) ¹	6.2	5.1	4.7	4.4			
Floodprone Width (ft) ¹	-	-	-	-			
Bankfull Max Depth (ft) ²	1.0	0.7	1.1	0.9			
Low Bank Elevation (ft)	1079.61	1079.5	1079.7	1079.8			
Bankfull Cross Sectional Area (ft ²) ²	3.1	1.9	2.5	2.5			
Bankfull Entrenchment Ratio ¹	-	-	-	-			
Bankfull Bank Height Ratio ¹	-	-	-	-

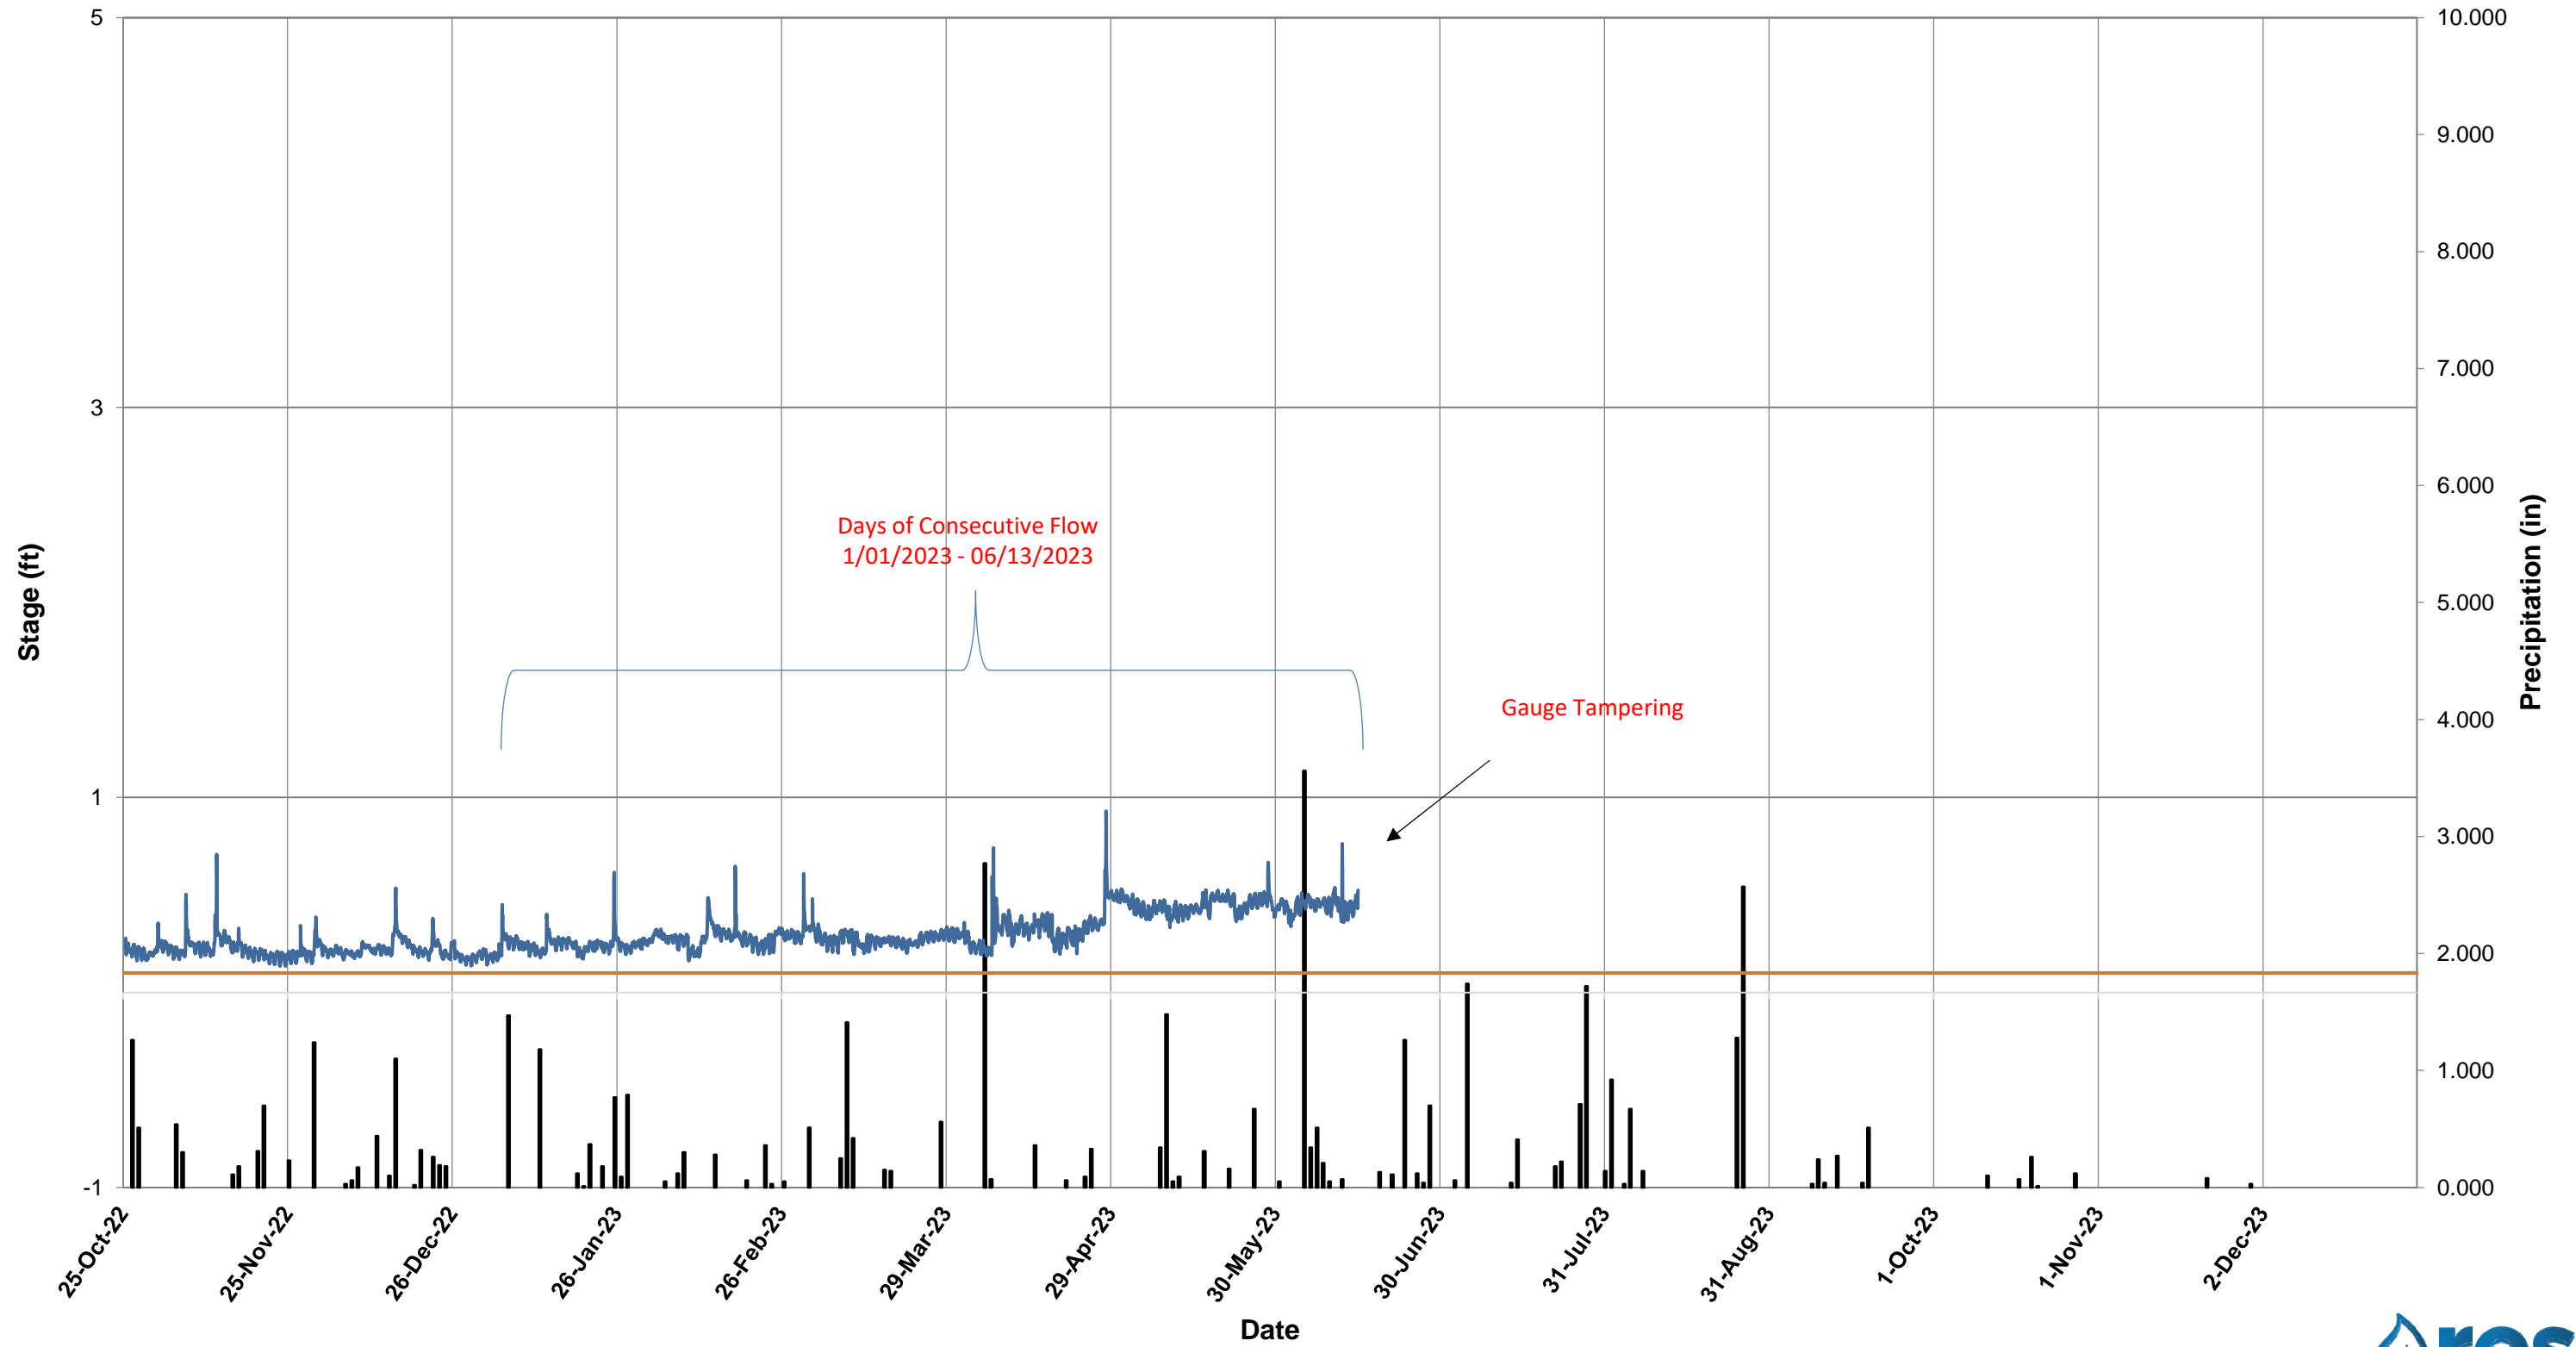
2023 Groundhog Hollow GF4a Flow Gauge Graph

164 Consecutive Days Consecutive Flow
01/01/2023 - 06/13/2023
