ANNUAL REPORT FOR 2004

Hanging Rock Creek Stream Mitigation Site
Avery County
WBS Element 34402.4.1
TIP No. R-2237WM

Prepared By:
Office of Natural Environment & Roadside Environmental Unit
North Carolina Department of Transportation
March 2005

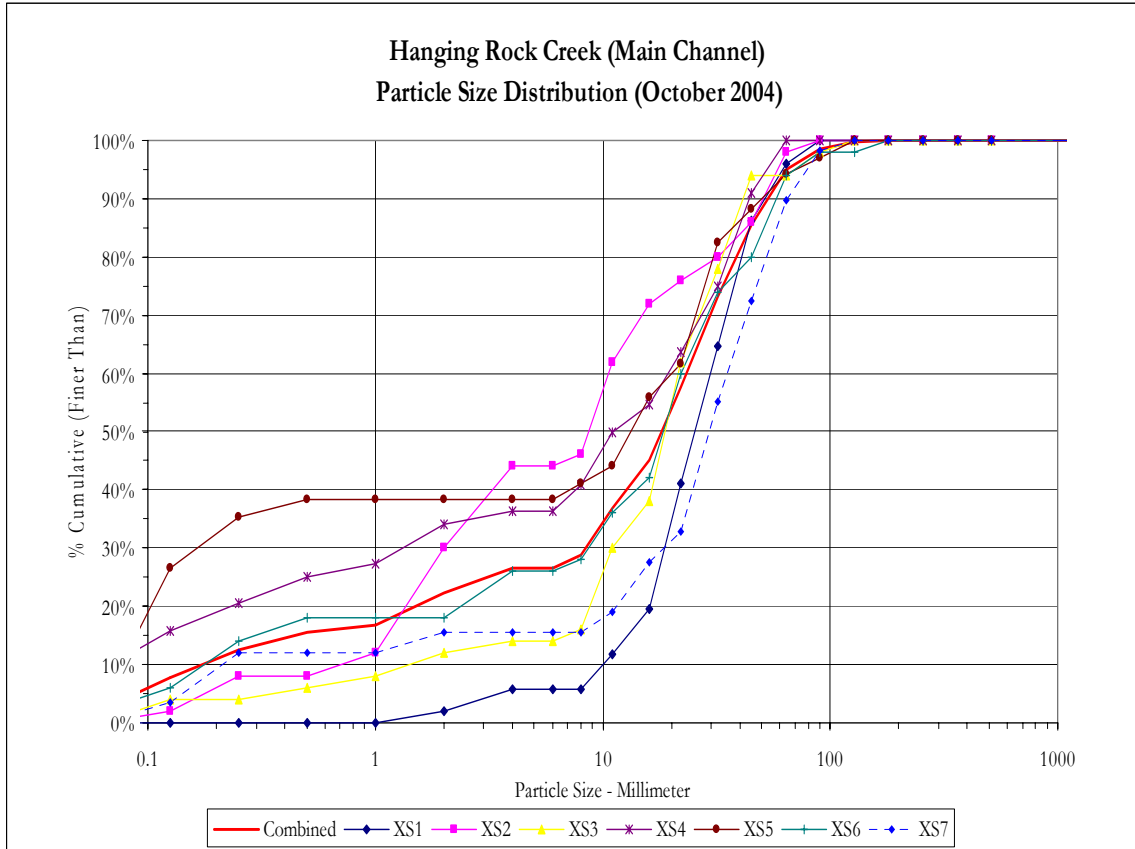
Pebble counts were also taken at each cross section as a means to determine the bed material at each cross section location. However, only pebble counts taken at riffle sections will be utilized to classify the stream. No existing data was available for Hanging Rock Creek or its tributary. The pebble counts taken during the Year 2004 monitoring period noted that the D_{50} (50 percent of the sampled population is equal to or finer than the representative particle diameter) for the riffle sections of Hanging Rock Creek was approximately 22.7 mm, which is indicative of a gravel-bed stream.

A chart depicting the particle size distributions for Hanging Rock Creek for the Year 2004 is presented below.

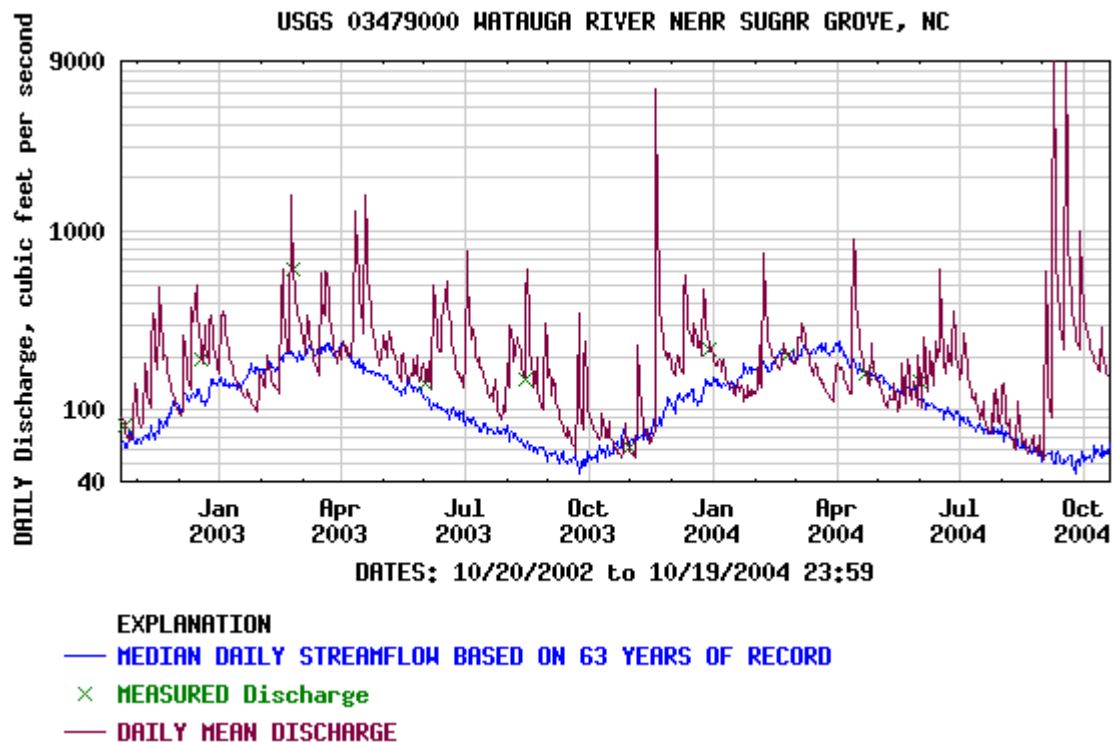
The Watuaga River gage was utilized for this report since it is the only active gage station in North Carolina located in the Watuaga River Basin. The Watuaga River Gaging Station has a drainage area of 92.1 square miles. It is situated in USGS Hydrologic Unit 06010103. Datum of the gage is 2,607.84 feet above sea level NGVD29. Based on the drainage area associated with the gage, the correlated bankfull discharge according to the NC Rural Mountain Regional Curves (USACE, 2003) is between 2,000 and 4,000 cubic feet per second (cfs). A review of peak flows was conducted for the period between October 2002 and October 2004. According to the graph, there were four bankfull events occurring during this period, three of which were in August 2004. Three of these events exceeded 6,000 cfs, well above the bankfull discharge. The USGS graph depicting these peak flows is presented below.

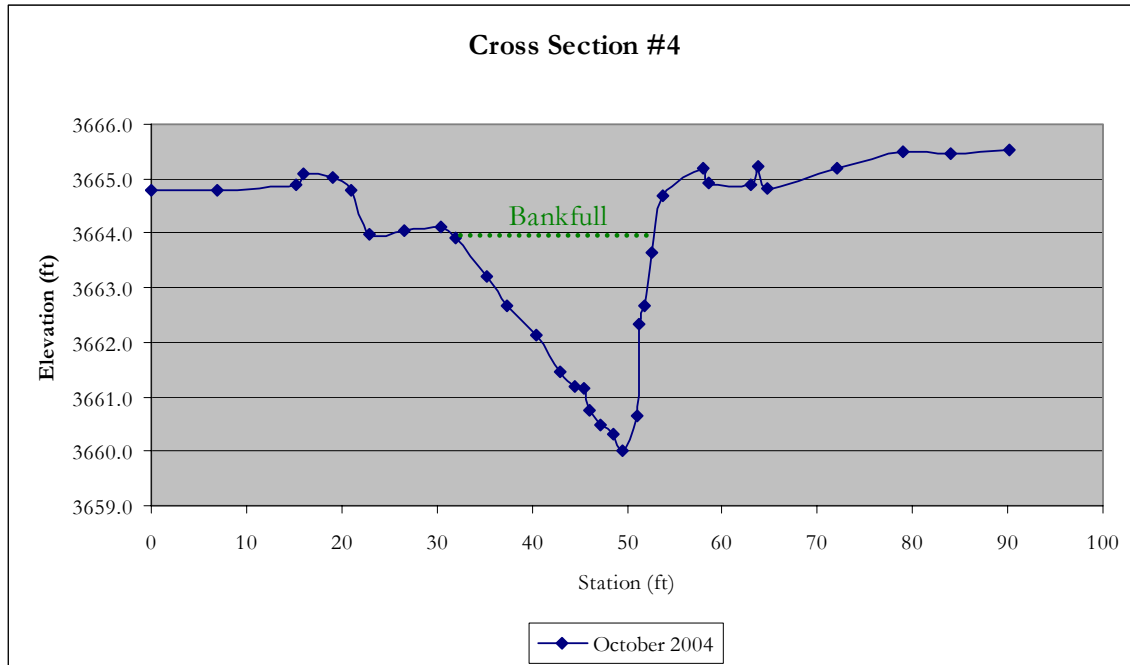
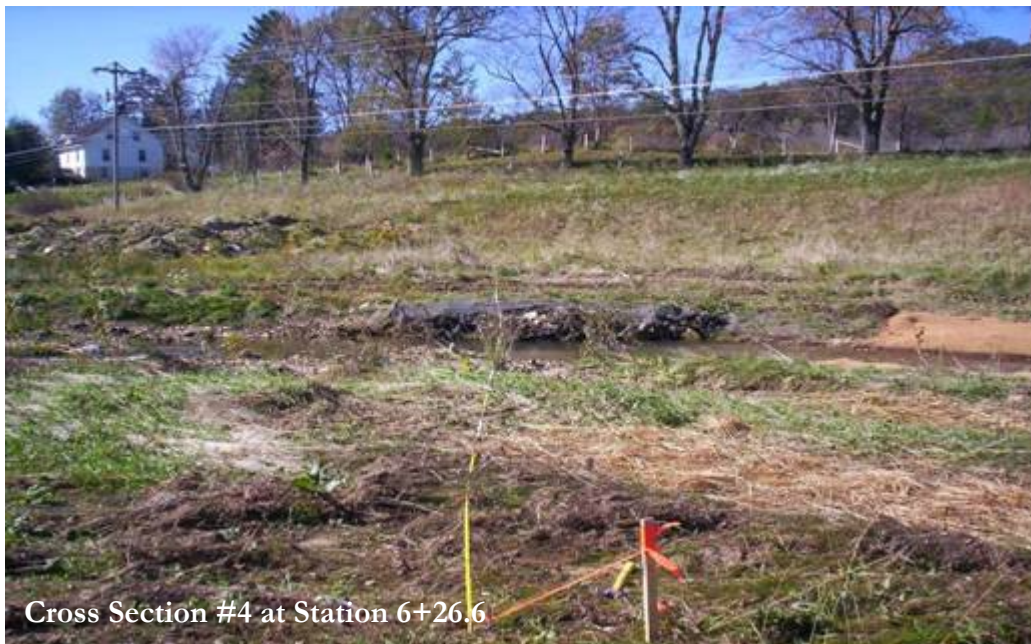
Cross-Section #4 (Pool) Abbreviated Morphological Summary*

2004	2005	2006	2007	2008
Bankfull Cross Sectional Area (ft²)	41.6				
Maximum Bankfull Depth (ft)	3.9				
Bankfull Mean Depth (ft)	2.0				
Bankfull Width (ft)	20.8

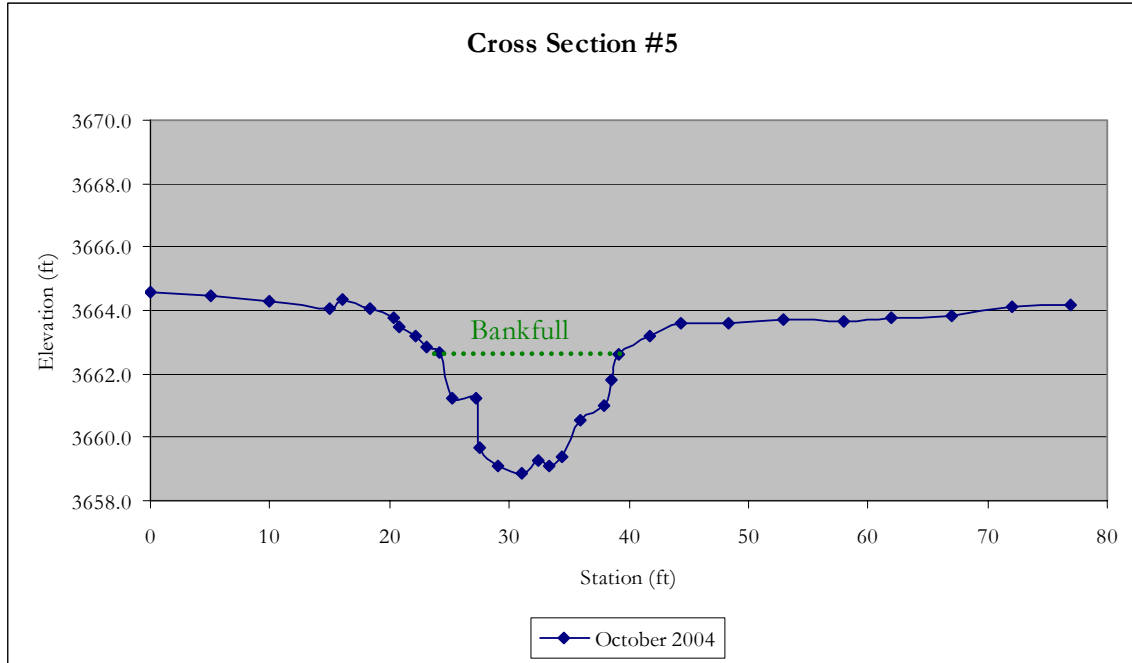
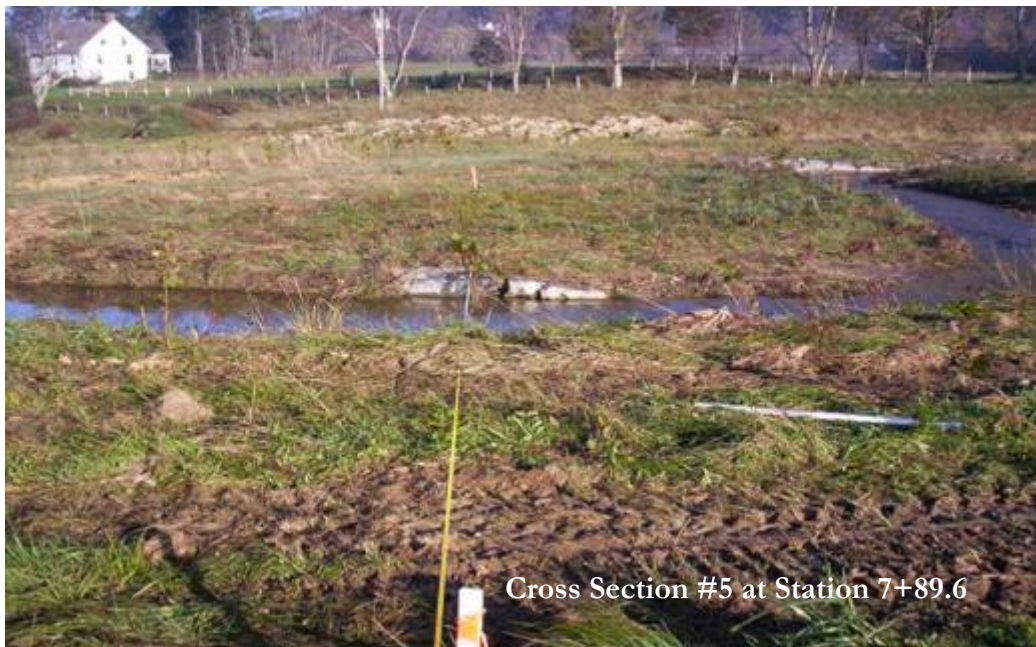
Cross-Section #5 (Pool) Abbreviated Morphological Summary*

2004	2005	2006	2007	2008
Bankfull Cross Sectional Area (ft²)	37.0				
Maximum Bankfull Depth (ft)	3.8				
Bankfull Mean Depth (ft)	2.5				
Bankfull Width (ft)	14.8

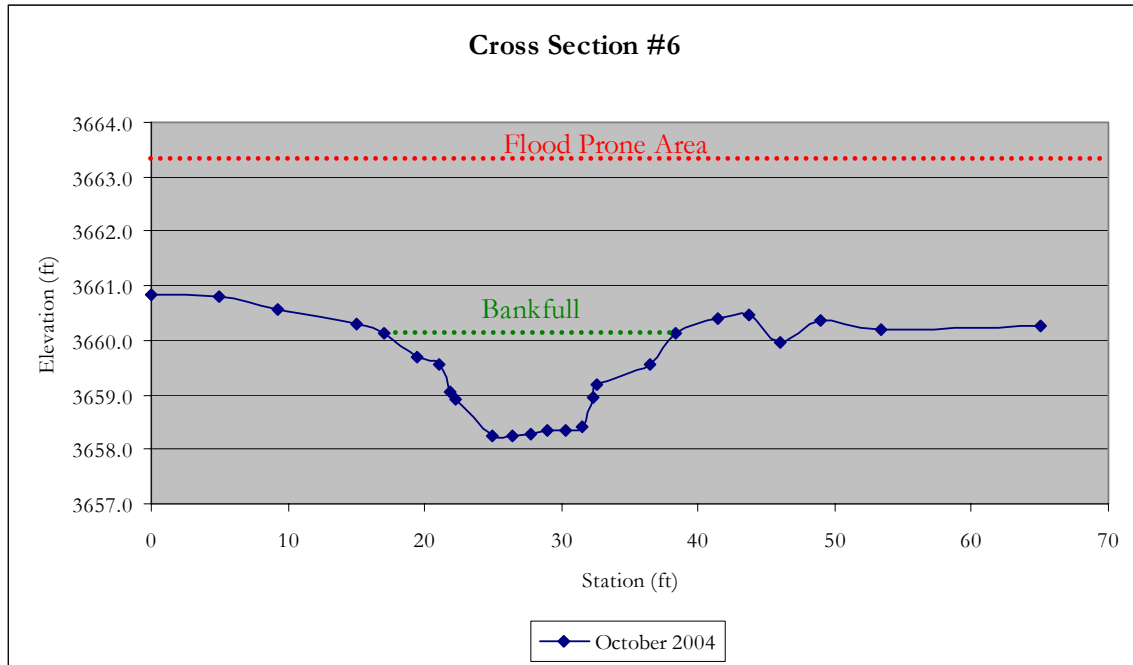
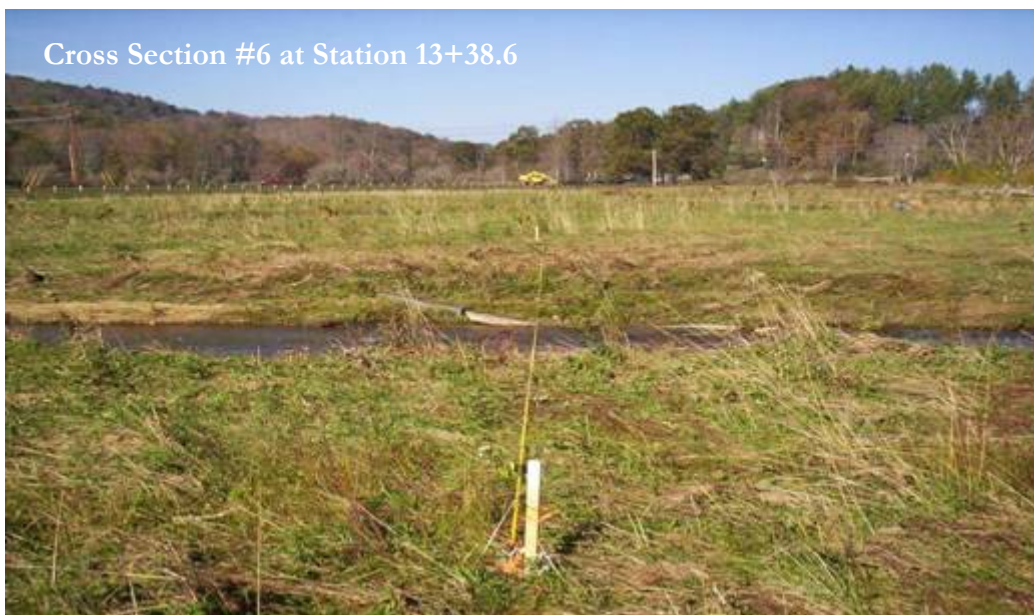
Cross-Section #6 (Riffle) Abbreviated Morphological Summary

2004	2005	2006	2007	2008
Bankfull Cross Sectional Area (ft ²)	30.3				
Maximum Bankfull Depth (ft)	2.2				
Width of the Floodprone Area (ft)	300				
Bankfull Mean Depth (ft)	1.1				
Width/Depth Ratio	25.0				
Entrenchment Ratio	>5				
Bankfull Width (ft)	27.5

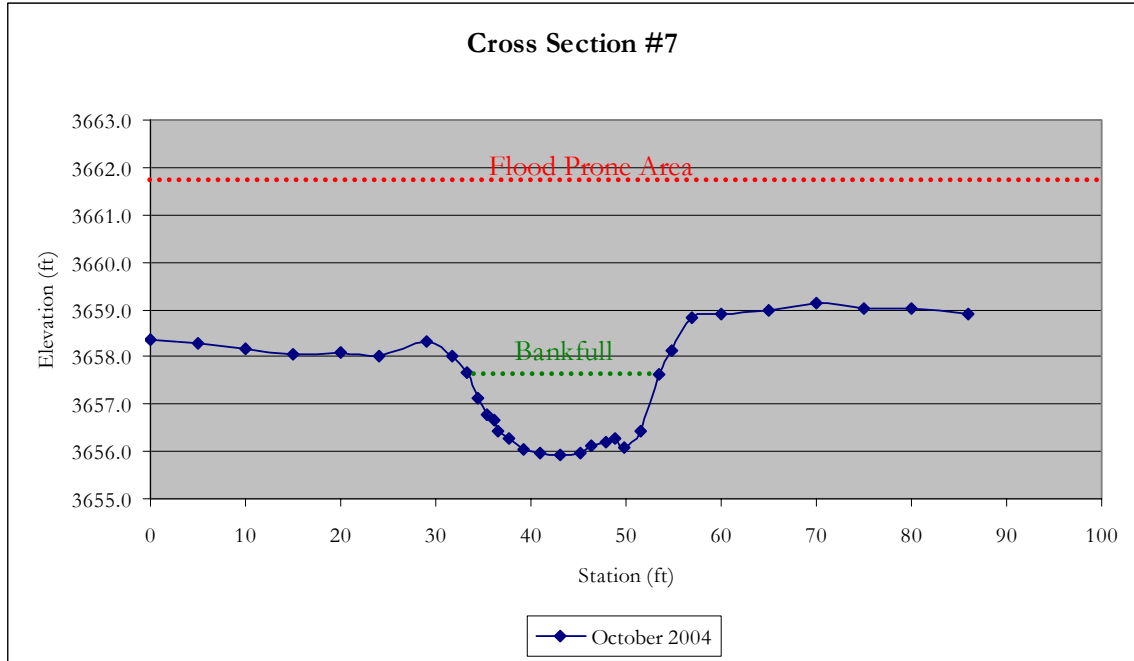
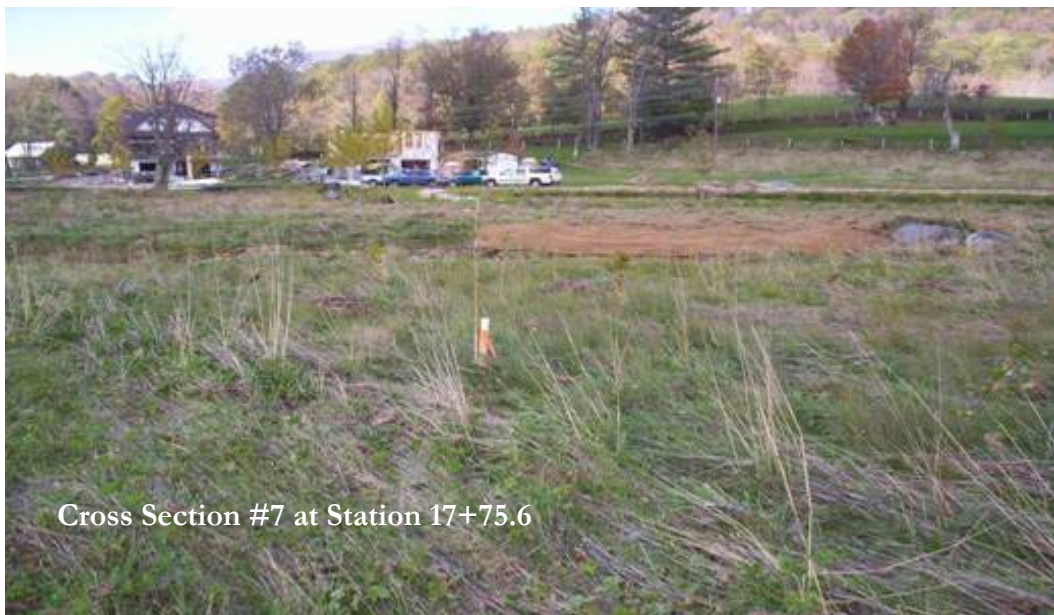
Cross-Section #7 (Riffle) Abbreviated Morphological Summary

2004	2005	2006	2007	2008
Bankfull Cross Sectional Area (ft ²)	34.7				
Maximum Bankfull Depth (ft)	2.1				
Width of the Floodprone Area (ft)	300				
Bankfull Mean Depth (ft)	1.5				
Width/Depth Ratio	15.4				
Entrenchment Ratio	>5				
Bankfull Width (ft)	23.1

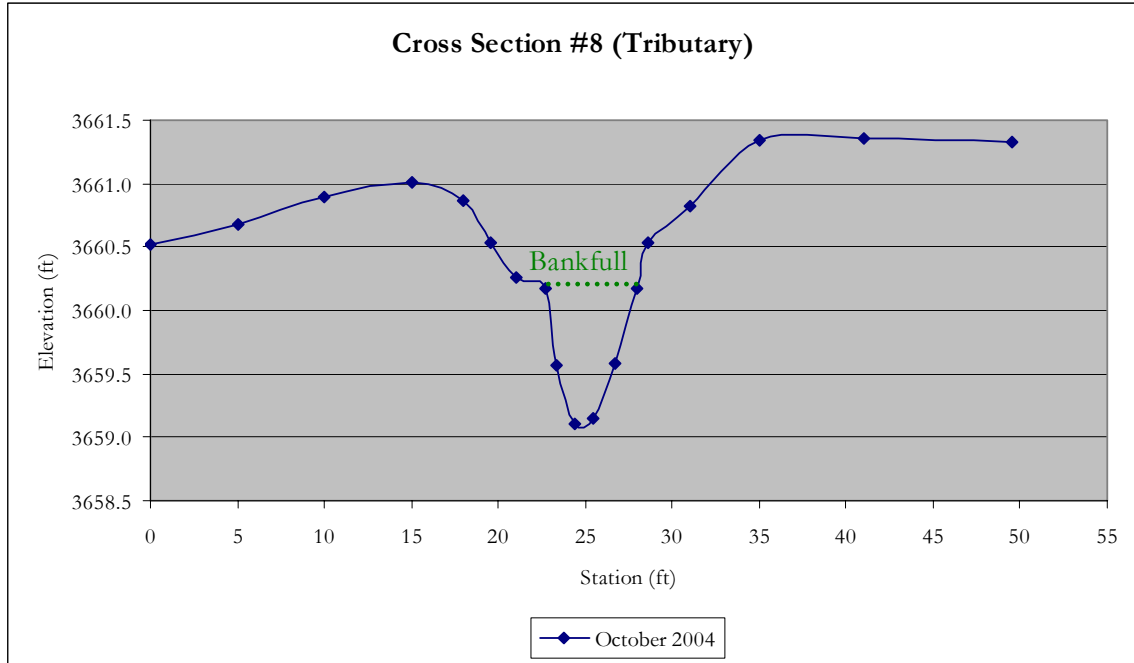
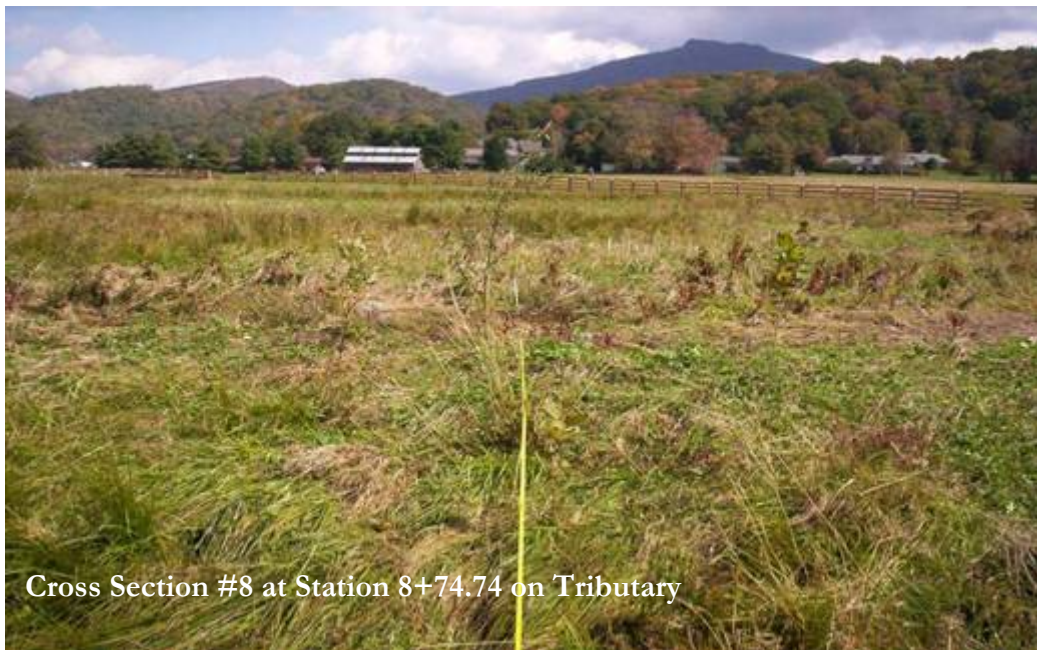
Cross-Section #8 (Run) Abbreviated Morphological Summary*

2004	2005	2006	2007	2008
Bankfull Cross Sectional Area (ft²)	3.6				
Maximum Bankfull Depth (ft)	1.1				
Bankfull Mean Depth (ft)	0.7				
Bankfull Width (ft)	5.1

Cross Section #8 at Station 8+74.74 on Tributary

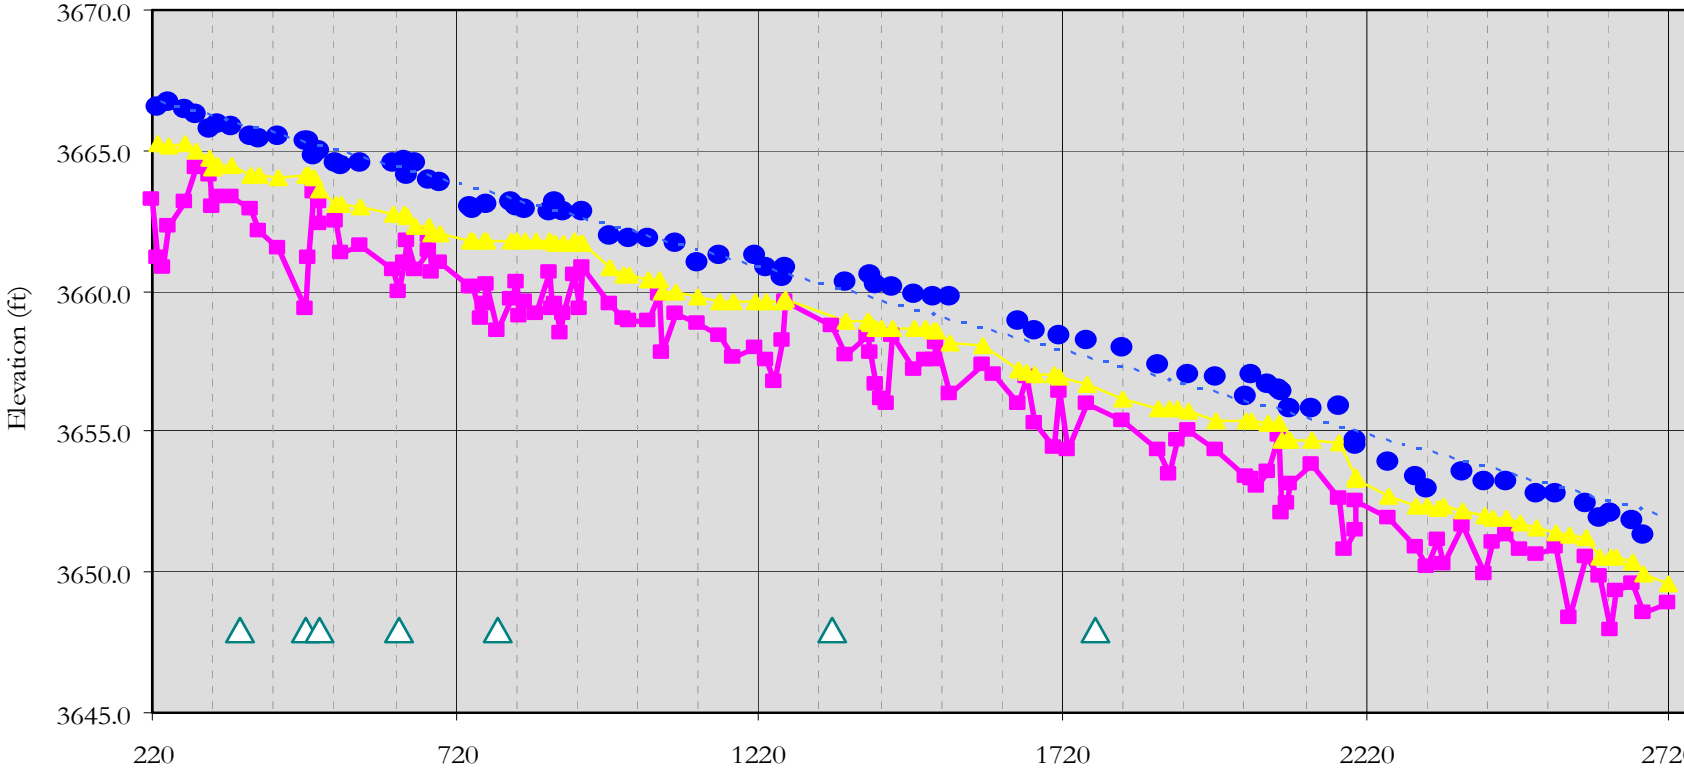
Hanging Rock Creek Main Channel

A longitudinal profile survey was conducted on a predetermined segment of Hanging Rock Creek. Bank stability was assessed during the cross section and longitudinal profile surveys. Two areas of active scouring were observed in 2004. Descriptions and evaluations of these areas are as follows:

- ◆ Station 7+55.6. Active scouring was noted around the rootwad on the left bank (facing downstream) in 2004. The scour did not appear to be compromising the structure. Establishment of vegetation should help to stabilize this area.
- ◆ Station 16+45.6. Bank undercutting was noted around a rootwad structure embedded in the left streambank. The structure, however, appeared stable. This area will be reassessed during the next monitoring period.

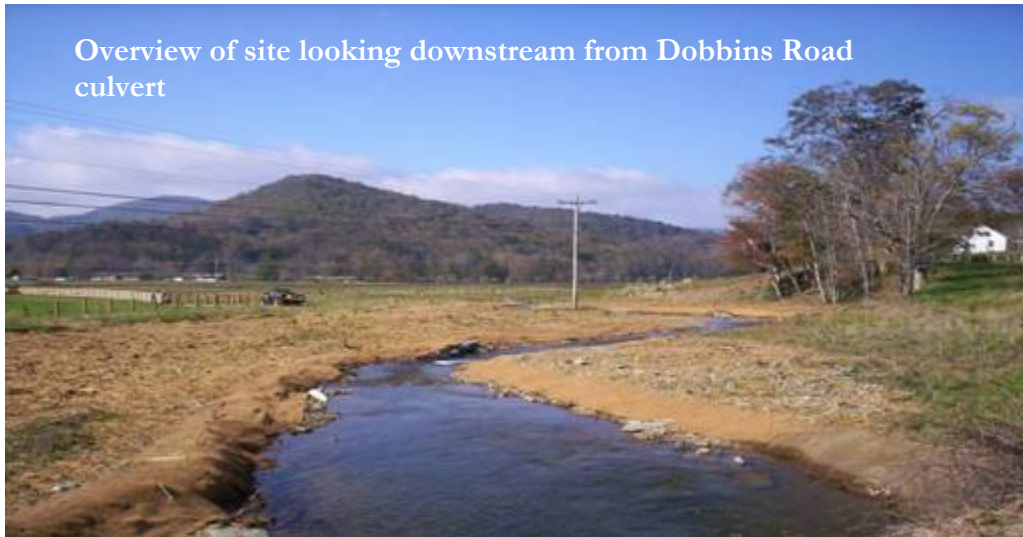
Overview of site looking downstream from Dobbins Road culvert

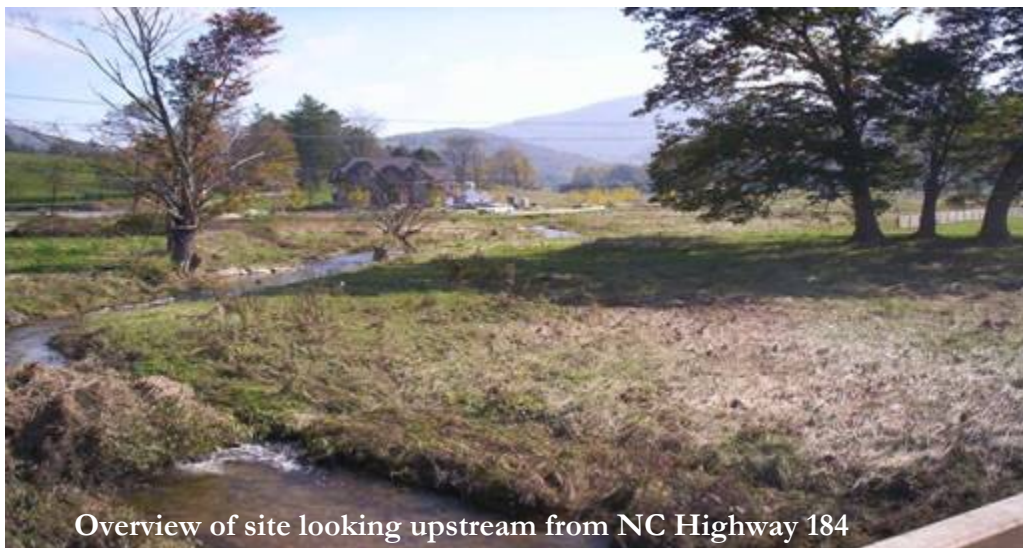
Overview of site looking upstream from NC Highway 184
