Hanging Rock Creek and Tributary Stream Restoration

NCEEP Project Number: 00165

Monitoring Year 3 of 5

2006 Annual Monitoring Report

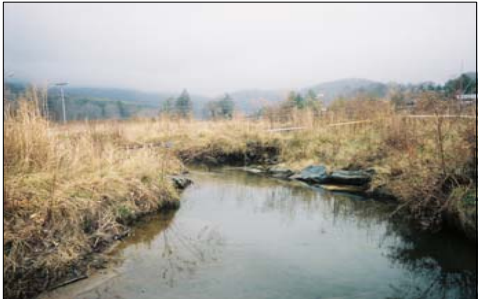
Photo of Cross-Section #2 - Looking Downstream

Cross-Section Summary Table		
Project Number and Name: 165 (Hanging Rock Creek)		
Cross-Section	Station	Observations / Comments
1	0 + 82.7	No significant change from MY1.
2	1 + 94.8	Disturbed. Missing left streambank monument/marker. Rebar missing. Left streambank monument/marker location extrapolated for MY2. Some horizontal/lateral migration of this deep pool is occurring. Right streambank scour behind rootwad. Cross-section orie
3	2 + 19.5	No significant change from MY1.
4	3 + 58.4	Disturbed. Dimension different than MY1
5	5 + 26.5	No significant change from MY1.
6	15 +03	Disturbed/destroyed (likely by vehicle traffic impacts in buffer area). Not located during MY2 (no field indicators)
7	1 + 58.2	Unnamed tributary.

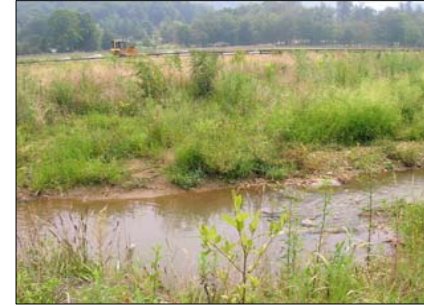
Photo of Cross-Section #4 - Looking Upstream

* No data exists for the As-built and therefore was not included in this graph.
 * Cross-section data for Cross-section 4 was mislabeled in prior report. Data was actually for Cross-section 5.
