Hanging Rock Creek and Tributary Stream Restoration

NCEEP Project Number: 00165

Monitoring Year 4 of 5

2007 Annual Monitoring Report

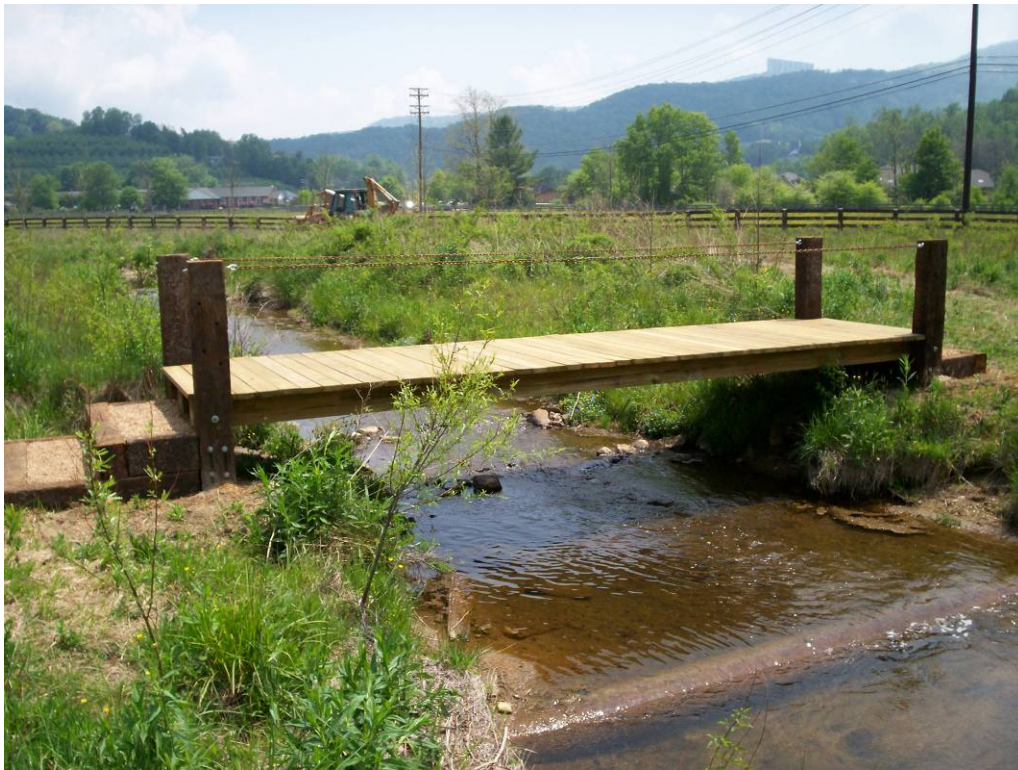
Photo #: 6

Description:
View of one of three
constructed foot bridges built
within the restoration
corridor.

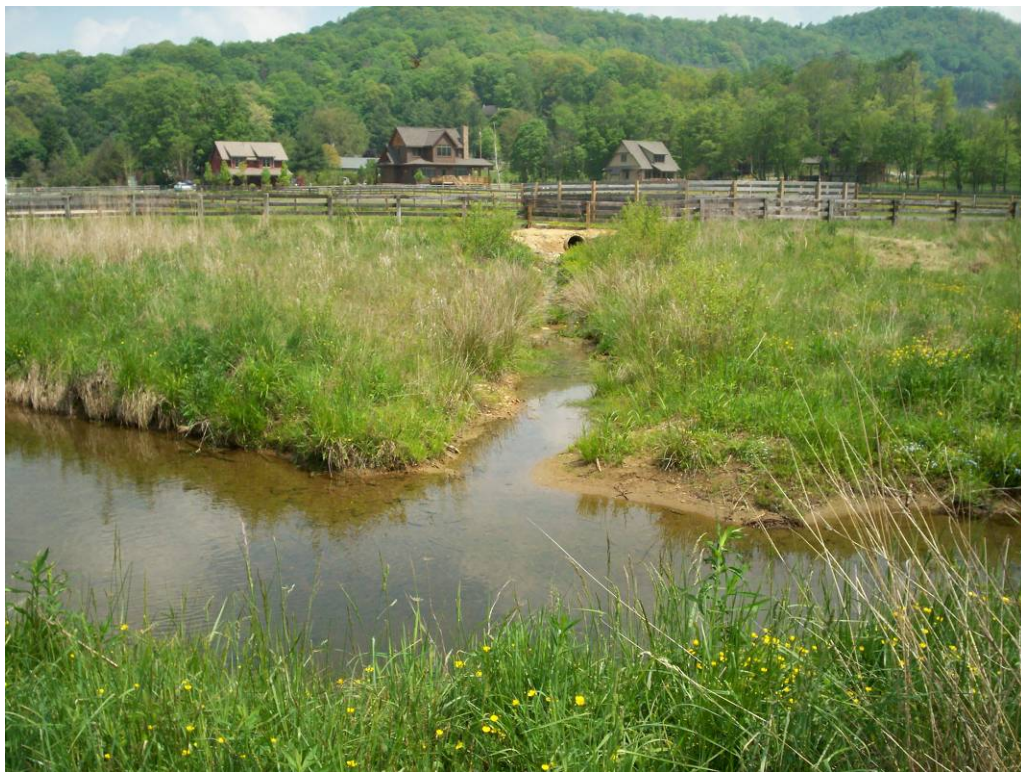
Site: Hanging Rock Creek
Avery County, North Carolina
Project No: 6470-06-1410.07
Date: May 2007
Photo #: 7
Photographed by: R.E. Spears

Description: Drainage ditch coming from Horse pasture to the east. Constructed road crossing with culvert constructed across drainage ditch.

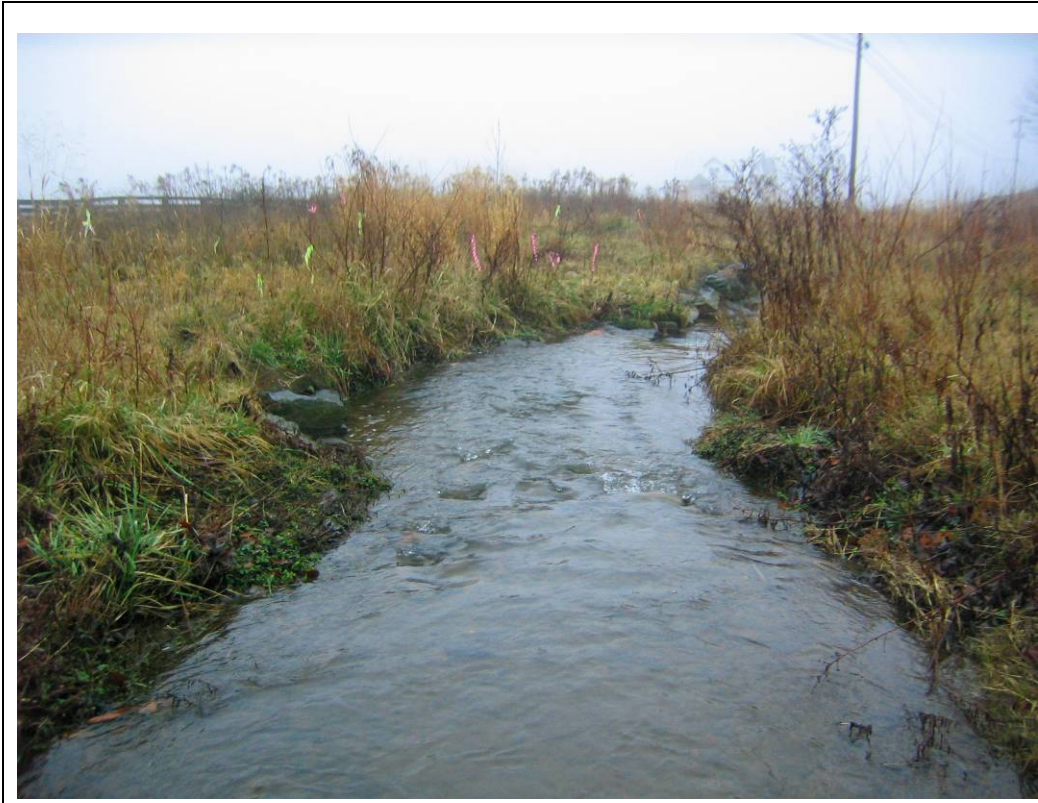
PHOTOLOG SHEET
Site: Hanging Rock Creek Station 00+00
Avery County, North Carolina
Project No: 6470-06-1410
Date: December 2007
Photo #: 1
Photographed by: R.L. Sain
Description: Photo taken facing down stream. Location downstream of road bridge, and up stream of cross-section number 1.

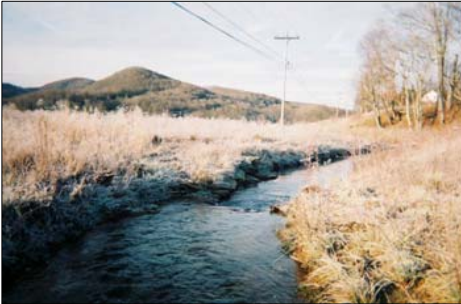
Photo of Cross-Section #1 - Looking Downstream

Bankfull Area				
	As-Built	MY2	MY3	MY4	MY5
Area	37.4	43.41	44.66	46.68	
Width	24.9	22.6	37.5	32.8	
Mean Depth	1.5	1.9	1.2	1.4	
Max Depth	2.7	3.0	2.8	3.0	
w/d ratio	16.6	11.8	31.4	23.0	
FPW			>100		
ER (greater than)	5.0	4.4	2.7	3.0

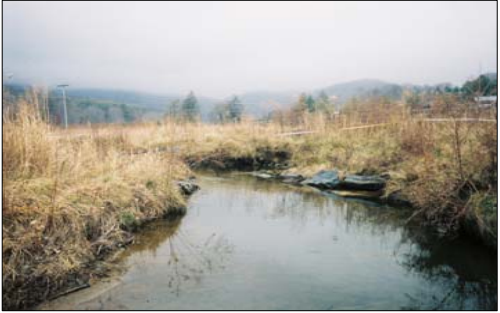
Photo of Cross-Section #2 - Looking Downstream

Bankfull Area				
	As-Built	MY2	MY3	MY4	MY5
Area	91.8	92.27	87.48	84.74	
Width	34.0	49.9	41.9	38.8	
Mean Depth	2.7	1.8	2.1	2.2	
Max Depth	5.8	5.3	5.3	5.0

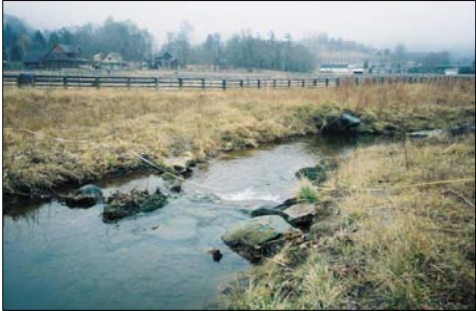
Photo of Cross-Section #3 - Looking Downstream

Bankfull Area				
	As-Built	MY2	MY3	MY4	MY5
Area	44.7	56.22	49.19	53.80	
Width	40.6	23.4	24.4	22.2	
Mean Depth	1.1	2.4	2.0	2.4	
Max Depth	2.9	3.0	2.6	3.4	
w/d ratio	36.9	9.7	12.1	9.2	
FPW			>100		
ER (greater than)	5.0	4.3	4.1	4.5

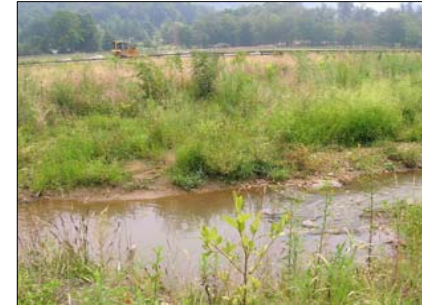
Photo of Cross-Section #4 - Looking Upstream

Bankfull Area					
	As-Built	MY2	MY3	MY4	MY5
Area	41.6		51.34	51.42	
Width	20.8		35.3	37.0	
Mean Depth	2.0		1.5	1.4	
Max Depth	3.9		4.2	4.2

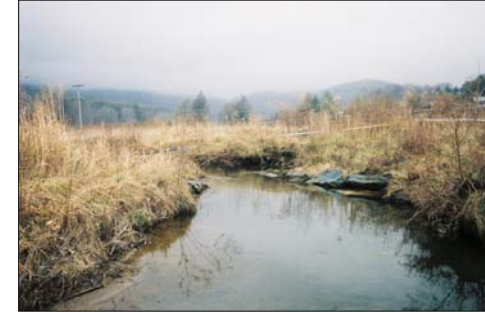
Photo of Cross-Section #5 - Looking Upstream

Bankfull Area				
	As-Built	MY2	MY3	MY4	MY5
Area	37.0	69.97	64.44	65.62	
Width	14.8	36.5	30.5	27.2	
Mean Depth	2.5	1.9	2.1	2.4	
Max Depth	3.8	0.7	4.7	4.7	
w/d ratio	*	19.0	14.5	11.3	
FPW			>100		
ER (greater than)		2.7	3.3	3.7

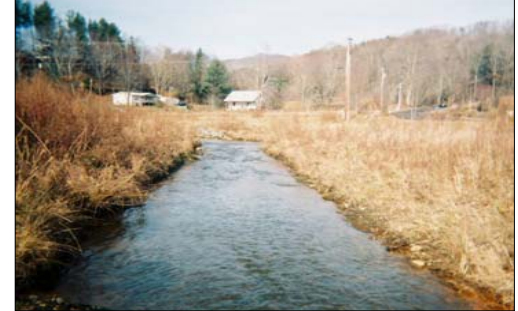
Photo of Cross-Section #6 - Looking Downstream

Bankfull Area				
	As-Built	MY2	MY3	MY4	MY5
Area	30.3		38.74	38.17	
Width	27.5		47.2	45.2	
Mean Depth	1.1		0.8	0.8	
Max Depth	2.2		2.4	2.4

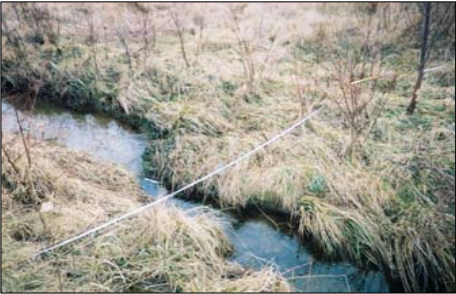
Photo of Cross-Section #UT1 - Looking Downstream

Note: Cross-Section data taken downstream of tape shown in photograph

* Data exists for the As-built but at a different station, station number 8+74.4
 **MY4 datum may have been taken at a different angle than in previous years

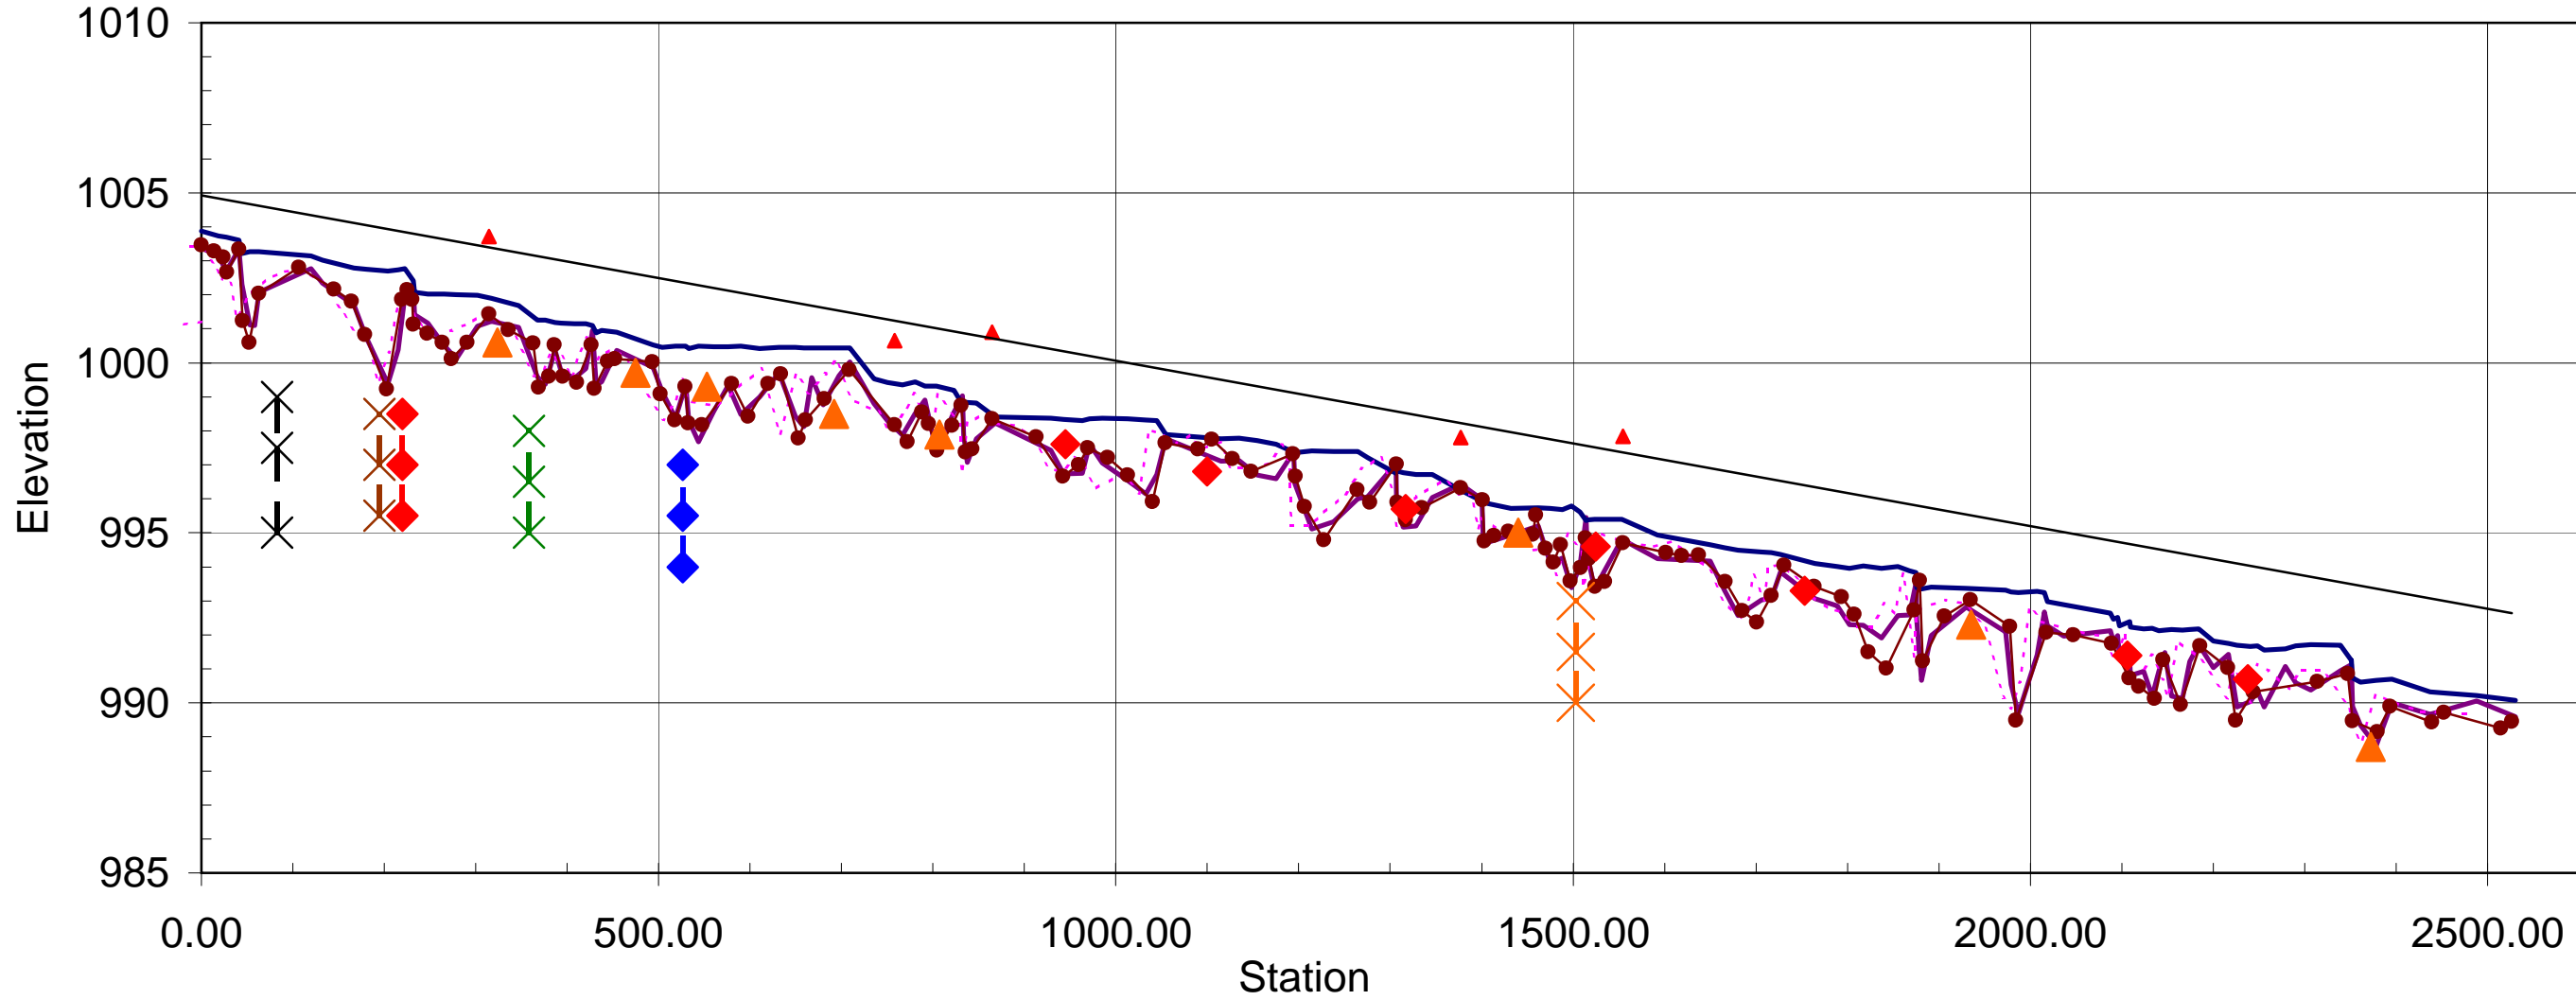
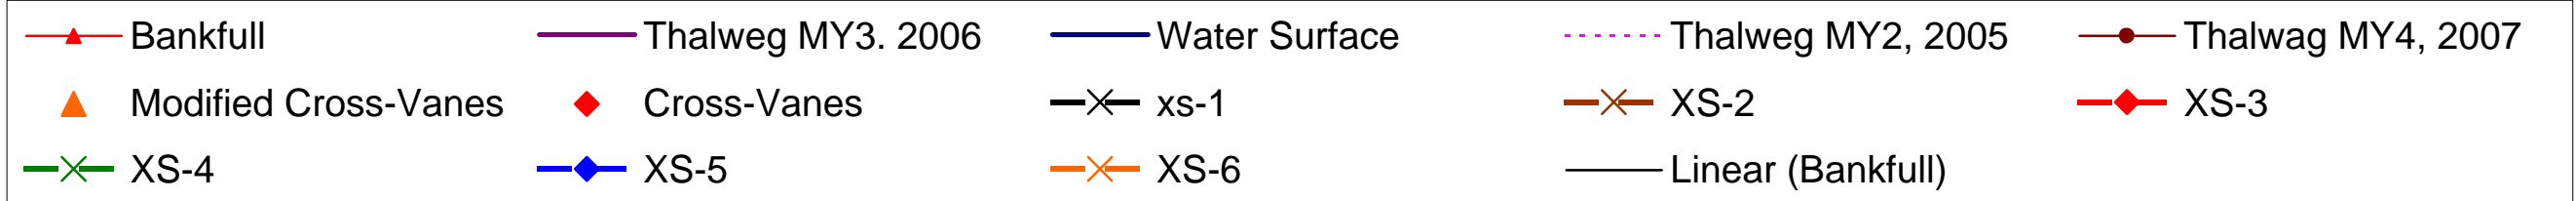
Hanging Rock Creek - Longitudinal Profile MY4, 2007

The MY4 channel profile of Hanging Rock Creek proper remained similar to the MY2 and MY3 surveys. Streambed elevations appear to have generally been maintained during the period between monitoring events. Width-to-Depth ratios in the riffle cross-sections remained similar to those observed for MY3. Channel cross-sections appeared to be generally stable, when compared to MY3 measurements (see Cross-Section Summary Table below). Planted and naturally-recruited vegetation along the streambanks are helping to maintain this stability. Consistent cross-sectional area has generally been maintained in the six surveyed cross-sections. Maximum depth is consistent to the previous MY3 condition and the entire reach appears to be functioning properly. Cross-section graphs are located in Appendix B.

Pool-to-pool spacing remained similar between MY3 and MY4. MY4 data indicated a median pool-to-pool spacing of approximately 110.0 lf (range: 40.0 – 205.0 lf). In comparison, MY3 data suggested a median pool-to-pool spacing of approximately 113.4 lf (range 26.0 – 205.8 lf). MY4 riffle slopes appear to be less steep than those observed in MY3. The MY4 median riffle slope was 0.50 percent (0.0050 ft/ft), while MY3 data indicated a median slope of 0.70 percent (0.0070 ft/ft). Riffle channel materials have generally remained consistent between MY3 and MY4. Gravel-sized material is dominant throughout the reach. Pool channel materials were also generally similar between MY3 and MY4, with some fining observed in MY4. Overall, the channel appears to be transporting the sediment load delivered to it by the watershed.

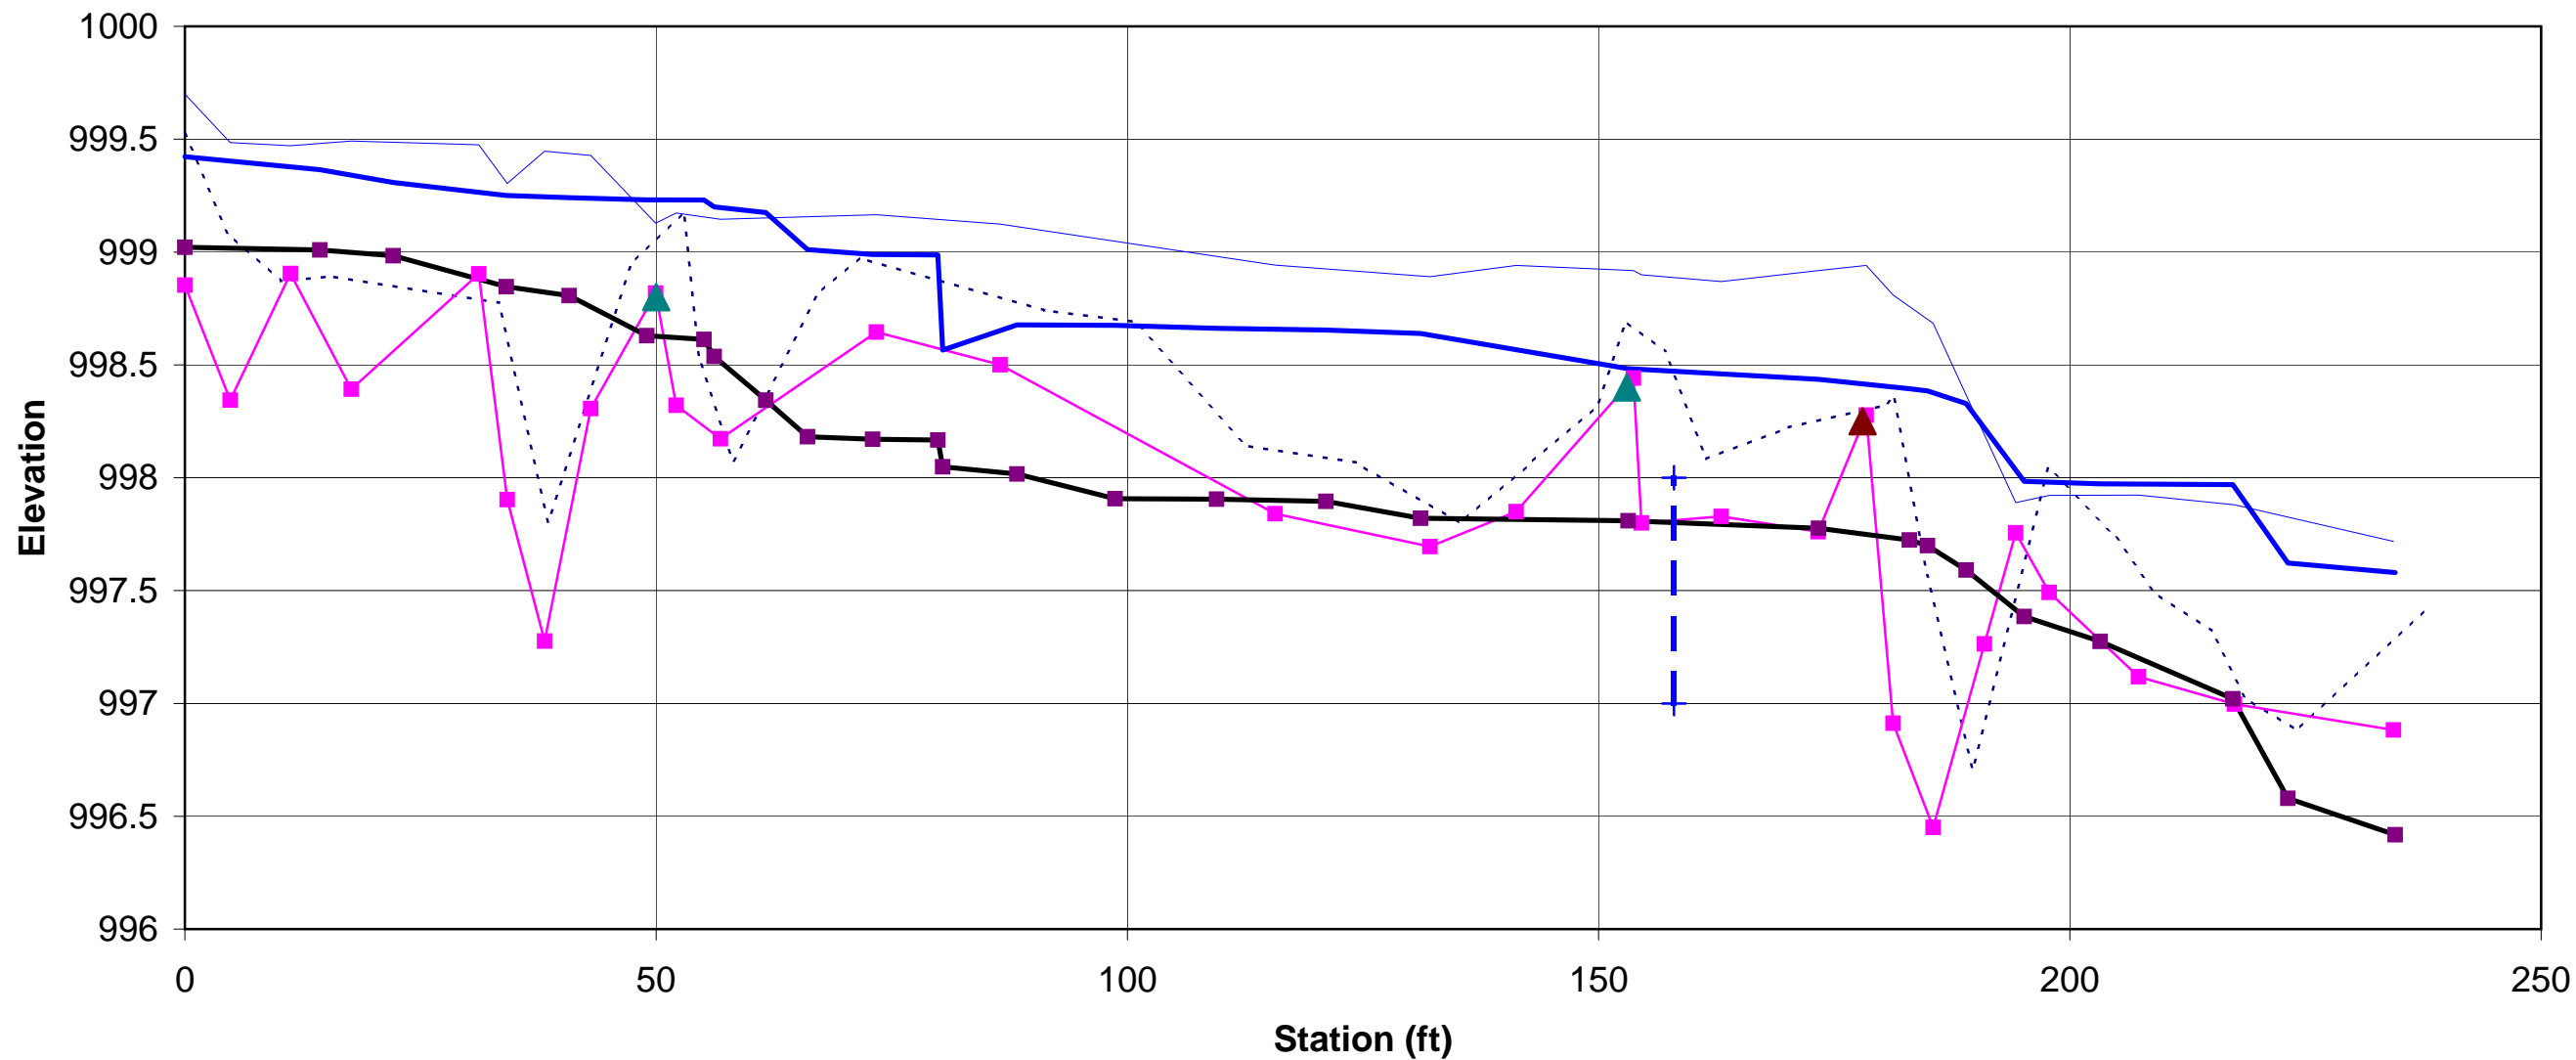
Unnamed Hanging Rock Tributary - Longitudinal Profile MY4, 2007

The MY4 channel profile for the unnamed tributary to Hanging Rock Creek appears to have undergone some significant change in bed profile. A layer of fine sediment was observed throughout the length of the tributary channel. Pools appeared to have filled in and riffles lengthened running along the top of this material. Riffle slopes lessened considerably and a small head-cut may be forming around station 0+80.
