Monitoring Report

Harrell Stream and Wetland Mitigation Site

Monitoring Year 3 (2022)

NCDMS Project No. 100005

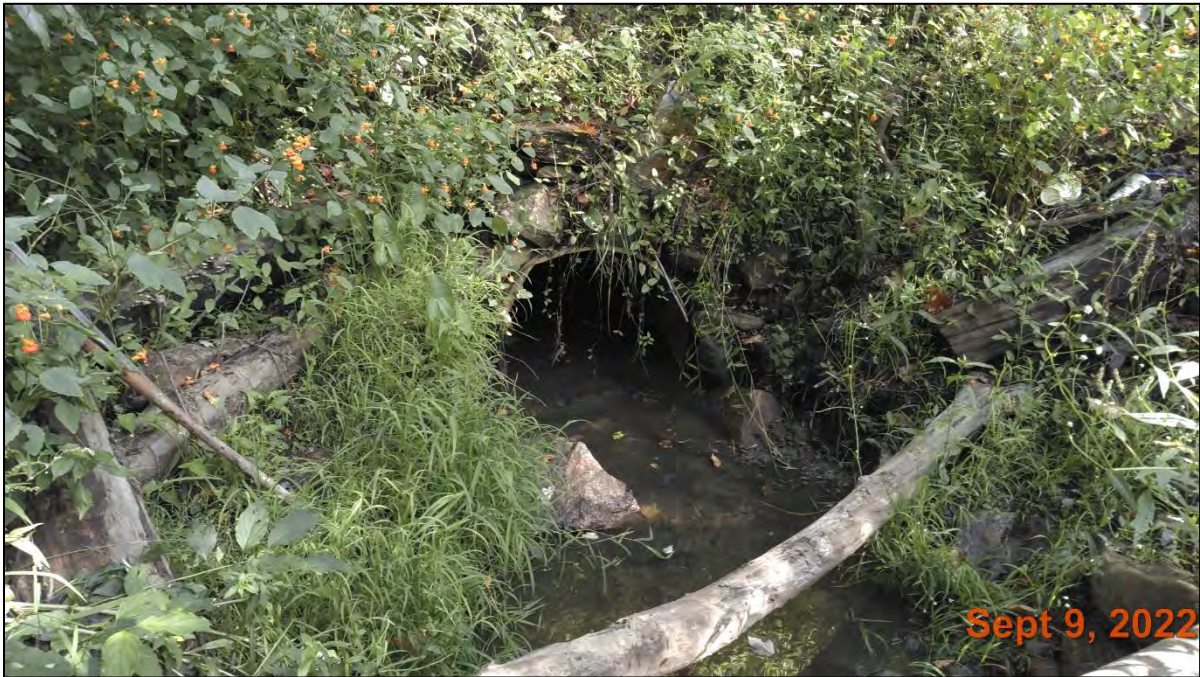
Photo point #8b, facing downstream Caney Fork Road culvert, Reach 1D.

One beaver dam was identified during MY3. This dam was located just outside of the easement at the Caney Fork Rd culvert. This dam was removed following a trapping effort in June 2022, and again in November 2022. Beaver have been an intermittent problem in Reach D since project completion. Aphis is actively working the site. The site will continue to be monitored for beaver activity. No other areas of instability were noted in MY3.

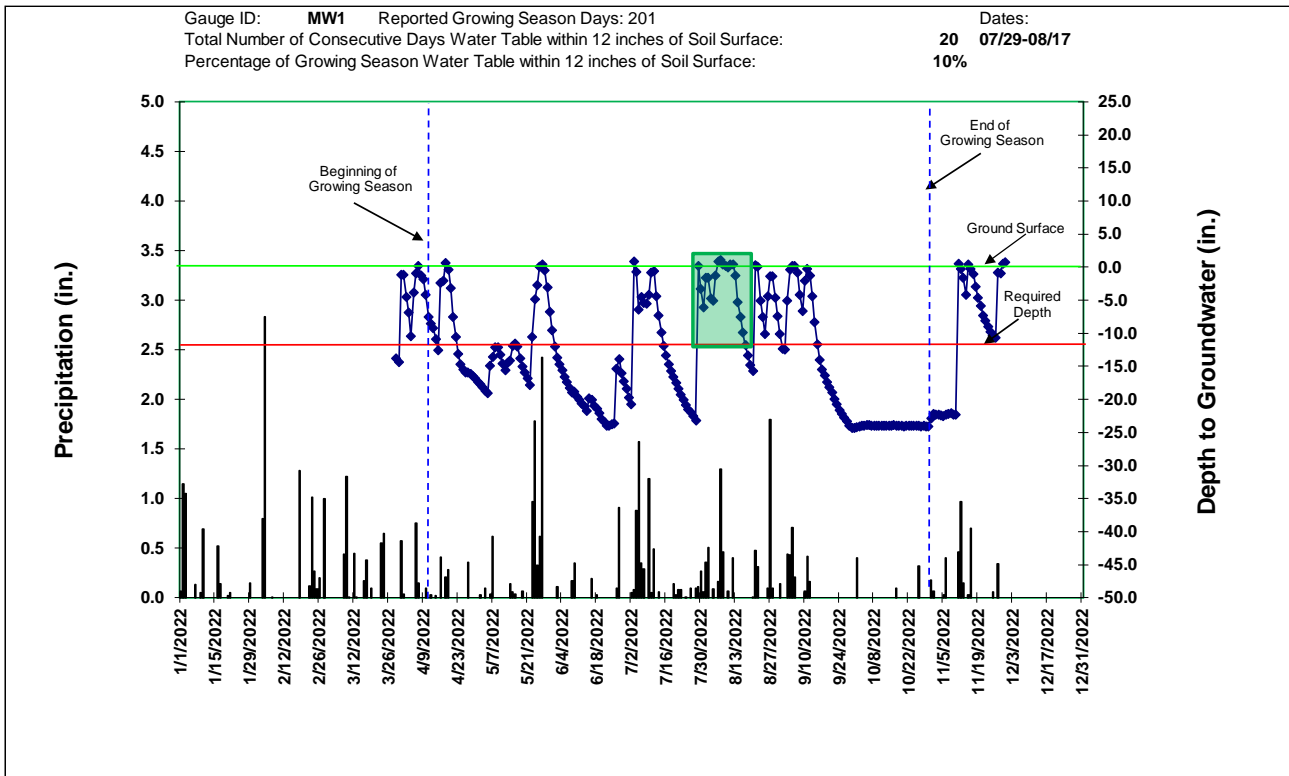
Four groundwater wells, #1, 2, 5, and 7, failed to meet the success criteria during MY3. Monitoring well #1 fell short of the performance criteria at 10%. Monitoring well #2 was similarly short of performance thresholds at 9%. The region had been experiencing intermittent level of drought conditions during MY3 (Drought.gov). Based upon the past performance of groundwater wells 5 and 7

Gauge ID: **MW2** Reported Growing Season Days: 201
Total Number of Consecutive Days Water Table within 12 inches of Soil Surface:
Percentage of Growing Season Water Table within 12 inches of Soil Surface:

Dates: **19 07/29-08/16**
9%
