# **Monitoring Report**

Harrell Stream and Wetland Mitigation Site

Monitoring Year 4 (2023)

NCDMS Project No. 100005

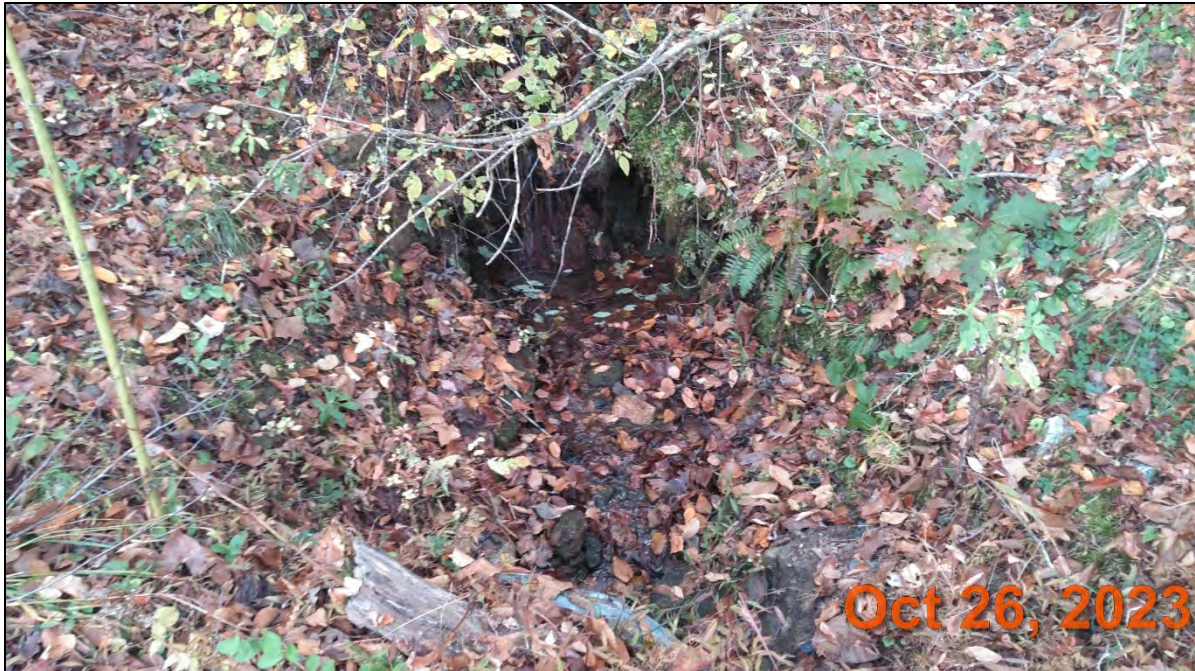
Photo point #1b, facing stormwater control measure adjacent to the Reach 1A boundary.

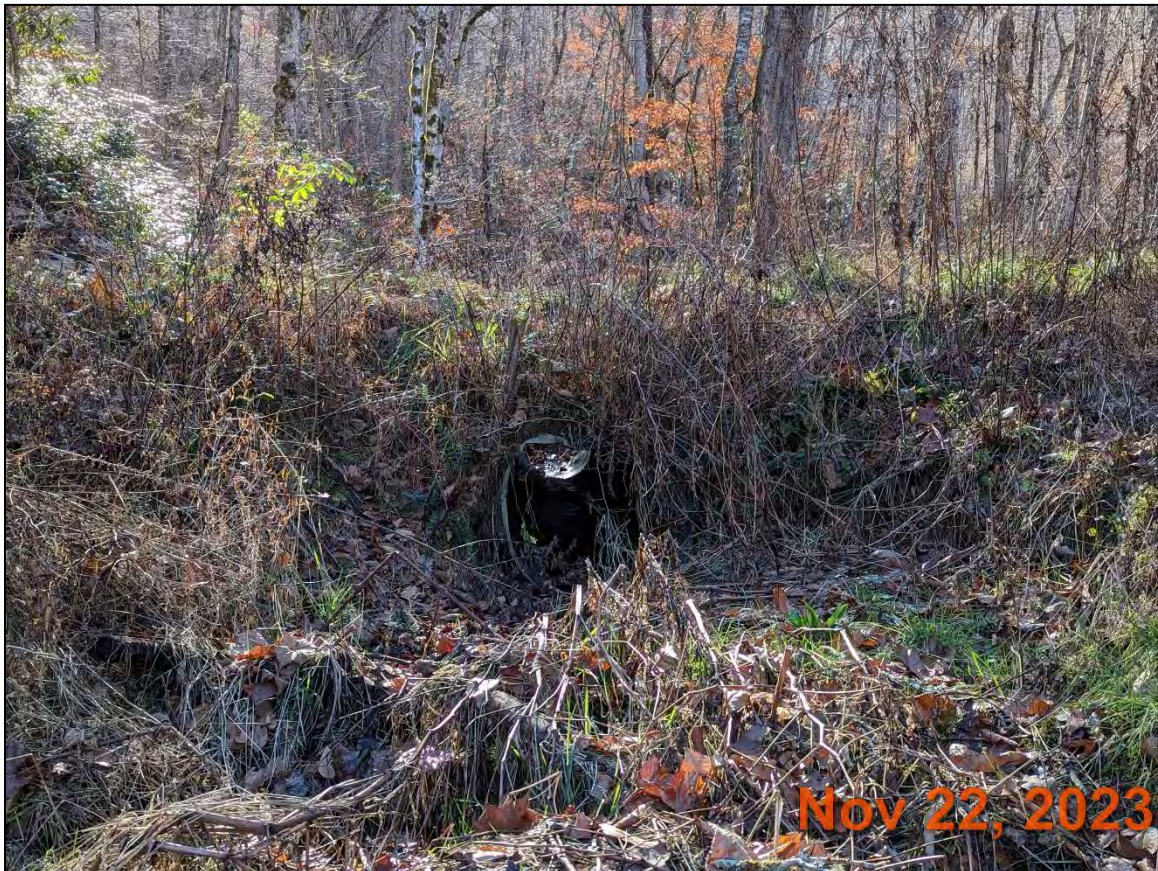
Photo point #1f facing upstream through the Reach 1A/B culvert.

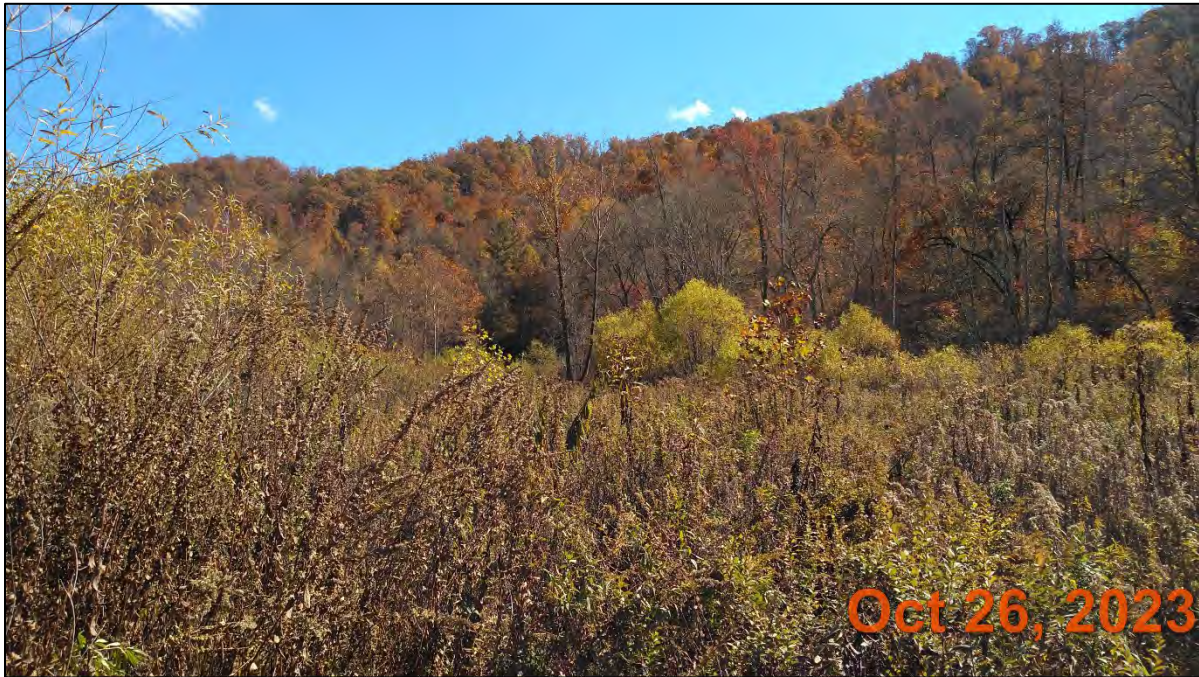
Photo point #4a, facing upstream, Reach 1C and Wetland C.

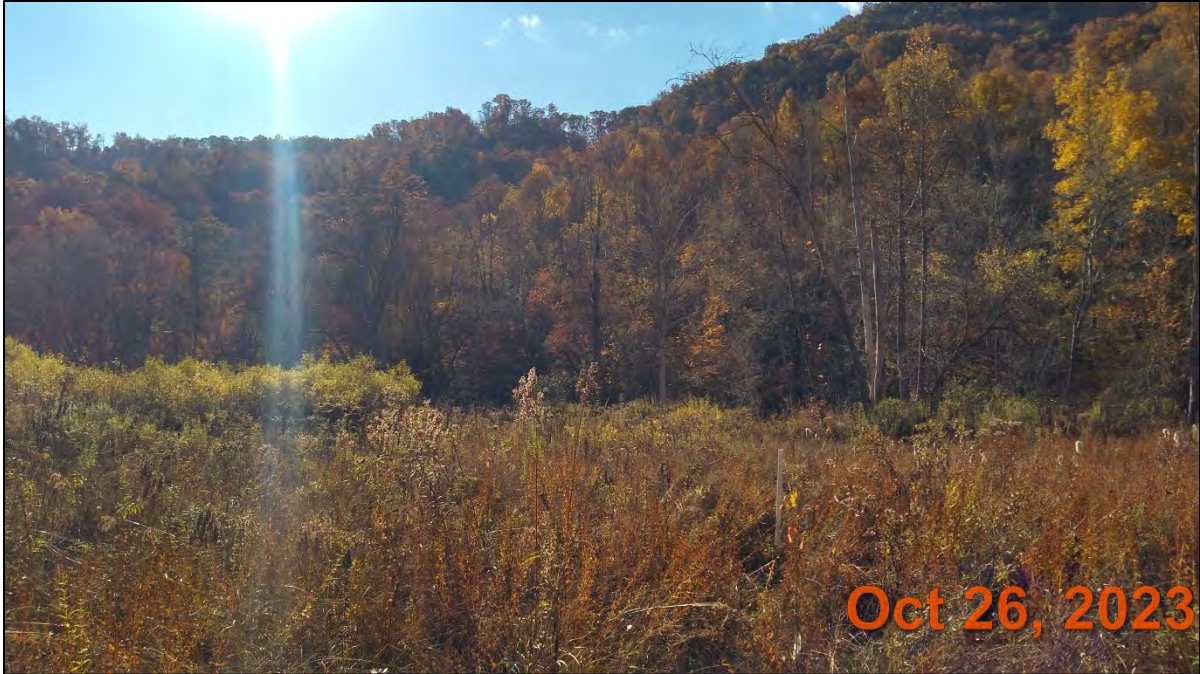
Photo point #5a, facing upstream, Reach 1C and Wetland C.

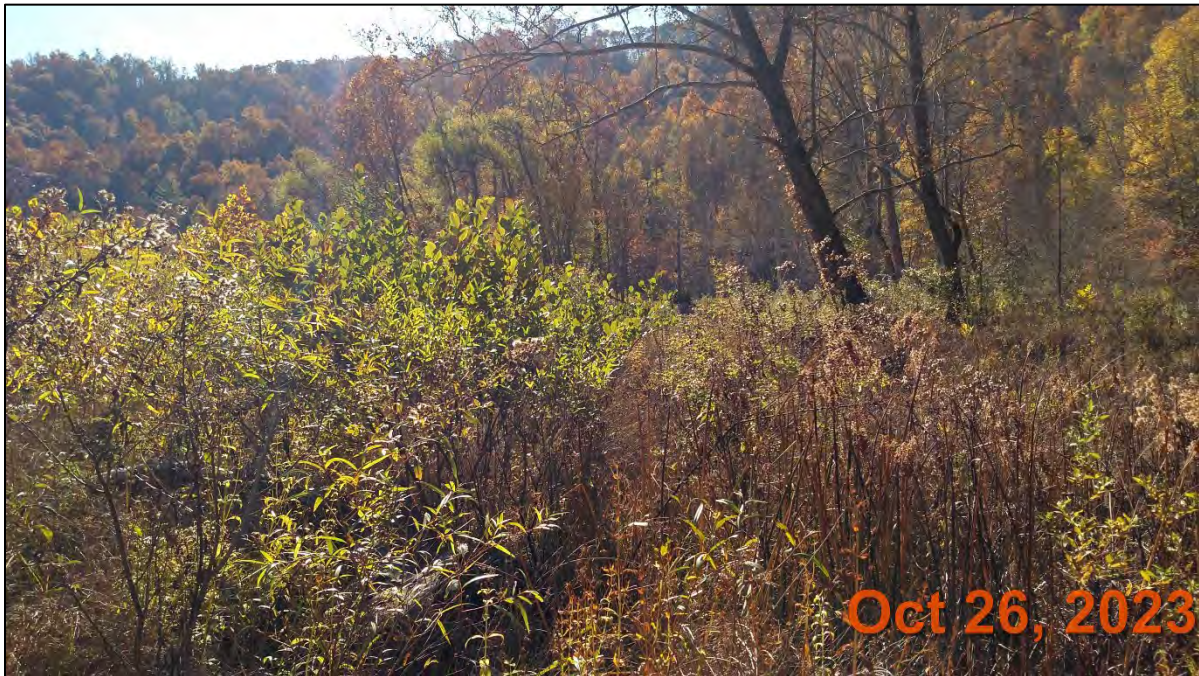
Photo point #6a, facing upstream, Reach 1C and Wetland C.

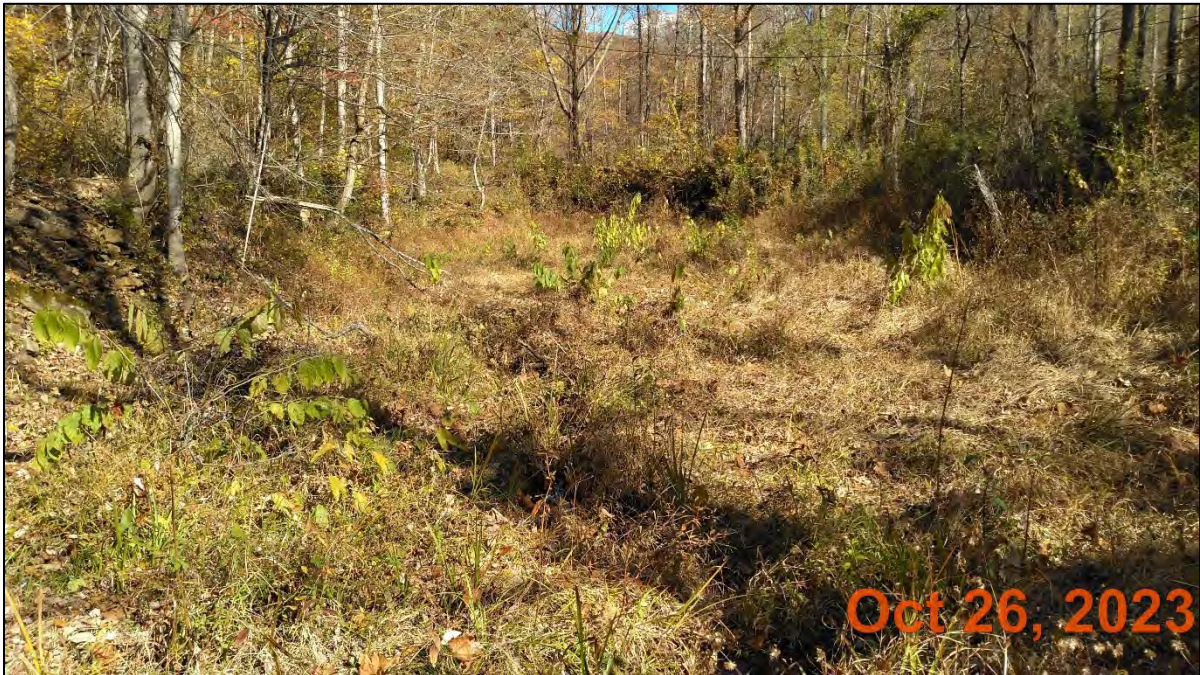
Photo point #7b, facing downstream from XS 5, Reach 1D.
