Harrell Stream and Wetland Restoration Site Monitoring Report – MY01 Edgecombe County, NC

December 2008

EXECUTIVE SUMMARY

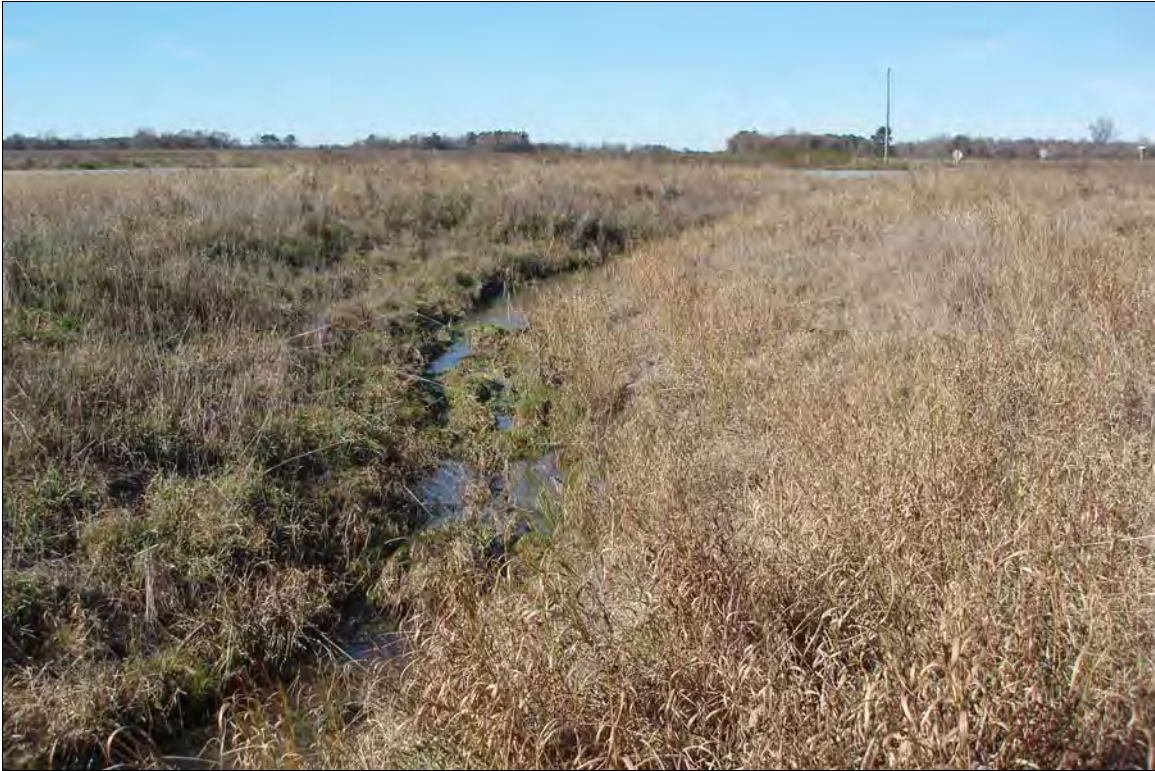
Photo Point S1: View looking upstream near Station 12+75. 11/19/08 – MY-01

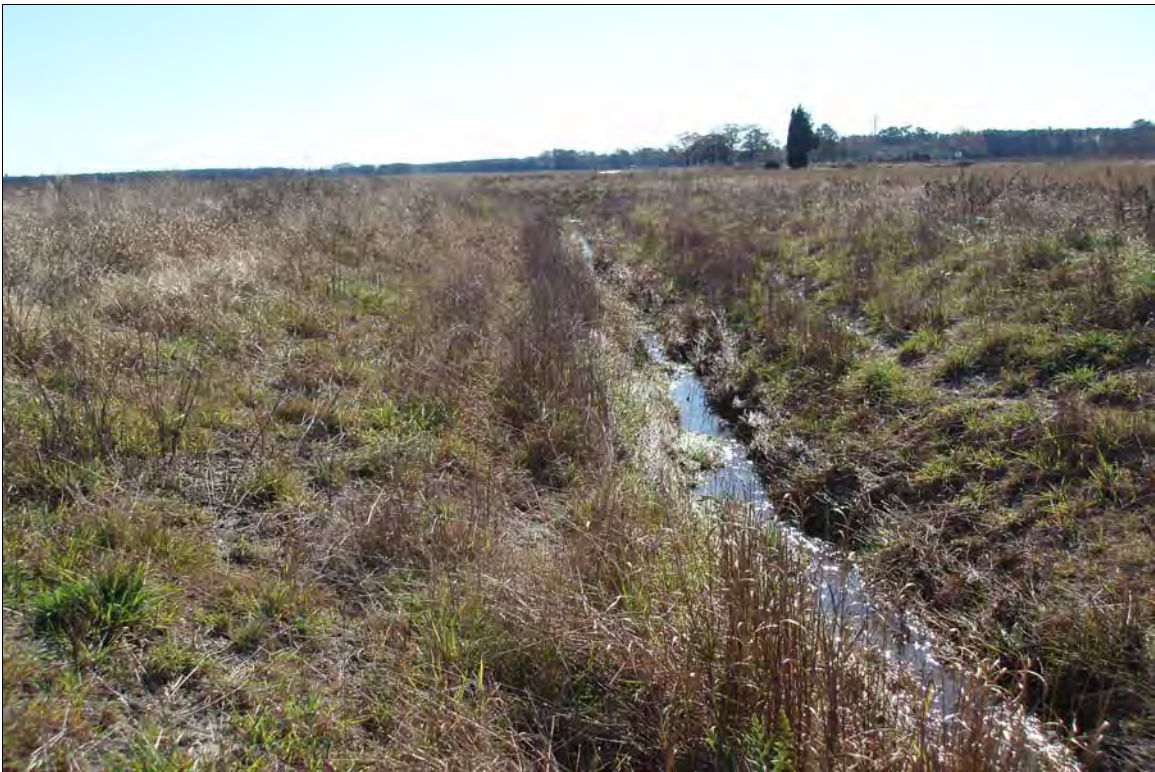
Photo Point S1: View looking downstream near Station 12+75. 11/19/08 – MY-01

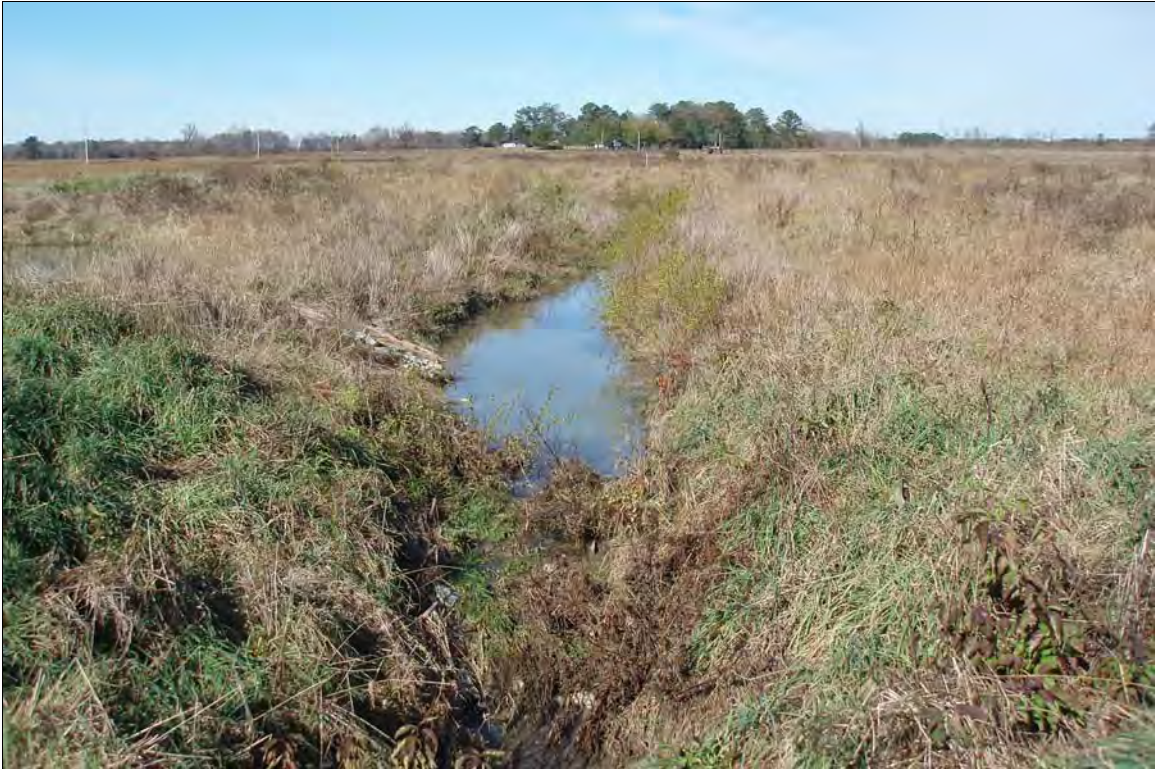
Photo Point S2: View looking upstream from farm road near Station 21+30. 11/19/08 – MY-01

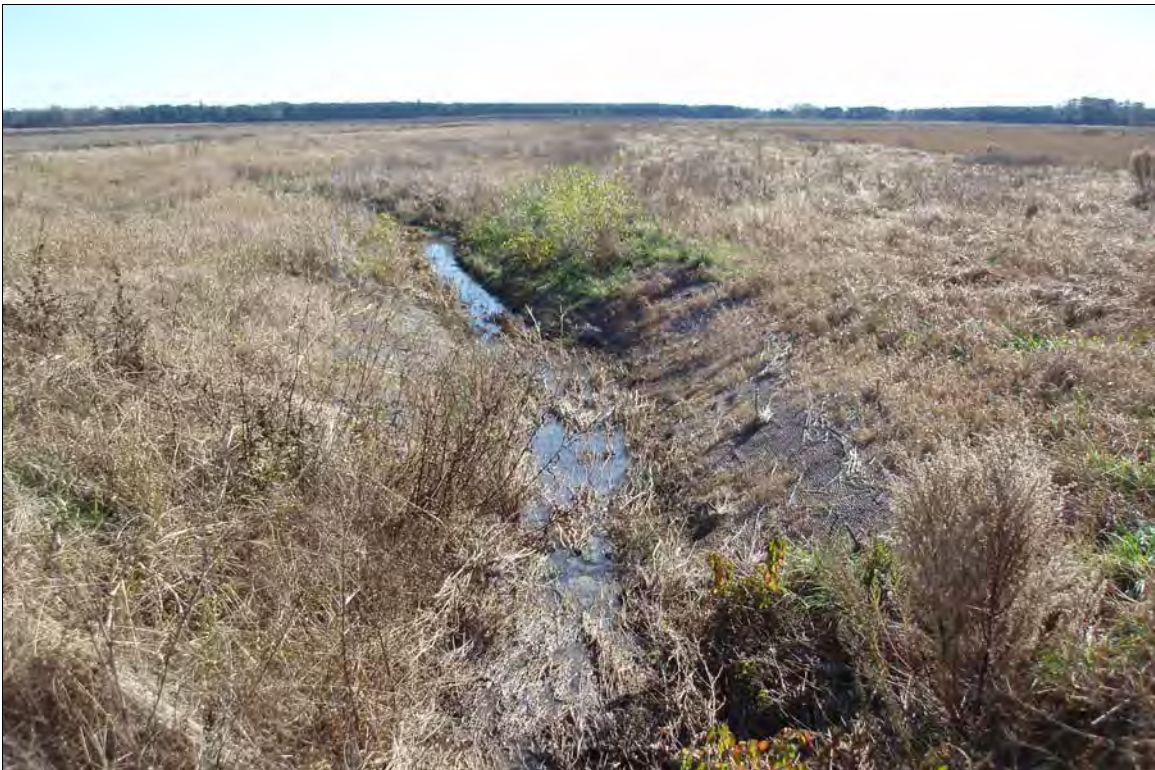
Photo Point S2: View looking downstream from farm road near Station 21+30. 11/19/08 - MY-01

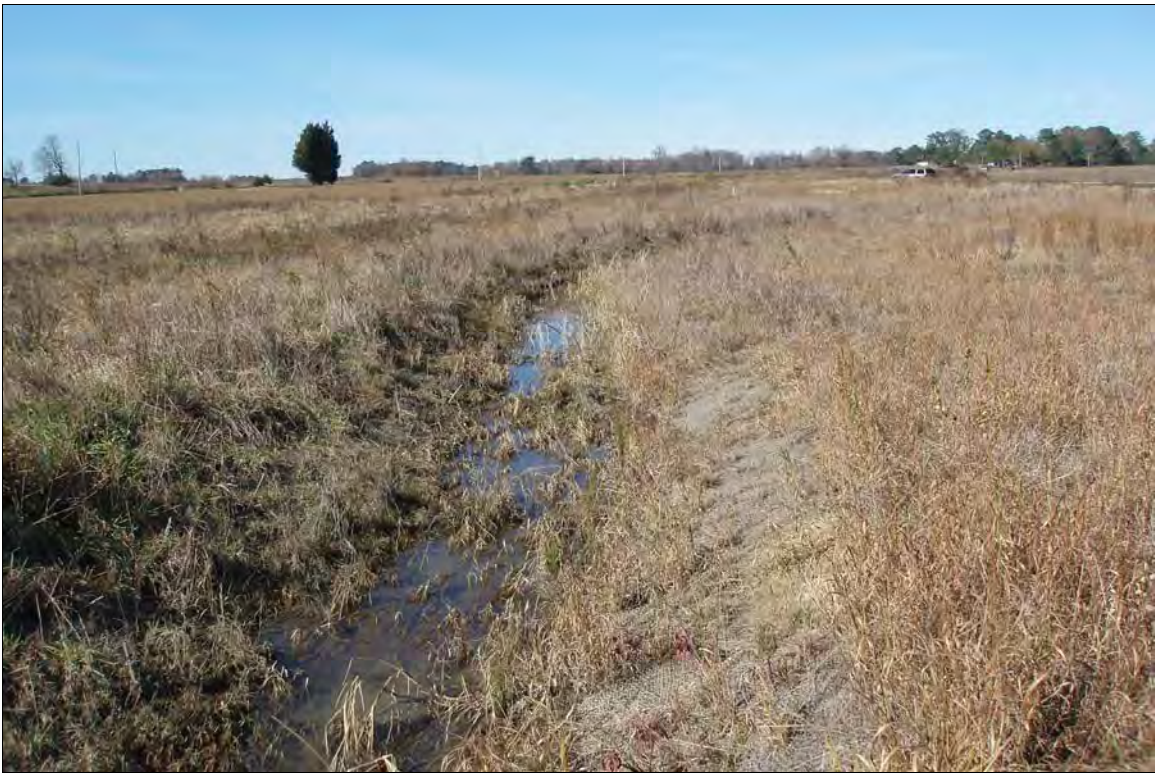
Photo Point S3: View looking upstream near Station 27+60. 11/19/08 – MY-01

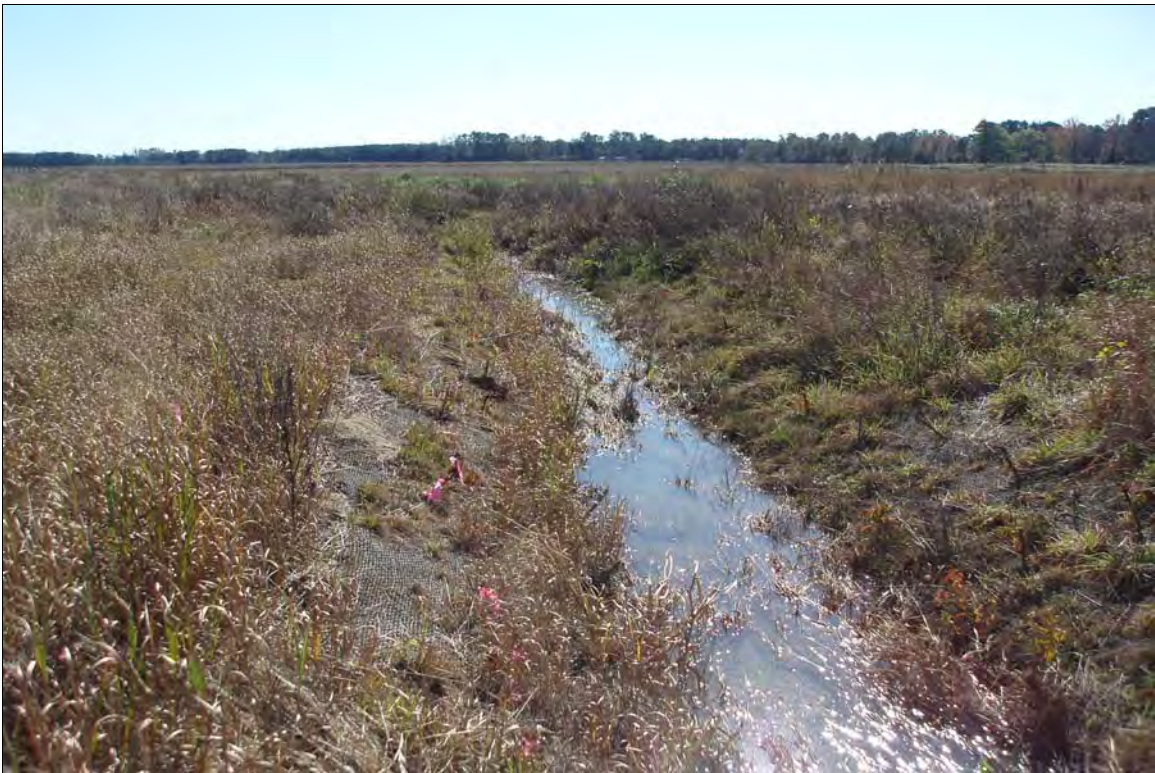
Point S3: View looking downstream near Station 27+60. 11/19/08 – MY-01

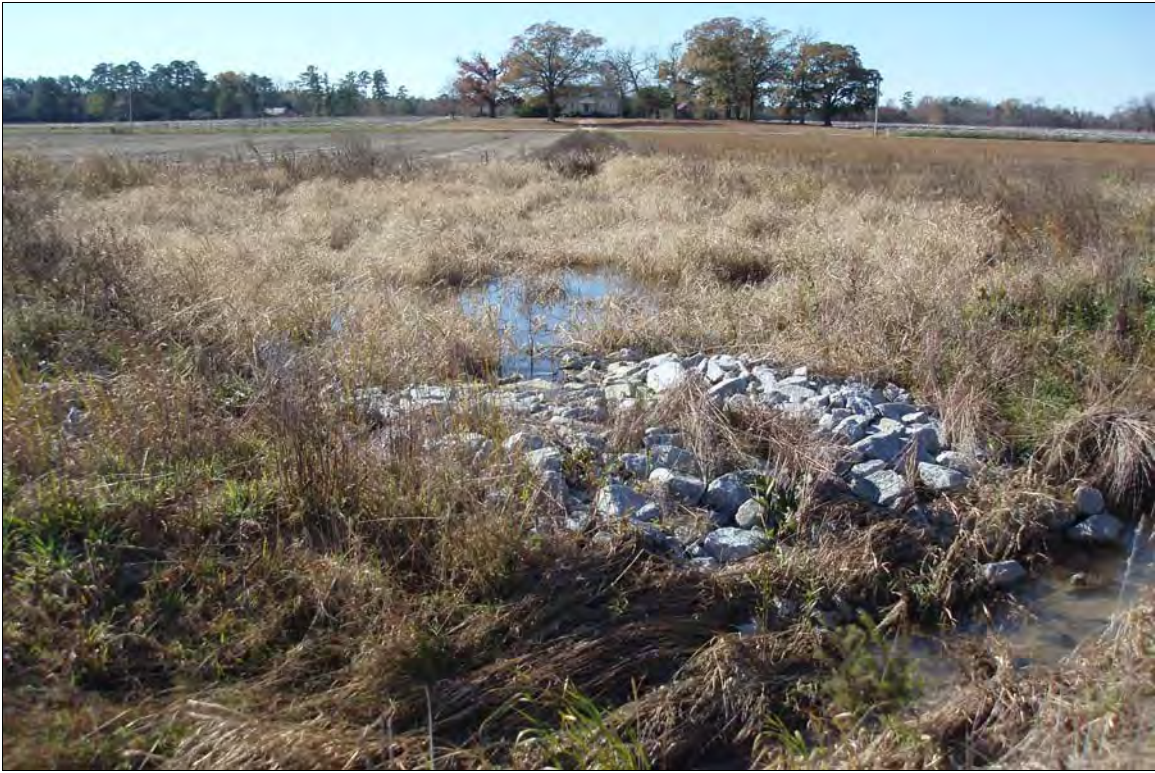
Photo Point S4: View of water quality treatment structure near Station 32+25. 11/19/08 – MY-01

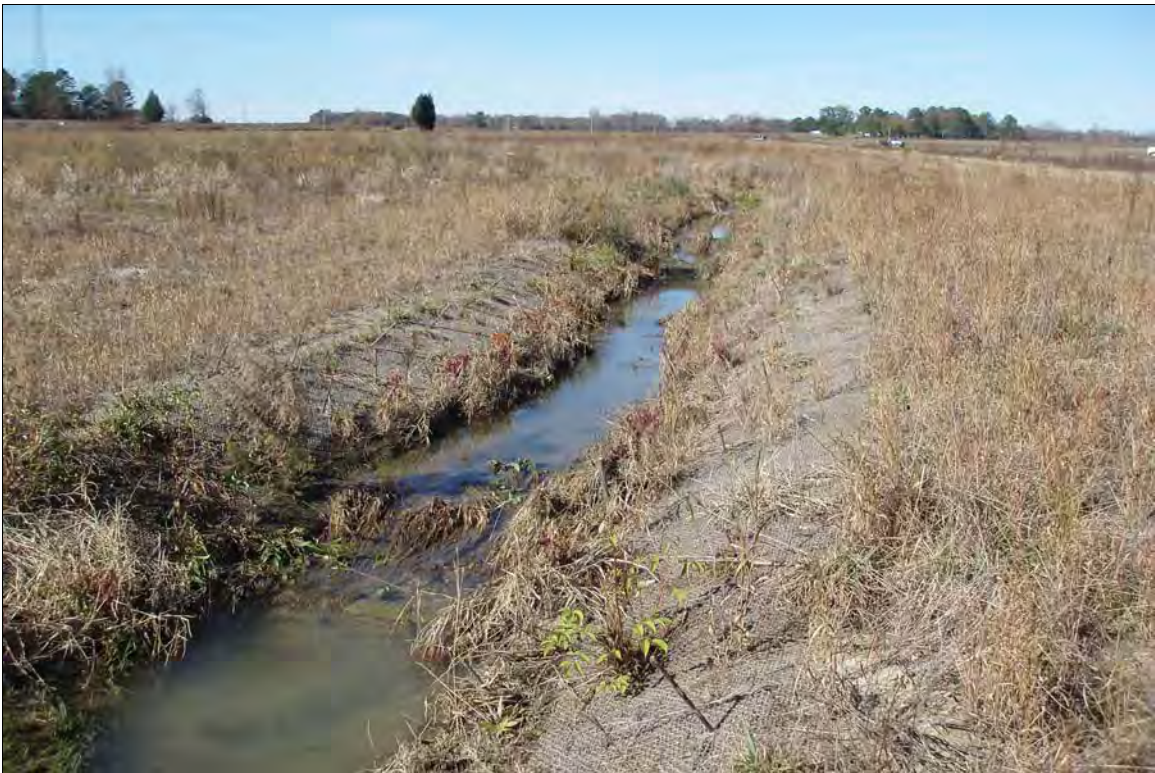
Photo Point S5: View looking at log drop structures, near Station 33+35. 11/19/08 – MY-01

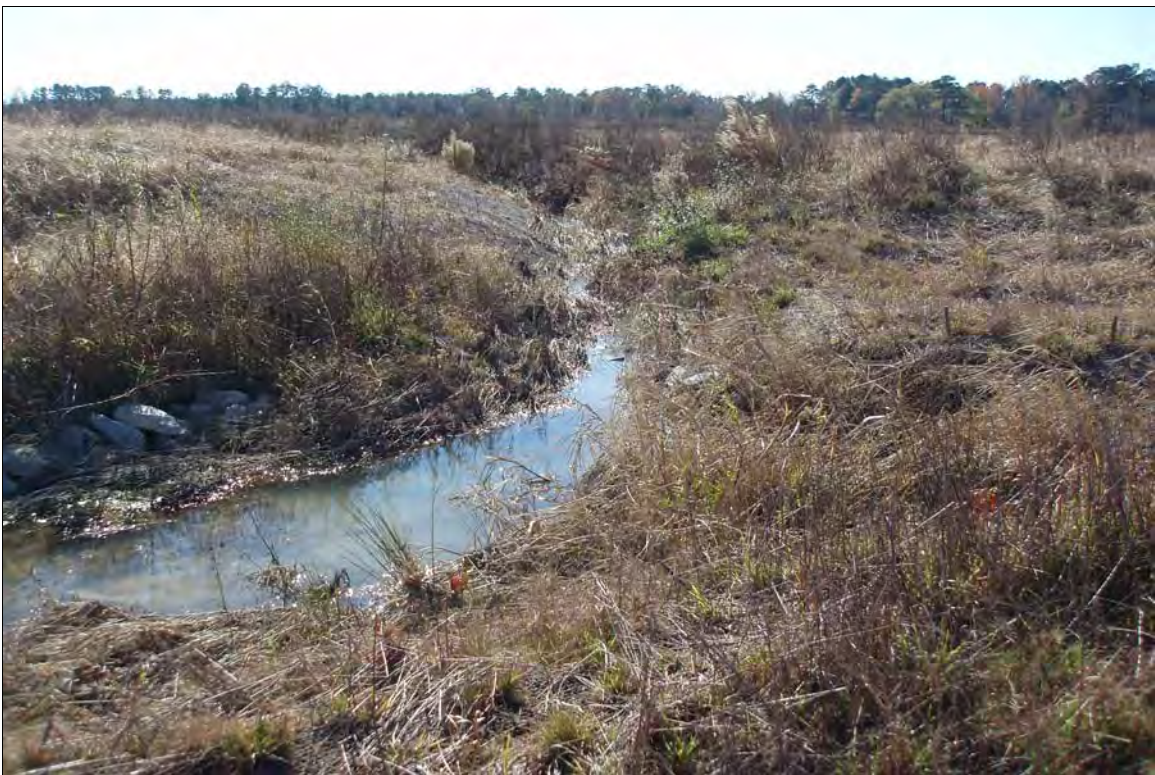
Photo Point S6: View of incoming drainage ditch near Station 37+25. 11/19/08 – MY-01

Maintenance was performed along the restored stream near stations 23+00, 37+00, 39+60 and 52+75. Minor bank and bed stabilization was conducted with rock at station 23+00 due to bed degradation. Near station 37+00 the banks of an incoming drainage ditch within the easement were sloped back and stabilized to alleviate bank erosion from the ditch. To further facilitate floodplain drainage, rock stabilization was added near Stations 39+60 and 52+75 where erosion was occurring as field drainage entered the channel. At each station erosion had been occurring. If any further maintenance actions are warranted, they will be documented in future monitoring reports.

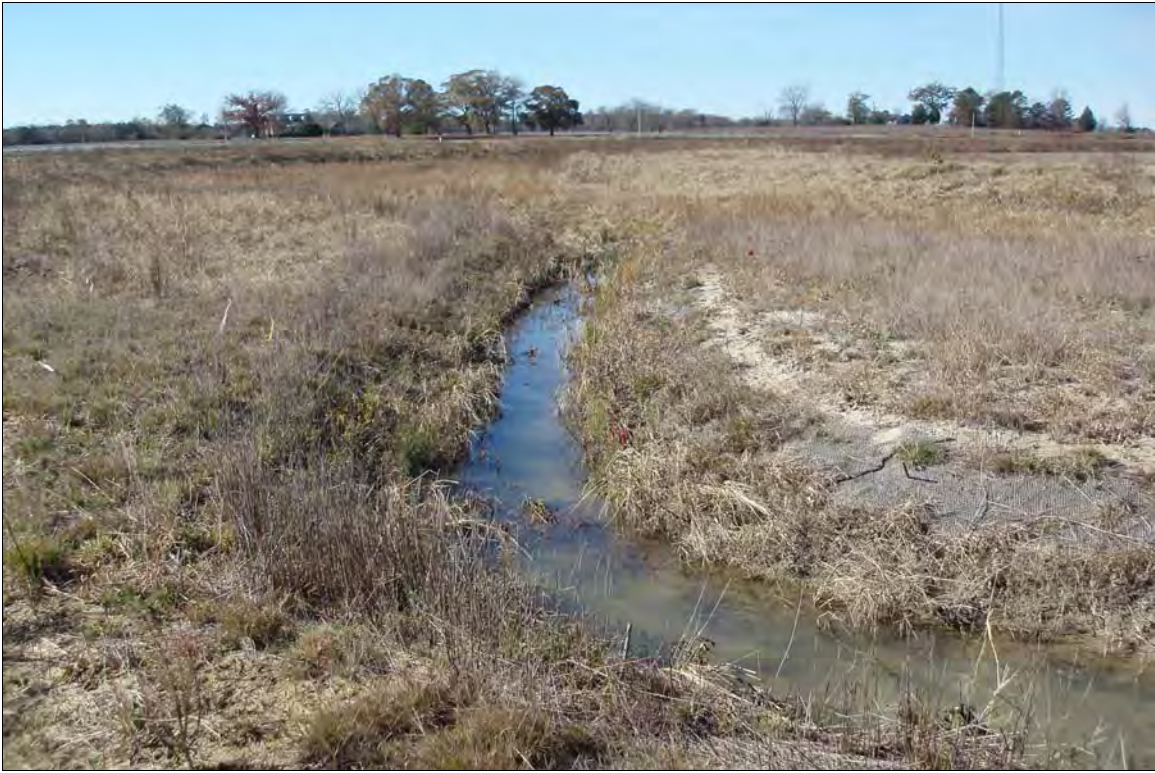
Photo Point S7: View looking upstream near Station 39+00. 11/19/08 – MY-01

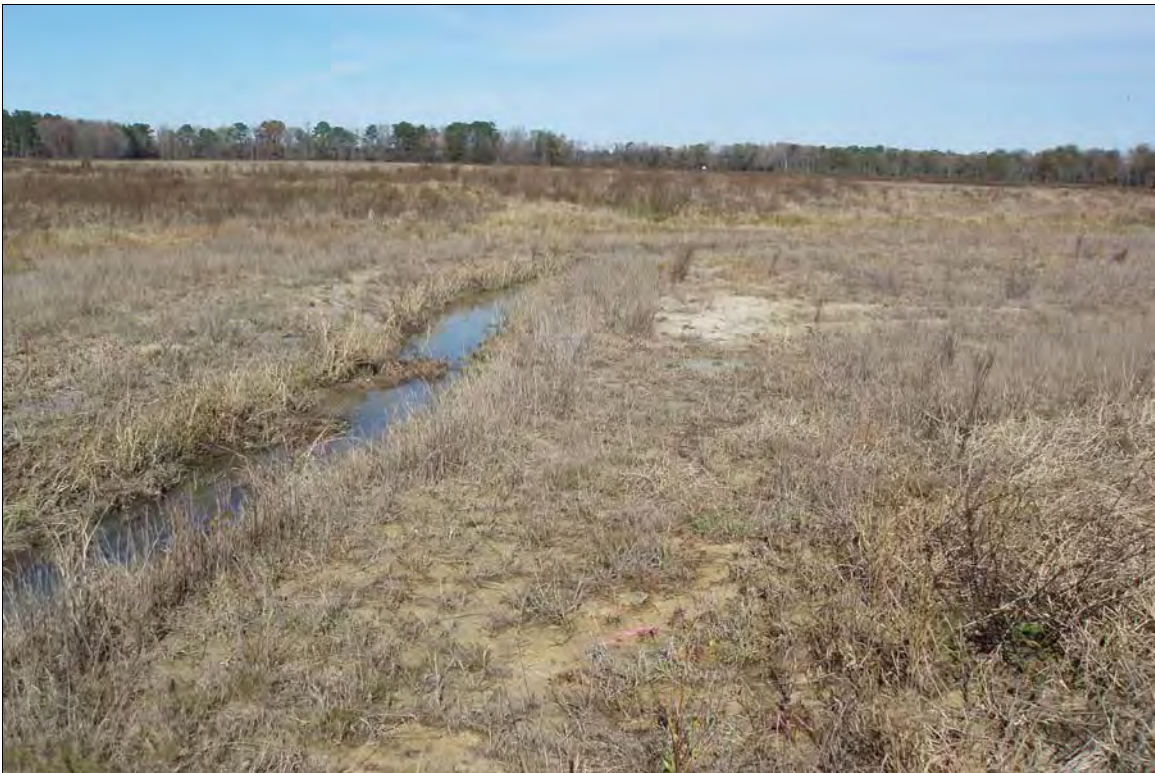
Photo Point S7: View looking downstream near Station 39+00. 11/19/08 – MY-01

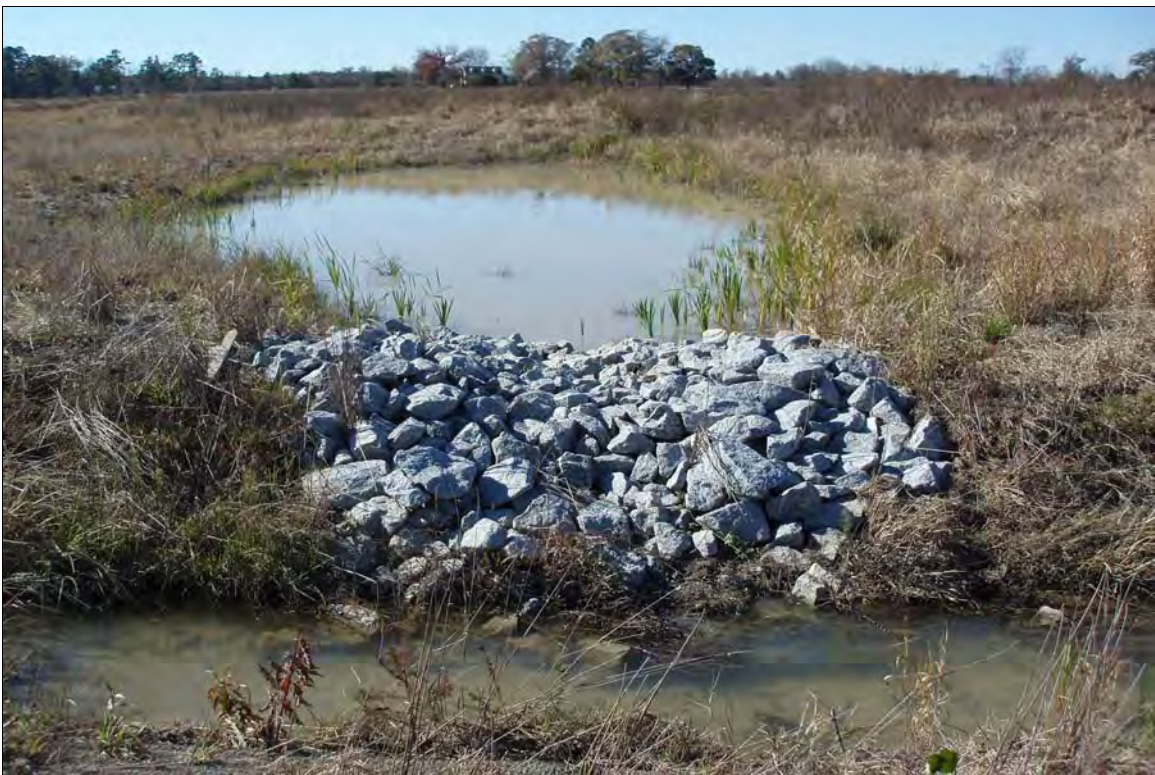
Photo Point S9: View of water quality treatment structure near Station 41+75. 11/19/08 – MY-01

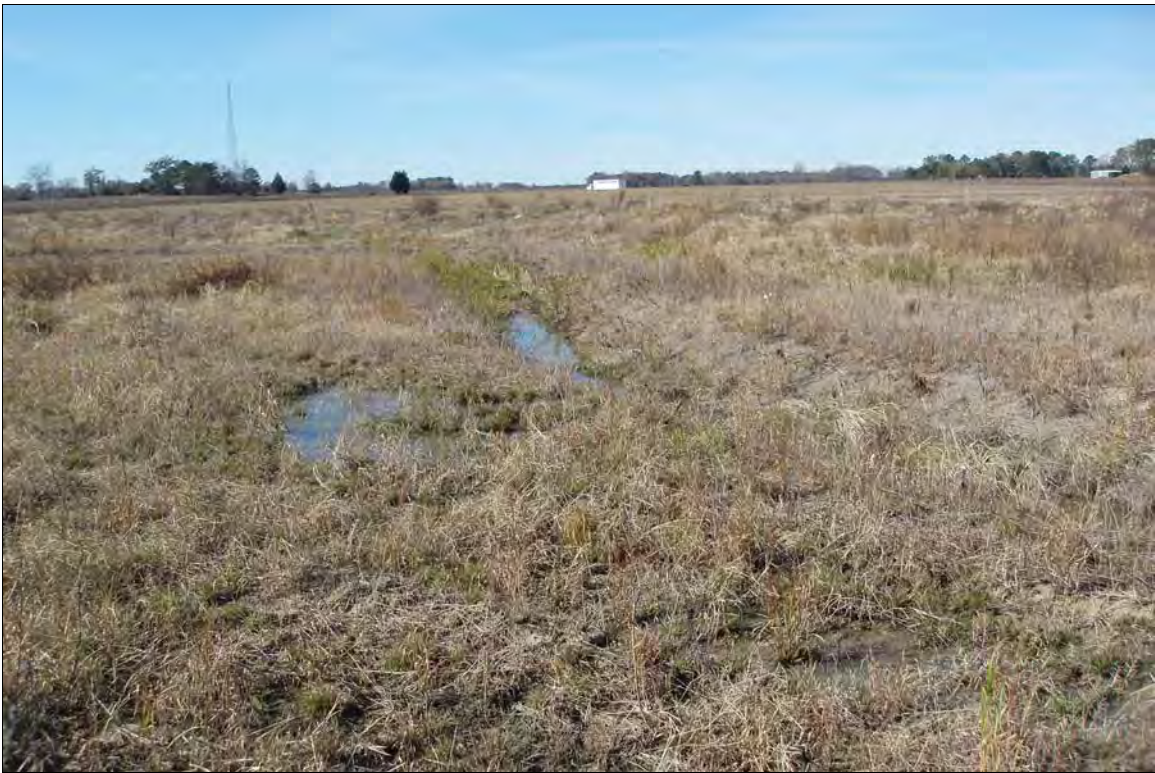
Photo Point S10: View looking upstream near Station 46+15. 11/19/08 – MY-01

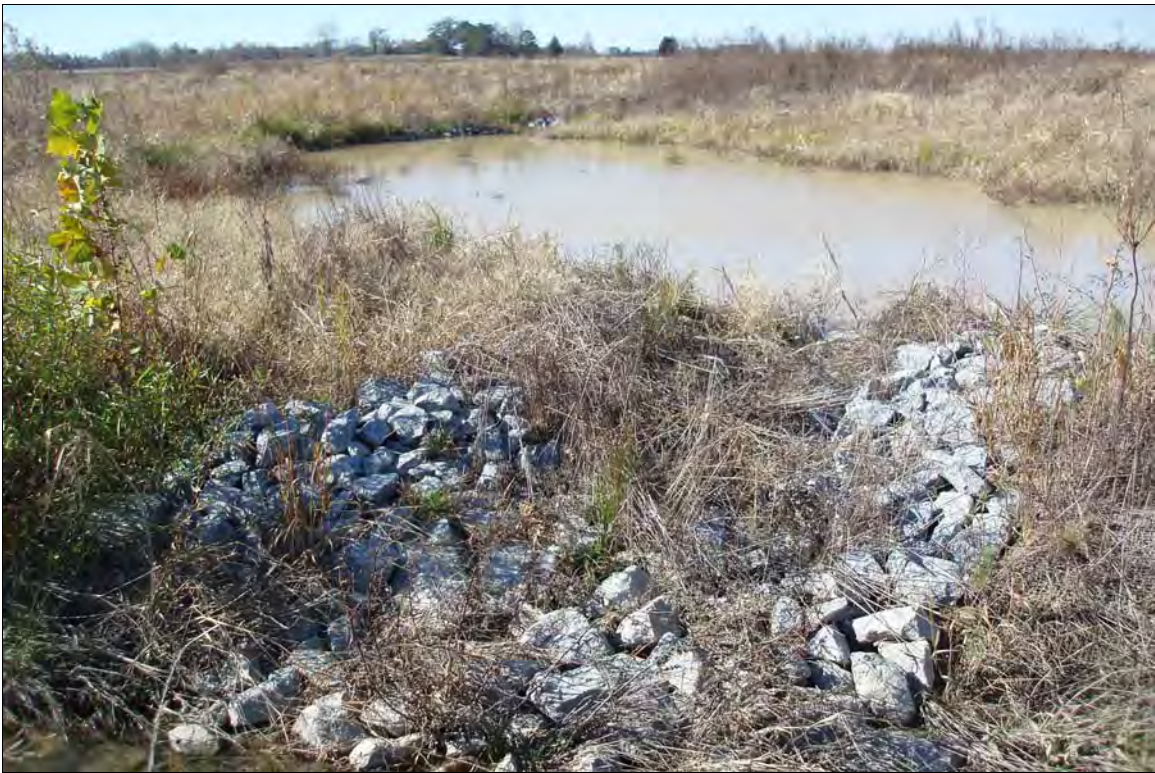
Photo Point S11: View of water quality treatment structure near Station 47+00. 11/19/08 - MY-01

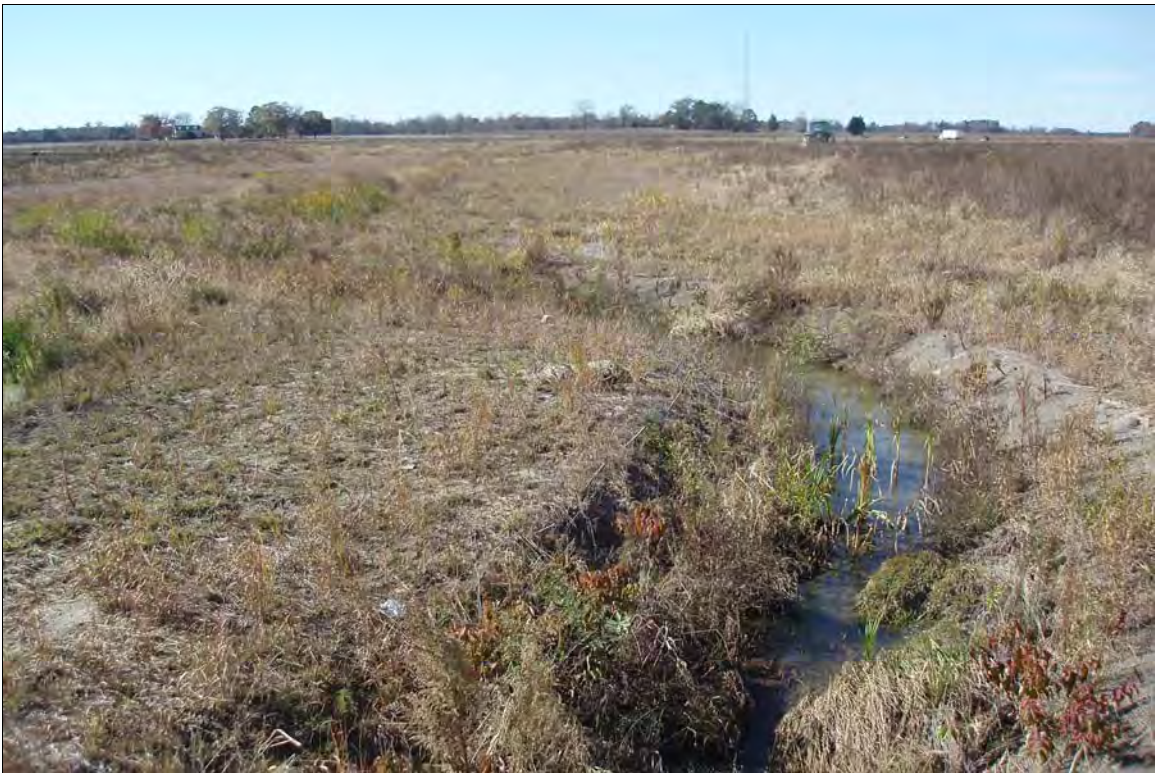
Photo Point S12: View looking upstream near Station 52+00. 11/19/08 - MY-01

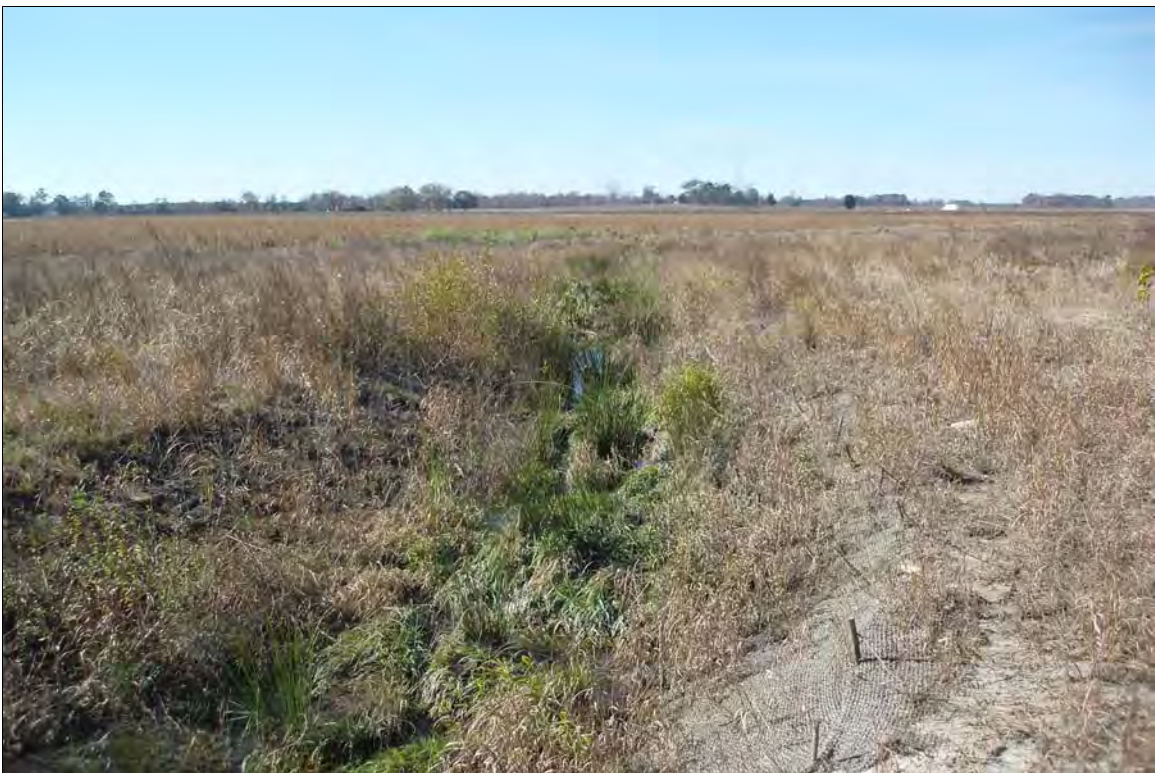
Photo Point S13: View looking upstream near Station 61+50. 11/19/08 – MY-01

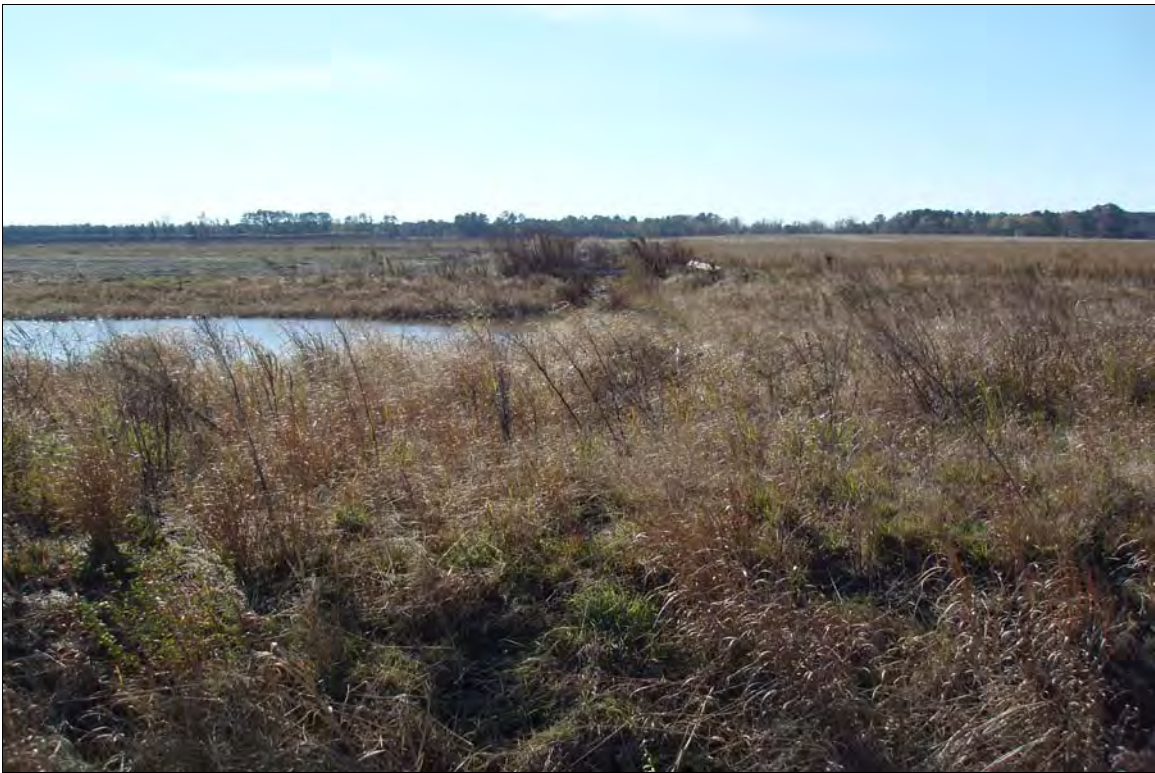
Photo Point S13: View of water quality treatment structure near Station 61+50. 11/19/08 - MY-01

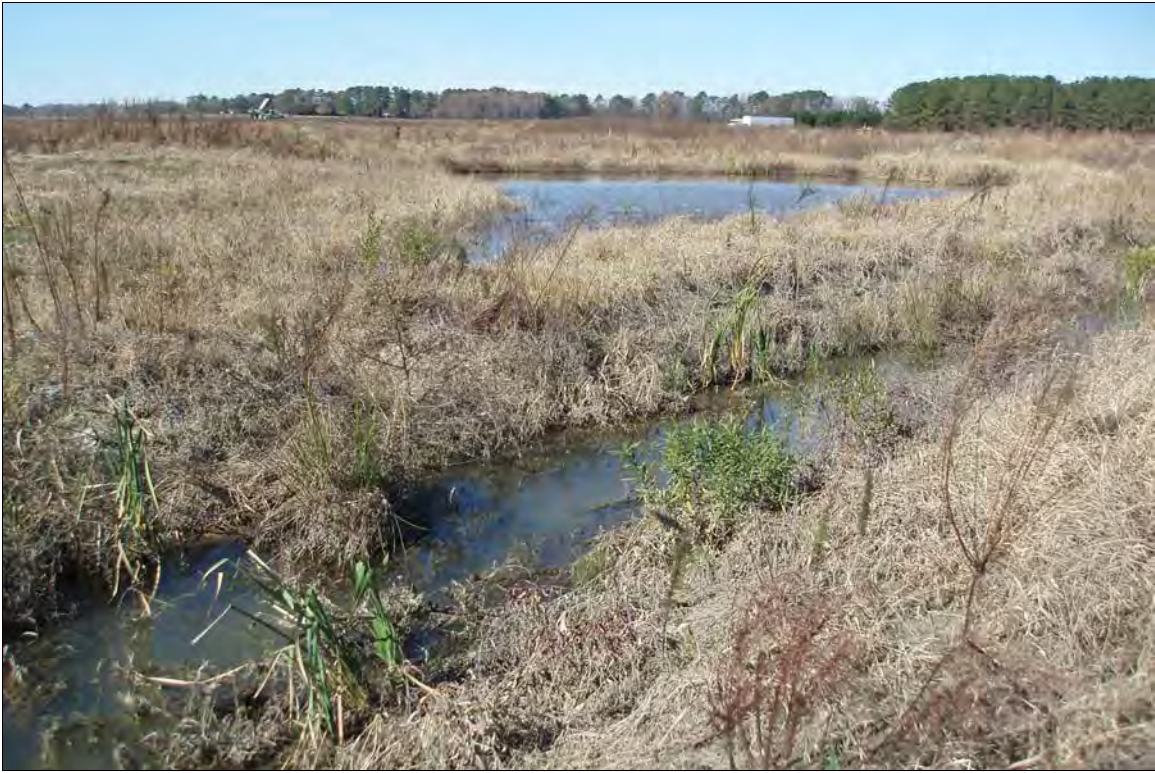
Photo Point S14: View of stream with water quality treatment structure in the background near Station 62+60. 11/19/08 - MY-01

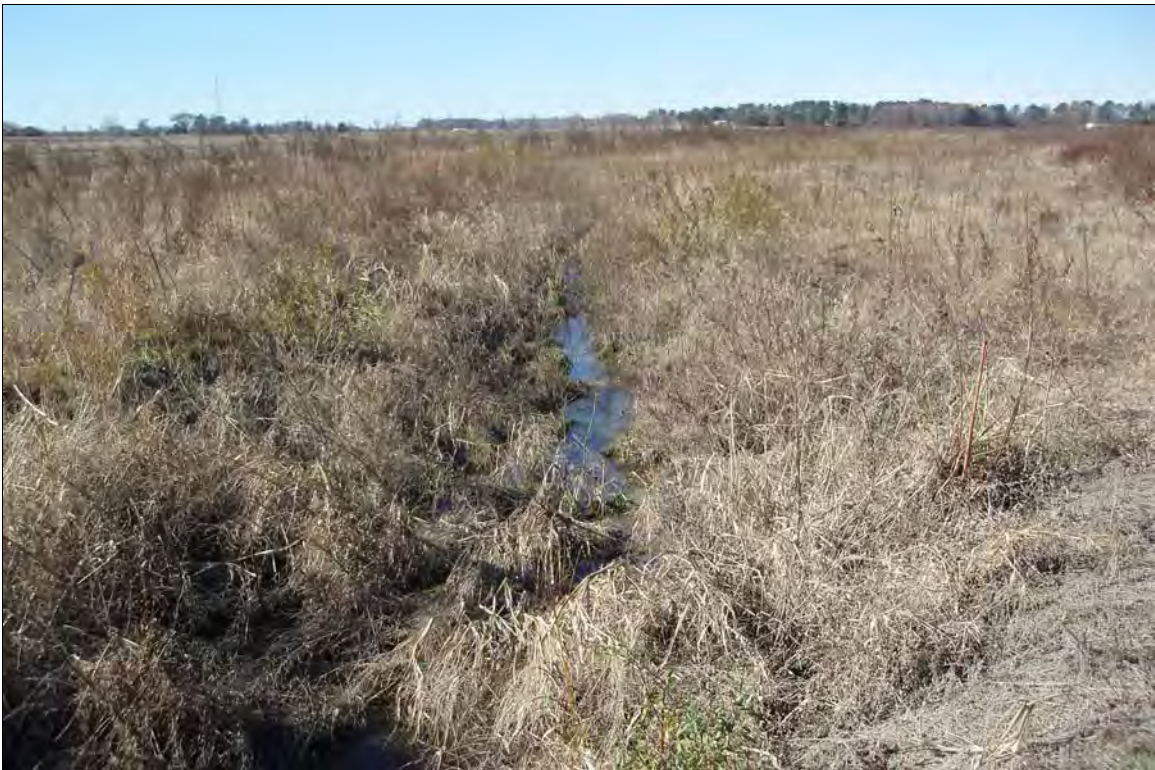
Photo Point S15: View looking upstream near Station 69+00. 11/19/08 – MY-01

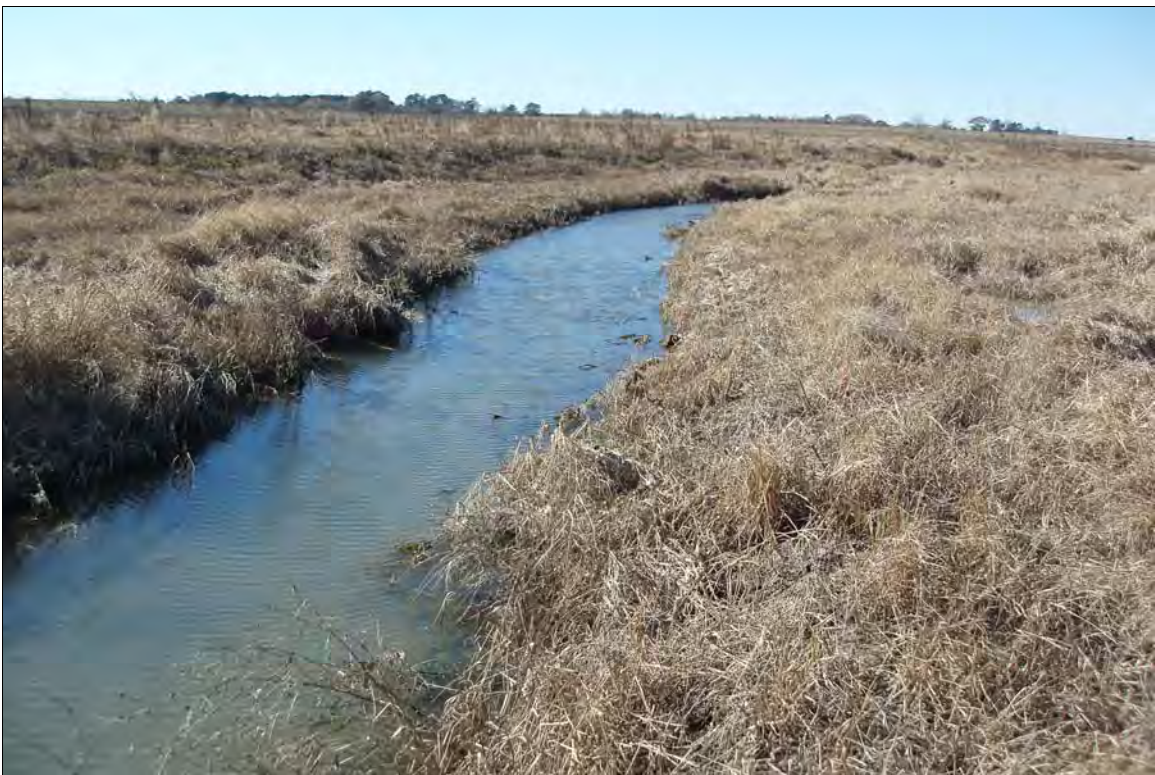
Photo Point S16: View looking upstream near Station 76+75. 11/19/08 – MY-01

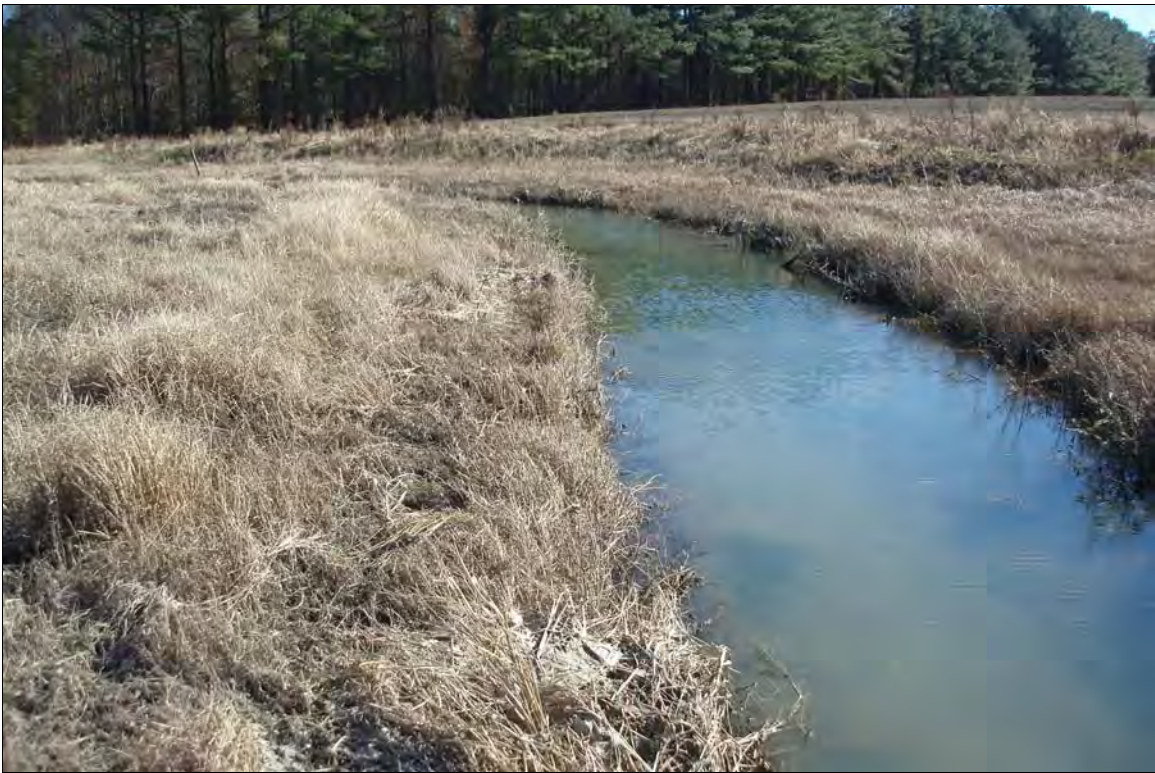
Photo Point S16: View looking downstream toward project end before the project stream joins Swift Creek near Station 76+75. 11/19/08 – MY-01

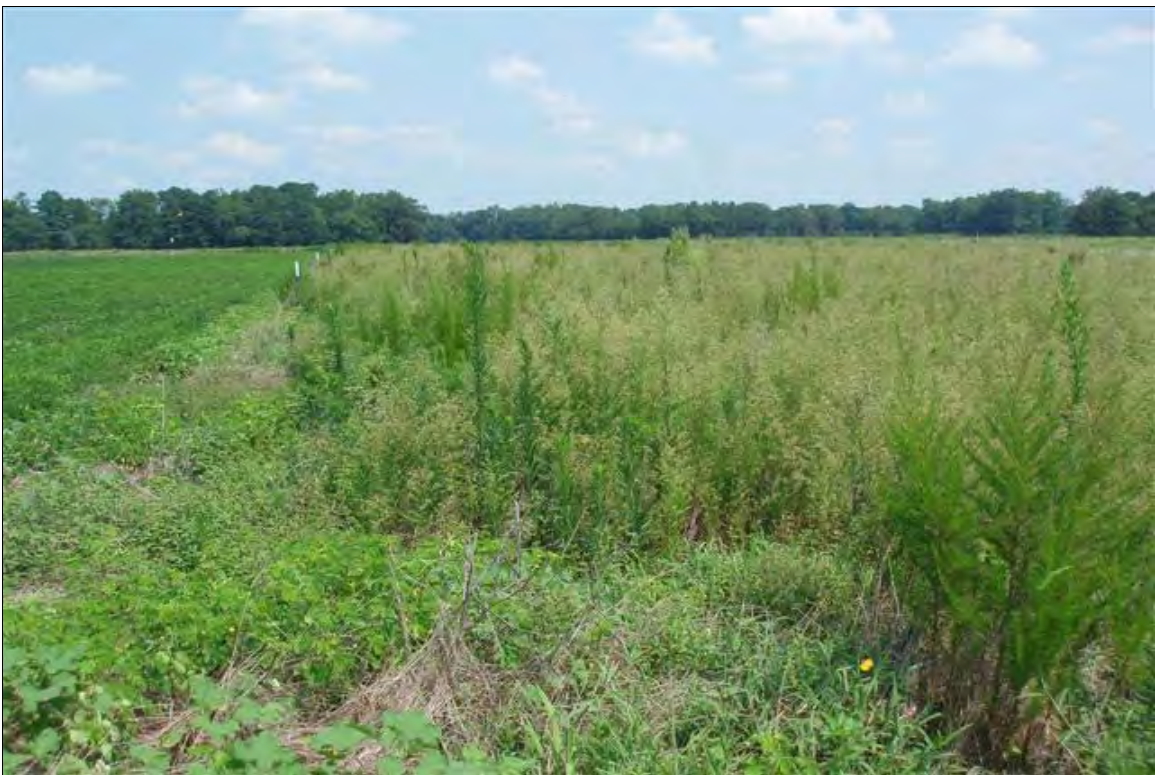
Photo Point W1: View looking north from southwest corner of wetland. 8/20/08 – MY-01

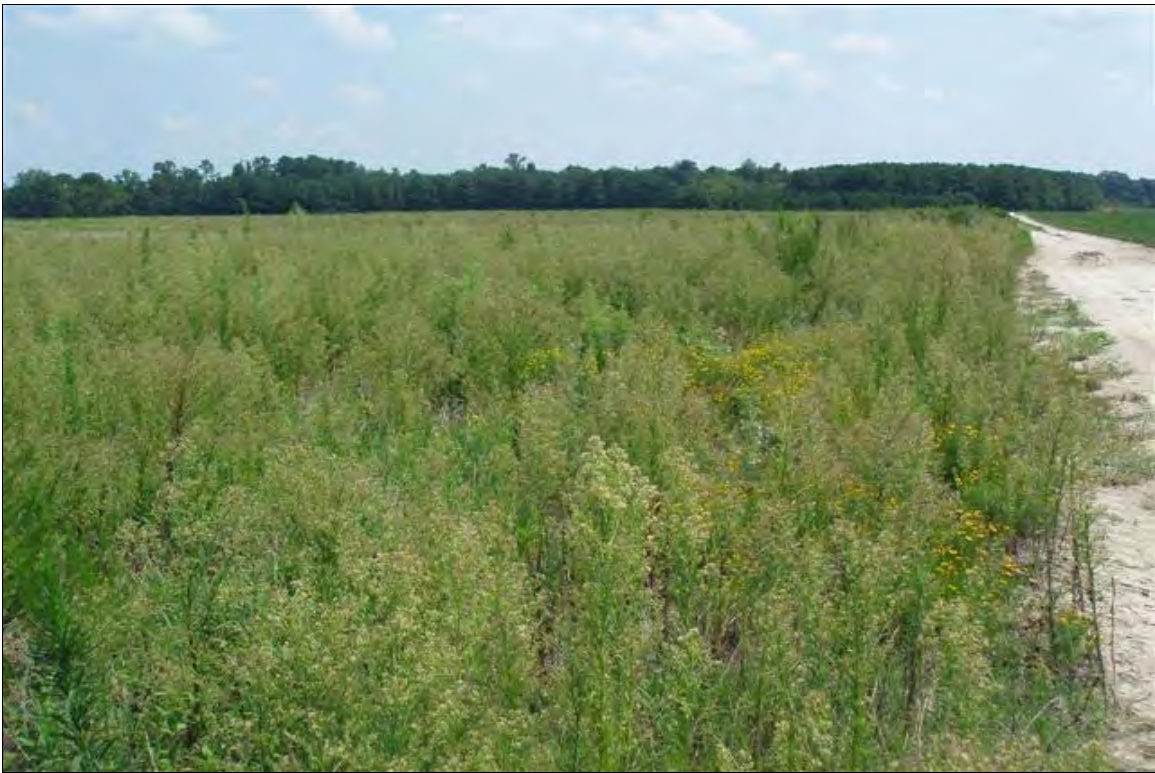
Photo Point W1: View looking east from southwest corner of wetland. 8/20/08 – MY-01

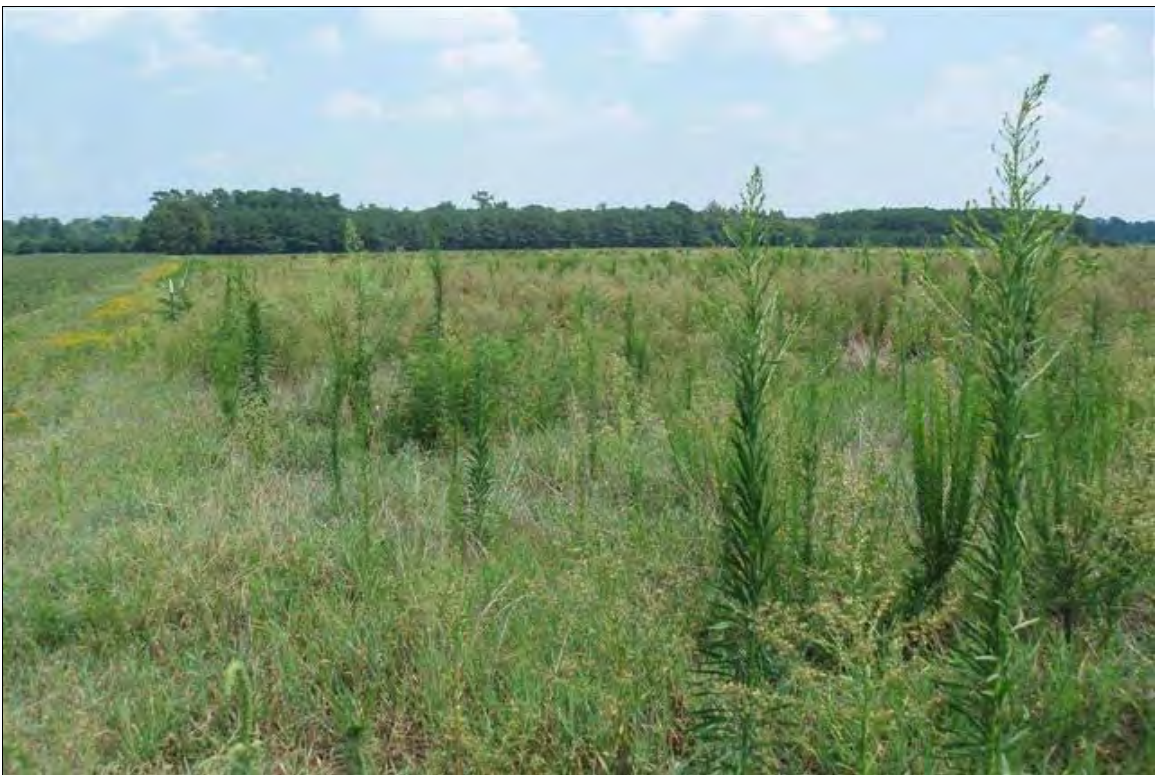
Photo Point W2: View looking east from northwest corner of wetland. 8/20/08 – MY-01

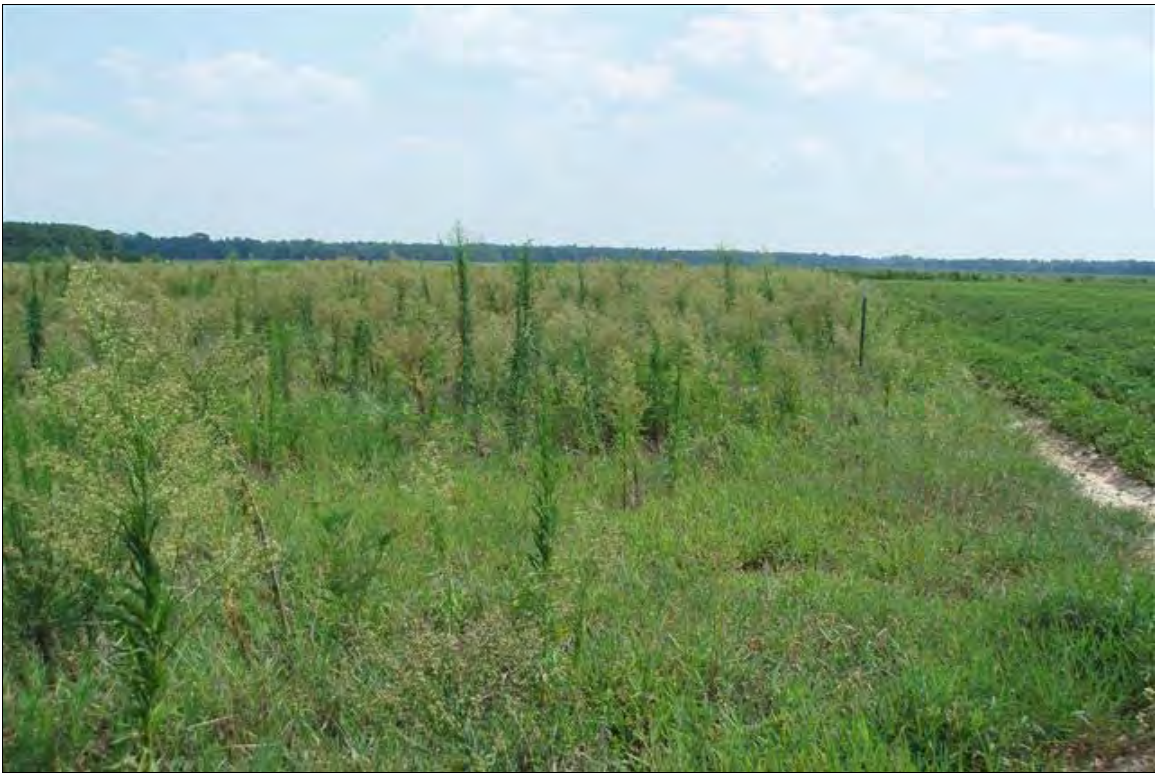
Photo Point W2: View looking southeast from northwest corner of wetland. 8/20/08 – MY-01
