Harrell Stream and Wetland Restoration Site Monitoring Report – MY01 Edgecombe County, NC

December 2008

EXECUTIVE SUMMARY

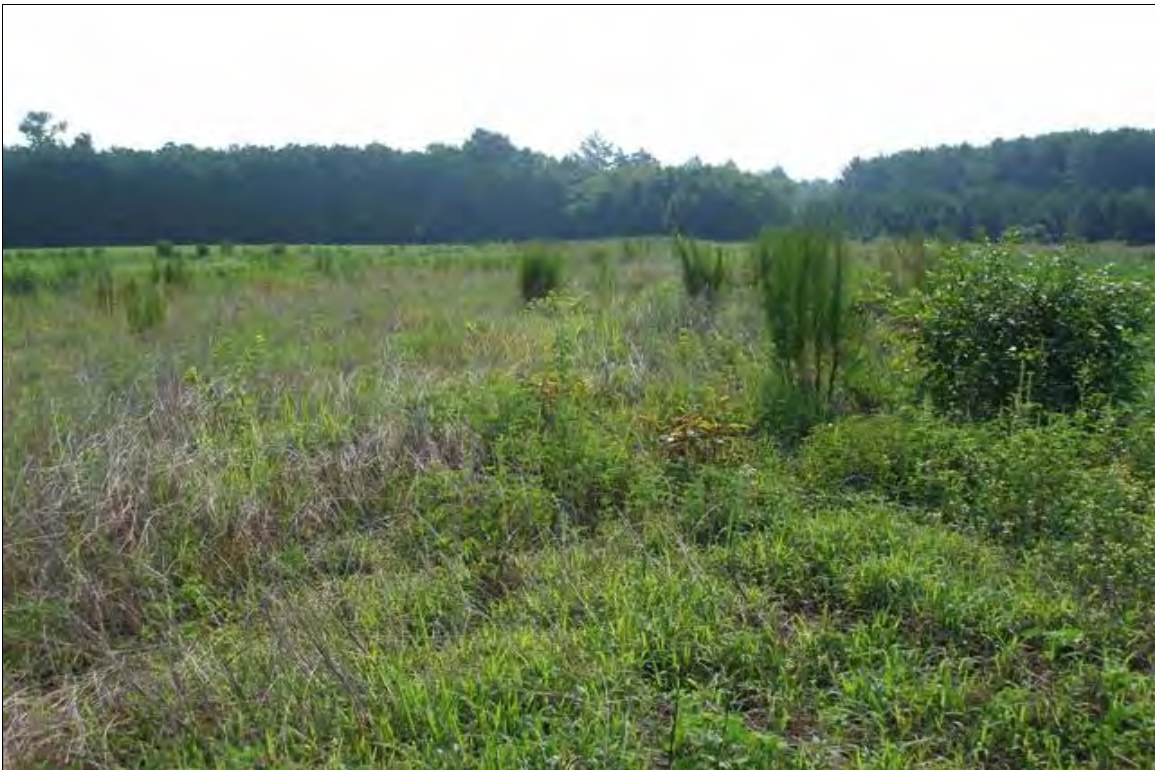
Photo Point W3: View looking east from middle corner of wetland. 8/20/08 – MY-01

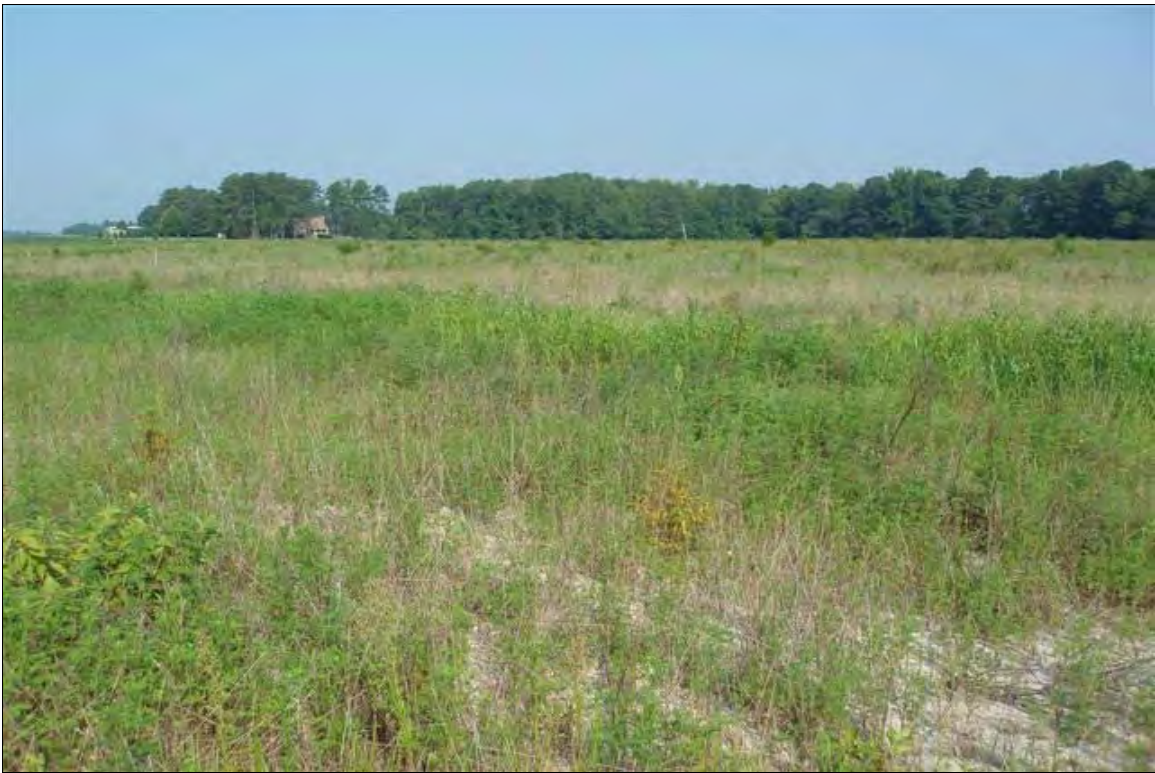
Photo Point W3: View looking west from middle corner of wetland. 8/20/08 – MY-01

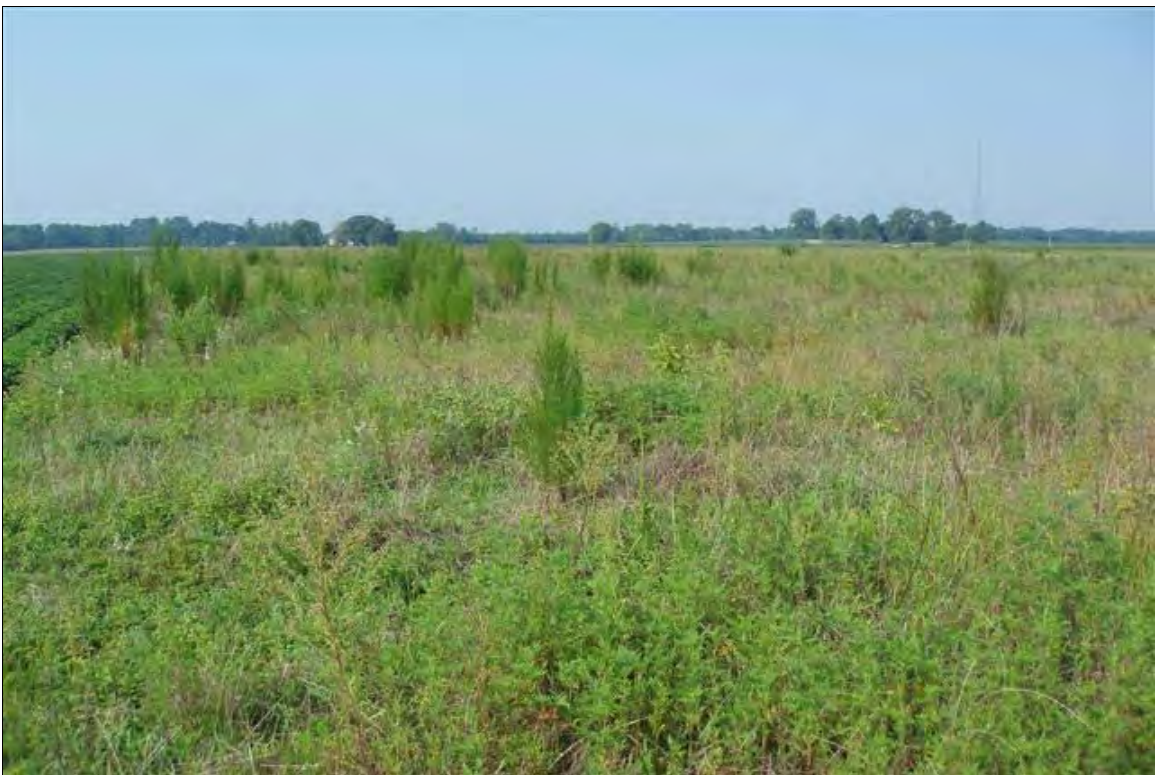
Photo Point W3: View looking southwest from middle corner of wetland. 8/20/08 – MY-01

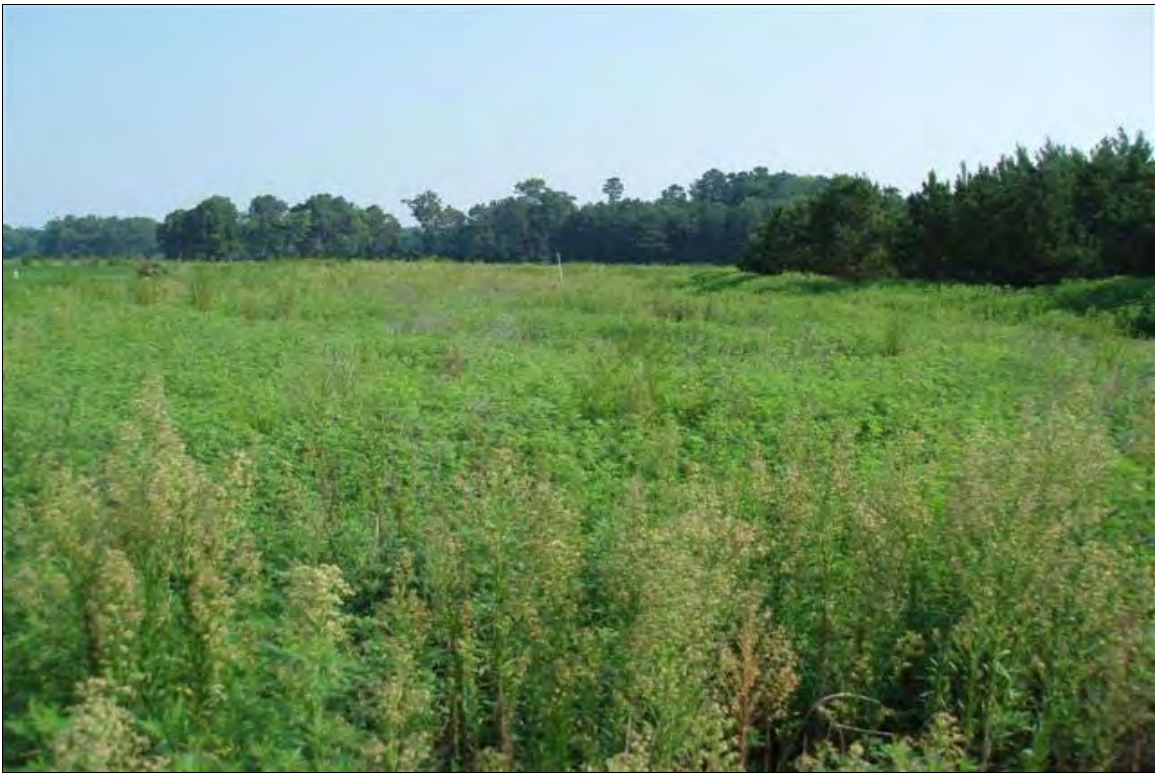
Photo Point W4: View looking north toward Wetland Gauge 1. 8/20/08 – MY-01

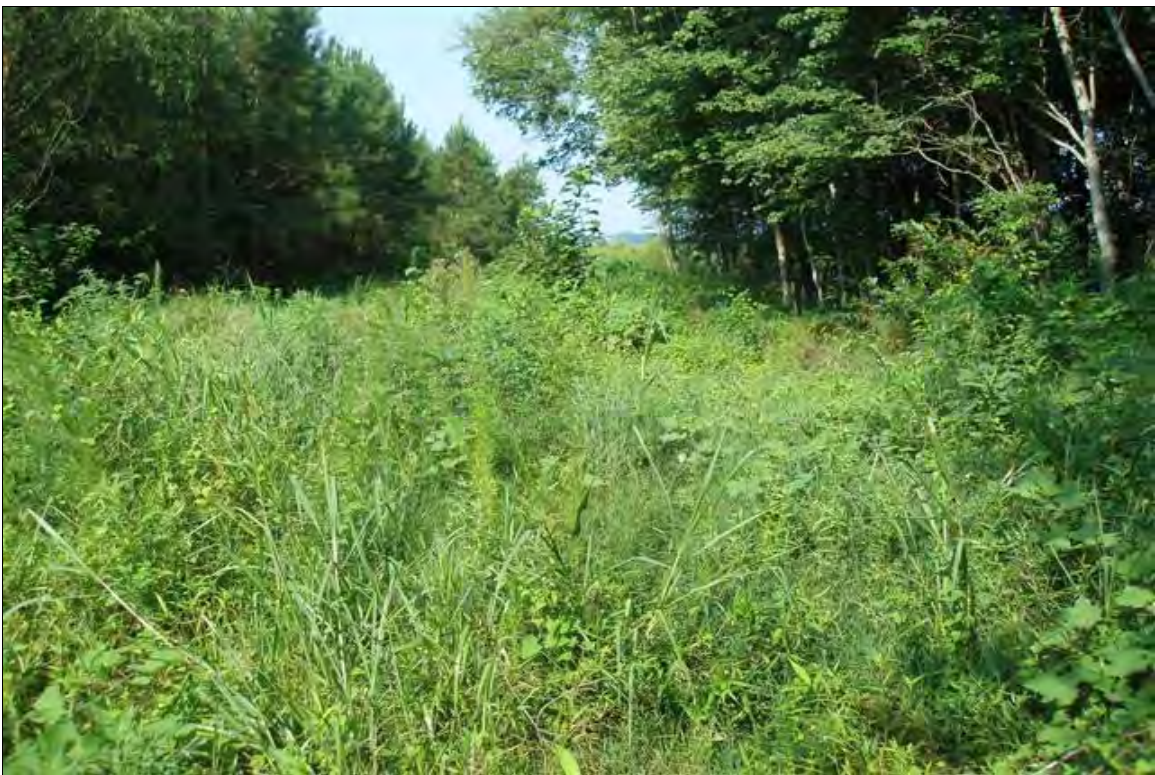
Photo Point W5: View looking west toward the downstream end of site. 8/20/08 – MY-01
