Heath Dairy Road Stream Restoration Site Randolph County, North Carolina

DMS Project #170

MY – 03 Fall Monitoring Report

Data Collected: September/October 2016

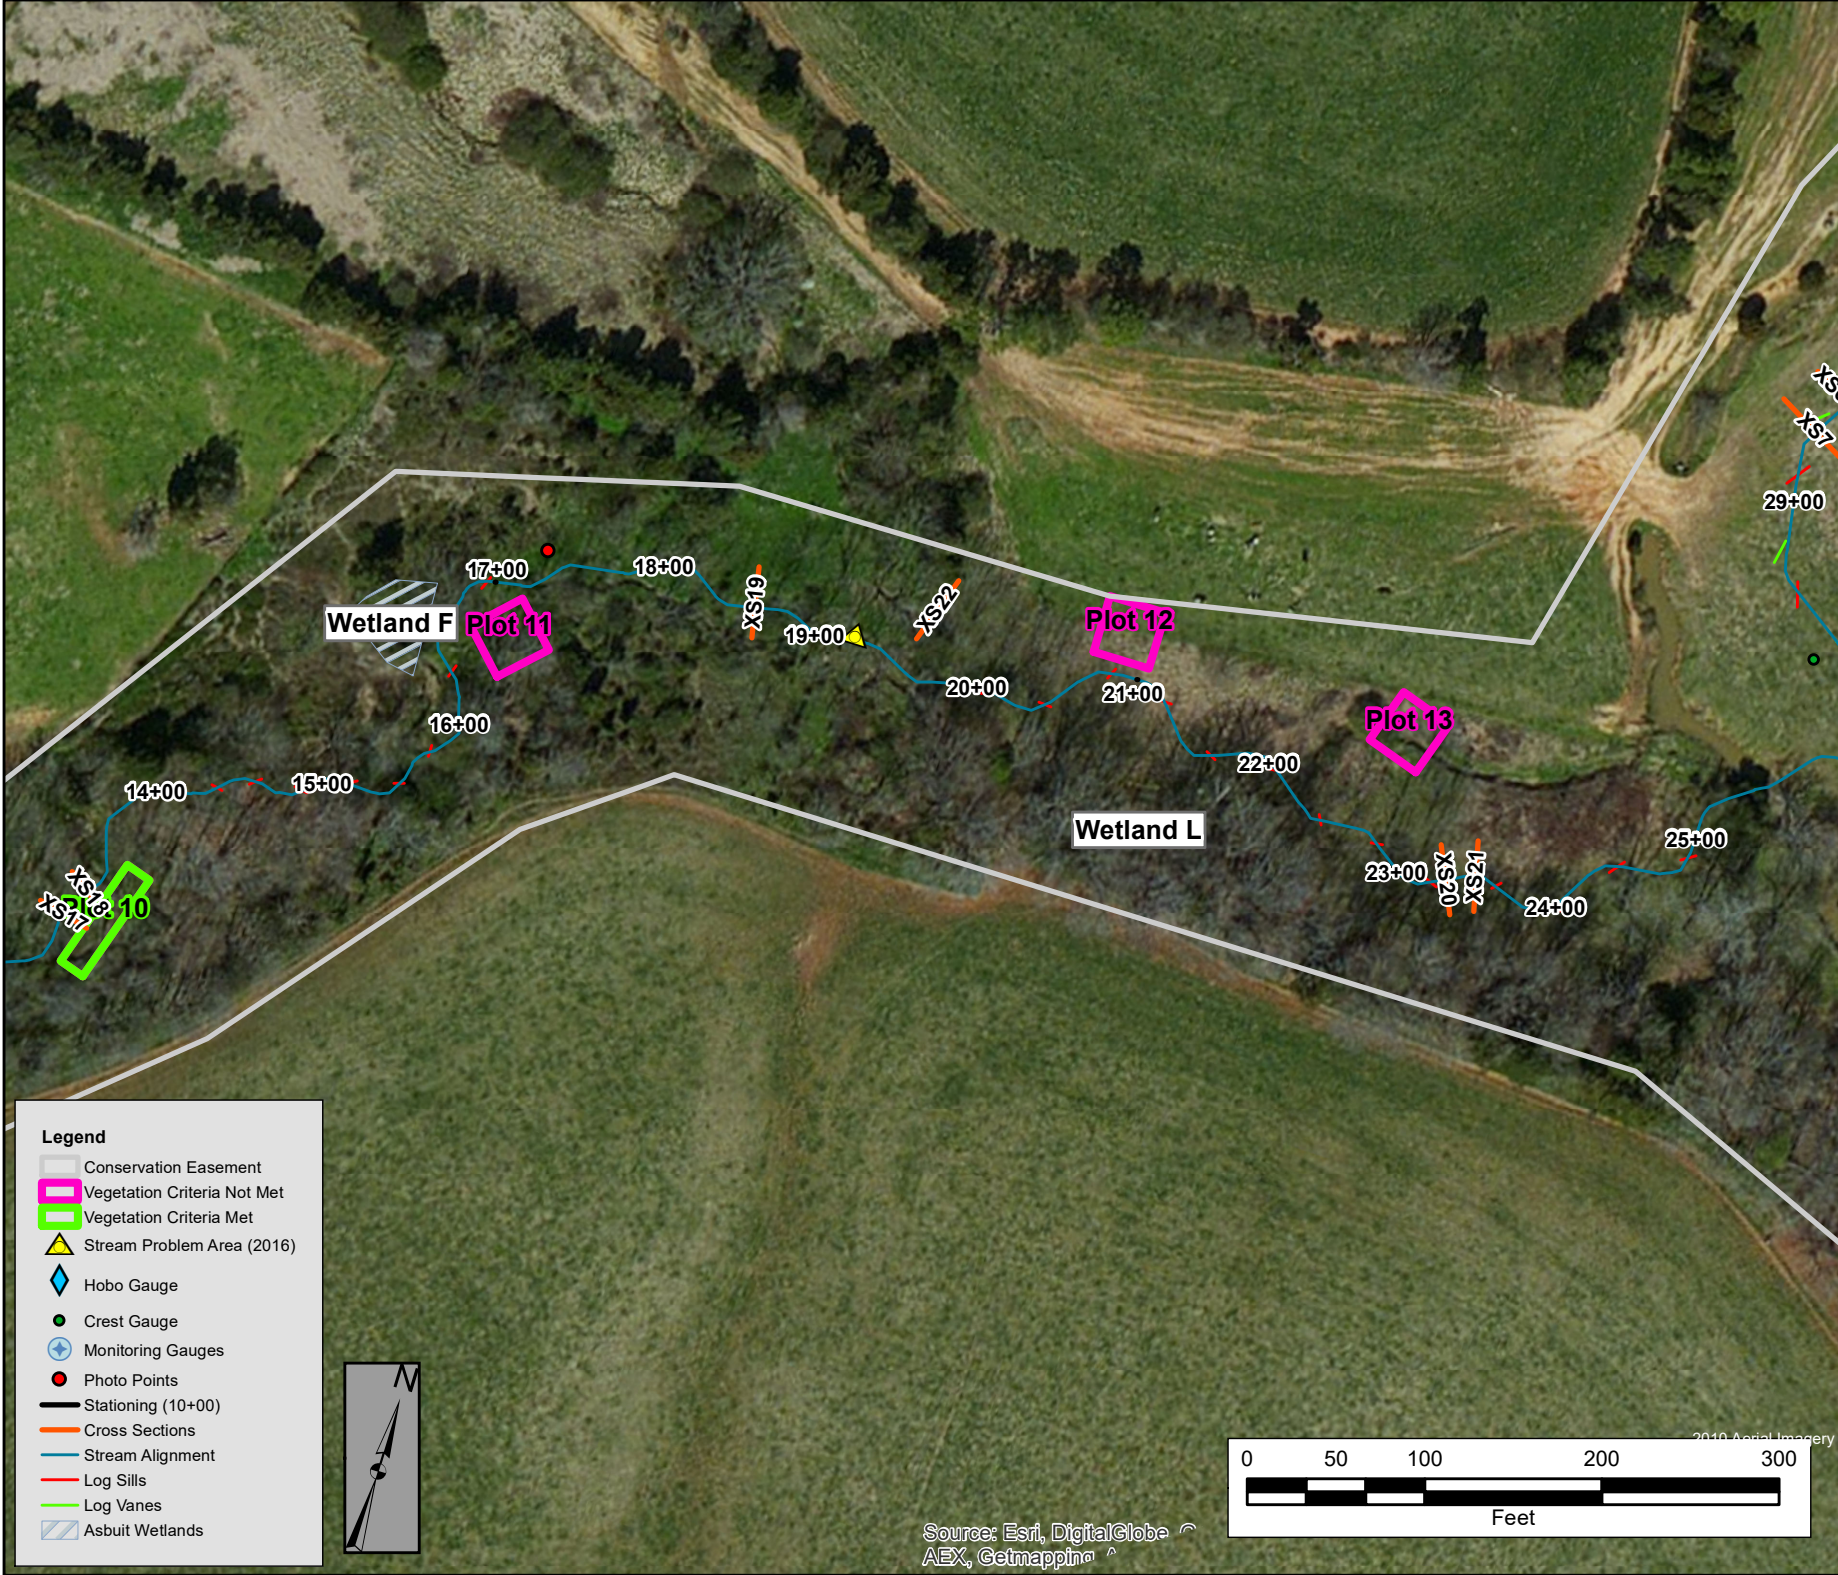
Figure 2.1

The hoof shear along West Branch that was noted in the spring site visit was no longer evident, however West Branch continues to be inundated with a thick herbaceous understory and native vines. One problem area was noted upstream of the confluence with the unnamed tributary to West Branch, whereby a large fallen tree is draped across the channel and may create erosion problems or minor stream diversion in the future (~sta. 19+20; fig 2.1).

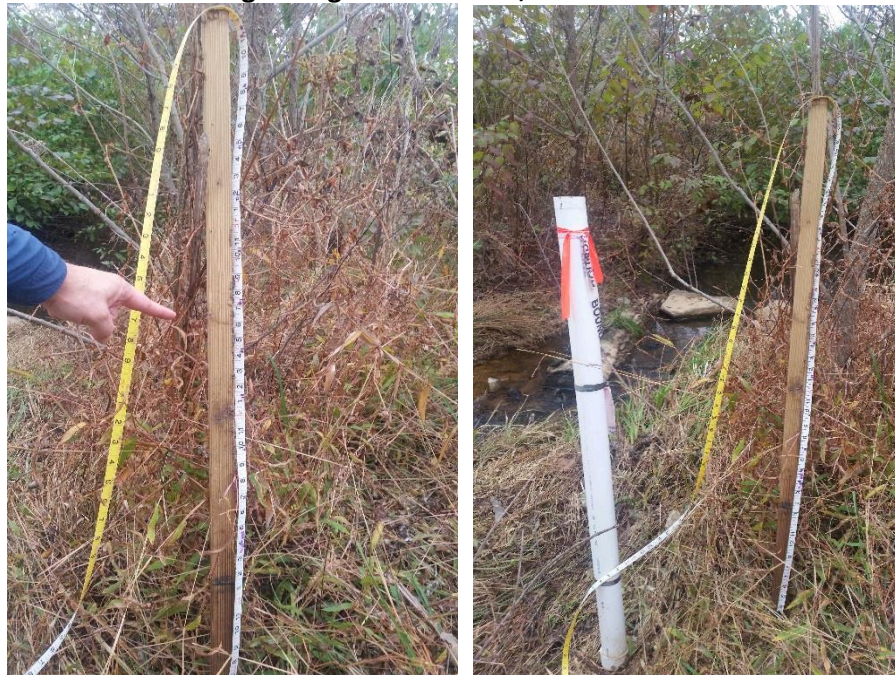
Crest Stage Gauge on Main Trib, November 2016

Date of Collection	Date of occurrence	Method and Location	Photo (If Available)	Feet Above Bankfull
Sep-15	May-Sept/2015	CSG on Main Trib	NA	0.4
Nov-15	11/9/2015	HOBO on North Trib	NA	0.7
Dec-15	12/22/2015	HOBO on North Trib	NA	6.8
Dec-15	12/30/2015	HOBO on North Trib	NA	6.5
Feb-16	2/16/2016	HOBO on North Trib	NA	0.4
Feb-16	2/24/2016	HOBO on North Trib	NA	2
Aug-16	8/8/2016	HOBO on North Trib	NA	1.4
Oct-16	Summer-Fall 2016	CSG on Main Trib	Below	1.4
