Heath Dairy Road Stream Restoration Site Randolph County, North Carolina

DMS Project #170

MY – 04 Fall Monitoring Report

Mogensen Mitigation, Inc.

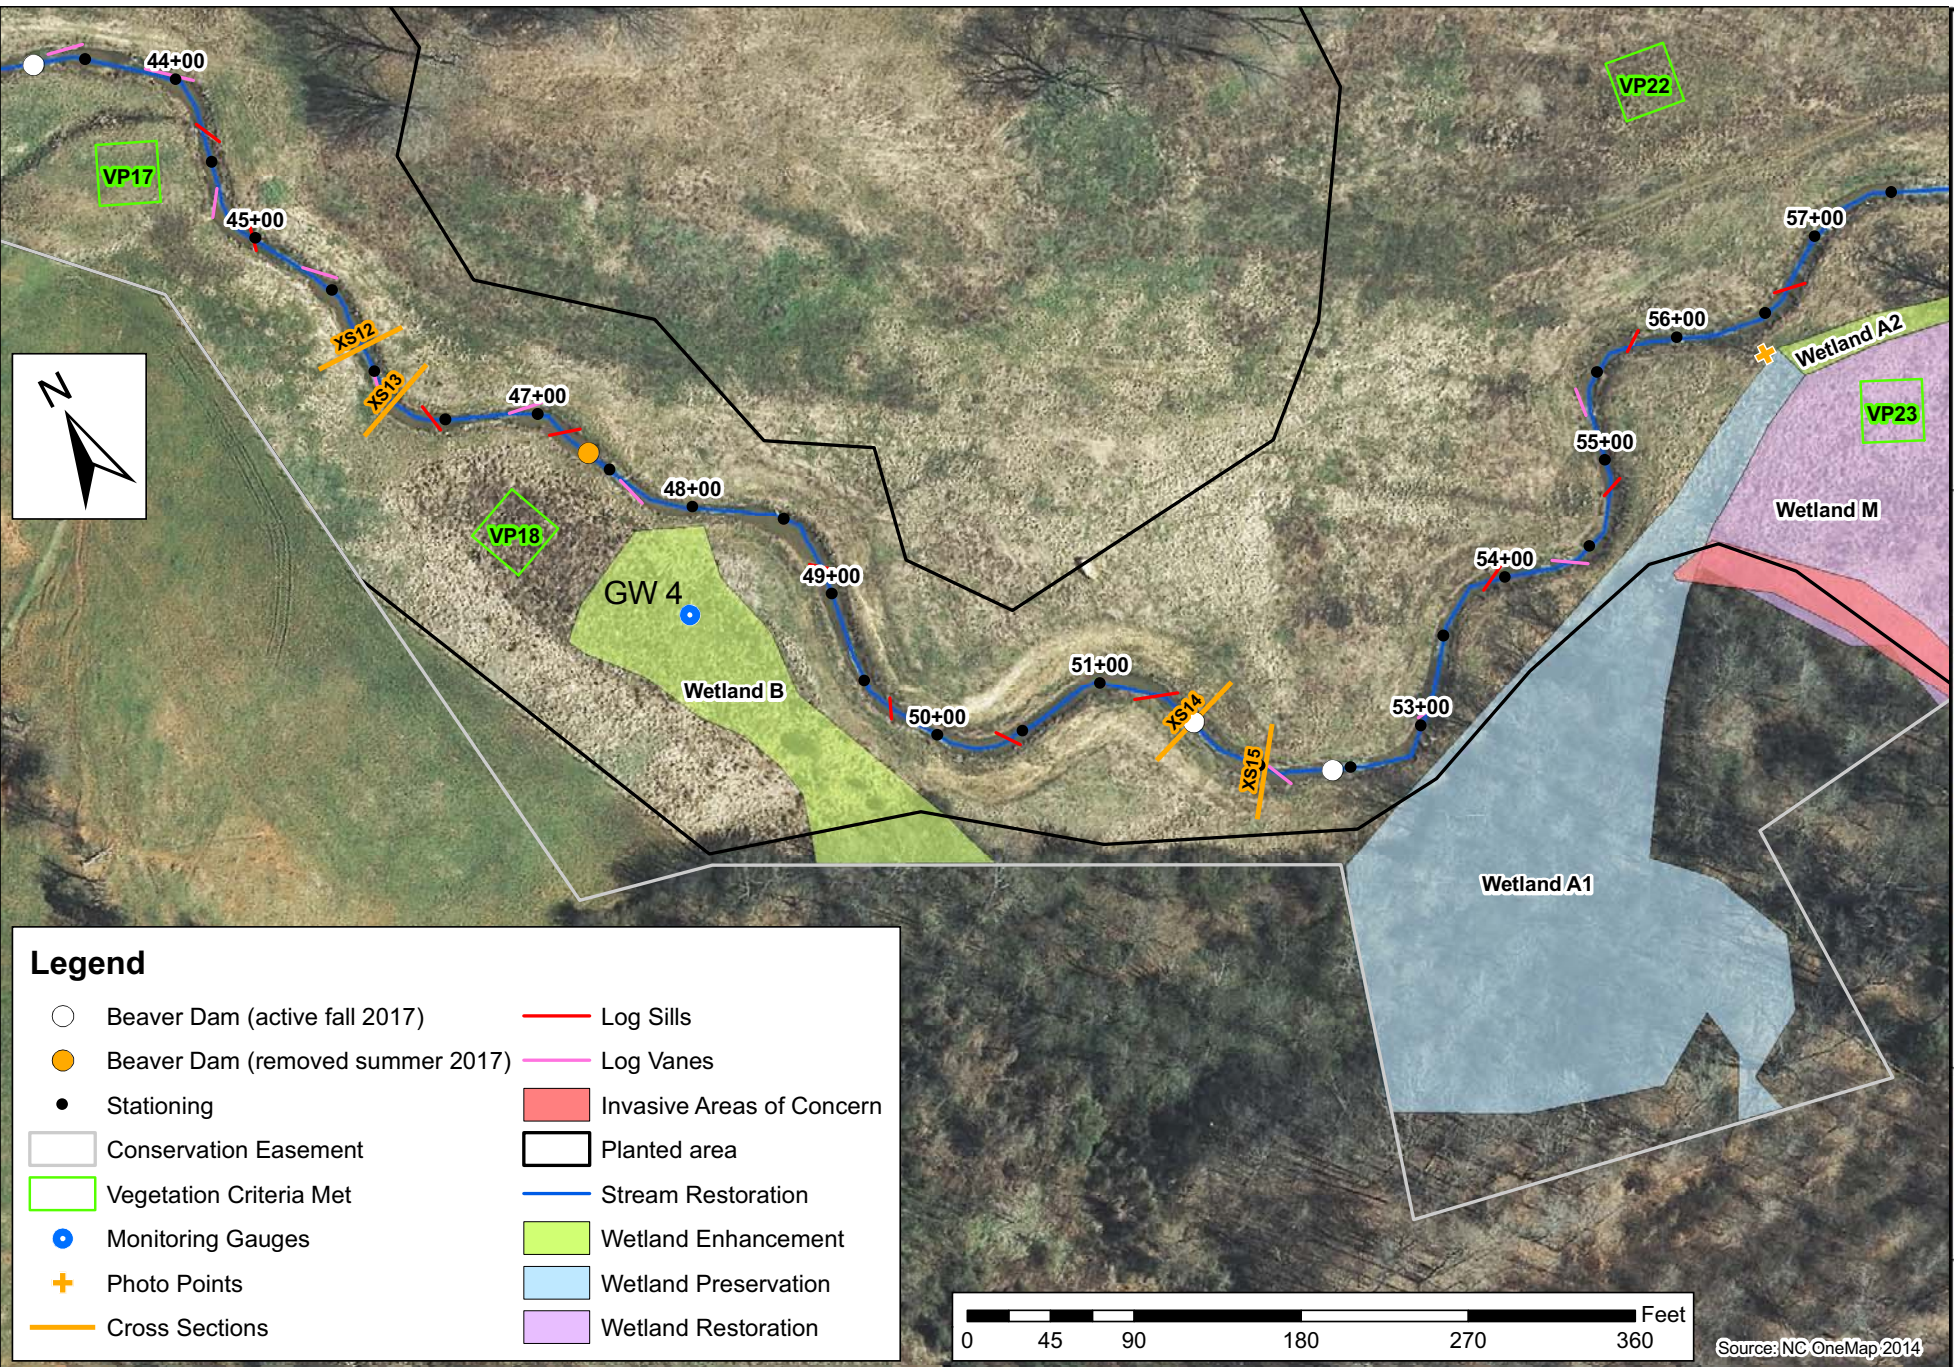
The only new, larger issue we observed during the fall site visit is the evidence of beaver activity in several places along Back Creek. During a routine visit to check gages in July, we discovered one dam and reported it to the DMS project manager – while that particular dam appears to have been successfully removed, several more have become established within the past two months. One large dam occurs at approximately Sta. 44+00 near VP 17 and is backing up water to at least XS's 10 and 11, where fresh beaver chew is evident. A second set of dams occurs further downstream near approximately Sta. 52+00. The larger of these two dams occurs at 50' downstream of XS 15 is creating a backwater effect up to XS 14. The smaller of these dams is located directly at XS 14. The locations of all active and remnant dams are denoted on the CCPV. Due to ongoing beaver activity on the site, first noted in the year 4 spring assessment, the site has been added to the APHIS contract and quarterly site visits will be mandatory. Traps have been set for current residents and dam removal will follow.

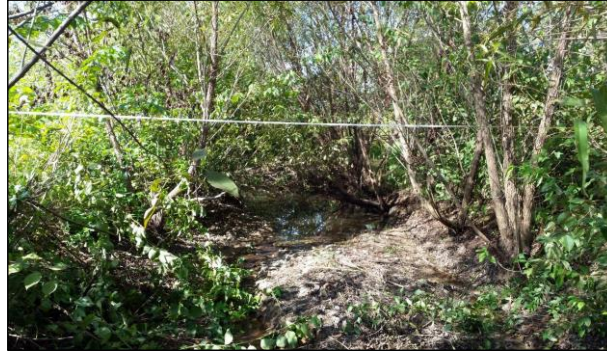
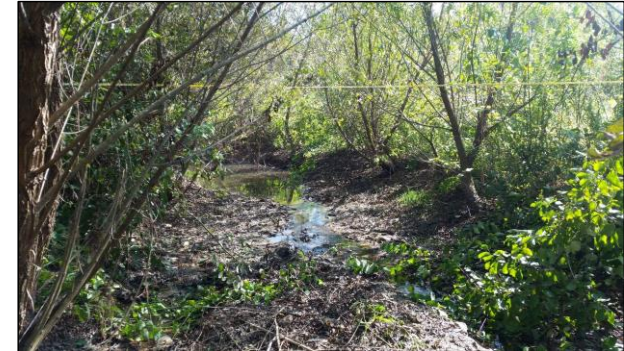
XS-12: Upstream

During our fall assessment, water was found through along the entire extent of Back Creek and North Branch with levels sufficient to cover all riffles to a depth of a few inches. West Branch and East Branch did not have base flow but still retained water in the deepest pools. The beaver activity influenced small changes to a few cross sections, such as a shallowing of XS11, and a change in the bank profile at XS 14. A large center bar is notably bifurcating the channel at XS12.

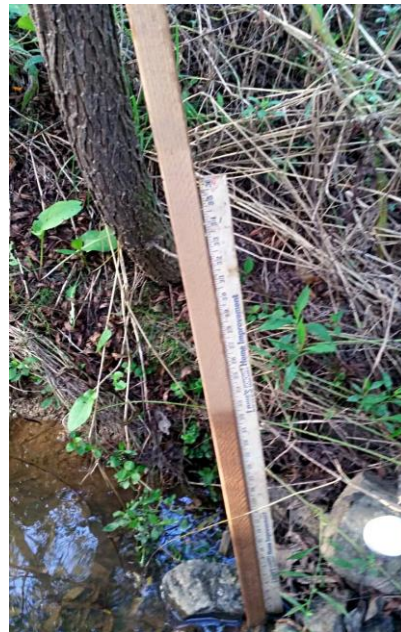
Downstream Crest Stage Gauge, September 2017

Date of Collection	Date of occurrence	Method and Location	Photo (If Available)	Feet Above Bankfull
Sep-15	May-Sept/2015	CSG on Main Trib	NA	0.4
Nov-15	11/9/2015	HOBO on North Trib	NA	0.7
Dec-15	12/22/2015	HOBO on North Trib	NA	6.8
Dec-15	12/30/2015	HOBO on North Trib	NA	6.5
Feb-16	2/16/2016	HOBO on North Trib	NA	0.4
Feb-16	2/24/2016	HOBO on North Trib	NA	2
Aug-16	8/8/2016	HOBO on North Trib	NA	1.4
Oct-16	Summer-Fall 2016	CSG on Main Trib	NA	1.4
Sep-17	Summer-Fall 2017	CSG on Main Trib	Below	2.5
Sep-17	4/25/2017; 6/20/2017	HOBO on North Trib	NA	>2
