Heath Dairy Road Stream Restoration Site Randolph County, North Carolina

DMS Project #170

MY – 05 Fall Monitoring Report

Mogensen Mitigation, Inc.

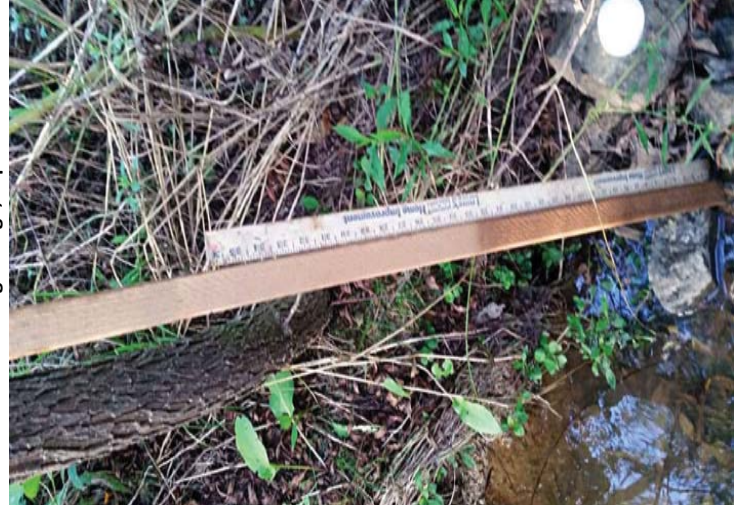
Downstream Crest Stage Gauge, September 2017
